SITE INSPECTION REPORT

PROJECT:	Grenfell Tower	REFERENCE:	7654
SITE ADDRESS:	Grenfell Tower,	CLIENT:	KCTMO
MAIN CONTRACTOR:	Rydon	REPORT NO:	2
INSPECTOR:	Jon White	INSPECTION DATE:	12 December 2014

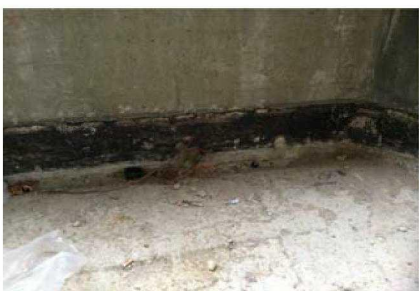
1. Walk way level, original floor level has been reduced down to slab level, ready for the sprung flooring.

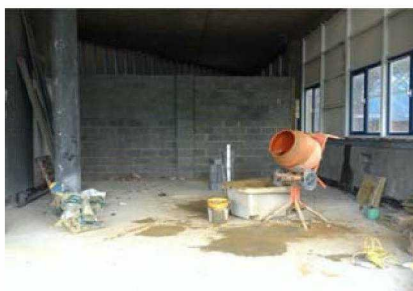
2. Walk way level, block work is nearly completed.

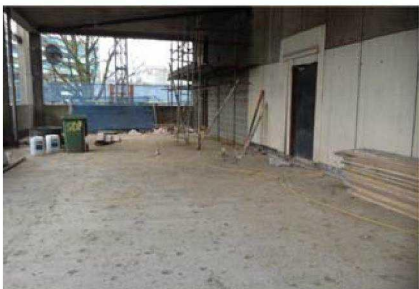
3. Walk way level, block work wall finished.

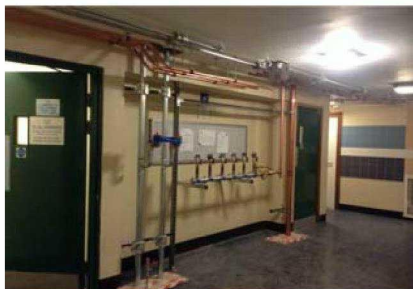
4. Heating flow and return and water mains being formed to each existing lift lobby.

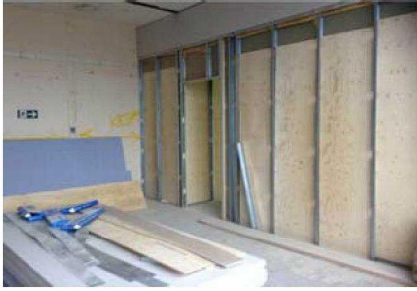
5. Walkway plus 1, partition all up one side ready for M&E 1st fix

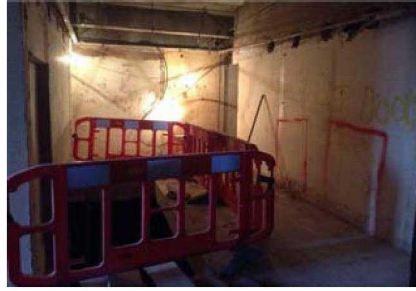
6. Walk way plus 1, lift lobby, three concrete walls access has been cut out for permanent use.

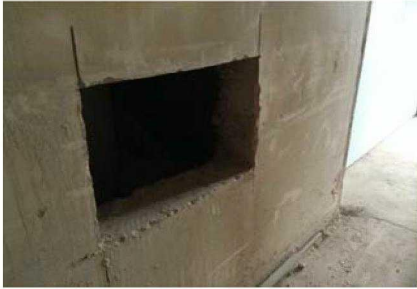
7. Walkway plus 1, rubbish hopper has also been cut out ready for permanent use.

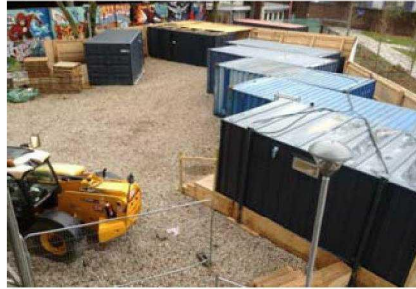
8. Ground floor site compound set up with containers and site huts

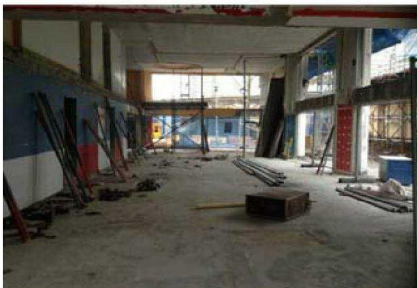
13. Ground floor and Mezzanine floors works being demolition ready for steel floor

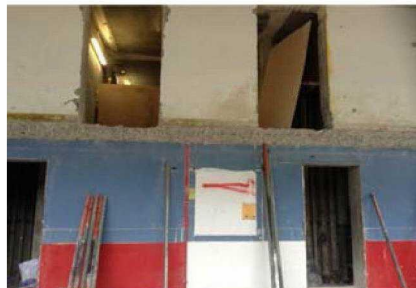
14. Ground floor and Mezzanine floors showing new lift lobby access formed

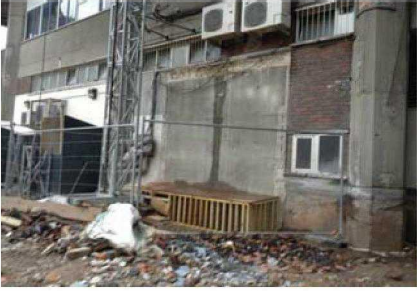
15. Ground floor three large concrete vent shafts have be demolished

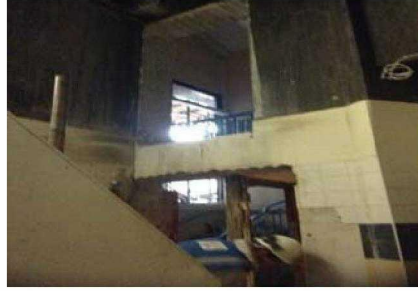
16. Ground floor and Mezzanine floors, lift lobby access holes being formed

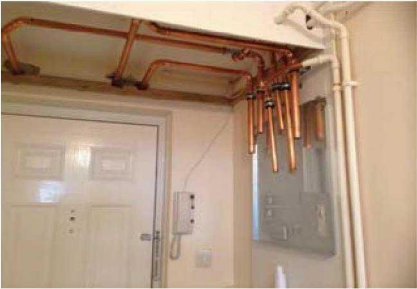
17. Flat 145 pilot, new position for the HRU to be placed adjacent to the front entrance door.

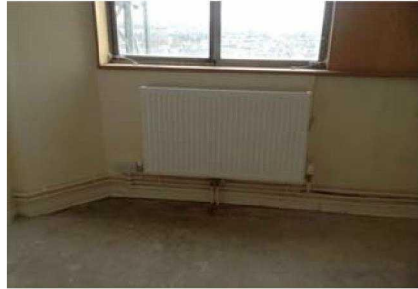
18. Flat 145 pilot, new rads fed from above the skirting (as apposed from the floor).

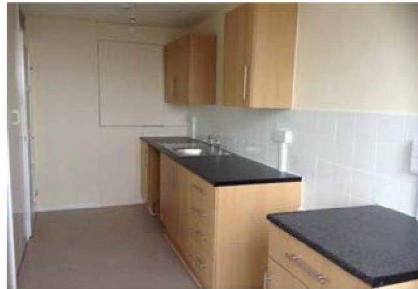
20. Flat 145 pilot, kitchen (new void kitchen fitted by KCTMO).
