SITE INSPECTION REPORT

PROJECT:	Grenfell Tower	REFERENCE:	7654
SITE ADDRESS:	Grenfell Tower,	CLIENT:	KCTMO
MAIN CONTRACTOR:	Rydon	REPORT NO:	3
INSPECTOR:	Jon White	INSPECTION DATE:	04 February 2015

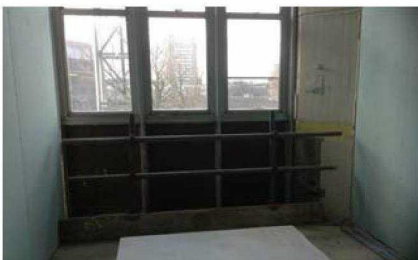
1. Walkway +1 level, scaffold handrail has been fixed ready for the external certain walling to be removed, so the internal finished can progress.

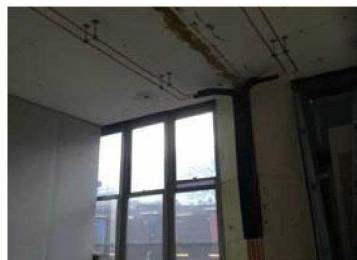
2. Walkway +1 level, all partitions have been changed, to enable the units to be a 3 bedroom unit from a 4 bedroom unit. M&E has also now been changed to suit.

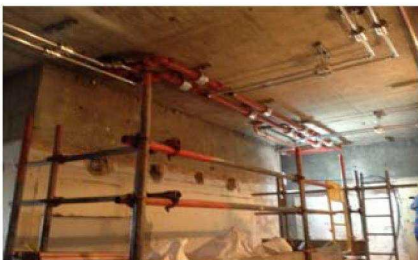
3. Walkway +1 level, lift lobby pipework progressing, well.

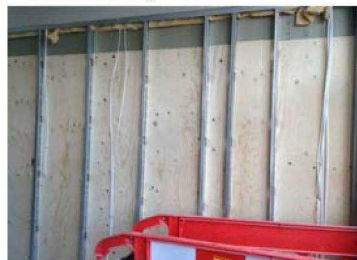
4. Walkway +1 level, 1st fix electrical to all the partitions progressing well.

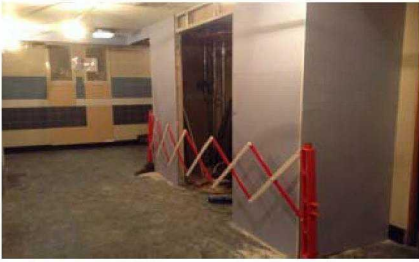
5. Floor 14, sample lobby pipe cupboard is now being erected for KCTMO and residents to approve.

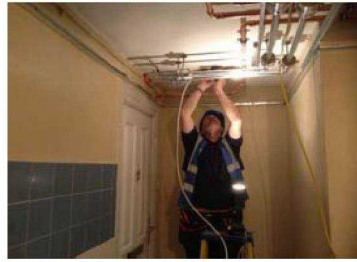
6. Floor 14, the original ceiling light is temporary being moved to the wall, as it clashes with the new ceiling soffit. New position is yet to be agreed. This includes the smoke detector in the lift lobby. This will have to be retested.

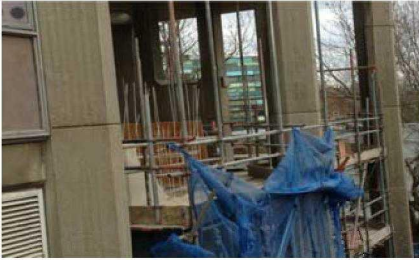
7. Walkway plus 1, external staircase and lift shaft being demolished.

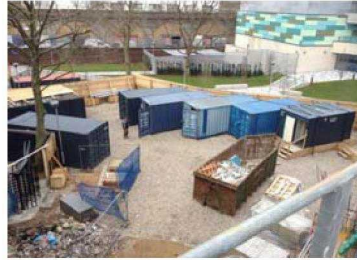
8. Ground floor site compound set up with containers and site huts

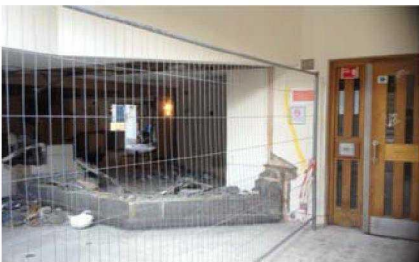
9. Ground floor concierge office now being demolished.

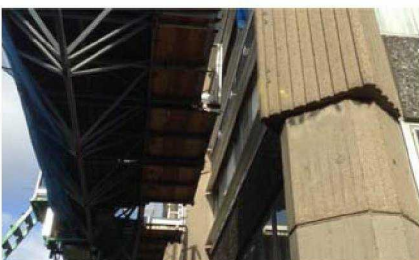
13. West Elevation, brackets to windows and mullions now being fitted.

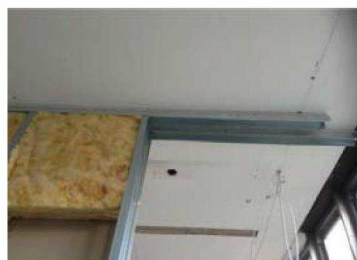
14. Walkway +1 portion wall being constructed, showing the fire detail.

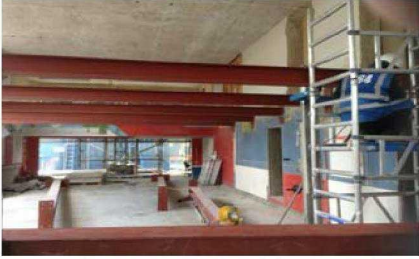
15. Ground floor mezzanine deck steels being installed.

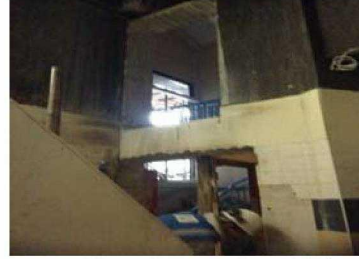
16. Ground floor and Mezzanine floors, lift lobby access holes have being formed

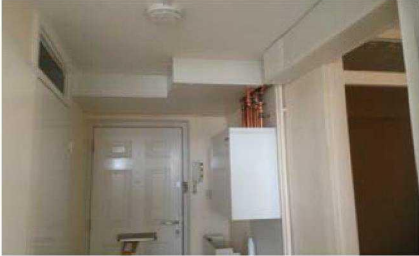
17. Flat 145 pilot, new position for the HRU to be placed adjacent to the front entrance door, pipes have now been boxed in.

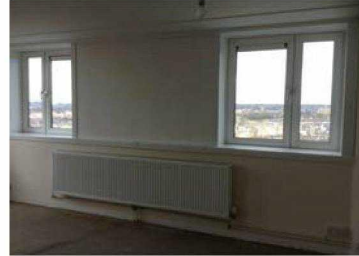
18. Flat 145 pilot, new rads fed from above the skirting (apposed from the floor), and new sample windows and internal cladding that has now been approved.

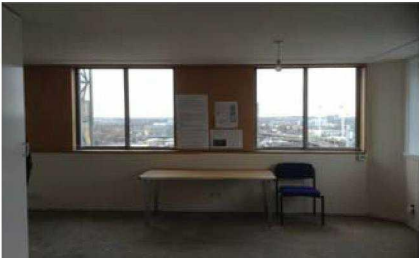
19. Flat 145 pilot, existing lounge window

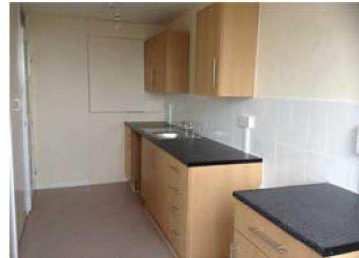
20. Flat 145 pilot, kitchen (new void kitchen fitted by KCTMO).
