SITE INSPECTION REPORT

PROJECT:	Grenfell Tower	REFERENCE:	7654
SITE ADDRESS:	Grenfell Tower, Grenfell Road, London W111TQ	CLIENT:	KCTMO
MAIN CONTRACTOR:	Rydon	REPORT NO:	5
INSPECTOR:	Jon White and Tony Batty	INSPECTION DATE:	11 March 2015

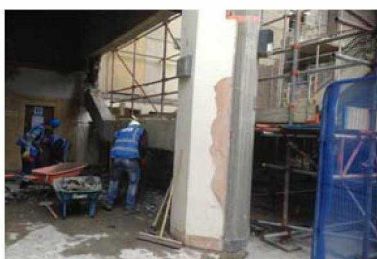
Ground floor entrance walls being demolished

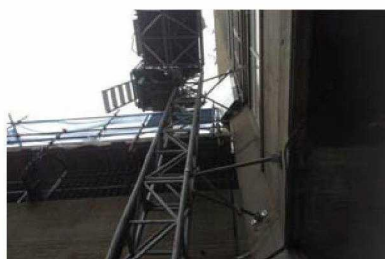
South Elevation climbing mast only erected a couple of floors.

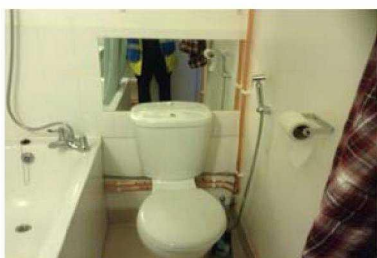
Flat 191, new pipes fitted behind WC.

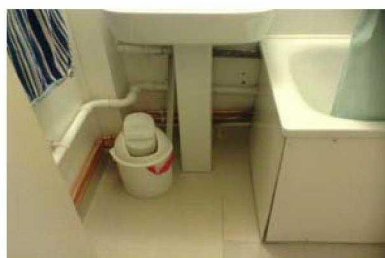
Flat 191, new pipes fitted behind whb.

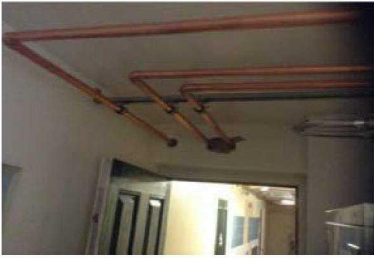
Flat 191, new pipes fitted above the FED, plaster to be made good and painted.

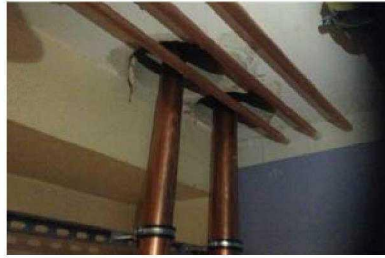
19th Floor riser pipes, to be fires sealed at a later stage.

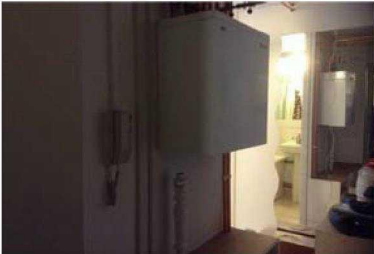
Flat 191, new HIU heating unit has been fitted, and 1st fix pipework has also been fitted, to be connected at a later date.

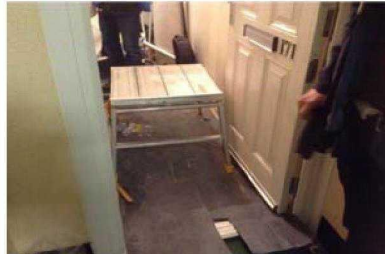
Flat 171, new HIU being fitted, protection to floor has been fitted.

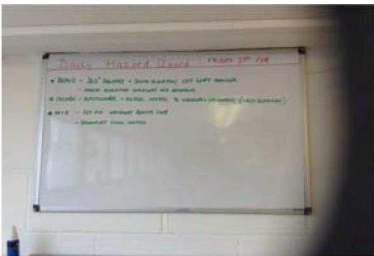
Daily Hazard board situated in the site office to be kept up to date. (this is currently dated as shown on Friday 27th February).

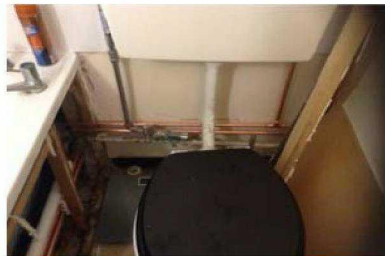
Flat 171, new pipes being fitted behind WC.

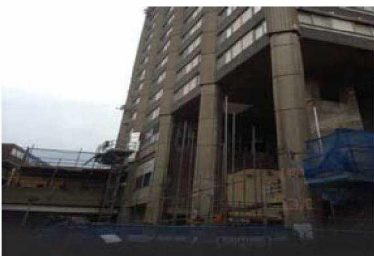
11. External South Elevation, showing climbing mast up to walkway +1 level

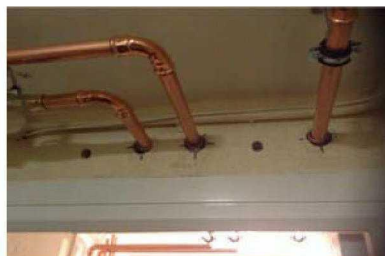
Flat 171, new pipes holes above the FED need to be fire sealed before being covered up.

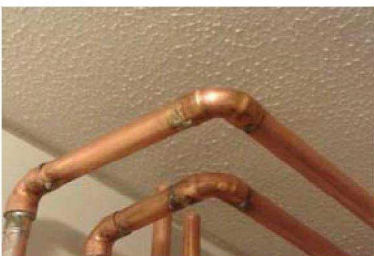
Flat 176, new pipes fitted the excessive flux is to be cleaned off.

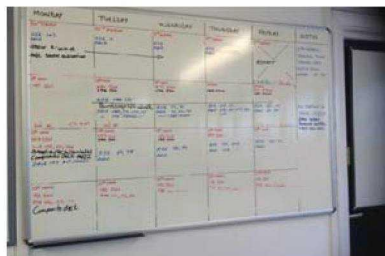
Rydons have got a wall board diary with up to date access for all works to each flat, situated in the site office.

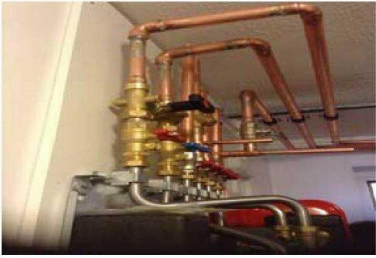
Flat 176, new pipes fitted have been fitted, and misaligned, and could cause future leaks.

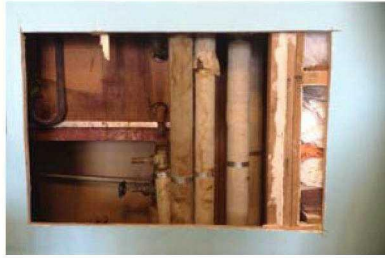
Flat 176, new access panel had had to be cut out of the existing kitchen side panel, make good when refitting.

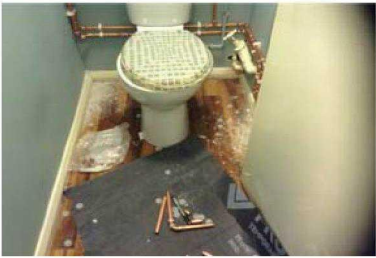
Flat 176, protection needs to cover ALL the floor, not just some.

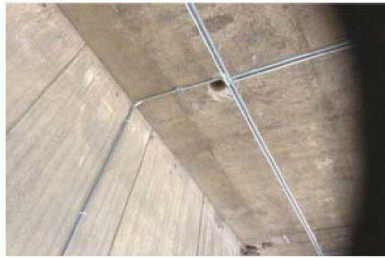
Boxing club, electrical first fix now has started.

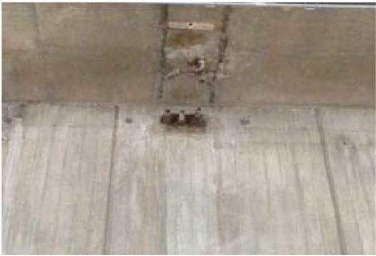
Boxing club, any existing old pipe work that has been cut off, the fire inter gritty to be maintained, if in a fire wall, pipes to be removed and fire stopped.

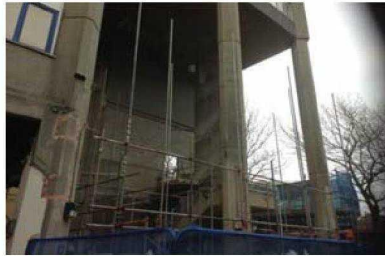
Demolition to external staircase and lift shaft has now been completed.
