SITE INSPECTION REPORT

PROJECT:	Grenfell Towers	REFERENCE:	7654
SITE ADDRESS:	Grenfell Tower, Grenfell Road, W11	CLIENT:	KCTMO
MAIN CONTRACTOR:	Rydons	REPORT NO:	21
INSPECTOR:	Jon White	INSPECTION DATE:	01 October 2015

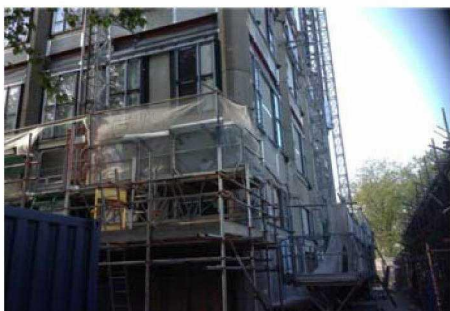
Low level cladding still to be finished, although most of the new windows now fitted. Picture taken from NE corner.

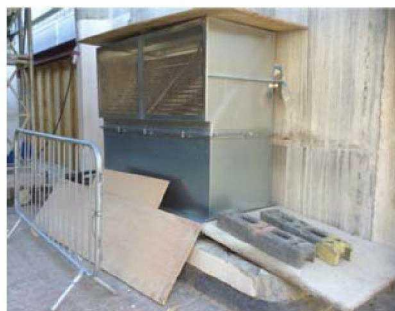
New basement extract duct has not been made good or weathered yet.

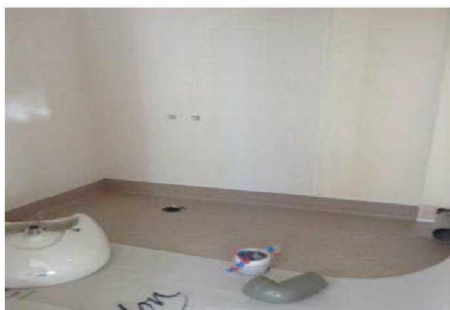
Walkway + 1, M&E 2nd fix progressing well.

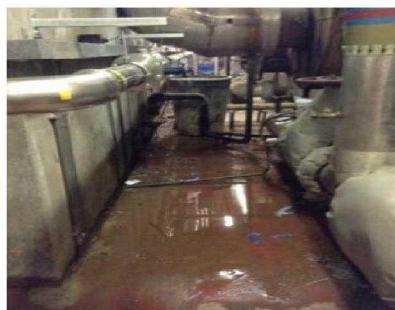
In the basement water is still puddling, causing problems with the Rydons workers, caused by existing water tank leaks. KCTMO to fix asp, with their term contractor.

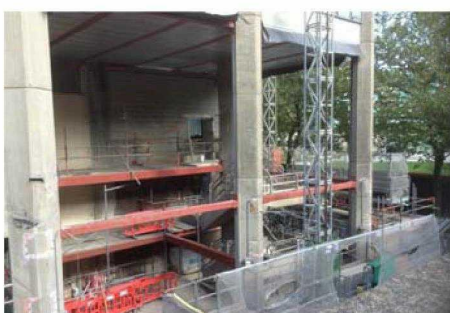
The South East corner the cladding has yet to start.

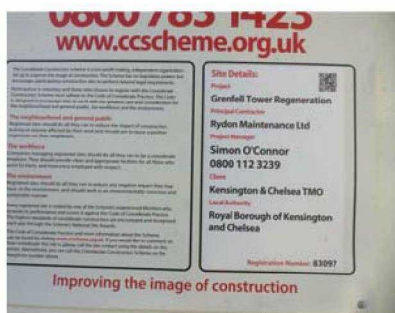
Harding sign to change the name of the person to contact, as Simon no longer on this contract.

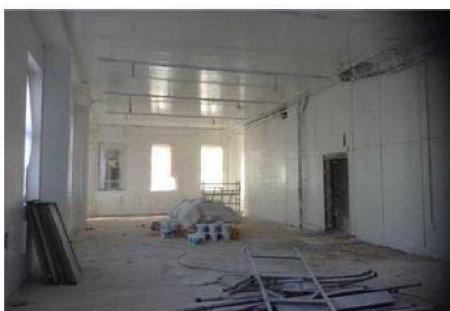
Boxing club has now had its first coat of paint.

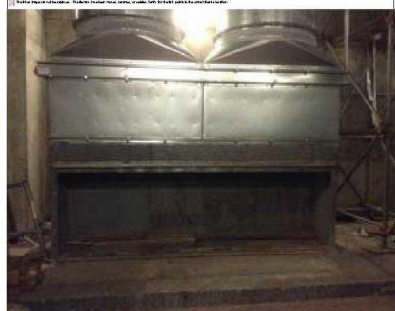
Basement intake air ducting to have grille and waffle fitted, and boilers will have to be re-commissioned.

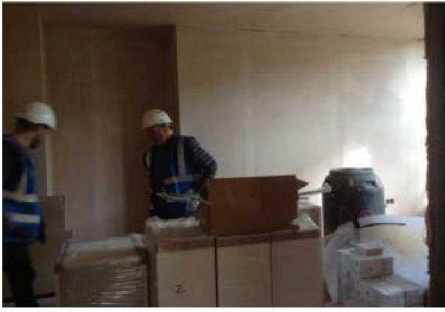
Walkway + 1 - new flats plastering painting and kitchen units progressing well. Flat no 26, nearly finished.

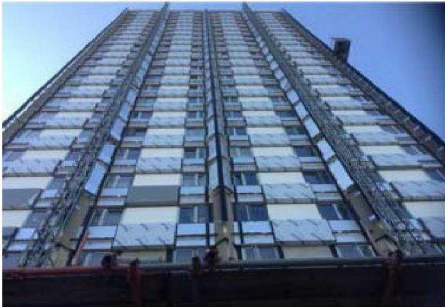
North Elevation - Only 80 panels out of 240 have been fitted. Also 90% of the column brackets have been fitted, and the top canopy is progressing. No mast climber working today, with no operatives.

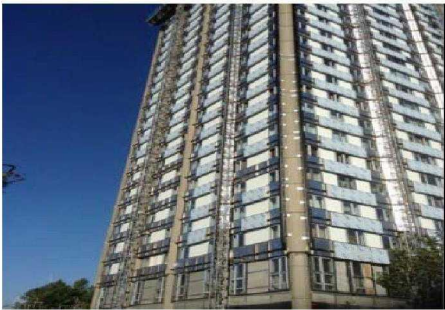
South Elevation, Only 66 of the panels out of 240 have been fitted. Also approx 50% of the column brackets have been fitted, and the top canopy is now being worked on. Only one mast climber working with 2 operatives today.

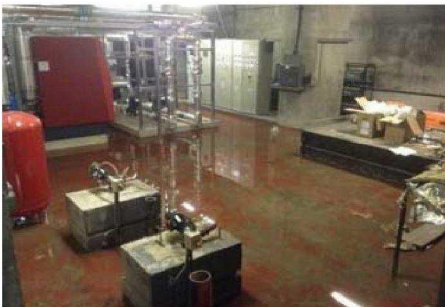
The boilers have been commissioned, but will have to be commissioned again when the permanent ventilation fans have been fitted.

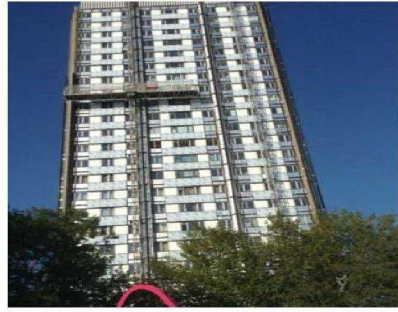
East Elevation - Only 60 panels out of 296 have been fitted, with very little progress in the last 7 weeks. Also 90% of the column brackets have been fitted, and the top canopy has started. Only one mast climber working with 2 operatives today.

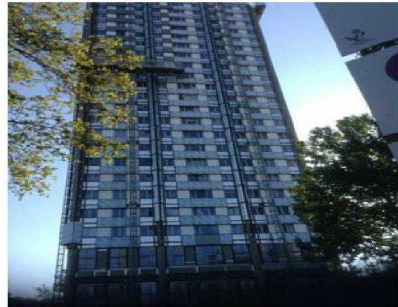
West Elevation - Only 138 panels out of 296 have been fitted. Also 75% of the column brackets have been fitted, and the top canopy is now being worked on. Only one mast climber working with 2 operatives today.

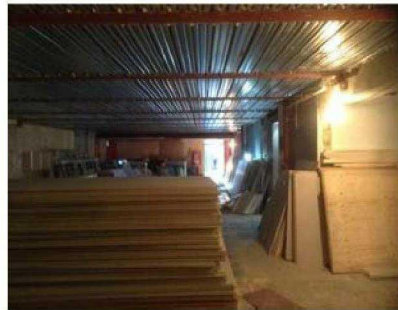
Ground floor works have not progressed now for several weeks.

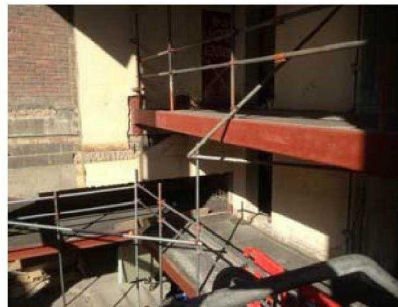
The concrete linking slabs have now been poured in the low level South East corner.

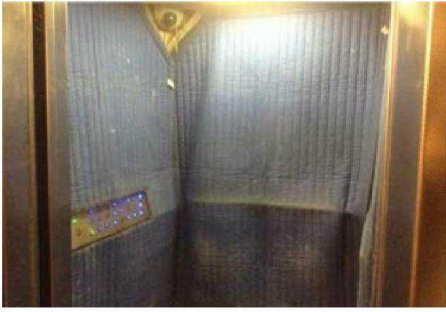
The residents left hand lift has been damaged because no protection has been fitted to the left hand panel. Rydons to protect asp.

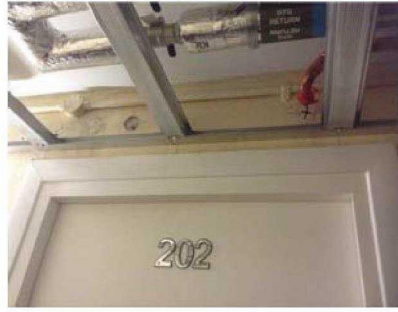
Heating HIU's not connected to the following flats, or access panels left out with Rydons to confirm if fitted. The flats are Nos.; 16, 26, 31,44,51,52,53,54,66,72,82,85,95,111,114,122,126, 132,133,134,152,155,156,173,174,182,183,185,186 ,192,193,196,202 and 205.

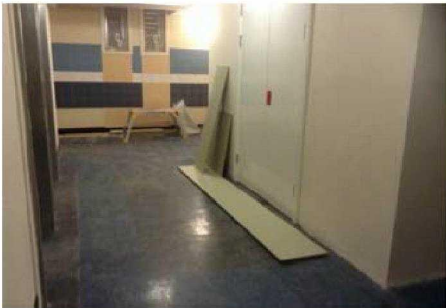
Generally the lift lobbies need a good clean, and all the materials need to be stored away either in each flat or in the lift lobby cupboards.

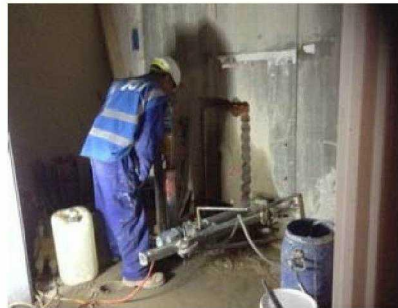
The AOV structural openings are now being cut out at the lower floors. One position to agree with Structural engineer. This hole is on Walkway +1.
