SITE INSPECTION REPORT

PROJECT:	Grenfell Towers	REFERENCE:	7654
SITE ADDRESS:	Grenfell Tower, Grenfell Road, W11	CLIENT:	KCTMO
MAIN CONTRACTOR:	Rydons	REPORT NO:	22
INSPECTOR:	Jon White	INSPECTION DATE:	15 October 2015

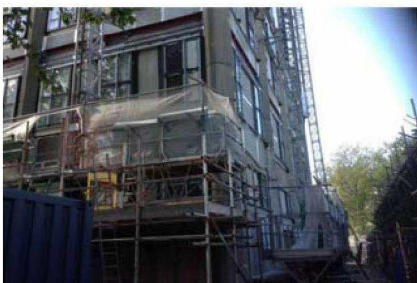
Low level cladding still to be finished, although most of the new windows now fitted. Picture taken from NE corner.

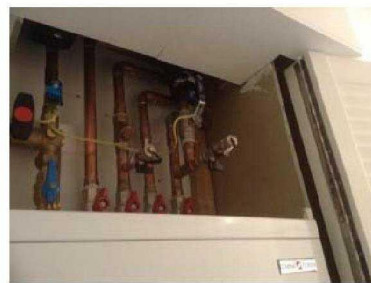
The new HIU's in the old flats have been installed with a new water mains stop cock positioned above the unit, and possibly difficult to get to for an old person. Has the position been agreed?

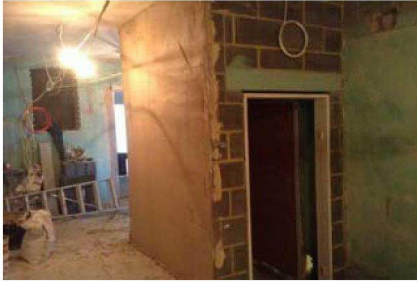
Walkway + 1, lift lobby, ceiling has now been plastered, walls in progress.

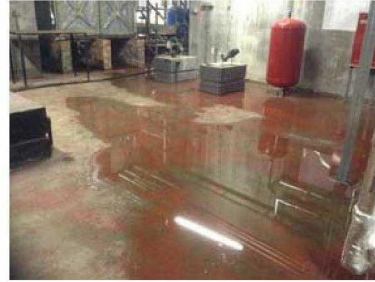
In the basement water puddling has now got better, hopefully this has now been resolved.

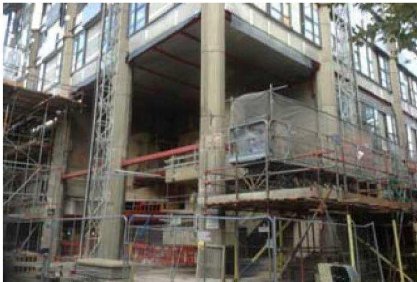
The South East corner the cladding has yet to start.

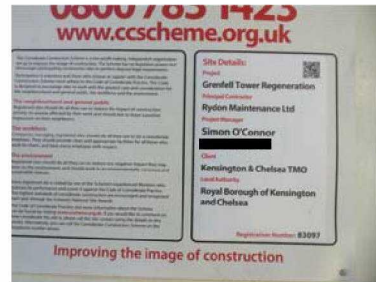
Harding sign still to change the name of the person to contact, as Simon no longer on this contract.

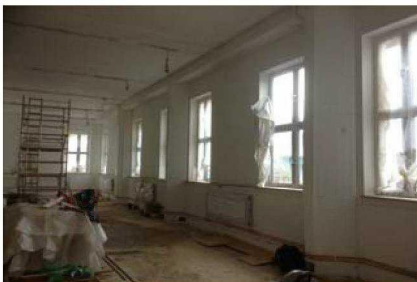
Boxing club has now had its first coat of paint, window boards fitted, and rads installed.

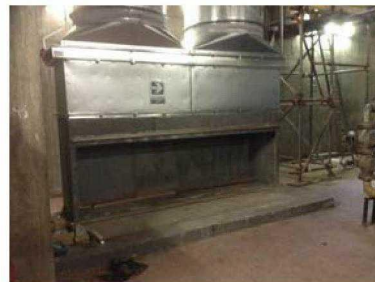
Basement intake air ducting to have grille and waffle fitted, and boilers will have to be re-commissioned.

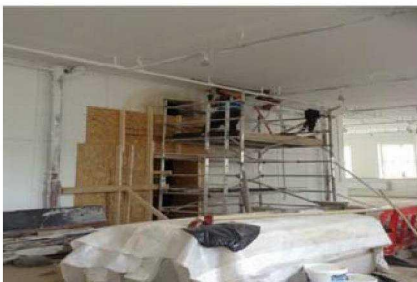
Boxing club AOV's are now being installed.

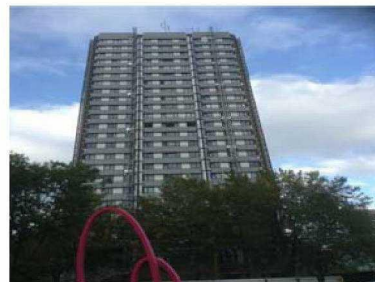
East Elevation - 17 panels out of 296 have to be fitted. 90% of the column brackets have been fitted, with no corner panels fitted yet. The top canopy has nearly finished. No lower floor panels have been fitted. Only one mast climber working with 2 operatives today.

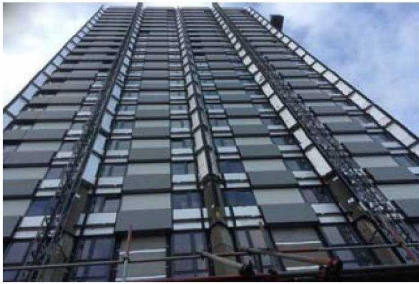
North Elevation - 94 panels out of 240 have been fitted. Also 90% of the column brackets have been fitted, and the top canopy is nearly finished. No column panels or lower floor panels have been fitted yet. Two mast climber working today, with 4 operatives.

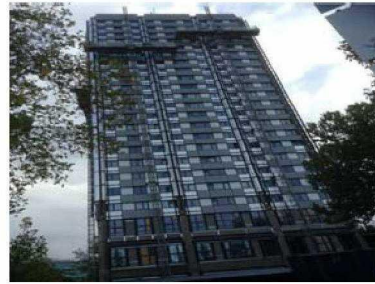
West Elevation - 102 panels out of 296 have to be fitted. Also 90% of the column brackets have been fitted, and the top canopy is nearly done. No column panels or lower floor panels have been fitted yet. Two mast climber working with 4 operatives today.

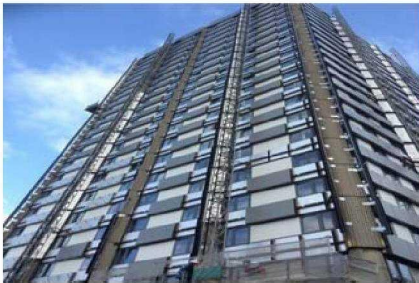
South Elevation - 131 of the panels out of 240 have been fitted. 70% of the column brackets have been fitted, and the top canopy is nearly done. No column panels or lower level panels have yet been fitted. Two mast climbers are working with 4 operatives today.

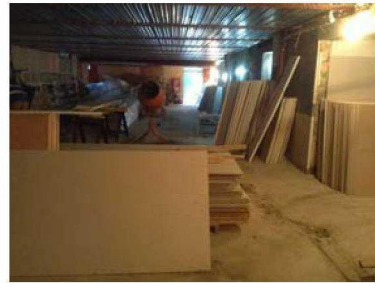
Ground floor works have not progressed now for several weeks.

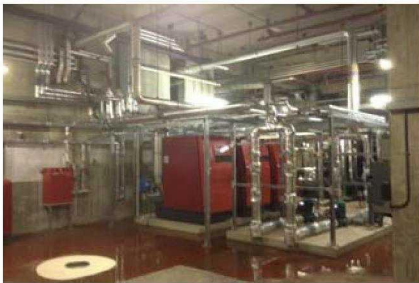
The boilers have been commissioned, but will have to be commissioned again when the permanent ventilation fans have been fitted. Labelling of all valves, schematic layouts, and general finishing off to all plant to be done.

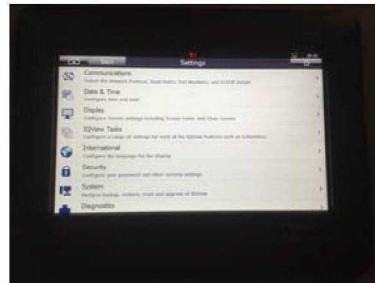
Basement boiler panel has yet to be installed fully.

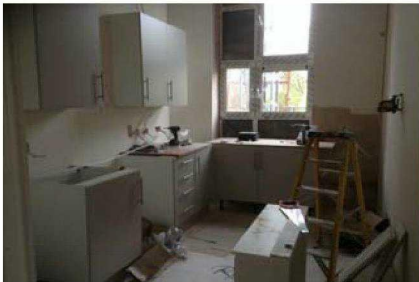
Walkway + 1, progressing well, flat D kitchen has now started, all other flats nearing completion.

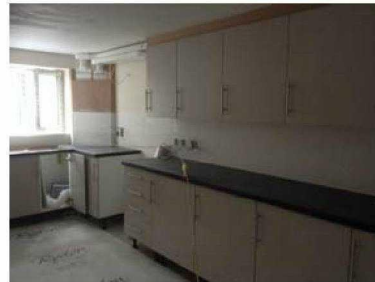
New riser cupboards to the 23th floor to the 4th floor, Rydons have stated that Max Fordams and building control are to agree the air ventilation and fire protection to the new lift lobby cupboards. Building inspector requires doors to be fire sealed.
Rydons to confirm that all the flats on the mezzanine floors have not got any heat detectors?

Mezzanine floor flats, kitchen and finishing trades progressing well. Query no evidence of the heat detectors being fitted yet in the kitchens.

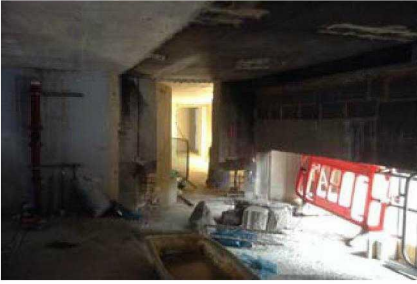
The last flat on Mezzanine floor, (on the south west corner), structural opening from the lift lobby now formed. No other work yet started.

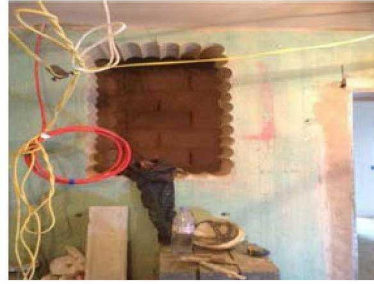
The AOV structural openings are now being cut out at the lower floors, all locations now agreed, nine openings to be cut out.
