# SITE INSPECTION REPORT

PROJECT:	Grenfell Towers	REFERENCE:	7654
SITE ADDRESS:	Grenfell Tower, Grenfell Road, W11	CLIENT:	KCTMO
MAIN CONTRACTOR:	Rydons	REPORT NO:	25
INSPECTOR:	Jon White	INSPECTION DATE:	17 November 2015

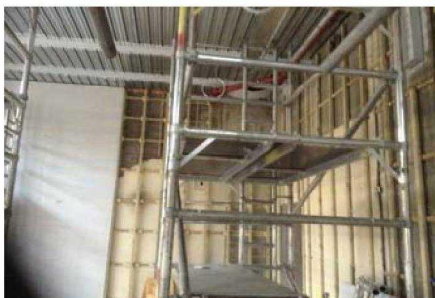
Mezzanine +1, entrance hall, battening for the cladding in progress. The AOV needs to be fitted first before all the finishing trades can be done. This should be installed according to Rydons in Six weeks.

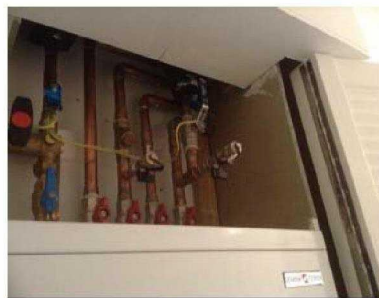
The new HIU's in the old flats have been installed with a new water mains stop cock positioned above the unit, and possibly difficult to get to for an old person. In the site meeting on 17th Nov, both KCTMO and Rydons agreed it was too late to change, as most have now been fitted.

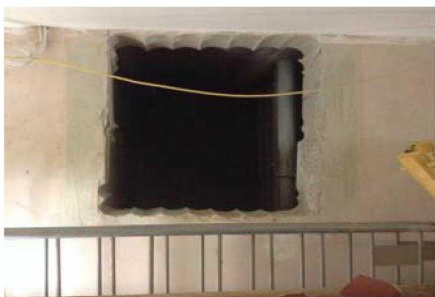
All the AOV holes are cut out except two to do. The extract ducting will not be on site for some 6 weeks.

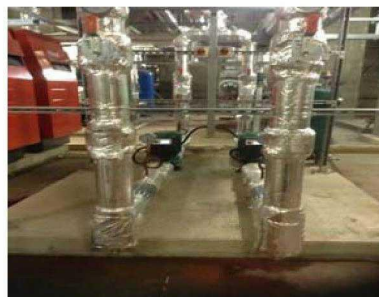
The new pipes to the basement have been lagged, but need to be clad.

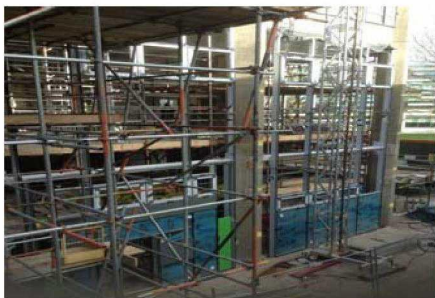
The South East corner the cladding is proceeding, and the glazed panels have also started.

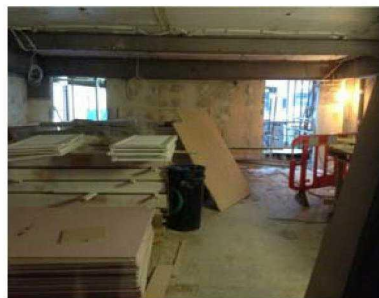
The ground floor openings have been formed, and the partitions and M&E 1st fix have also started.

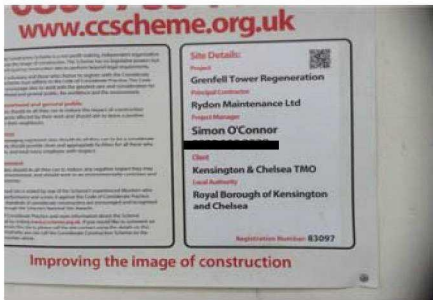
Rydots still have not changed the hoarding signage for the contact details. Please change.

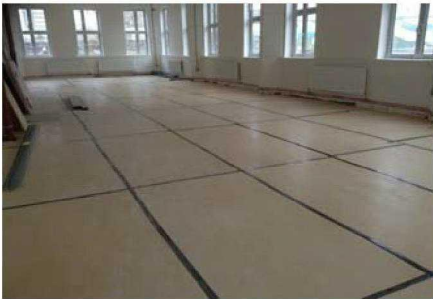
Boxing club AOV's are now installed, above the lift opening. Suspended floor being fitted now, Rydots to confirm it has been installed to the manufacturer specification and clients ER's.

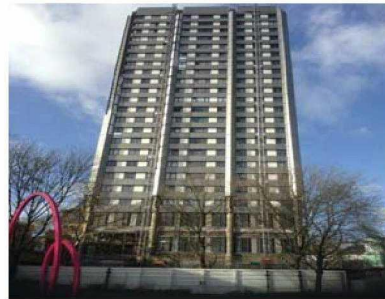
East Elevation - 16 panels out of 296 have to be fitted. 90% of the column brackets have been fitted, with 128 column panels fitted out of 138. (Not including the lower floors). The top canopy has nearly finished. No lower floor panels have been fitted. Only one mast climber working with 2 operatives today.

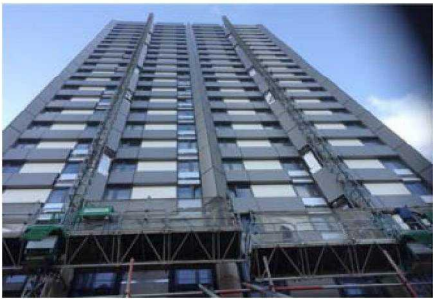
North Elevation - 24 panels out of 240 have to be fitted. Also 90% of the column brackets have been fitted, and the top canopy is nearly finished. 100 out of 184 column panels have been fitted. None of the lower floor panels have been fitted yet. One mast climber working today, with 2 operatives.

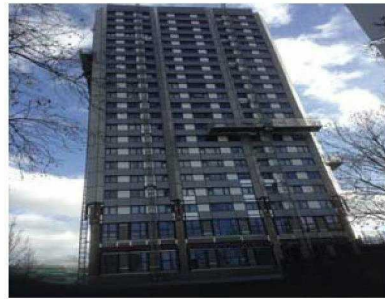
West Elevation - 25 panels out of 296 have to be fitted. Also 90% of the column brackets have been fitted, and the top canopy is nearly done. All of the column panels have been fitted, down to the 3rd Floor. No lower floor panels have been fitted yet. One mast climber working with 2 operatives today.

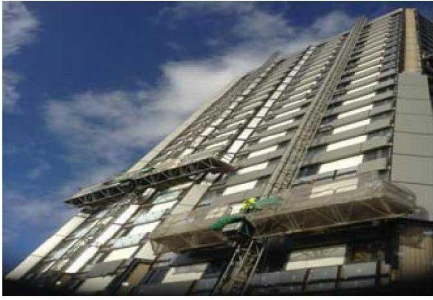
South Elevation - 118 panels out of 240 have to be fitted. 80% of the column brackets have been fitted, and the top canopy is nearly done. 67 of the 184 column panels have been fitted. Lower entrance framework is now being installed. Two mast climbers are working with 4 operatives today.

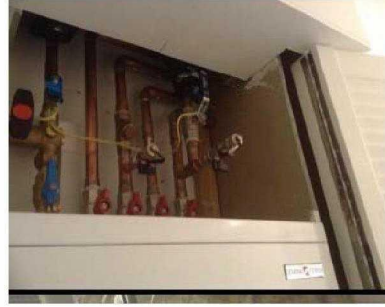
The final commissioning of the new boiler room plant cannot start until all the two ventilation holes have been made good, and all the holes to the new pipes fitted into the main concrete core, so a complete seal is achieved.

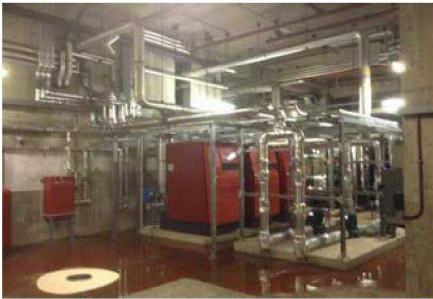
The boilers still have been commissioned, but will have to be commissioned again when the permanent ventilation fans have been fitted. Labelling of all valves, schematic layouts, and general finishing off to all plant to be done.

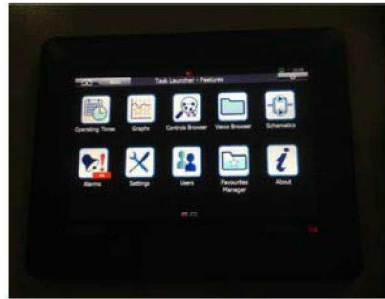
Basement boiler panel is still yet to be installed fully. Can Rydons confirm why 42 alarms have been activated. Still no Schematics have been installed. Rydons have now confirmed the date to start commissioning the boiler controls, etc, has been moved from Friday 13th, to a later date.

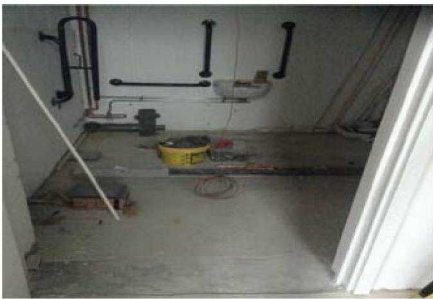
Boxing club disabled WC in progress, floor yet to be laid.

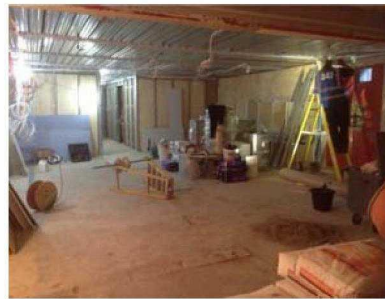
Ground floor area, and nursery area, partition have started one side, 1st fix M&E is in progress.

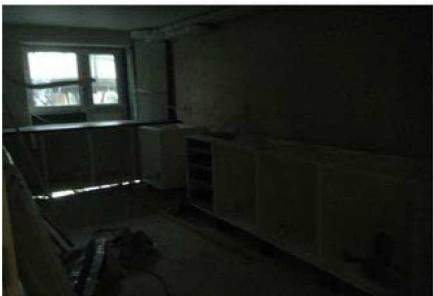
Mezzanine last flat to the South West corner, plastering now done, and 2nd fix carp and M&E and kitchen fitting has now started.

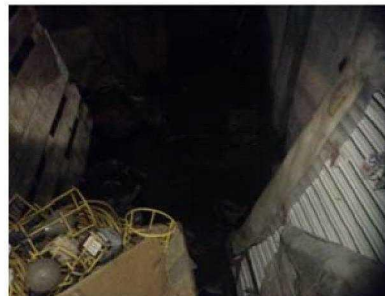
As discussed in the last site meeting, the existing soil pipe in the basement is still leaking, and KCTMO to action as soon as possible.
