SITE INSPECTION REPORT

PROJECT:	Grenfell Towers	REFERENCE:	7654
SITE ADDRESS:	Grenfell Tower, Grenfell Road, W11	CLIENT:	KCTMO
MAIN CONTRACTOR:	Rydons	REPORT NO:	28
INSPECTOR:	Jon White	INSPECTION DATE:	23 December 2015

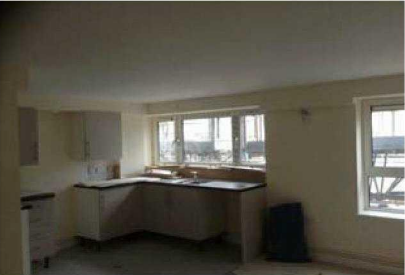
Mezzanine flats progressing well. Max Fordams and Rydons to confirm No heat or smoke detectors are scheduled to be fitted, on all of the mezzanine flats, and this has been approved by building control.

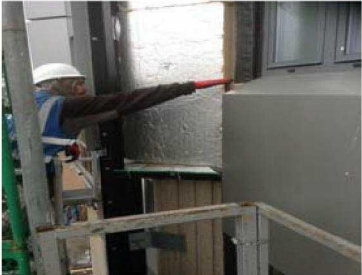
The South Elevation cannot be finished at all, because the access behind the West climber on the South Elevation, is totally unsafe. This is now being resolved by Rydons, but needs to be approved by all the H & Safety officers. This is on the critical path.

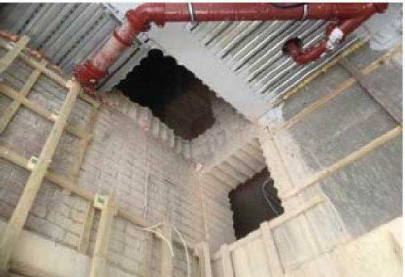
All the AOV holes have been cut out. The extract ducting is due on site after the Christmas break.

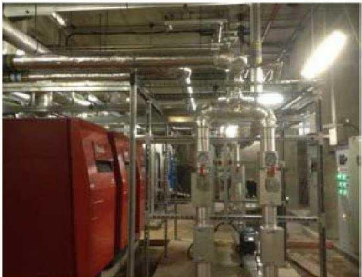
The new pipes to the basement have been lagged, and has started to be clad, but high level pipes need to be done.

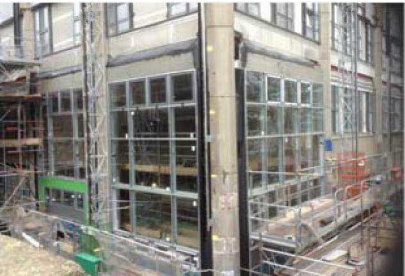
The South East corner the cladding is proceeding, and the glazed panels have nearly finished. The column trims are now being fitted.

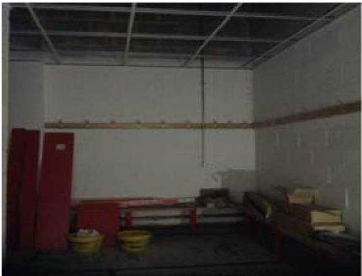
The boxing club changing rooms are progressing, but ceiling and M&E etc, yet to be finished,

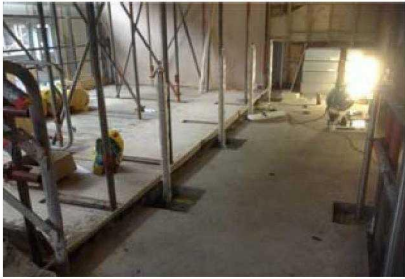
The entrance hall balustrades have started to be installed.

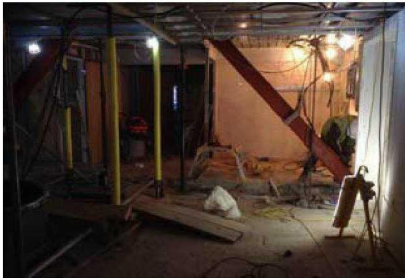
The two steel supports to the ground floor entrance hall have now been fitted.

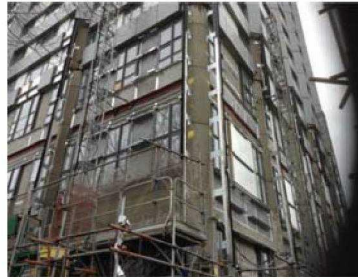
Low level cladding is progressing slowly. Picture of the North East corner.

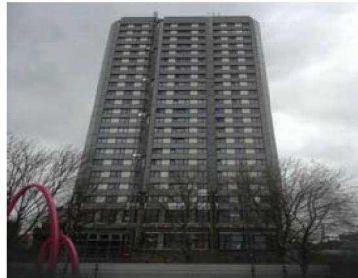
East Elevation - Still 3 panels out of 296 have to be fitted. 90% of the column brackets have been fitted, with 33 column panels to be fitted. The top canopy has been finished. No lower floor panels have been fitted. Snagging and de snagging to the North climber is finished, and mast climber down to level 3. South mast climber still fitted, and area not ready to snag.

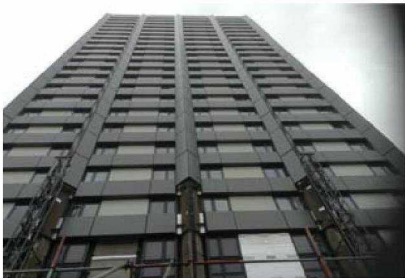
North Elevation - has been snagged and de snagged down to level 3, all finished apart from the lower levels. Master climbers have come down to level 3. Lower panel have made a start.

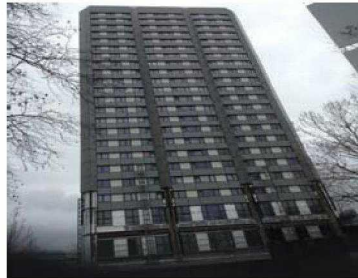
West Elevation - has been snagged and de snagged down to level 3. Both master climbers have come down to level 3. Lower floor cladding has now started.

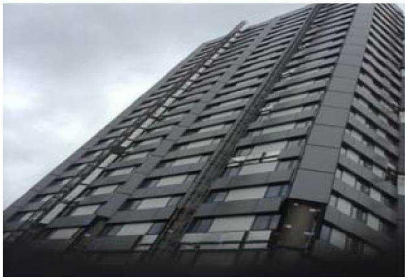
South Elevation - All the cladding panels have been fitted, except the lower levels, and ones that are affected by the hoist ties. 90% of the column brackets and panels have been fitted, and the top canopy is nearly done. Lower entrance framework is now being installed. One panel behind the North climber can't be accessed from the ground all the way up to the roof.

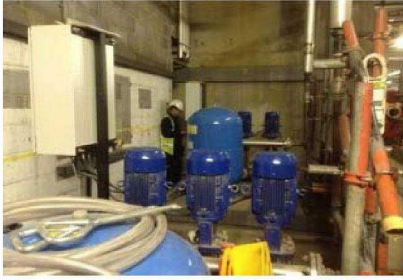
In the boiler room the water pumps in the basement maintained by Cofely, broke down again last week. This has happened several times, and Rydons have been getting the blame for the water being switched off in all the flats. KCTMO to ensure these are properly maintained.

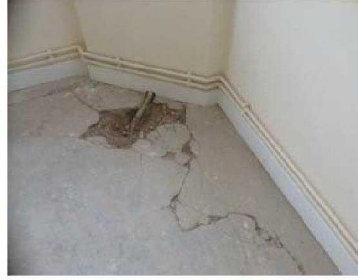
The existing concrete and screed is cracked. Rydons to get their screeding contractor to measure up and repair all these cracks.

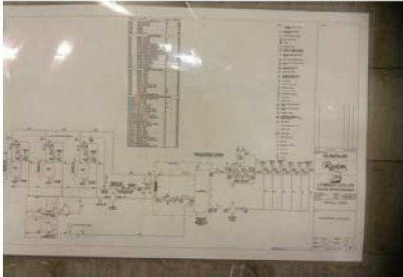
The basement plant schematic layouts have started to be produced, and put on the plant room walls. Labelling still to be finished.

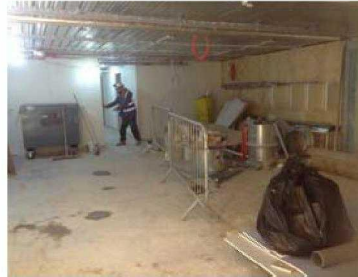
Ground floor area, and nursery area, partition are progressing well. M&E 1st and 2nd fix in progress.

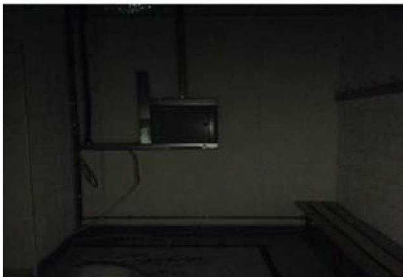
Both the boxing club and nursery electrical meters have not been fitted yet. Rydons to confirm when this has been booked in.

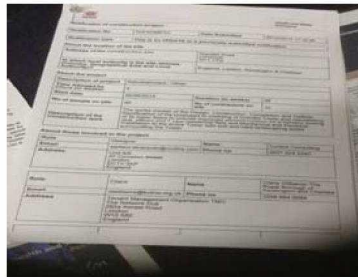
The current F11 on the office wall is out of date. Rydons to get it updated to suit the new finishing date.
