BRE Global Client Report

Grenfell Tower Fire Investigation - On-Site Investigation Interim Report, work to 31st January 2018

Prepared for: Metropolitan Police Service

Report Number: P109378-1012 Issue: 1

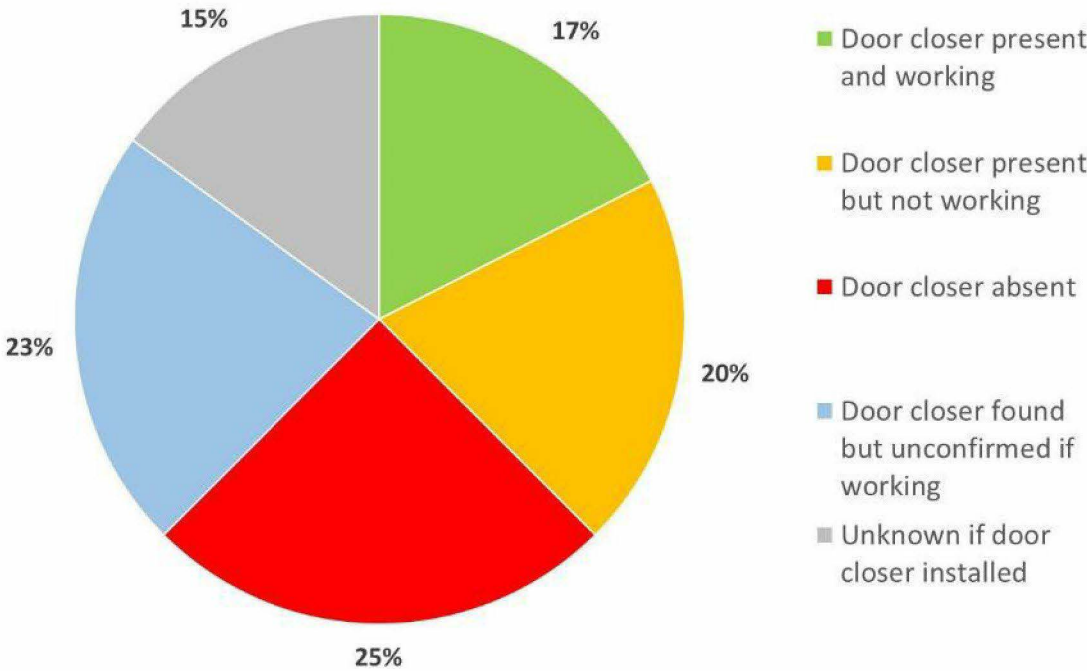
- 18 Table 1 provides current data relating to flat front doors (further work is ongoing to attempt to reduce the number of unknowns currently in this table). As shown by Figure 1, 45 percent of flat front doors from Floor 4 to Floor 23 did not have a working door closer installed (“Door closer present but not working” plus “Door closer absent”), 38 percent were unknown (“Door closer found but unconfirmed if working” plus “unknown if door closer installed”) with 17 percent of flat front doors with working door closers.

Figure 1 – Chart showing percentage of working versus non-working door closers from Floor 4 to Floor 23 (120 flats)
