Witness Statement

8 The Metropolitan Police Service (MPS) requested an investigation into the gas installations within Grenfell Tower following a serious fire, the fire took place on the 14th June 2017.

Grenfell Tower over the years has undergone major renovations, which included the decommissioning of one of the original gas service risers and a new gas service riser being installed in 2017.

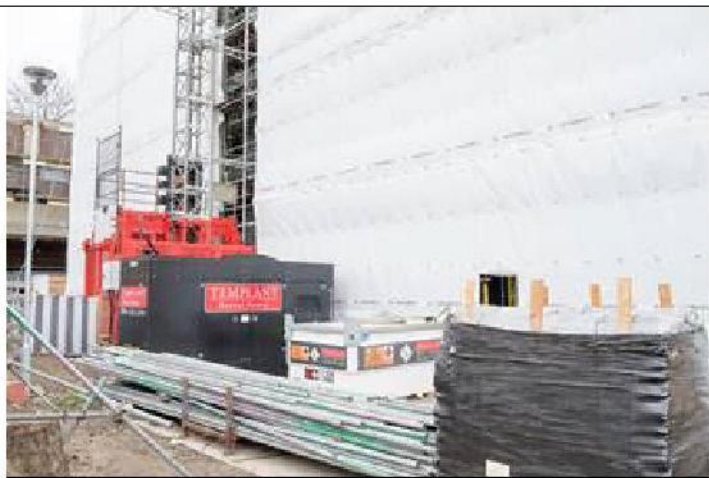
Reference 2632559 -
0052

Restricted access to
PIV locations.

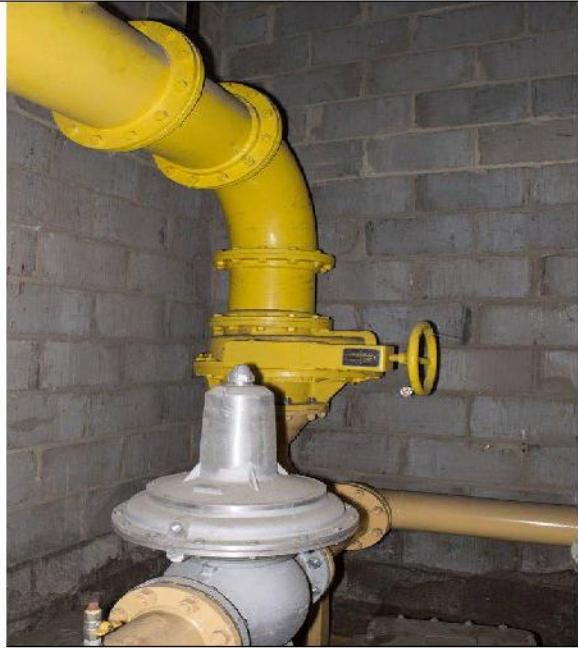
Reference 2633009-
0008

No line diagram
displayed at meter
installation

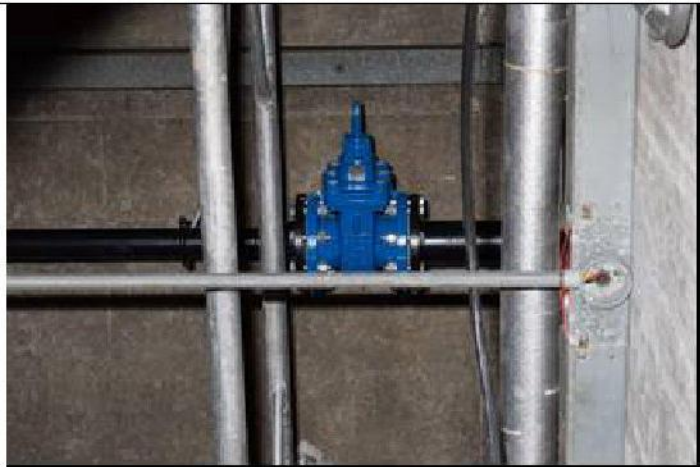
Reference 26330009 –
0019

New Service Riser IIV
fitted high in
basement

No wheel head for
operation

No Line diagram of
installation in vicinity
of (IIV)

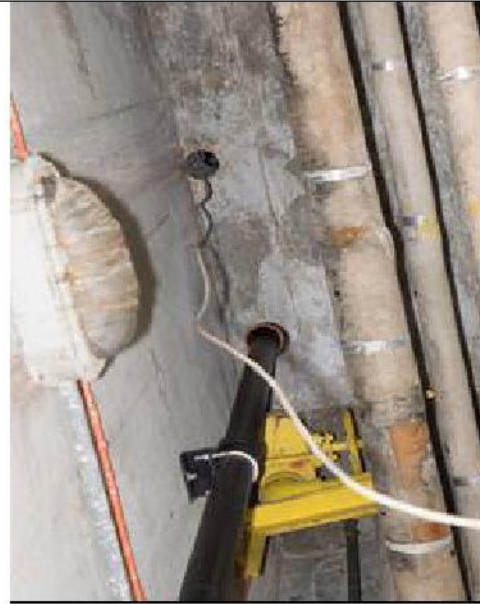
Reference 2633009 - 0051

Valves to risers in basement – Old decommissioned Riser BIV location (yellow). Adjacent to new Riser.

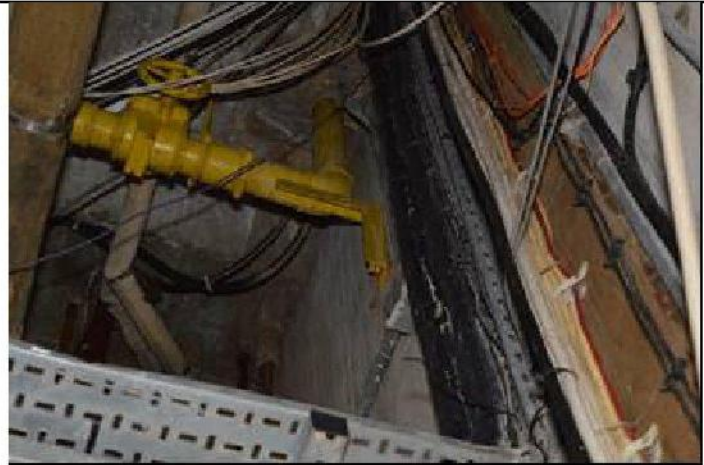
Reference: 2633537 - 0014

Valves to risers in basement – BIV location

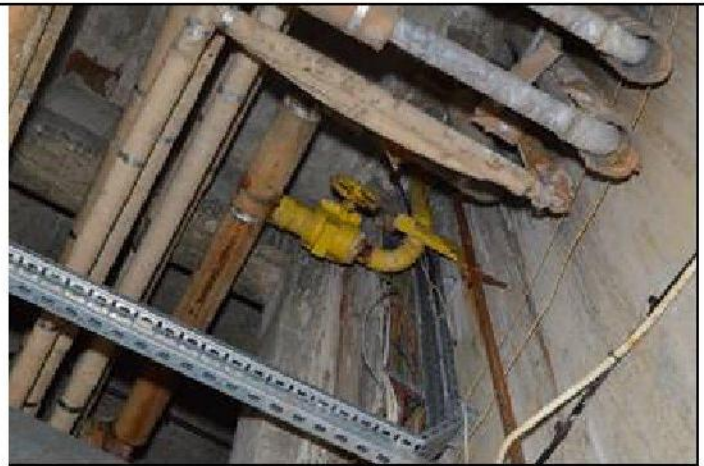
Reference: 2633537 - 0015

Valves to risers in basement – BIV location

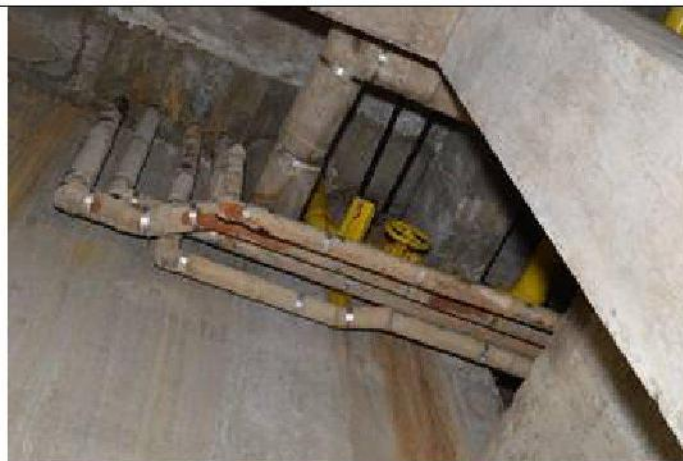
Reference: 2633537 -
0017

Valves to risers in
basement – BIV
location

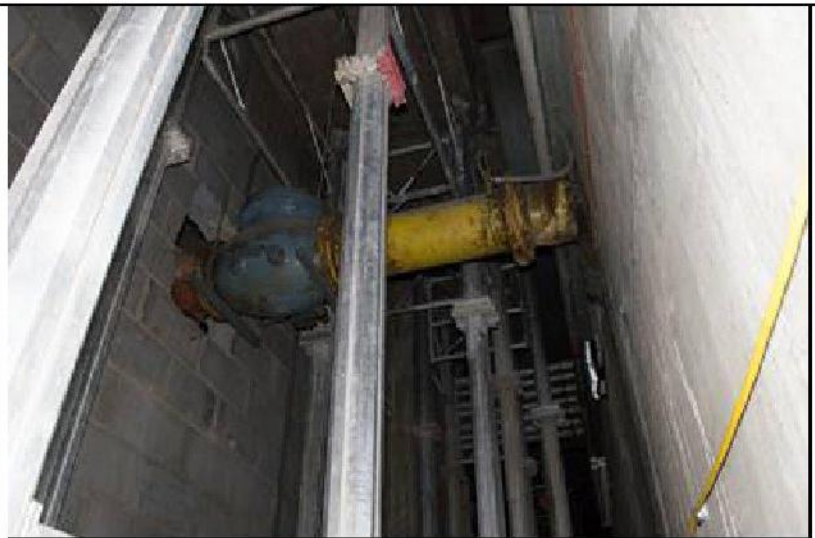
Reference:
2633009 - 0004

No pipe
sleeves

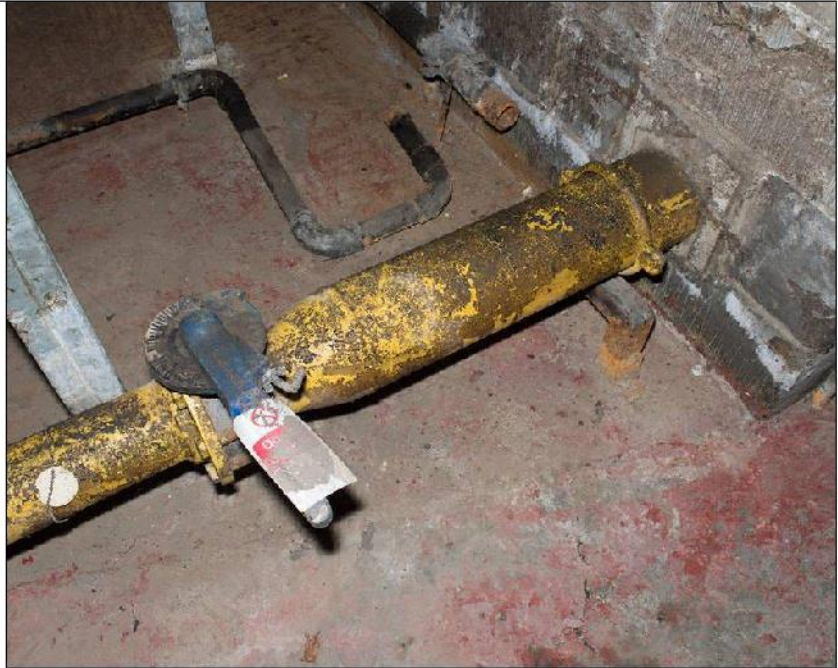
Reference:
2633009 - 0038

No pipe
sleeves

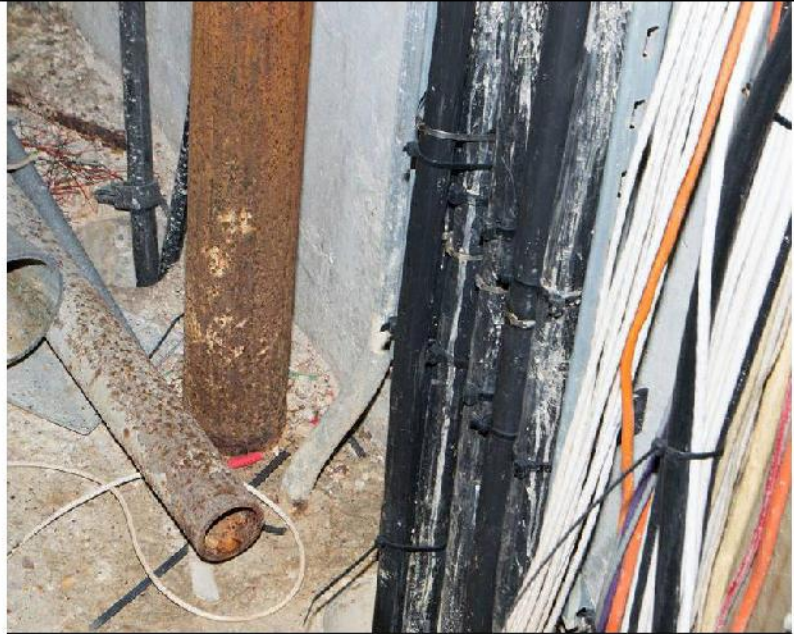
Reference:
2575110 - 0003

No pipe
sleeves

Pipework
installed within
a non-
ventilated void
/duct

Pipework with
signs of
corrosion.

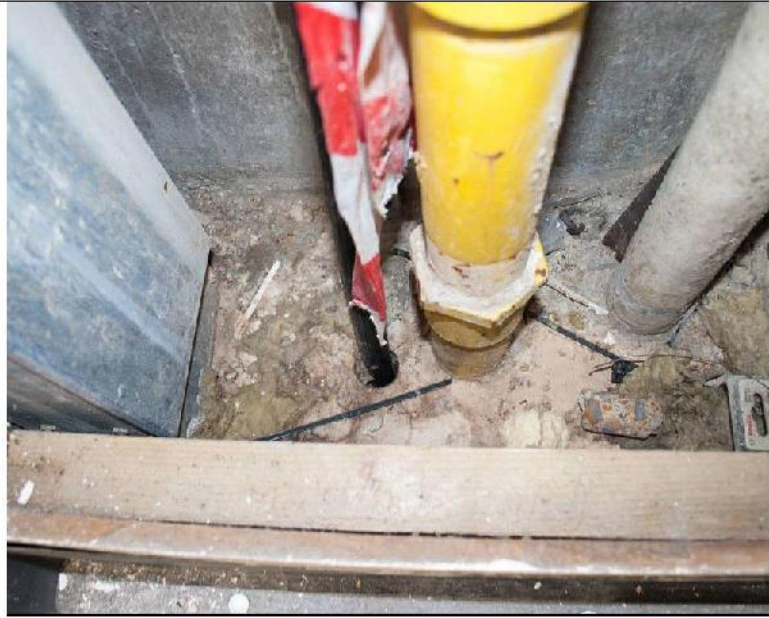
Reference:
2596758 - 0098

No pipe
sleeves

Pipework
installed within
a non-
ventilated void
/duct

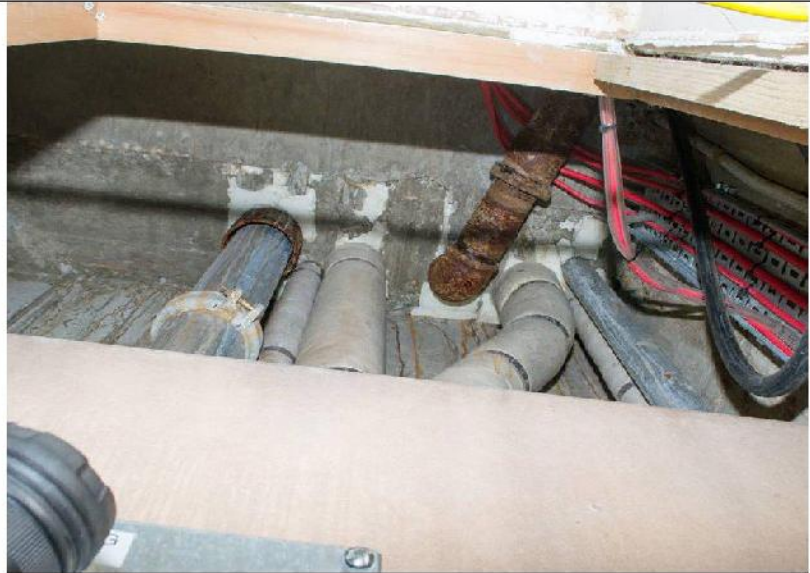
Reference:
2575110 - 0024

The pipework was found to be suffered from surface corrosion on all original existing gas service risers through the property.

Pipework with
signs of
corrosion

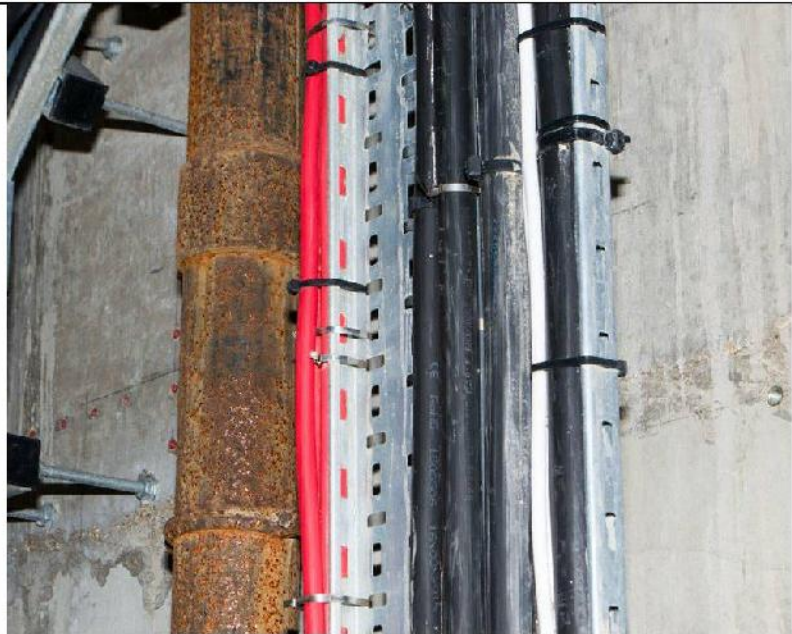
Reference:
2575110 - 0017

Pipework
installed within
a non-
ventilated void
/duct

Pipework with
signs of
corrosion

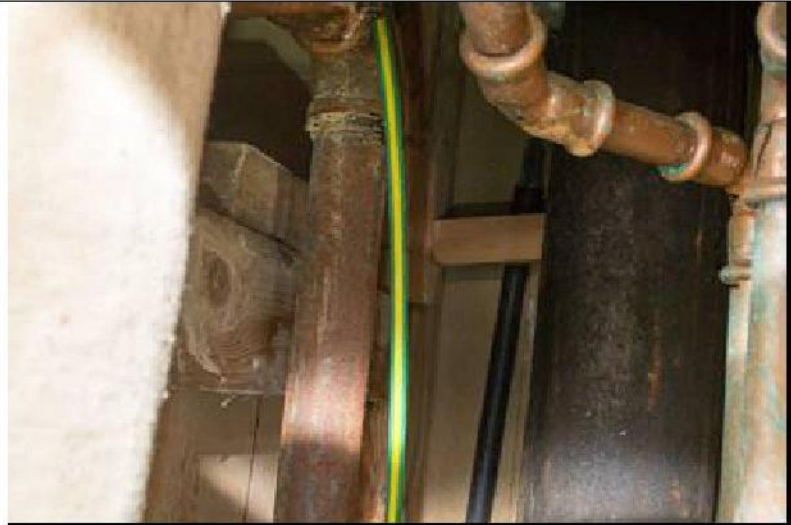
Reference:
2575110 - 0041

Service
pipework with
signs of
corrosion

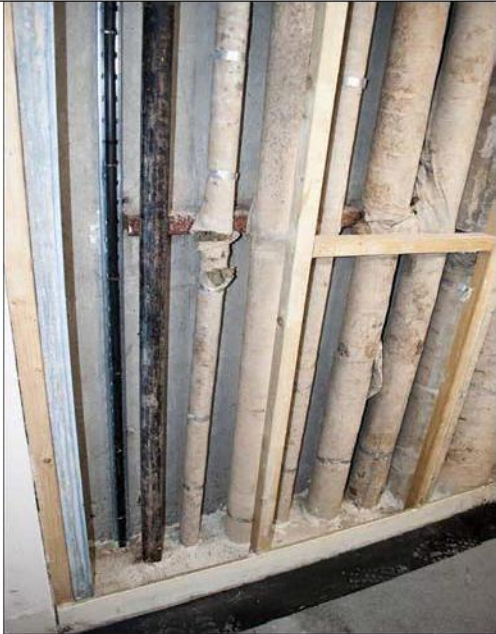
<p>No visible sleeves</p> <p>Pipework installed within a non-ventilated void /duct</p> <p>Pipework with signs of corrosion</p> <p>No support other than cemented in top & bottom</p> <p><i>Reference: 2596758 - 0153</i></p>

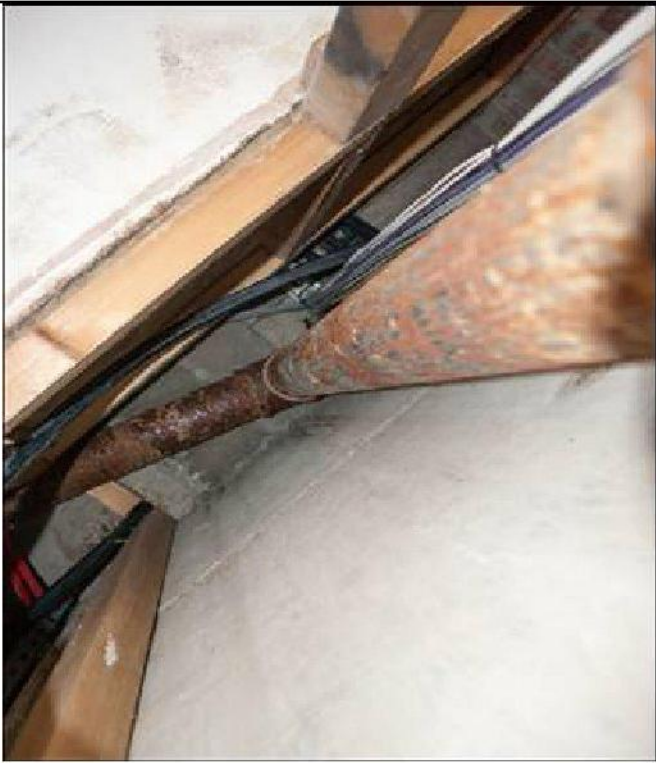
<p>Pipework installed within a non-ventilated void /duct</p> <p>Pipework with signs of corrosion</p> <p>No support and change in direction</p> <p><i>Reference: 2596758 - 0070</i></p>

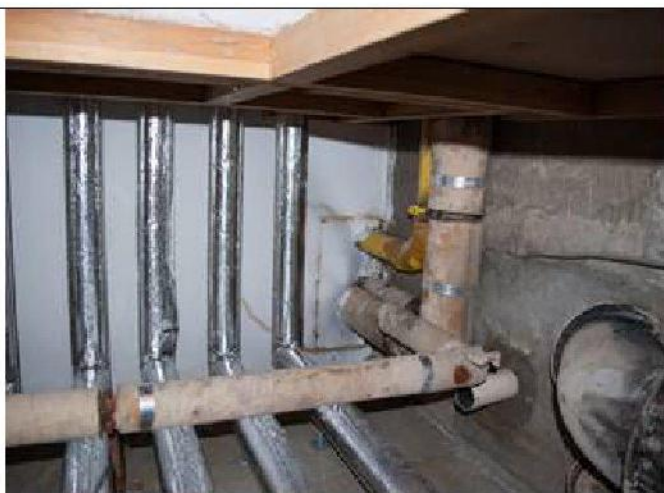
**Reference: 2596758 -
0111**

No visible sleeves

Pipework with signs of
corrosion

Incomplete support and
change in direction

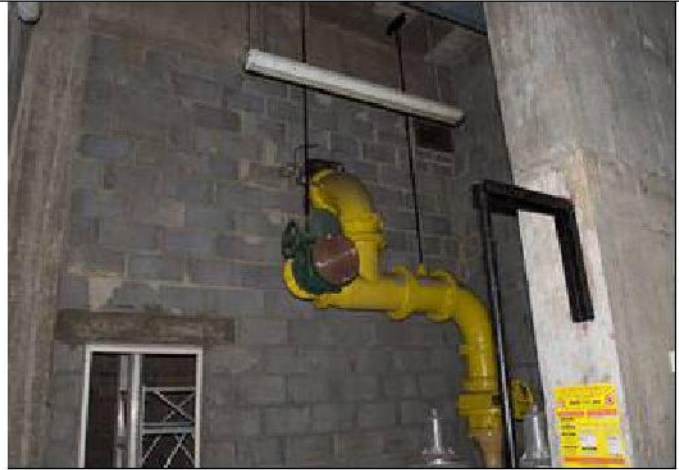
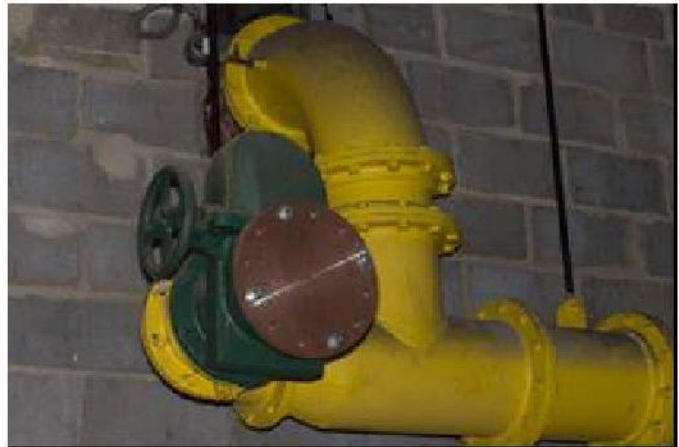
*Reference: 2633009 –
0017 & 0017a*

Fittings incomplete not
all flange retention bolts
installed.

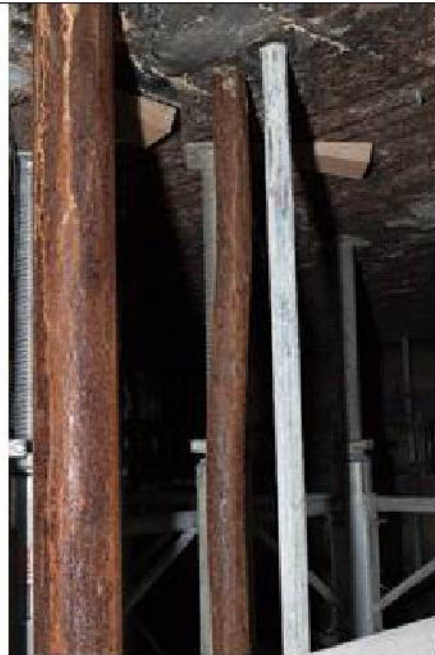
*Reference: 2633562 -
0058*

Pipework installed
passing through floor
not sleeved, no
provision for expansion.

Pipework with signs of
corrosion and distorted.

Incomplete support and
change in direction

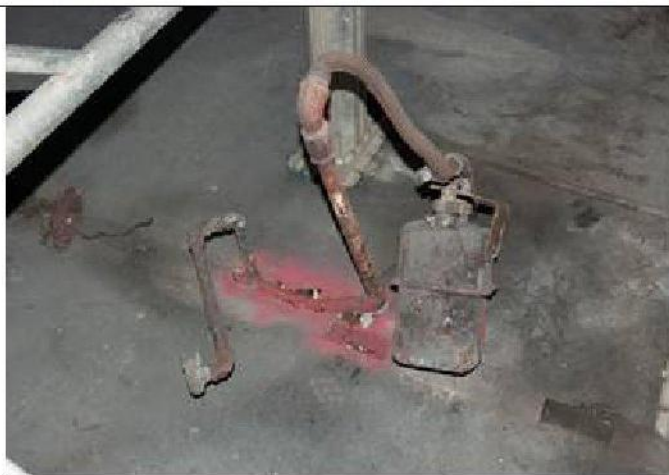
Reference: 2618842 - 0046

Pipework installed in floor with no signs of protection from corrosion.

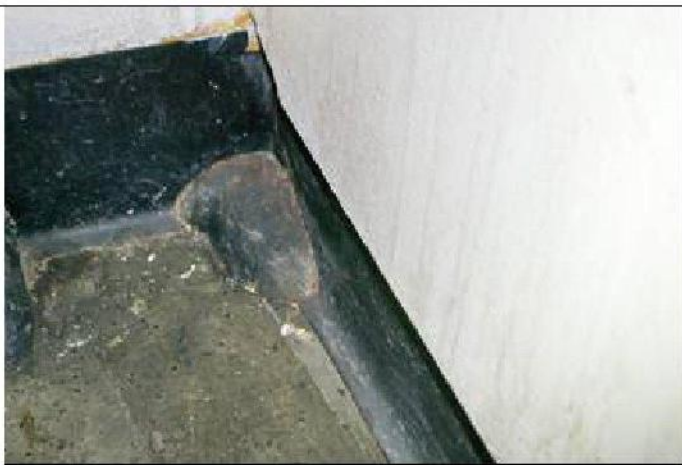
Reference: 2575110 - 0029

Pipework installed in floor with no signs of protection from corrosion.

Pipework rising and changing direction

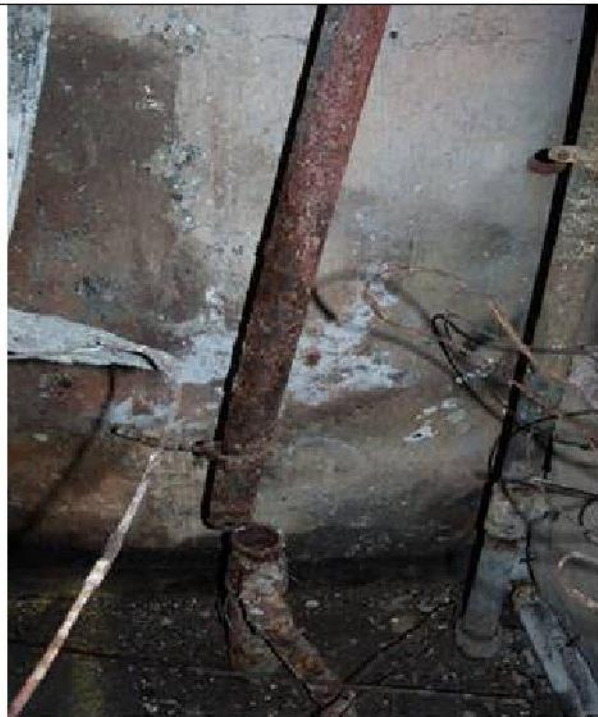
Reference: 2618842 - 0057

Pipework installed in floor with no sleeve no signs of protection from corrosion.

Pipework separated at steel threaded joint, ruptured, no provision for expansion

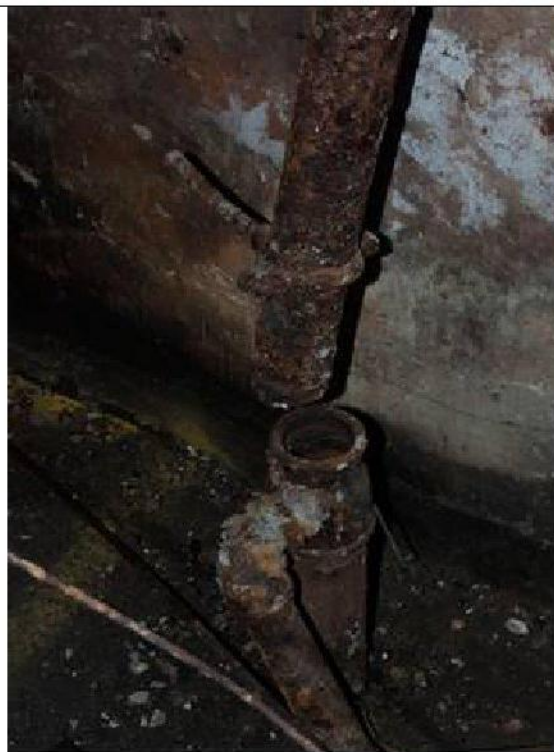
Reference: 2618842 - 0058

Pipework installed in floor with no sleeve no signs of protection from corrosion.

Pipework separated at steel threaded joint, ruptured, no provision for expansion

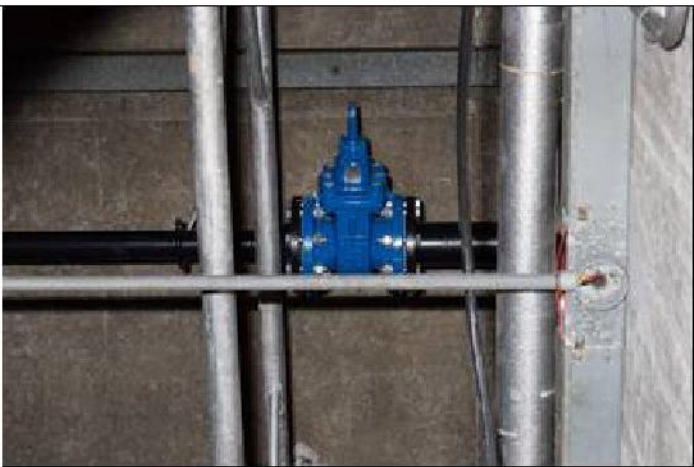
<p>New Service Riser IIV fitted high in basement</p> <p>No wheel head for operation</p> <p>No Line diagram of installation in vicinity of (IIV)</p> <p>Reference 26330009 – 0019</p>

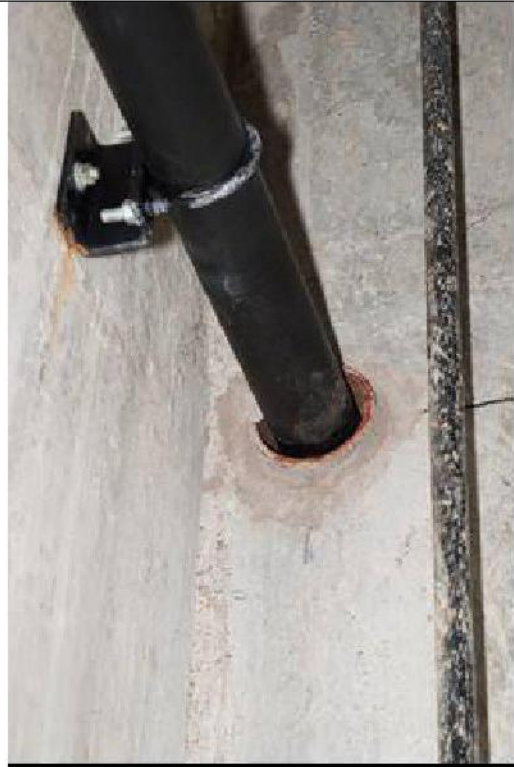
Reference: 2633009 - 0050

New service riser in basement, sleeving incorrectly installed

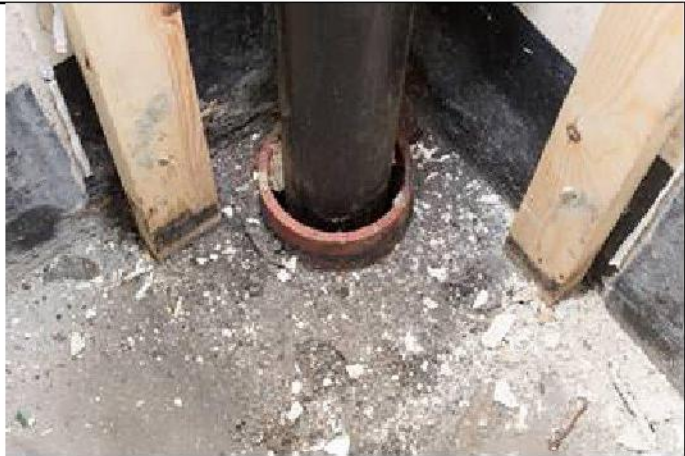
Reference: 2627389 C1 - 0056

New service riser in stairwell, sleeving incorrectly installed

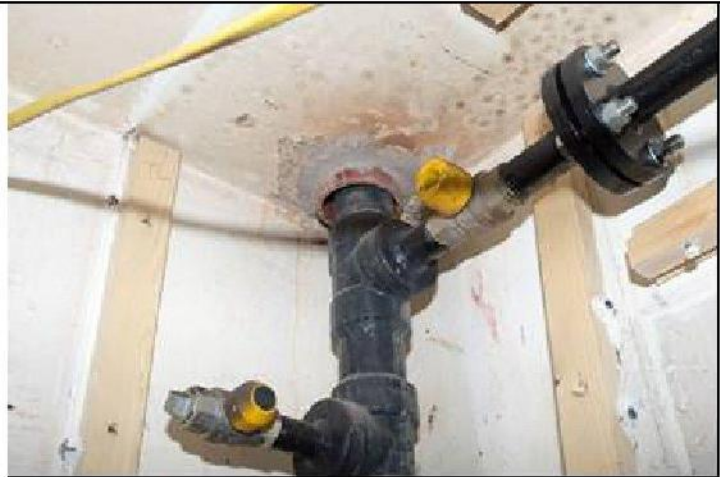
Reference: 2627389 C2 - 0020

New service riser in stairwell, sleeving incorrectly installed

BIV's and mechanical flanged joint with fibre gasket

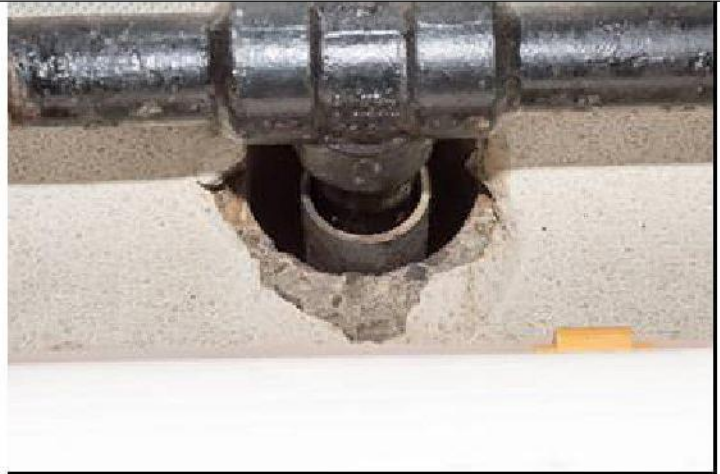
Reference: 2627389
C2 - 0025

New service riser in stairwell, sleeving incorrectly installed

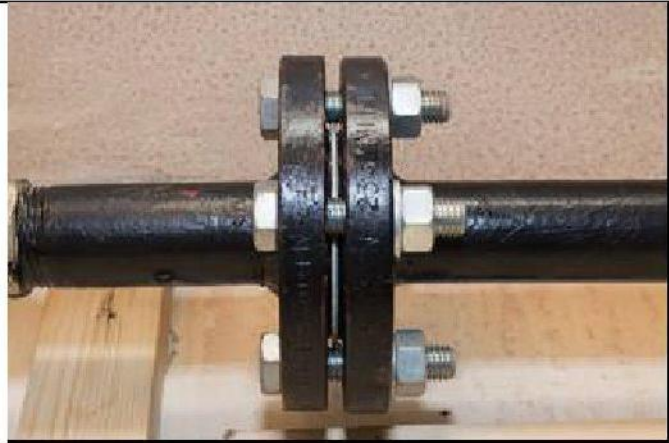
Reference: 2627389
C1 - 0053

New service riser in stairwell, mechanical flanged joint with fibre gasket

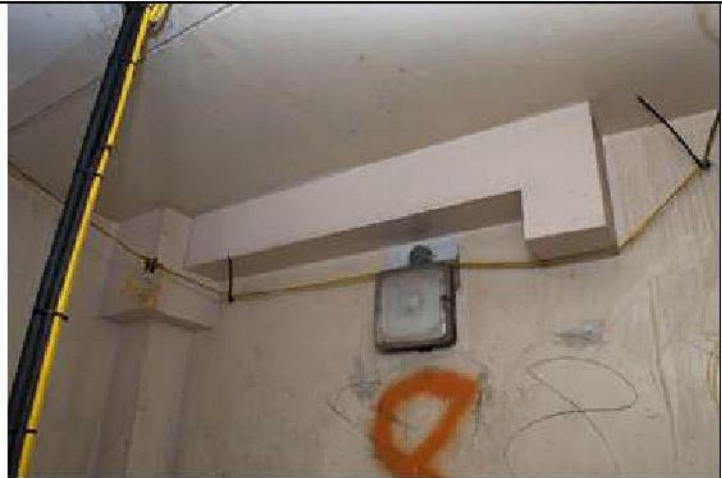
Reference: 2627389 –
C1 - 0077

New service riser in stairwell, sleeving incorrectly installed

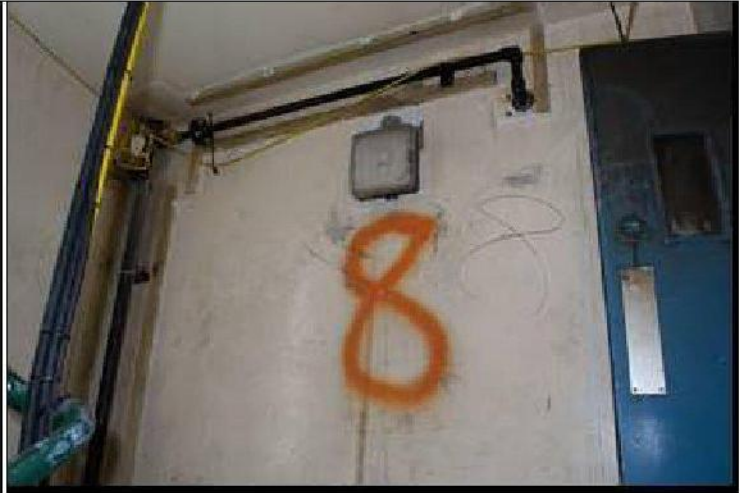
Reference: 2627389
C2 - 0046

New service riser in stairwell, sleeving incorrectly installed

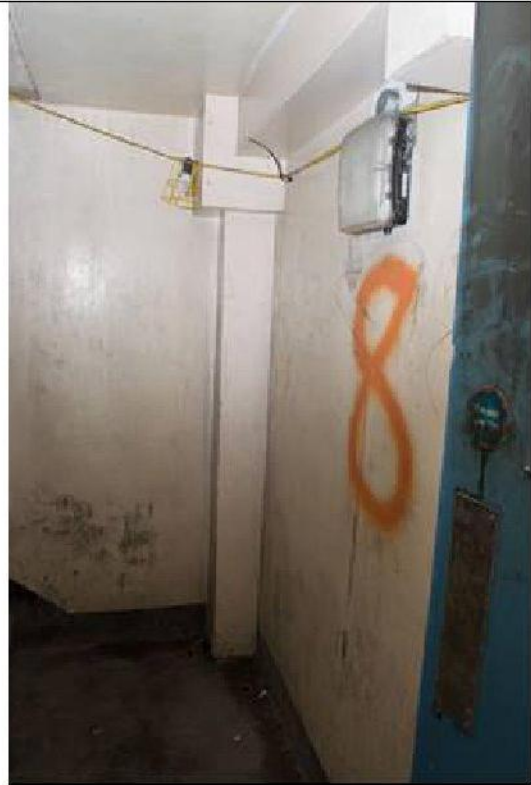
Reference: 2627389
C1 - 0076

New service riser in stairwell, sleeving incorrectly installed

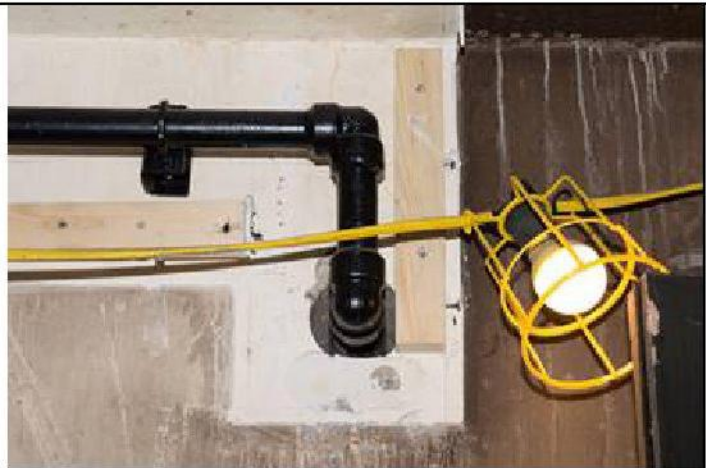
Reference: 2627389
C1 - 0070

New service riser in stairwell to lift lobby, sleeving incorrectly installed

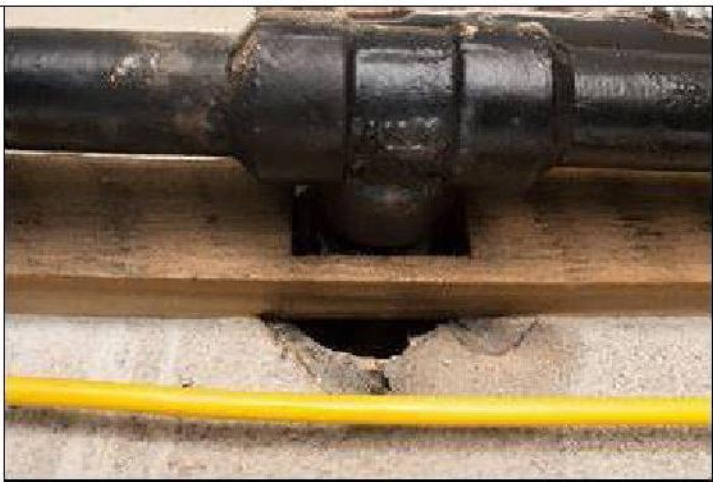
<p>New service riser in lift lobby to stairwell, sleeving incorrectly installed</p> <p>Reference: 2627389 C2 - 0053</p>

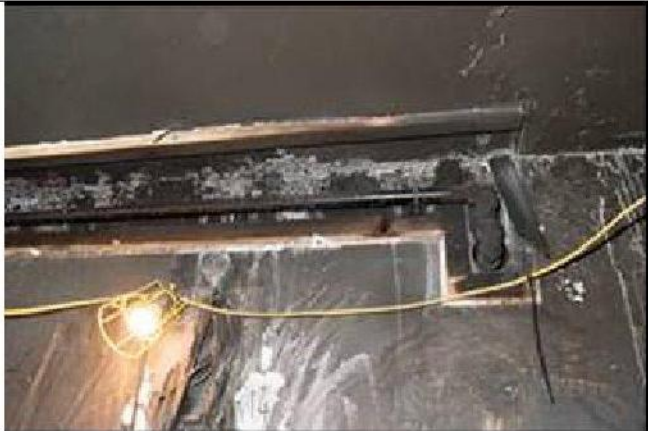
<p>New service riser in stairwell to lift lobby, sleeving incorrectly installed.</p> <p>Shows route of smoke</p> <p>Reference: 2632559 - 0014</p>

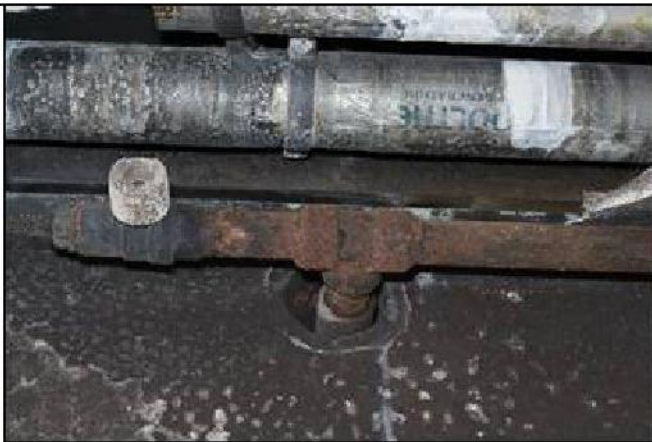
<p>New service riser in lift lobby from stairwell, sleeving incorrectly installed</p> <p>Reference: 2576173 - 0003</p>

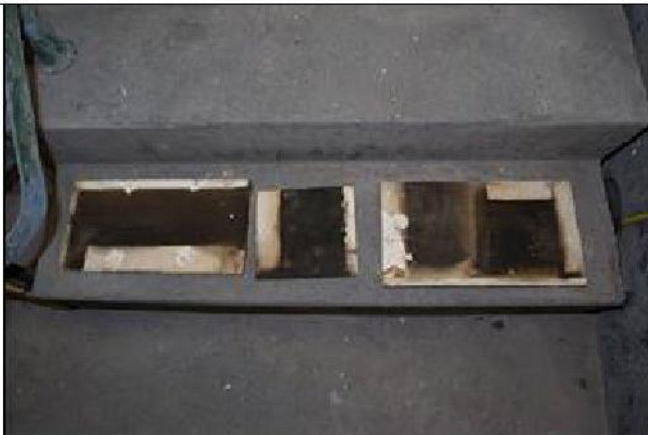
<p>New service riser boxing showing signs inside of scorching and smoke damage.</p> <p>Reference: 2576173 - 0057</p>

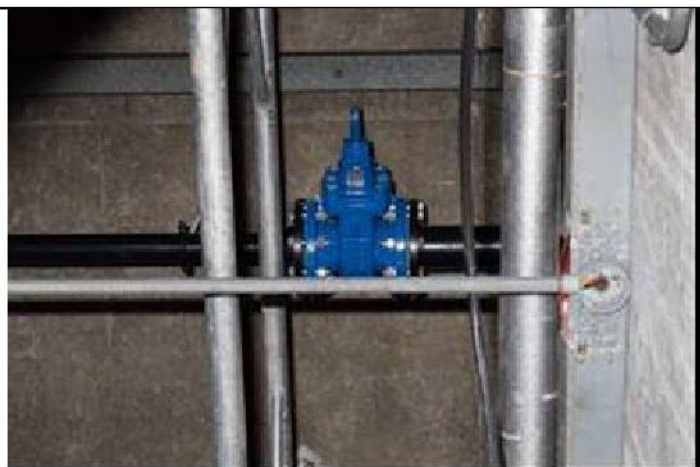
Reference 26330009 –
0019

No Line diagram of
installation in vicinity
of (IIV)

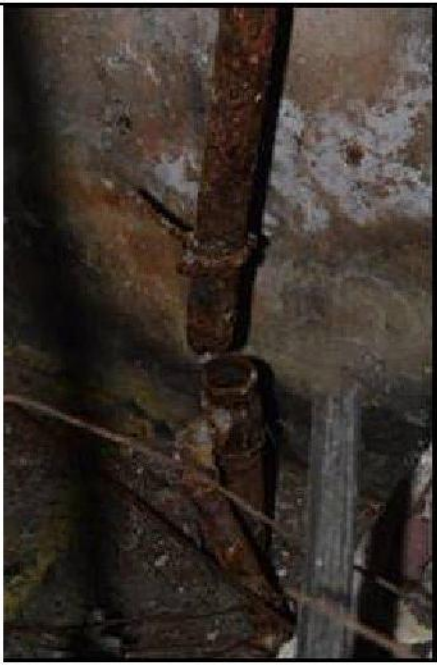
- The fire and heat caused the steel gas riser pipework to rupture in Flat 5, floor 14, if gas supply was still live to the building when this occurred then there would have been a significant release of gas.
- 18 flats were found to have regulators that had melted due to fire and heat, if the gas supply was still live to the building when this occurred then there would have been a significant release of gas.

<p>(a) Gas Service Riser ruptured at joint</p> <p>Reference 2633537 – 0047</p>

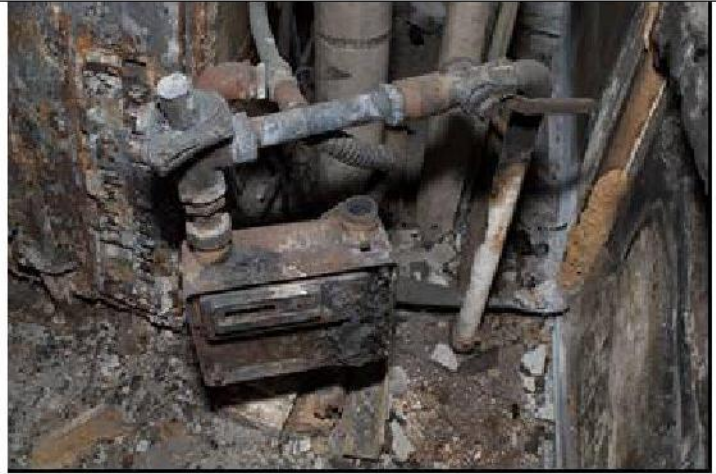
Reference: 2633562 – 0017

(b) Emergency control valve (ECV) in the ON or partially ON position with an open end

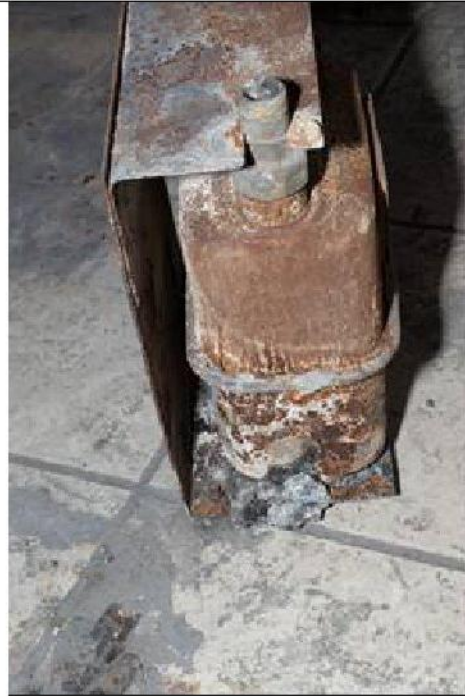
Reference: 2633562 – 0072

(c) Installation with melted Regulator, melted on meter

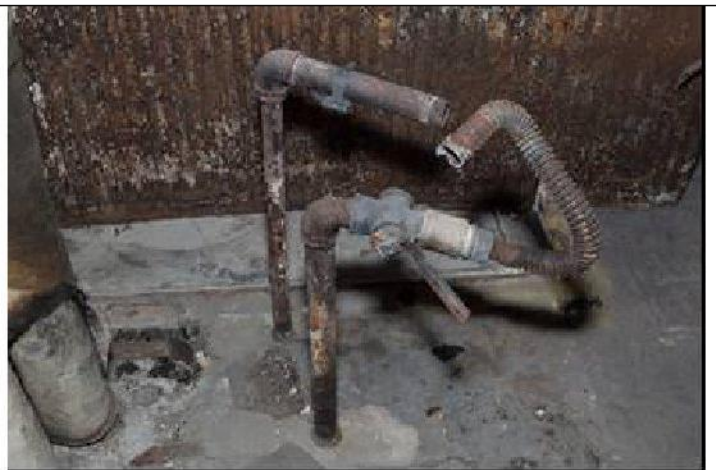
Reference: 2633562 – 0074

(d) ECV with open end
