RE: Updated Summary Report; Gas Installations at Grenfell Tower

The Metropolitan Police Service (MPS) requested an investigation into the gas installations within Grenfell Tower following a serious fire, the fire took place on the 14th June 2017.

Grenfell Tower is in North Kensington, Inner London. The tower was managed on behalf of Kensington and Chelsea London Borough Council by Kensington and Chelsea Tenant Management Organisation (KCTMO).

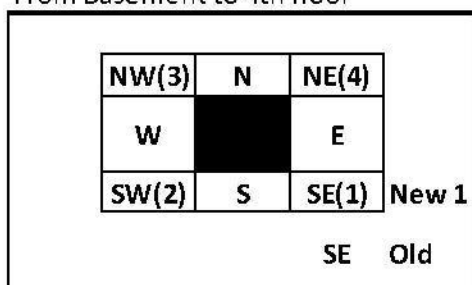
From Basement to 4th floor

- SE - original riser (decommissioned)
- SE (1) - new riser, replaces decommissioned riser
- SE - original riser capped off on the ground floor, SE (1) replaces this supply through building.

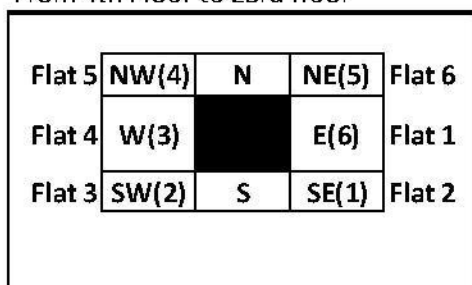
From 4th Floor to 23rd floor

- SW (2) splits at fourth floor level to become W (3) & SW (2) on higher floors.
- NE (5) splits at fourth floor level to become E (6) & NE (5) on higher floors
