OPERATION NORTHLEIGH

GRENfell TOWER BUILDING MANAGEMENT SYSTEM REVIEW FOR METROPOLITAN POLICE

Date of First Issue: 20th April 2018

Document Reference: J1656_4UOWPF_002 Operation Northleigh BMS Final Report.docx

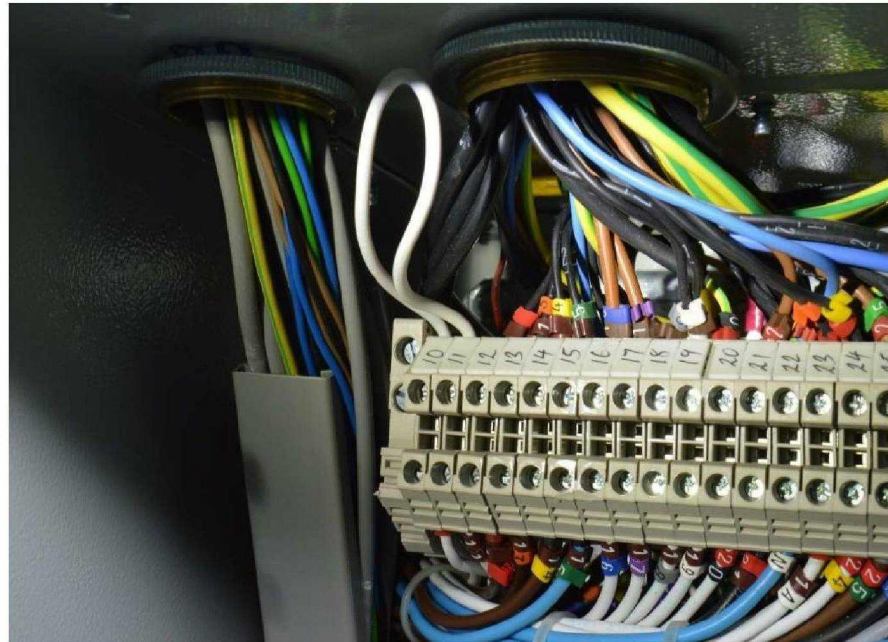
Appendix 1 – Refers to Page 12

However, the fire alarm shut down facility on the new MCC panel (terminals 10/11) was found to be linked out (see Appendix 1 photo). No fire alarm interface was evident and it looked as if there had never been an interface installed or connected.

The fire alarm shut down facility on the old original MCC was identified by tracing the gas valve interlock from the new MCC (terminals 12/13 - see Appendix 1 photo) to the original MCC terminals 112/113 (see Appendix 2 photo). In turn, this allowed us to identify the electrical connections to the gas solenoid valve and the associated safety circuit within the old MCC (for which no drawings or documentation have been found so far). It was established that the fire alarm shut down facility on the old panel was also linked out (terminals 200/201) and had probably never been fitted (see Appendix 3 photo). No fire alarm interface or associated cabling could be found.

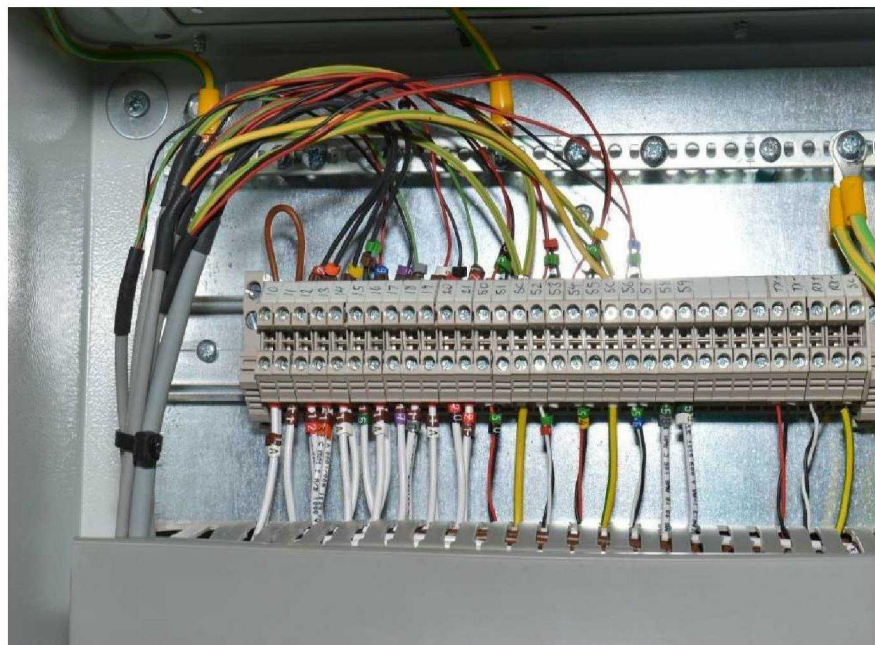
Appendix 4 - Refers to Page 13

The roof BMS panel was inspected and the fire alarm shutdown facility (terminals 10/11 – see Appendix 4 photo) were found to be linked out with no fire system interface evident. This should have been present in order to stop the normal ventilation software, but as the “vent run” signal was sent via the BMS network to the Basement MCC, the fire alarm shut down could have been provided in the basement had it been fitted (which it was not).

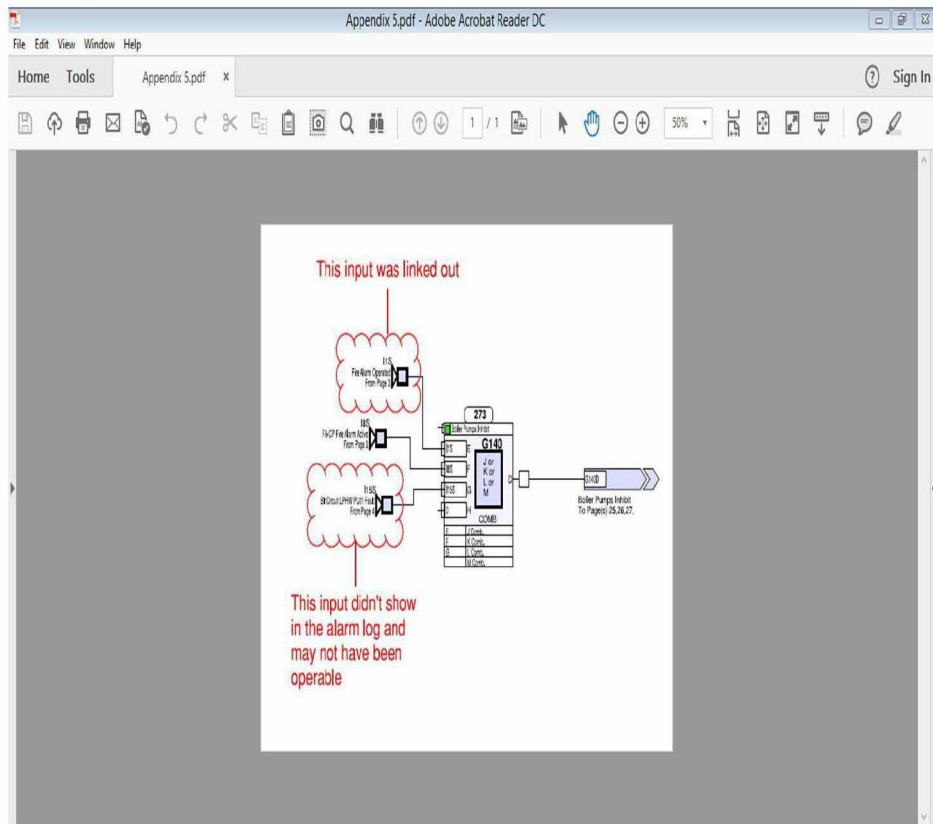
Appendix 5 – refers to Page 12

The direct interconnections between the BMS and Fire Alarm system (terminals 234-243 inclusive) were identified and found to be connected. These were software dependent. The signal entitled "FA-CP Fire Alarm Active" was configured in software to shut down the boilers but could not have closed the gas valve (see Appendix 5 – SET drawing excerpt). However, this point did not appear in the alarms log (see Appendix 6 on Page 18) so may not have operated at the time of the fire. This cannot be determined.

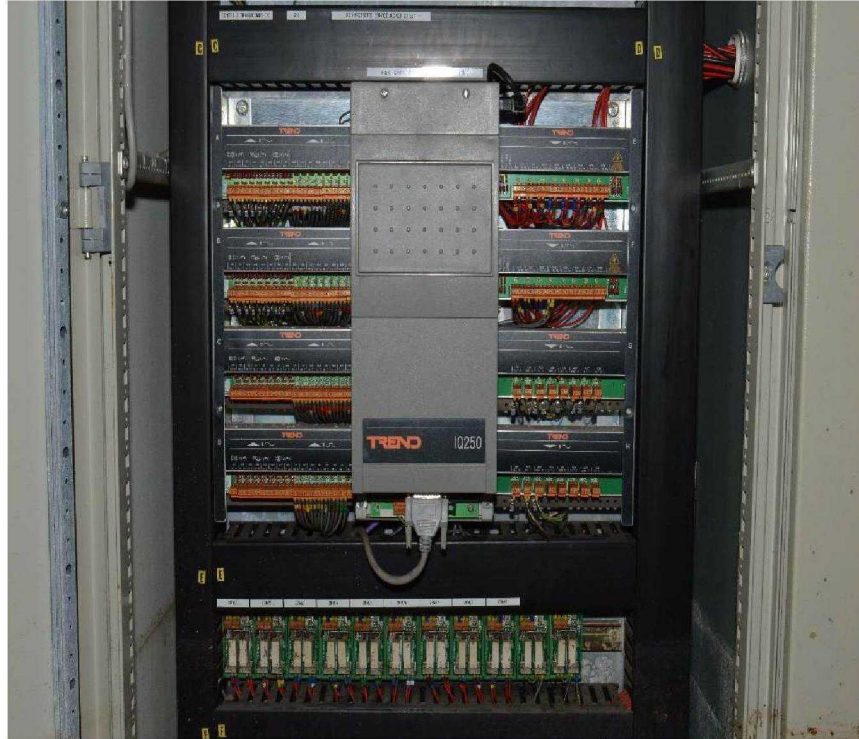
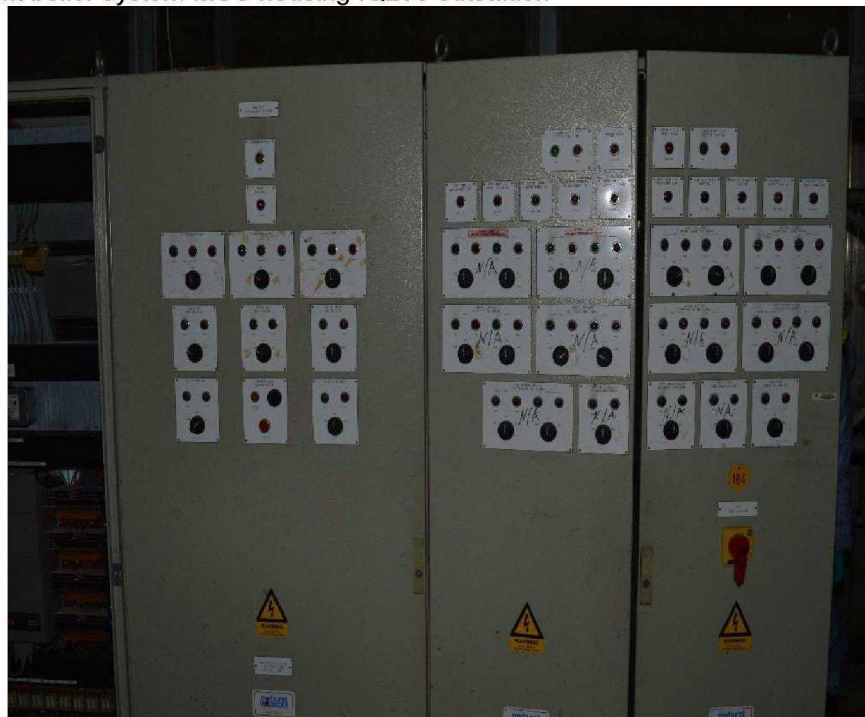
Appendix 7 – Refers to Page 10.
Original Basement IQ250 Outstation

Although the basement partially filled with water from firefighting during the incident to a depth of approximately 700mm, this outstation was mounted above the waterline and was therefore undamaged.

However, it was only possible to extract a Trend IQF file from the device and although there was no documentation against which to compare the device, it is believed that it was largely redundant as it controlled the original boiler system which was later superseded.

Redundant boiler system MCC housing IQ250 outstation

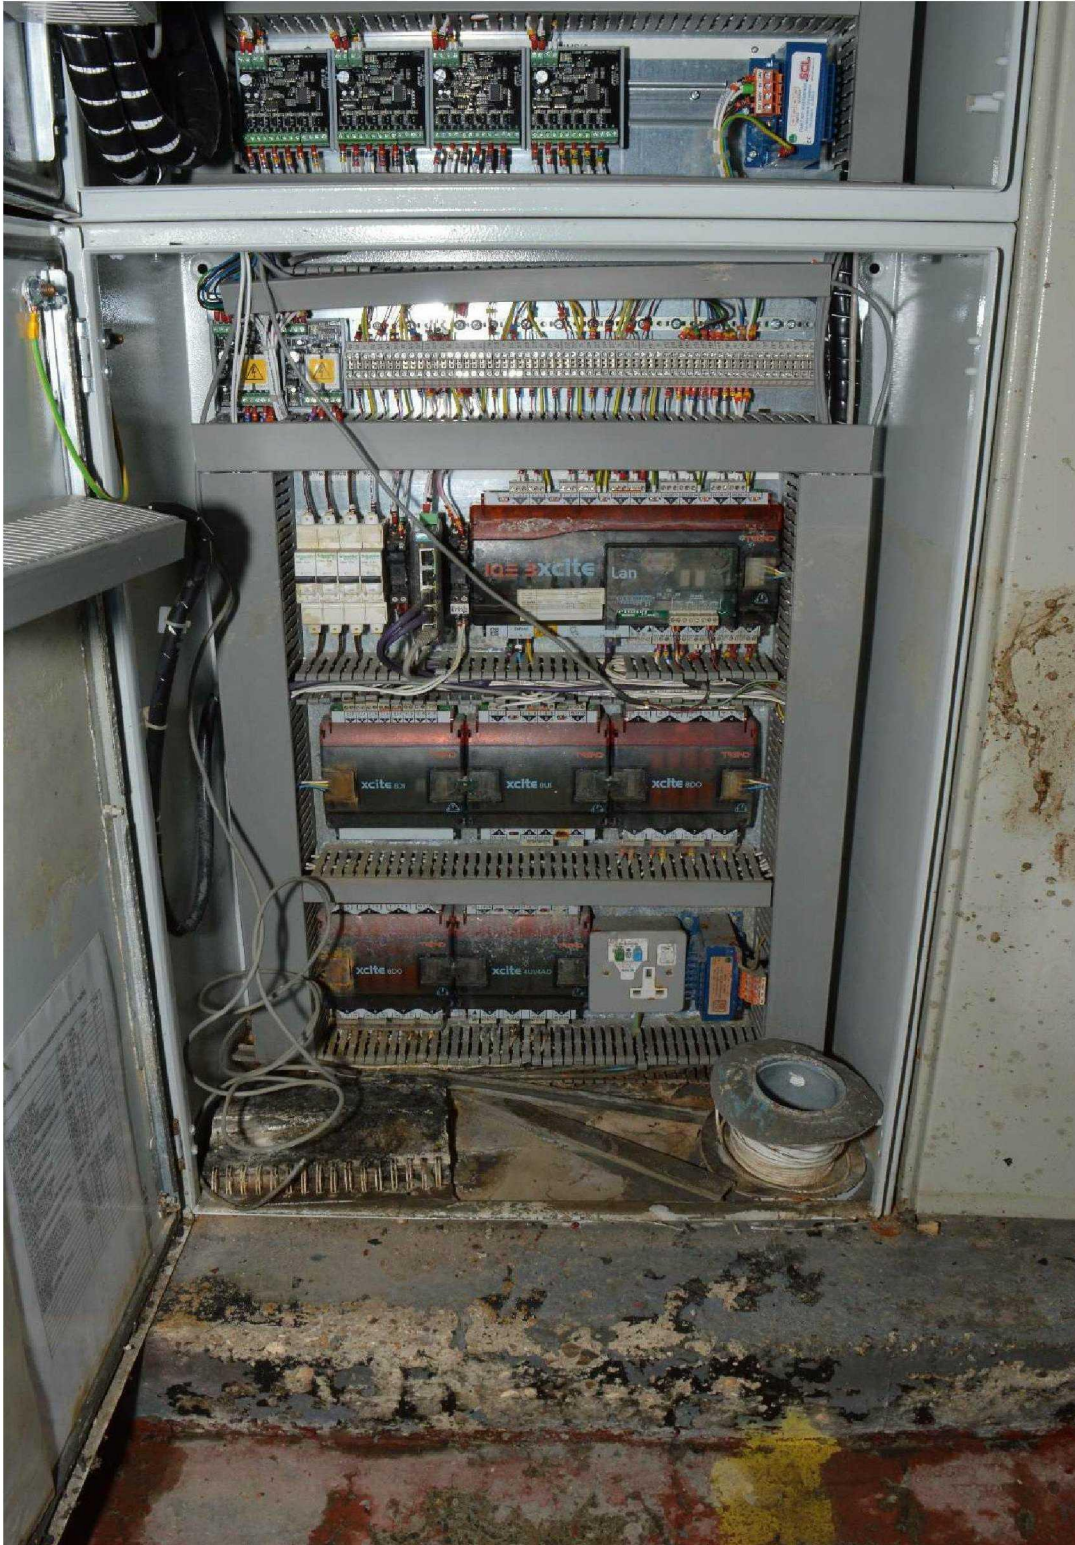
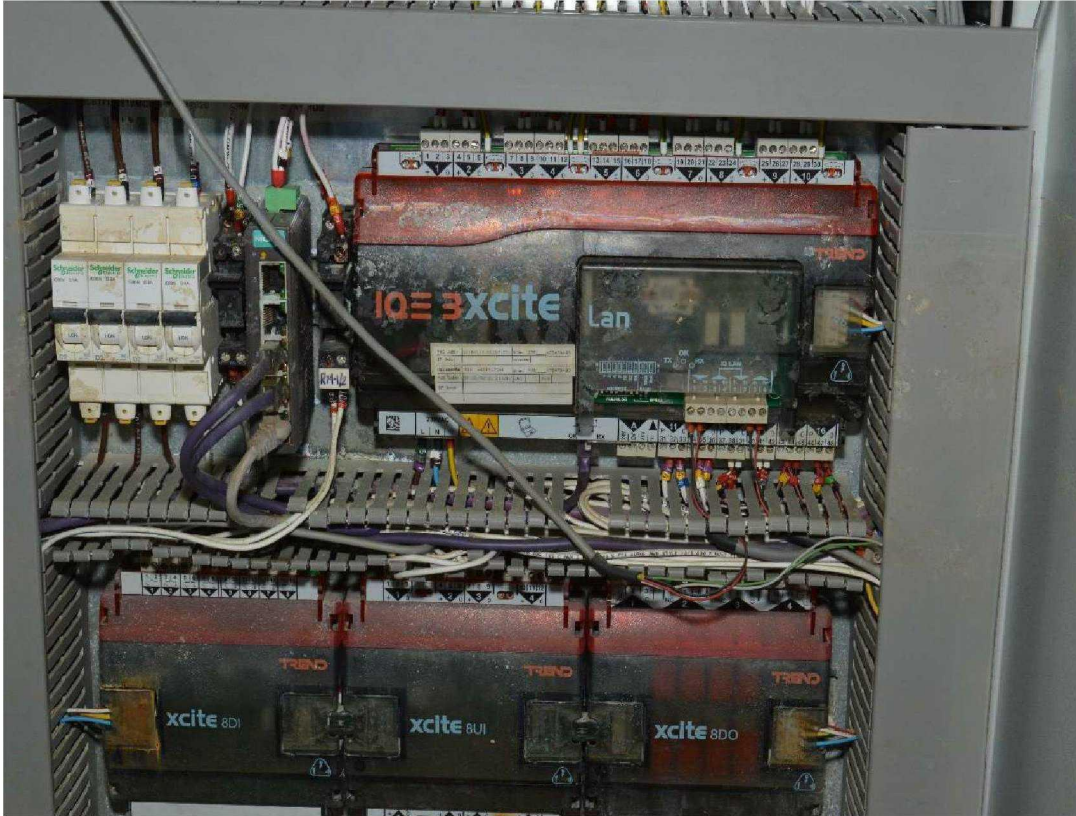
Appendix 8 – Refers to Page 10.
New Basement Outstation

This outstation was mounted at the bottom of the new MCC and was therefore completely immersed by water for a period of time (unknown). However, after a careful cleaning and drying out process, the Outstation powered up successfully and its data was successfully retrieved. Where relevant, those findings are detailed later.

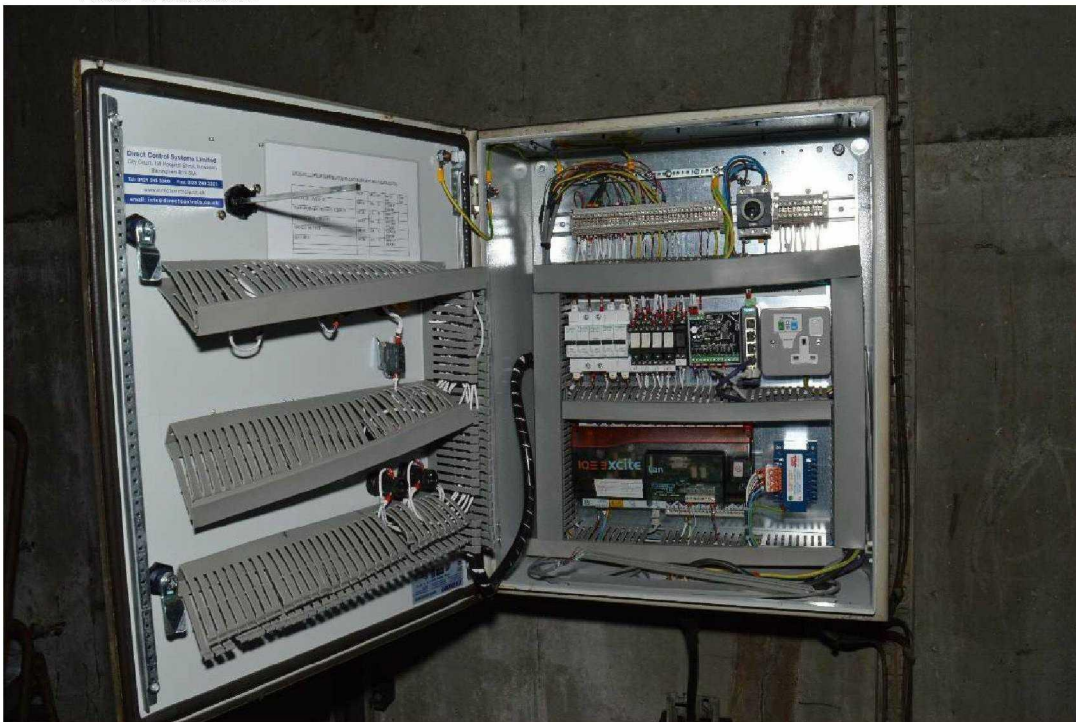
Appendix 9 – Refers to Page 10
Roof Outstation

Apart from one digital output to the ventilation system sent via the BMS network from the basement, this outstation was for monitoring purposes only and had no control functions. It can therefore be excluded.
