OPERATION NORTHLEIGH
Site Investigation Report

Site Investigation Report

PROJECT NO. 70042523

DATE: AUGUST 2018

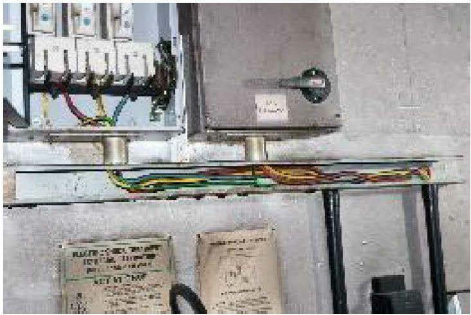
- The trunking lids were removed (during this visit) from underneath the mains isolators in order to check the condition of the mains cables.

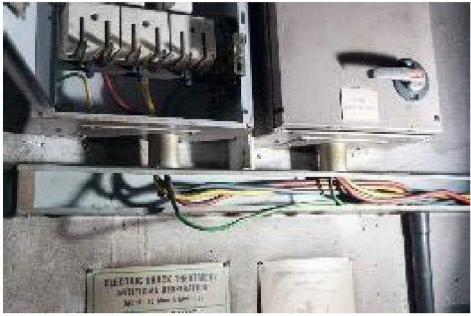
- The incoming earth wire to the left hand isolator, Lift H091, was wrapped with insulation tape which was hidden inside the conduit. The earth wire was possibly too short and had been extended.

The incoming earth wire to the main isolator of lift H091 was extended and wrapped with insulation tape before being concealed inside the conduit. This is poor / bad practice. The earth wire should have been replaced during the modernisation works.

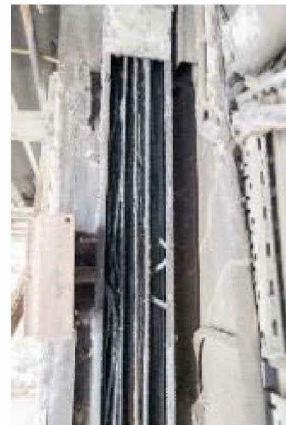
- An attempt was made to determine the route of the incoming mains wire at the top floor riser but extensive fire damage prevented a positive identification.

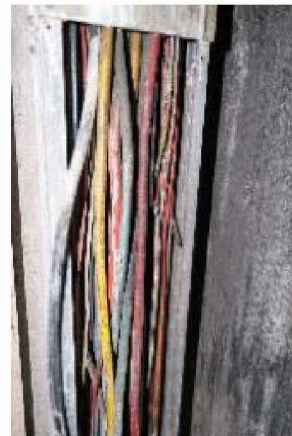
- We removed the trunking lid on the 9th floor riser to confirm there were 2 x red, 2 x blue, 2 x yellow, 2 x green/yellow and 1 x black cables. This was the case.

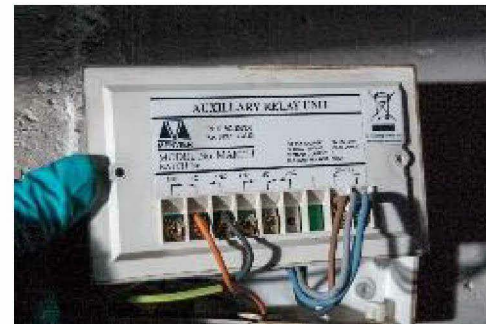
- Within the machine room an electrical unit to provide the electrical connectivity interface for the lifts to the building alarm system.
- The purpose of this unit was to recall the lifts to a designated floor when a fire was detected.
- We removed the protective cover to confirm wiring was intact.

- We confirmed fire alarm interface was connected to one of the controllers. We also confirmed that an interconnecting wire was connected to the second controller in order to provide a suitable signal.
- We confirmed there was a connection for the fireman's switch on the controller wiring diagrams.
- We confirmed there was a connection for the fireman's switch to both controllers (yellow & grey wiring).
- We were unable to confirm a connection of a second fireman's switch.

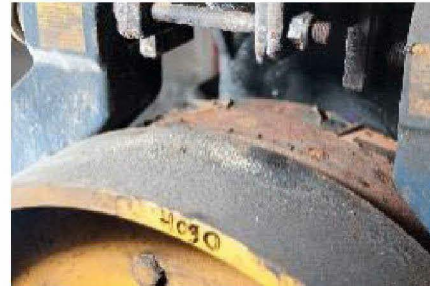
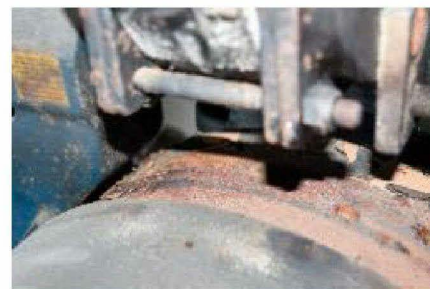
- Guarding to hand winding wheels was removed.
- Both brake couplings were corroded with evidence of flaking on top of the brake coupling on the left hand lift. Therefore the brake may not be in a suitable condition to stop the lift car if operated whilst on site.

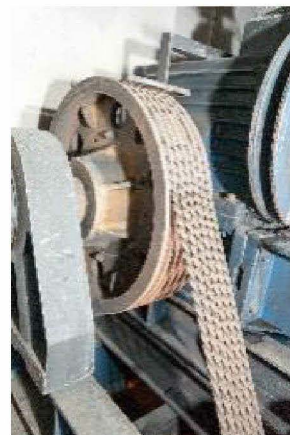
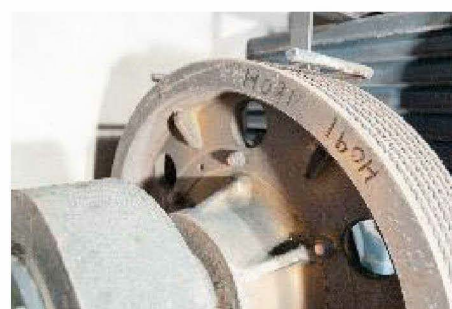
- The traction sheaves show signs of heat damage as there were very little signs of any yellow paint.

- The traction sheaves and grooves were corroded.

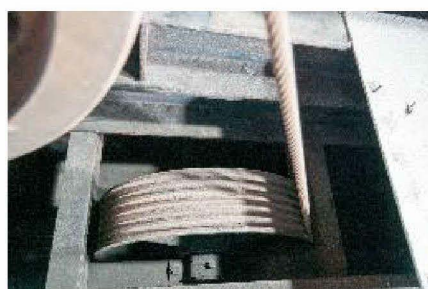
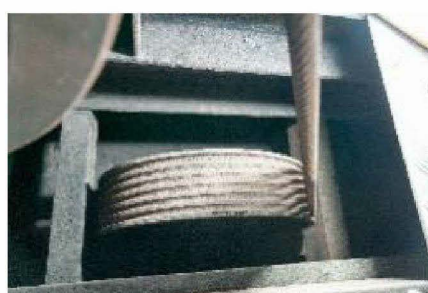
- The diverter sheaves were corroded and indicated signs of heat damage.

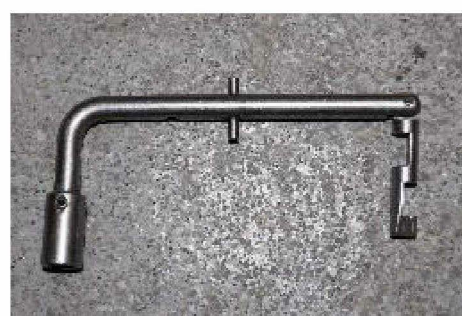
- A drop type key is used to both operate the fireman's switch and to open the landing doors of the lift in an emergency.
- The notches on the release key align with similar notches inside the box in order to operate the switch. This is to prevent access by unauthorised persons.

The drop key used to operate the fireman's switches proved to be very difficult to operate and may prevent the fireman from gaining use of the lift to fight the fire. We would recommend these are replaced by triangular type keys in accordance with clause 5.8.2 of BS EN 81-72 which states:

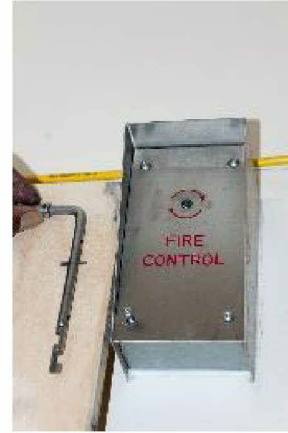
- It was not possible to operate the fireman's switch using the release key.

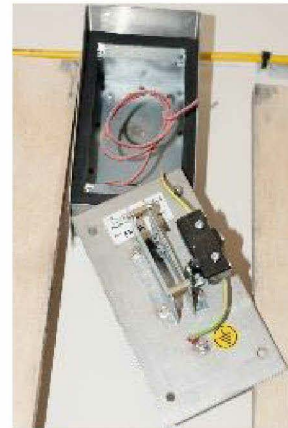
- We removed the faceplate to discover that there were no wires connected to the fireman's switch.

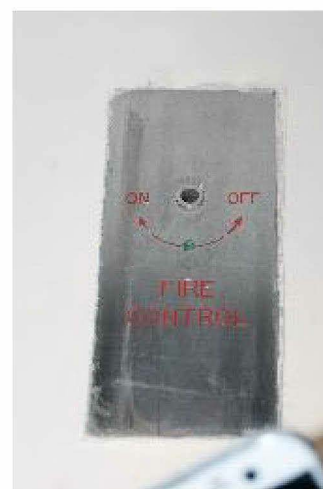
- A green flag could be seen through the hole in the faceplate.

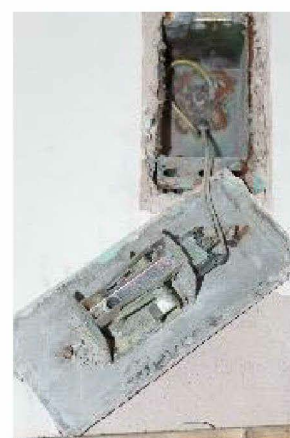
- The fireman's switch was difficult to operate.
- The faceplate was removed to determine the reason for failing to operate the switch.

- We discovered that the mechanism was seized and damaged/deformed.
- The contacts were open circuit when checked with a multi-meter.
- The wiring was coloured yellow and grey.

As the mechanism on the fireman's switch on the ground floor was defective then we can assume this had not been examined by the lift service company at regular intervals.

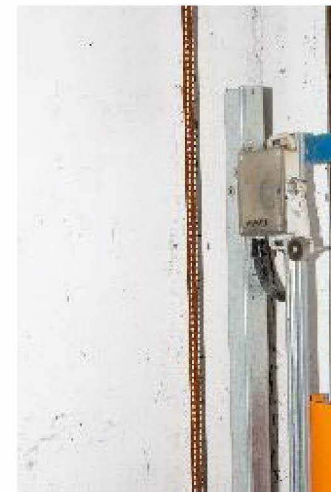
- It should be ascertained if the position reference system is operated via infra-red as this could have a detrimental effect on the operation of the lift.
