BRE Global Test Report

Fire resistance test in accordance with EN1634-1:2014 on a single action, single-leaf doorset with one vision panel, mounted in a brick and block-wall supporting construction.

Report Number: P111605-1001 Issue 1

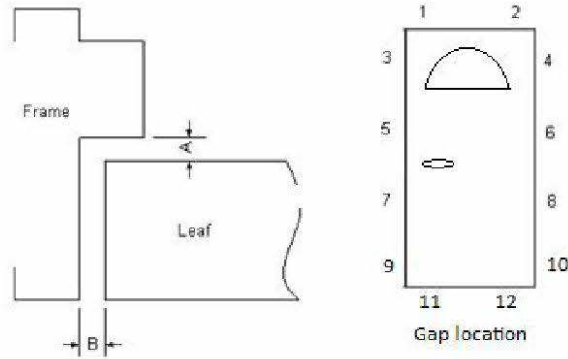
The gaps between the door leaf and frame were measured (in mm) and found to be as given in the sketch and table below.

Location	Gap A	Gap B
1	0	6.5
2	1.5	5
3	0	6
4	2	4.5
5	0	6
6	2	4

Location	Gap A	Gap B
7	0	5
8	3.5	4
9	0	5
10	4	4
11	0	0
12	1.5	1.5

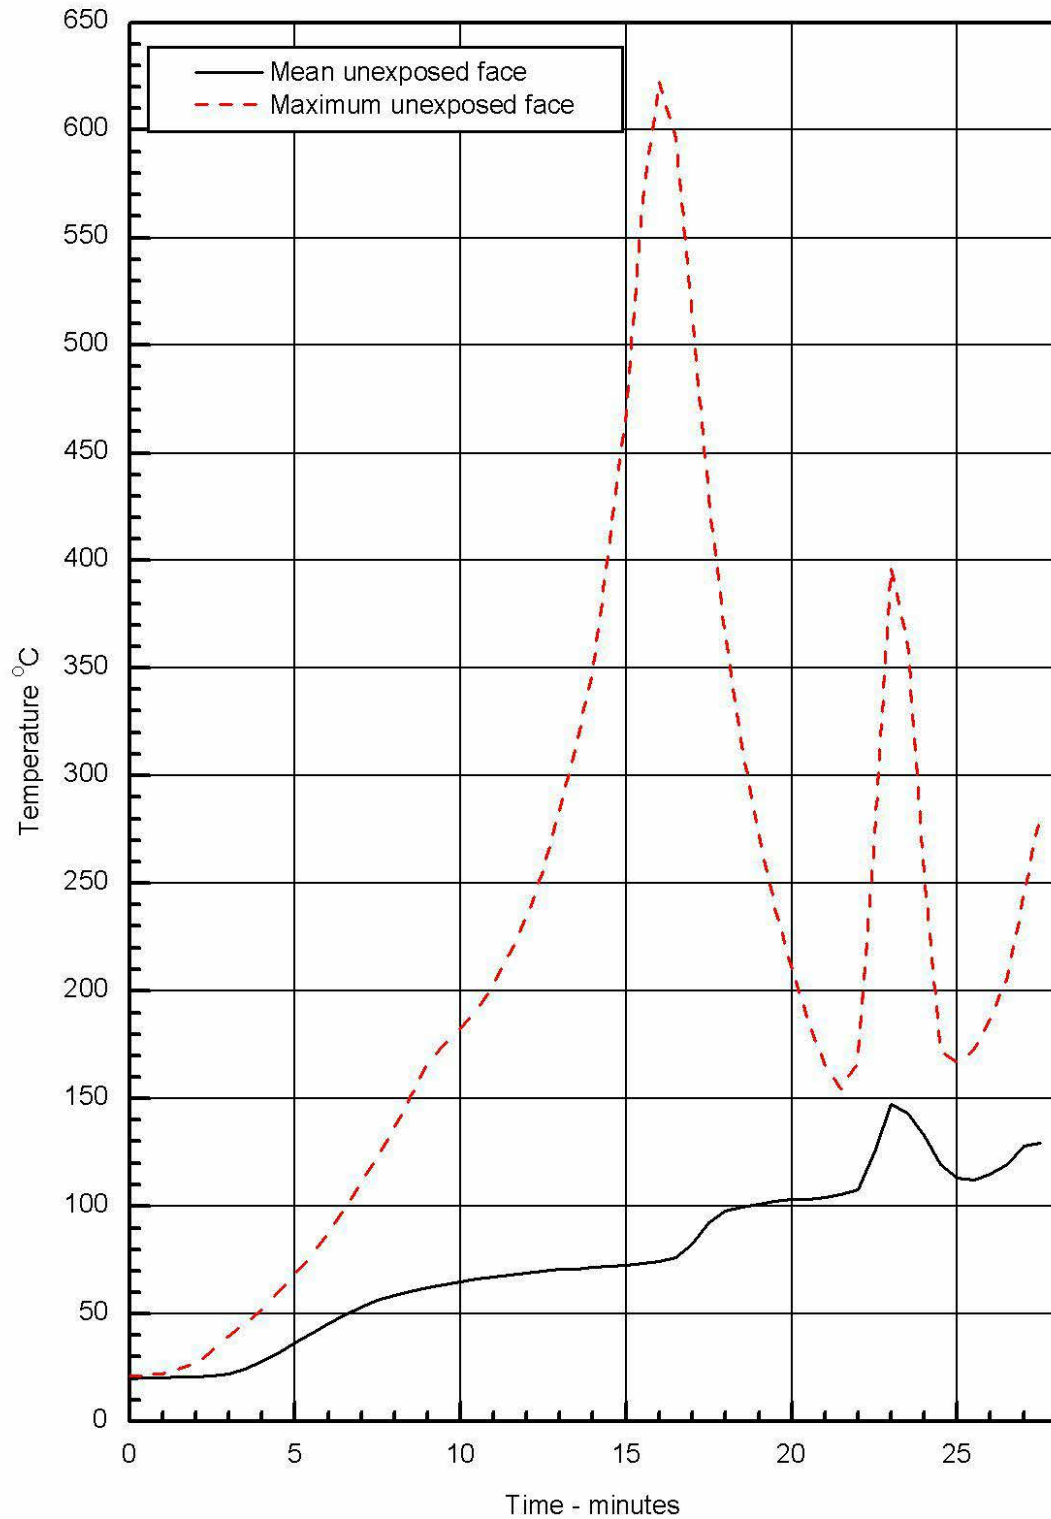
The maximum temperature of the door leaf exceeded the 180°C temperature-rise limit after 10 minutes of the test.

The mean unexposed face temperature of the door leaf did not exceed the 140°C temperature-rise limit during the test.

The maximum temperature of the door frame did not exceed the temperature-rise limit of 360°C during the test.

Mean and maximum temperatures recorded on the unexposed face.

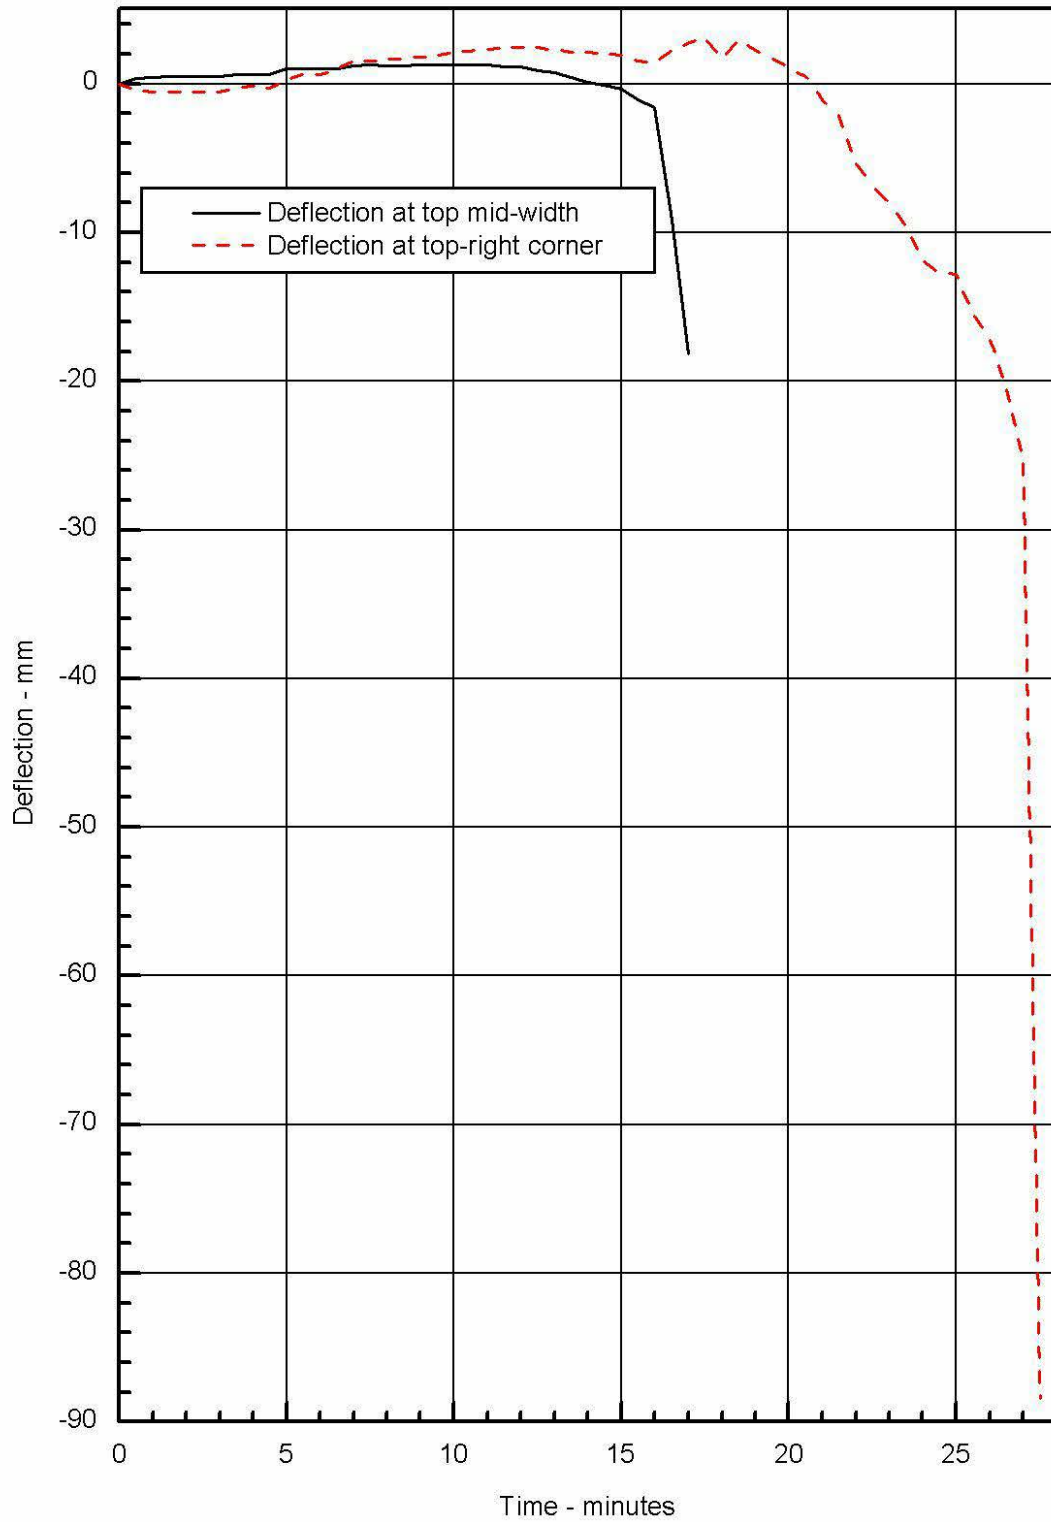
After approximately 17 minutes from the start of the test, the flaming from the door leaf caused the wire attached to the top of the door leaf at mid-width to detach from the specimen. As such, data from this transducer was not recorded after 17 minutes.

The maximum deflection measured by the transducer attached to the top right-hand side corner of the door leaf was 88mm away from the furnace, recorded at the end of the test.

Horizontal deflection recorded at the top of the door leaf.

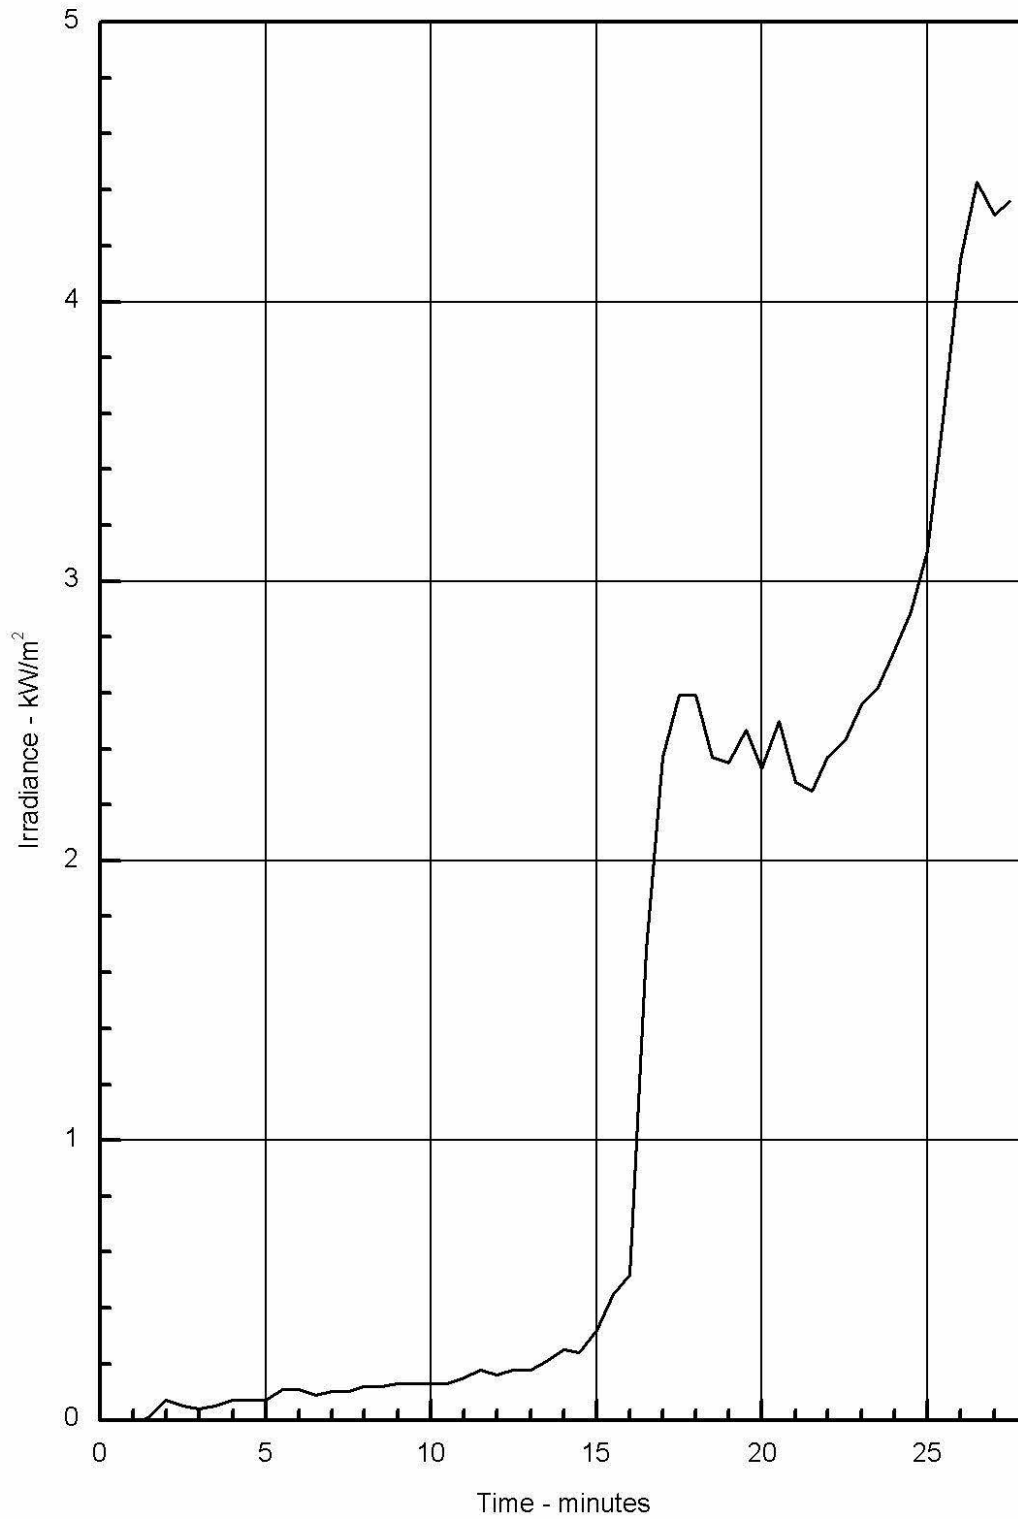
The irradiance recorded 1m from the centre of the specimen is given in the attached Graphs. The maximum irradiance was 4.36kW/m² recorded at the end of the test.

Irradiance recorded 1m from the centre of the doorset.

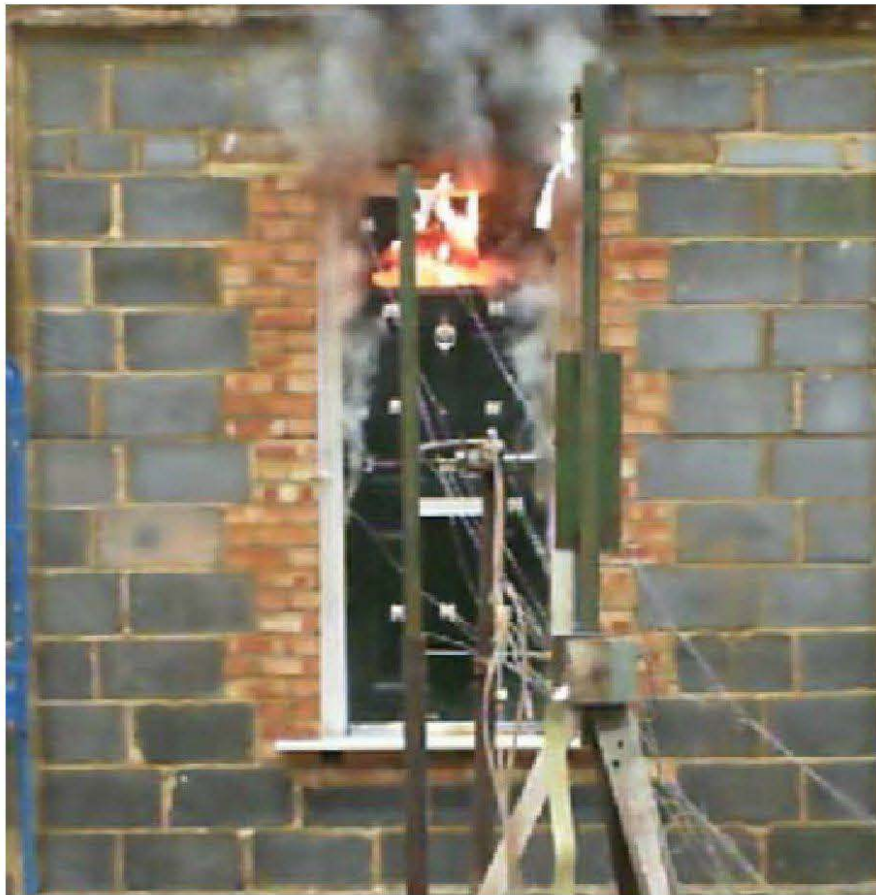
The first failure of integrity occurred after 15 minutes.

Exposed face of specimen at time of first integrity failure (15 minutes).

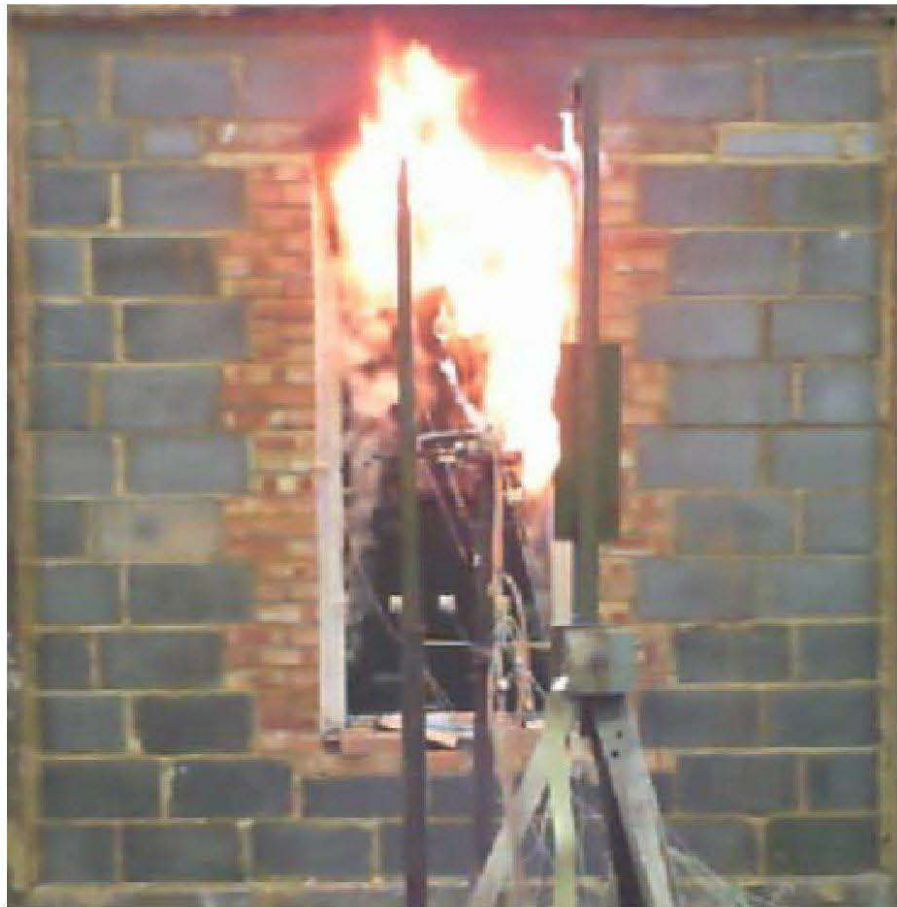
Time minutes	Observation
0	Start test.
2	A considerable amount of smoke is coming from the doorset, with most smoke from the right-hand side edge of the leaf.
4	Smoke is coming from the letterbox.
9	Approximately half the glazed area has darkened with soot deposits. The unexposed face layer of glass has cracked in several places.
10	Considerable smoke continues to come from the right-hand side edge of the door leaf.
12	Some smoke is now coming from the cracks in the glass.
15	Failure of integrity from sustained flaming at the top edge of the glazing.
16	The glazing fell out from the leaf.
20	Flames coming out from where the glazing has fallen are setting fire to the door frame at the top of the doorset.
21	A red glow and intermittent flaming from adjacent to the handle/latch area.
23	Sustained flaming from the latch area. The front cover of the letterbox has fallen off.
27	The trim around the perimeter of the doorset is flaming and melting.

Unexposed face of specimen at end of test (28 minutes).
