Prepared for:	Martin Tucker
Date:	10 February 2020
Report Number:	P116337-1001 Issue: 1

This report summarises the work done, and observations made on site by BRE in February 2019 in relation to the fire detection system installed in Grenfell Tower.

The overall objective of this work was to gain a greater awareness of the operation of the smoke detection system; determine why the lift did not return to the ground floor upon activation of the smoke detection system; and determine why the smoke vent opened on the 11th floor.

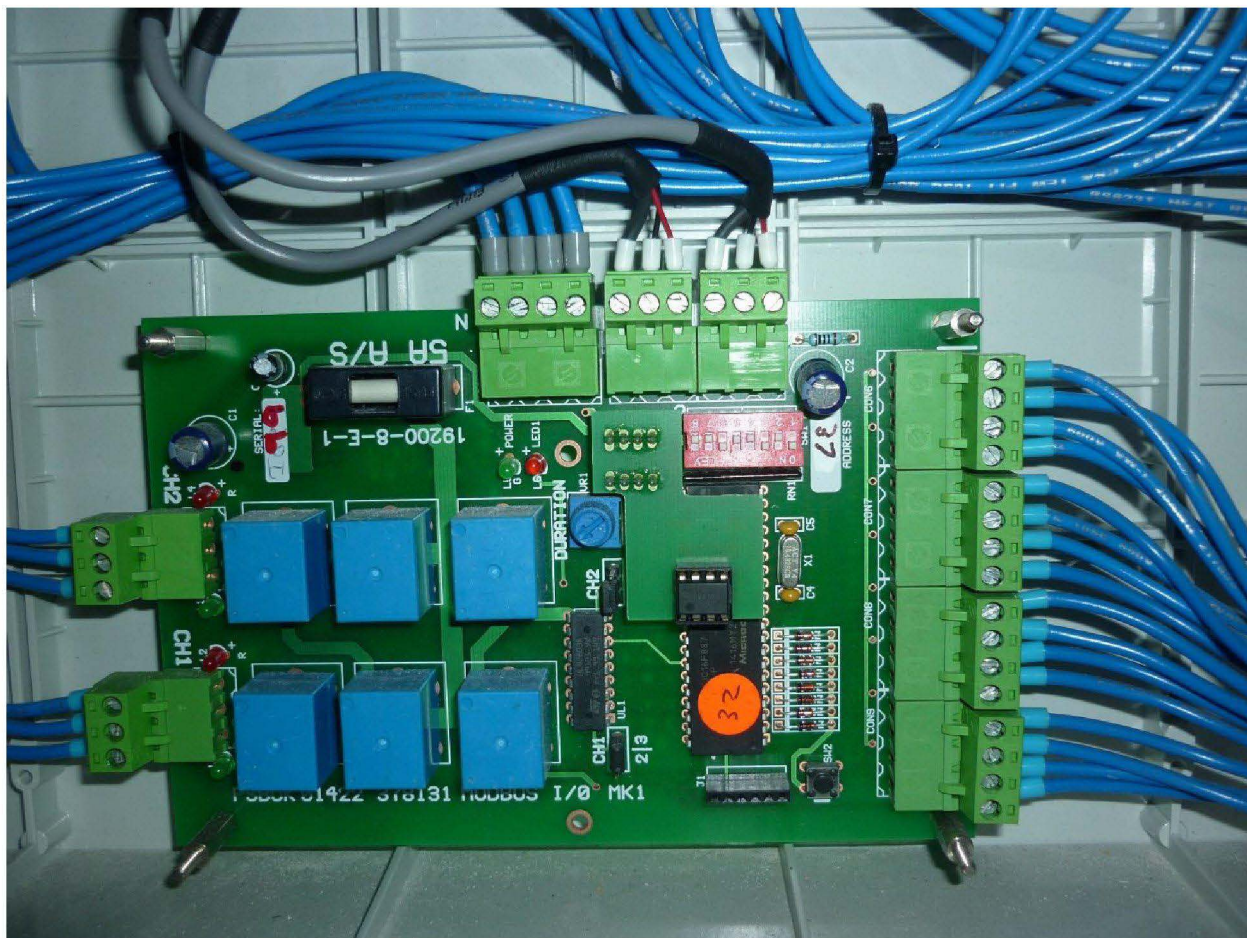
Figure 1: Example MK1 Modbus I/O board in Outstation O/S 3, 4th floor (address = 37)

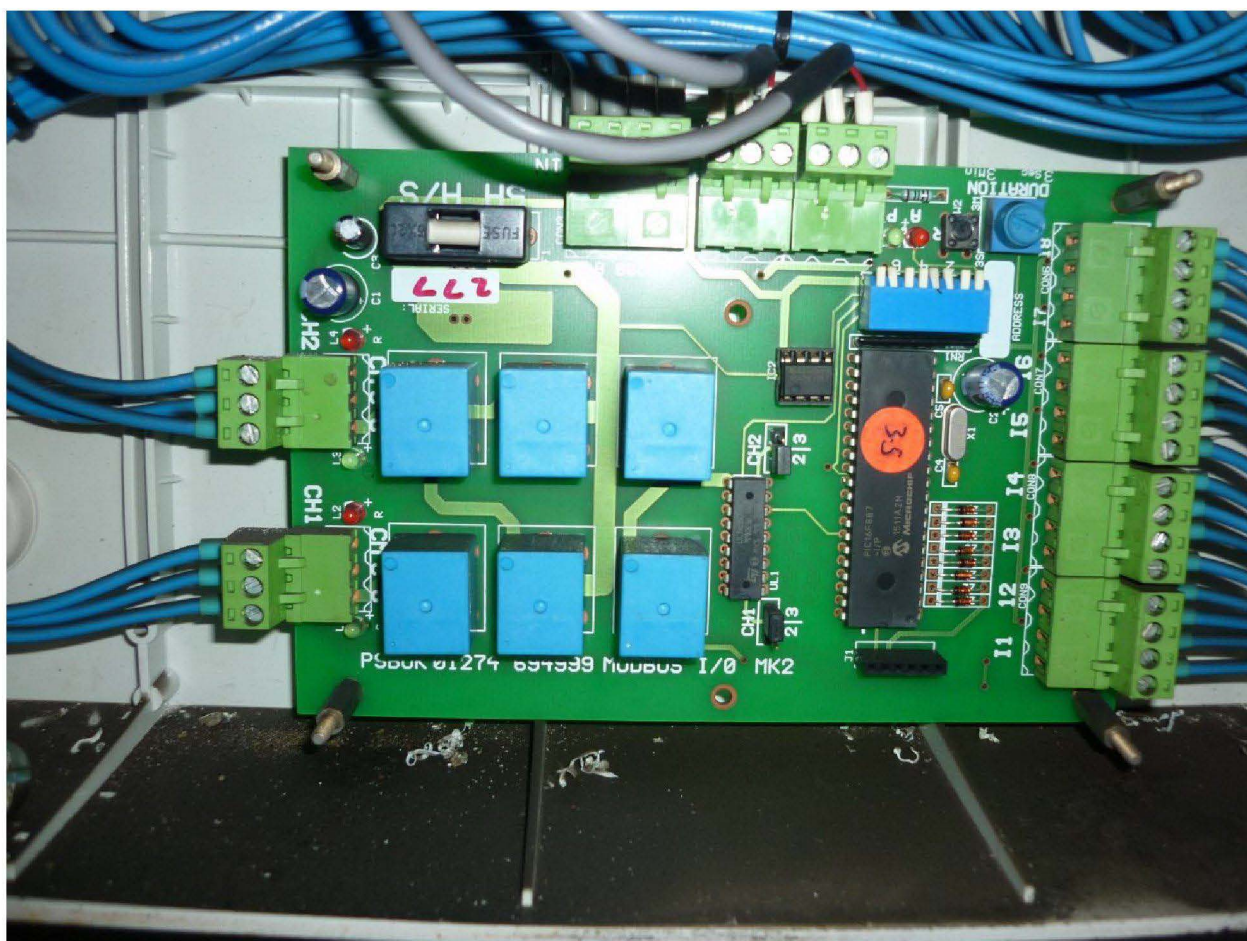
Figure 2: Example MK2 Modbus I/O board in Outstation O/S 16, 17th floor (address = 76)

Note: No handwritten address on this particular board

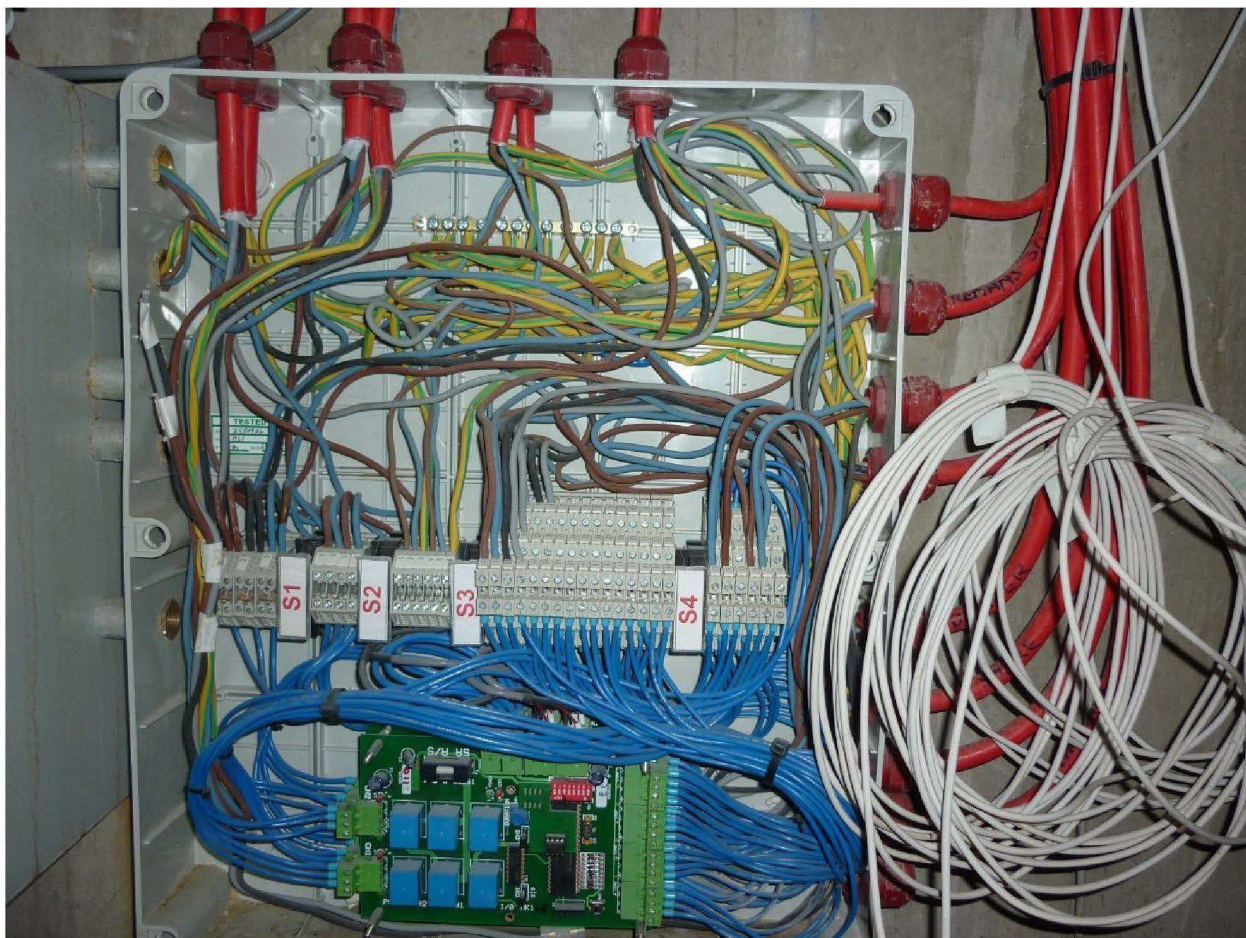
Outstation 1 (2nd floor) was the exception in that it had three individually addressed Modbus I/O boards, stacked on top of each other.

Figure 3: Outstation O/S 1 (2nd floor), exceptionally had three stacked Modbus I/O boards

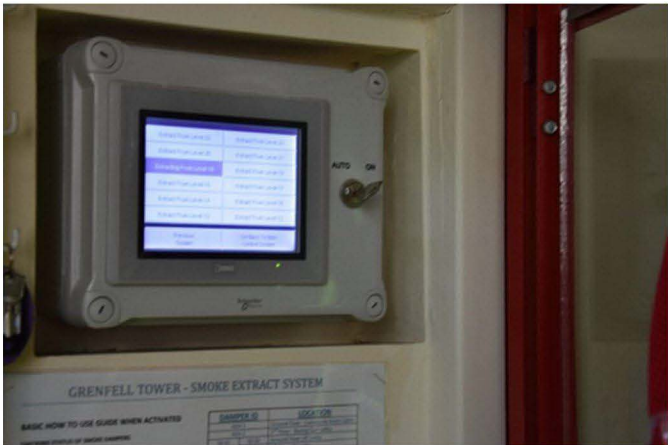
Note: The fireman's override switch is labelled Auto / ON on the front panel of the HMI unit to the right of the touch screen. The HMI unit had been removed from its panel prior to BRE's site visit but a photograph of the unit before it was removed is shown in Figure 4.

Figure 4: HMI panel, incorporating touch screen and Fireman’s Override Switch

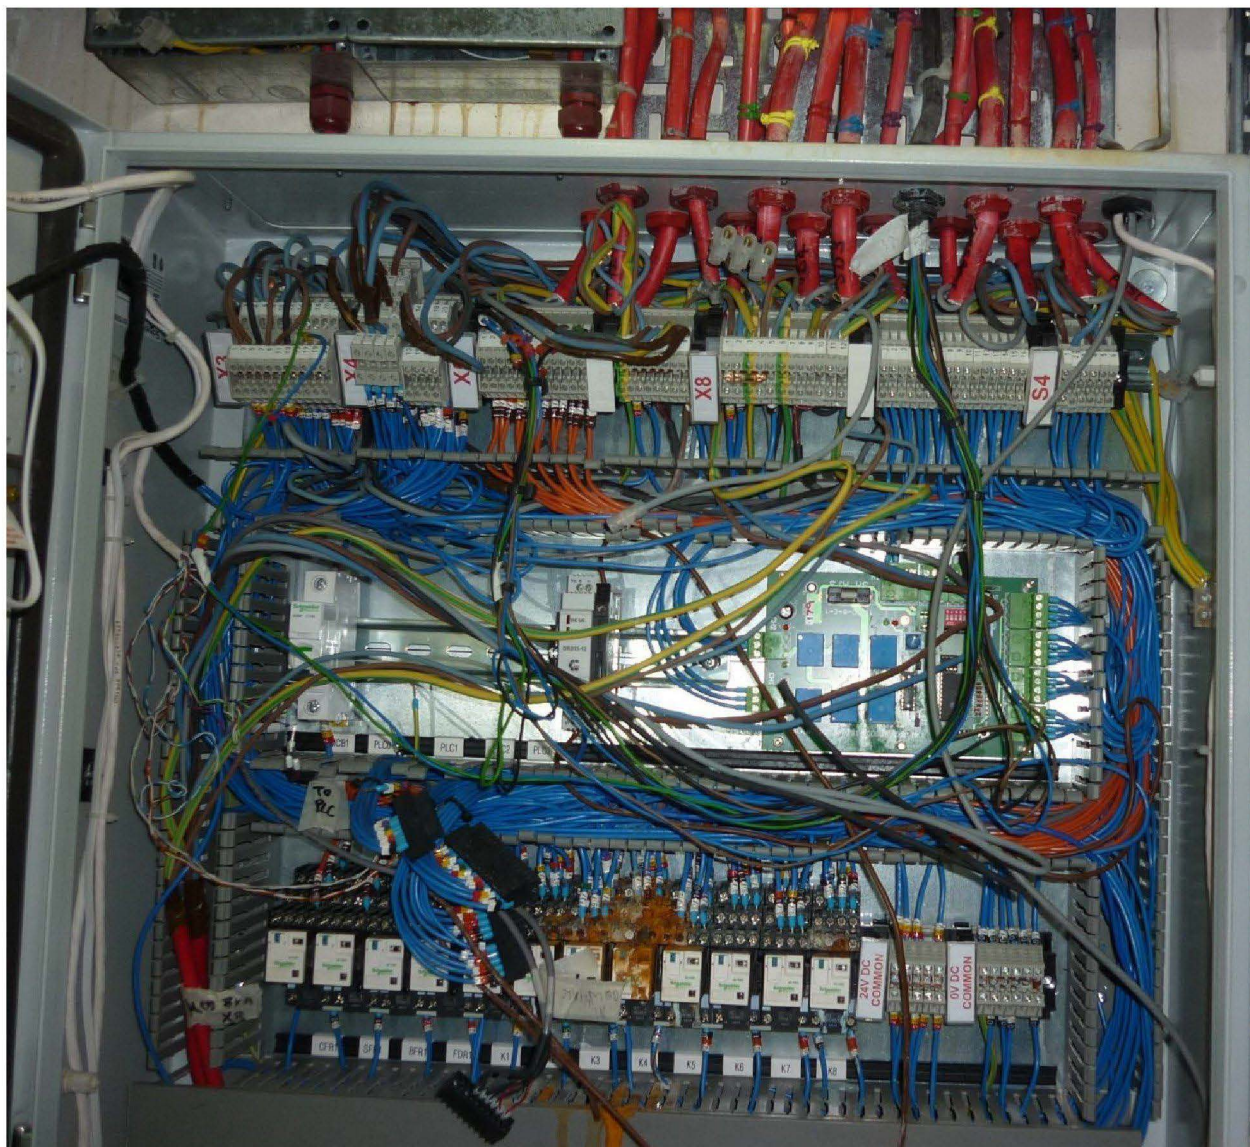
Figure 5: Master Panel with cable ties attached with PLC removed

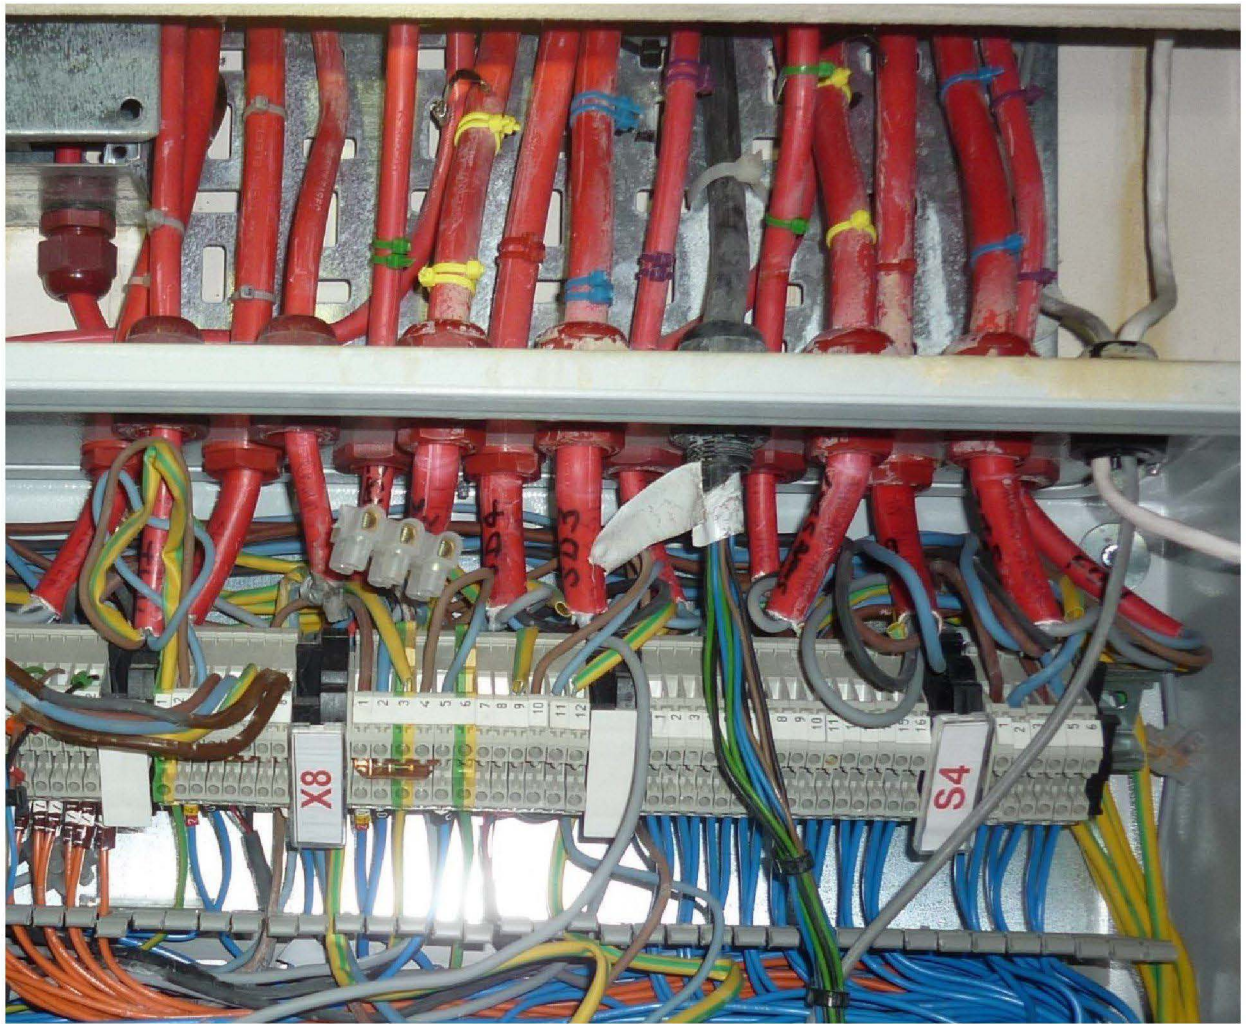
Figure 6: Master Panel – detail of top right cables

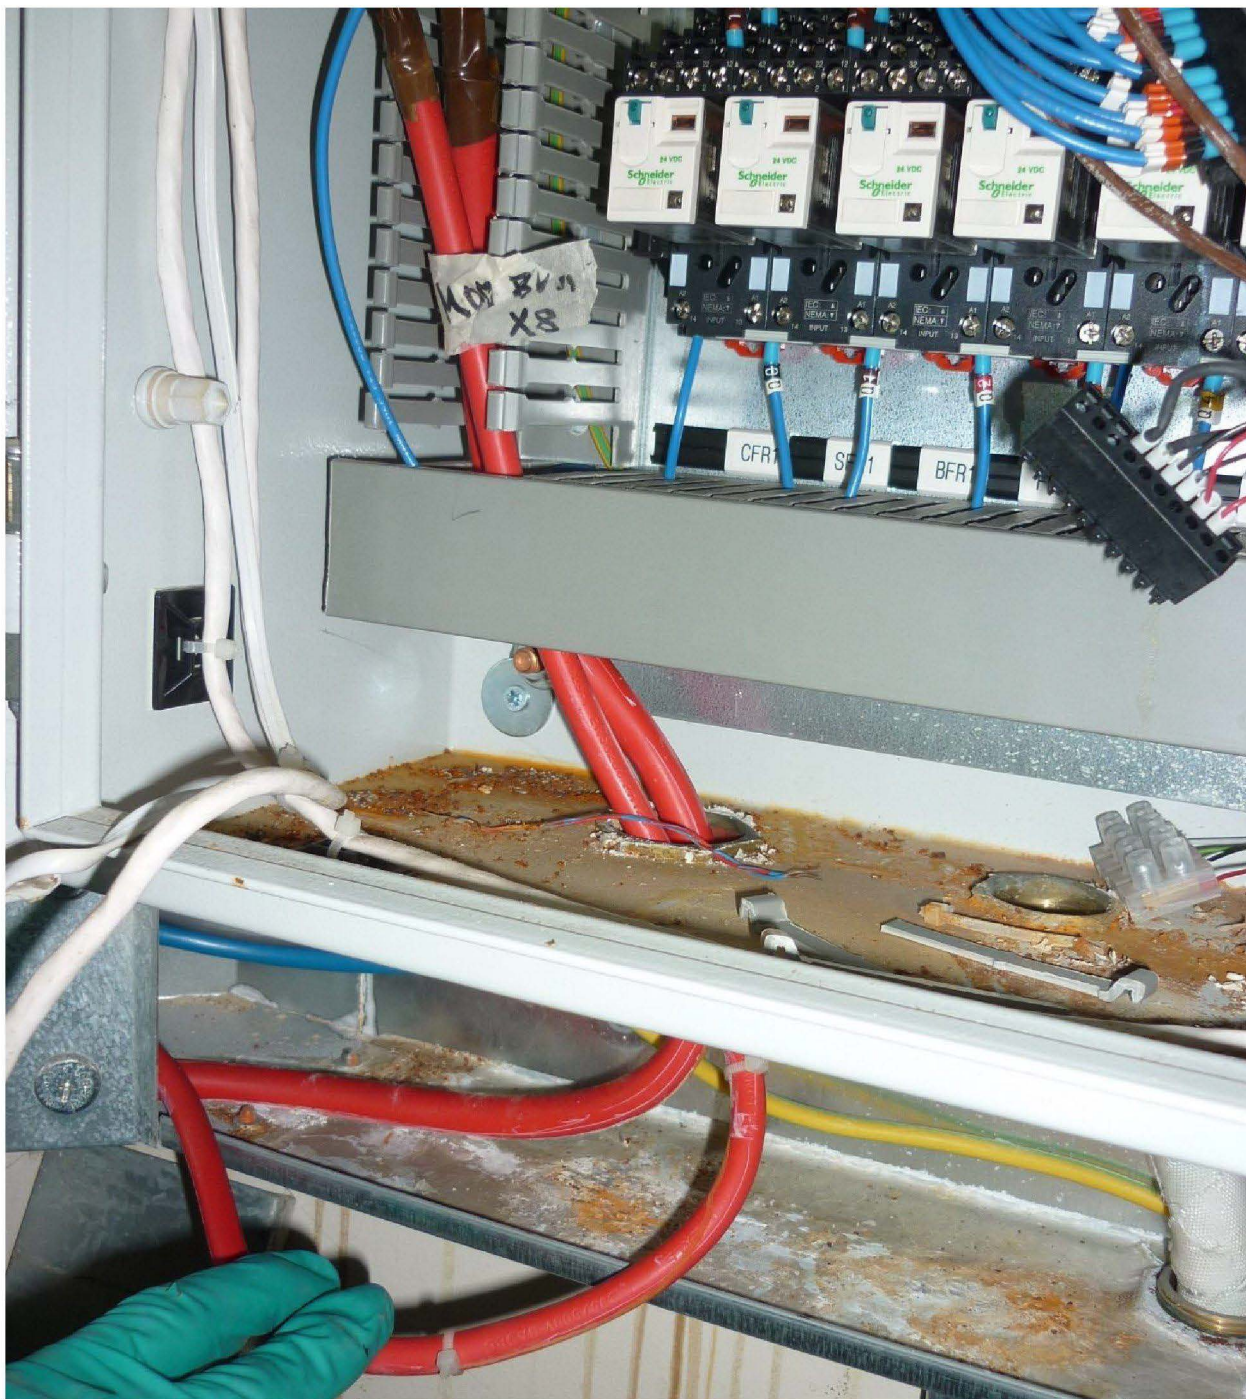
Figure 7: Master Panel – detail of bottom left cables

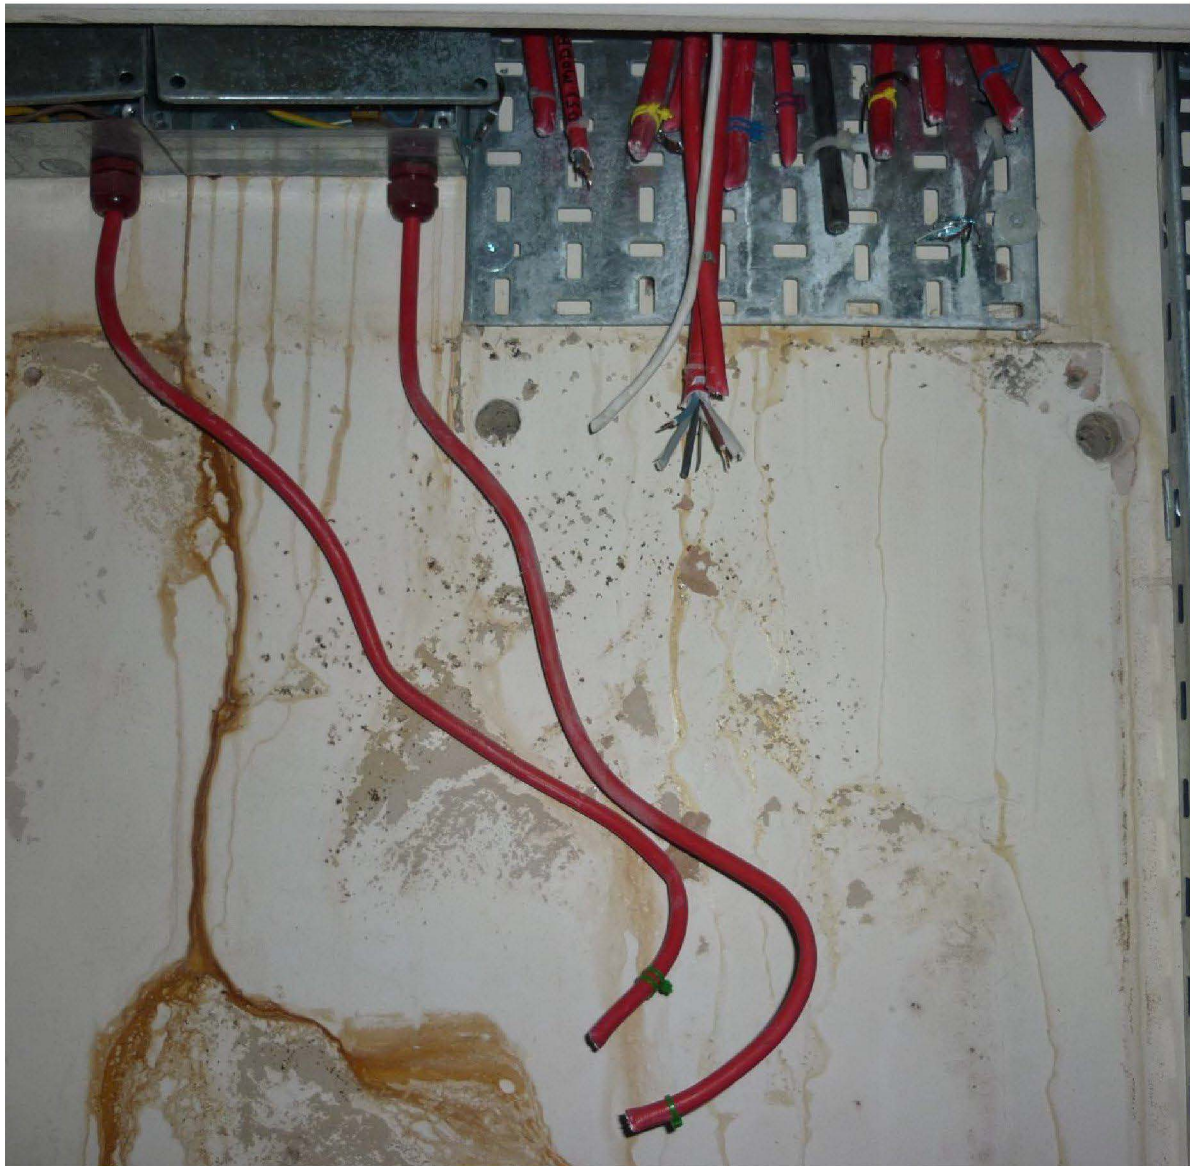
Figure 8: Master Panel cables after panel removed

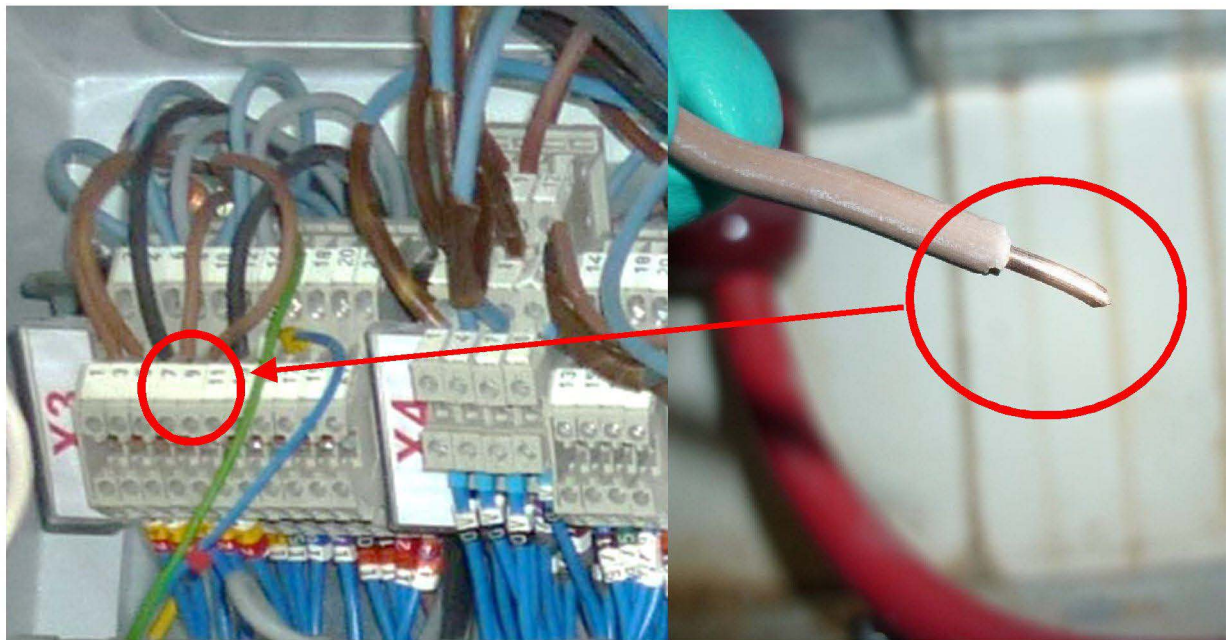
It should be noted that while checking the connection from Terminal X3/7 to the 1st floor lift lobby pressure switch continuity testing showed no electrical continuity. Inspection showed that the wire was loose in the terminal due to the terminal screw not having been tightened, as shown by the exposed copper core having no marks, see Figure 9.

Figure 9: Master Panel - Unsecured wire in Terminal X3/7 failed continuity test

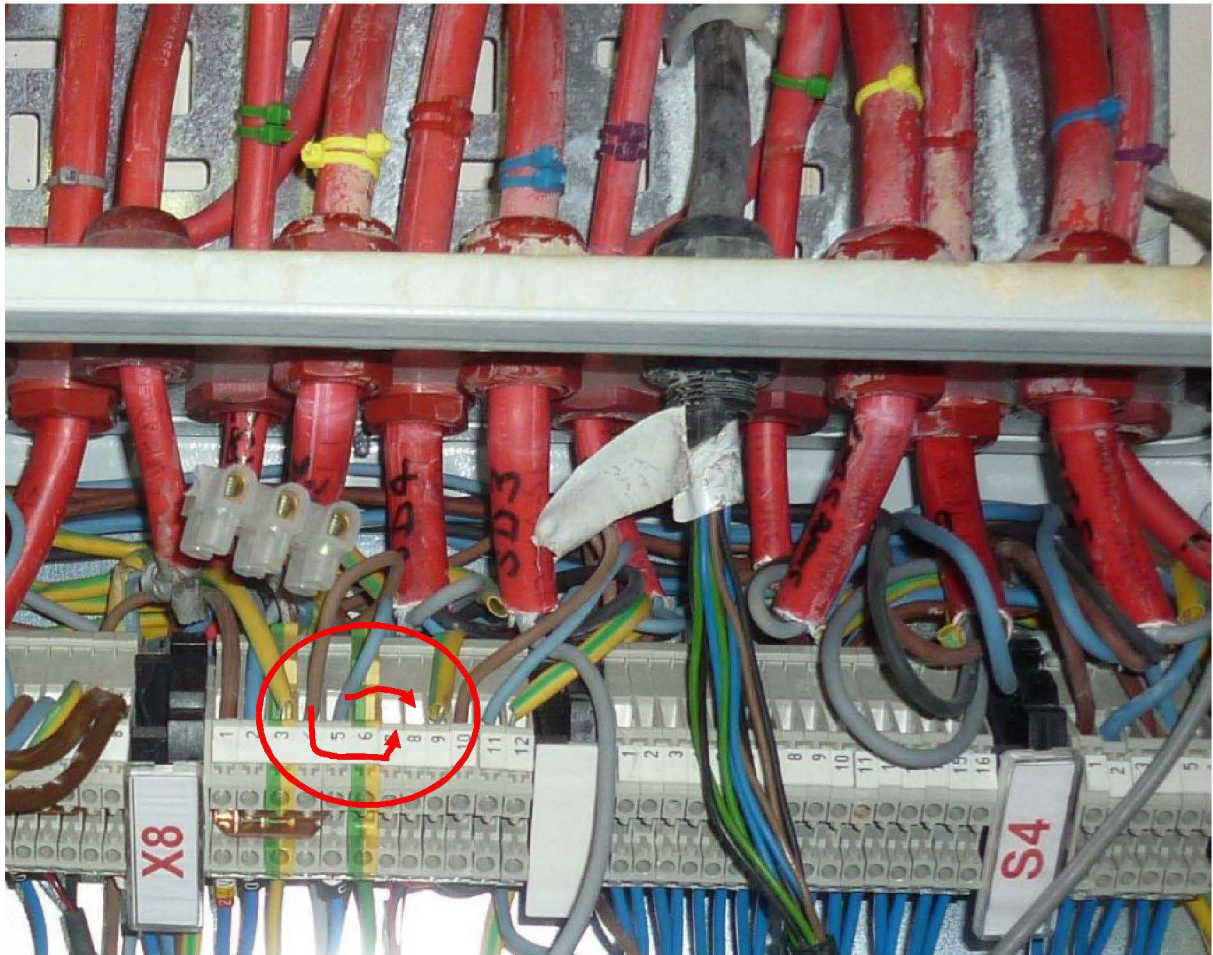
NOTE: An error was made when reinstating two cables after an electrical continuity test by BRE. Brown wire in X8/4 should go to X8/7, and blue wire in X8/5 should go to X8/8, see Figure 10.

Figure 10: Master Panel - Details of error made when reinstating wires after continuity test

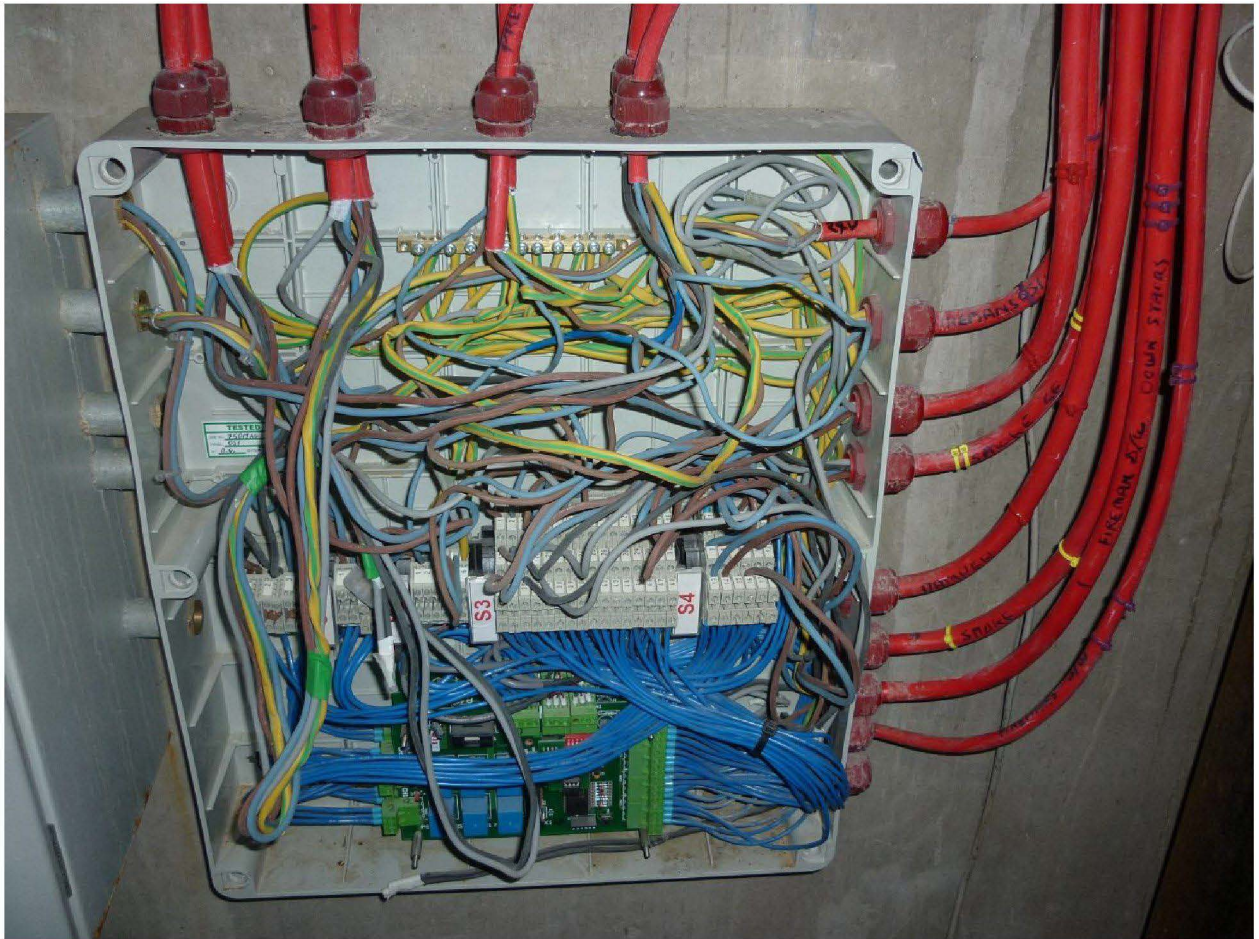
Figure 11: Outstation O/S 1

Outstation 1 (O/S 1) has more connected devices than all of the other outstations since it also controls the window smoke vents (AOVs) in the Boxing Club and Community Room as well as the 2nd floor lift lobby smoke extract dampers. Table 6 shows the function of the devices connected to the wiring terminals in Outstation O/S 1. A photograph of Outstation O/S 1 is also shown in Figure 11. Note that the lift lobby smoke dampers are 3-wire devices whereas the window smoke AOVs in the Community Room and Boxing Club are 2-wire devices. Table 6 is based on the PSB Wiring Tables but with confirmation and additional information from BRE's visual inspection.

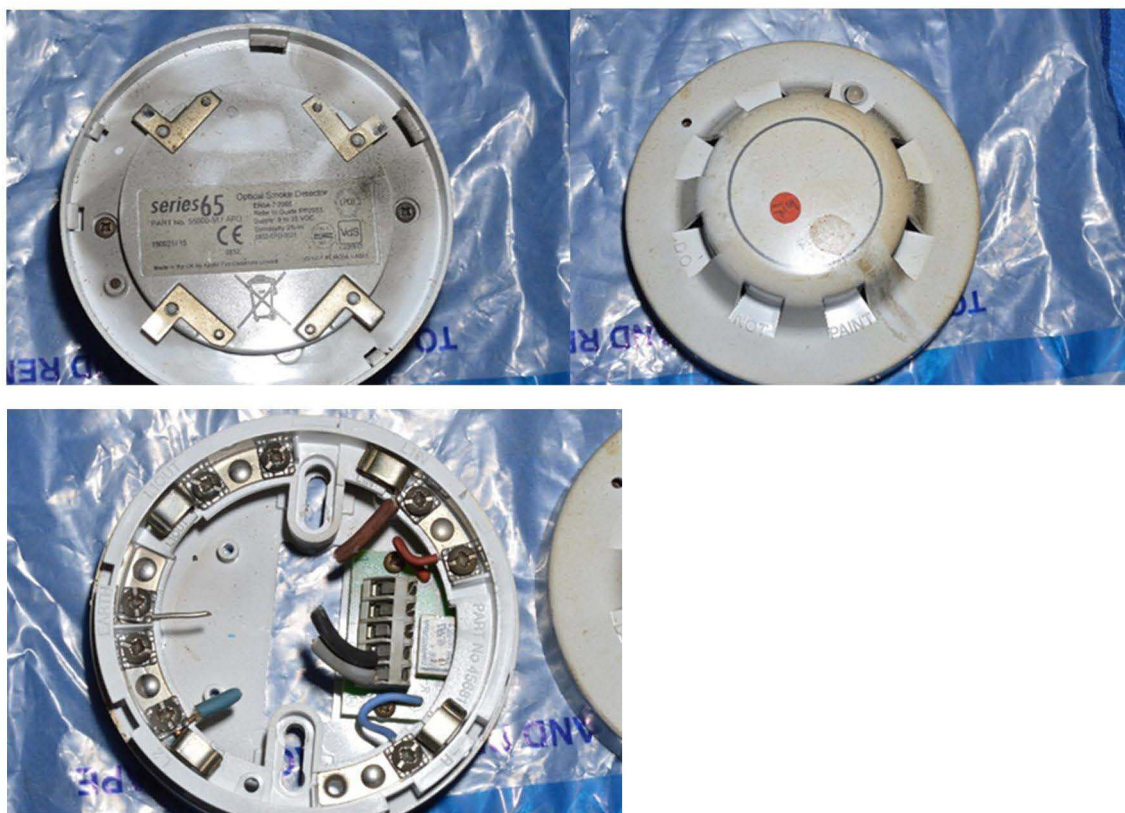
The cable to each detector is a 4 core cable, 2 cores supply 24Volts to the detector, and the other 2 cores are for the signal from the detector relay base when the detector is activated, see Figure 12.

Figure 12: Typical smoke detector and relay base

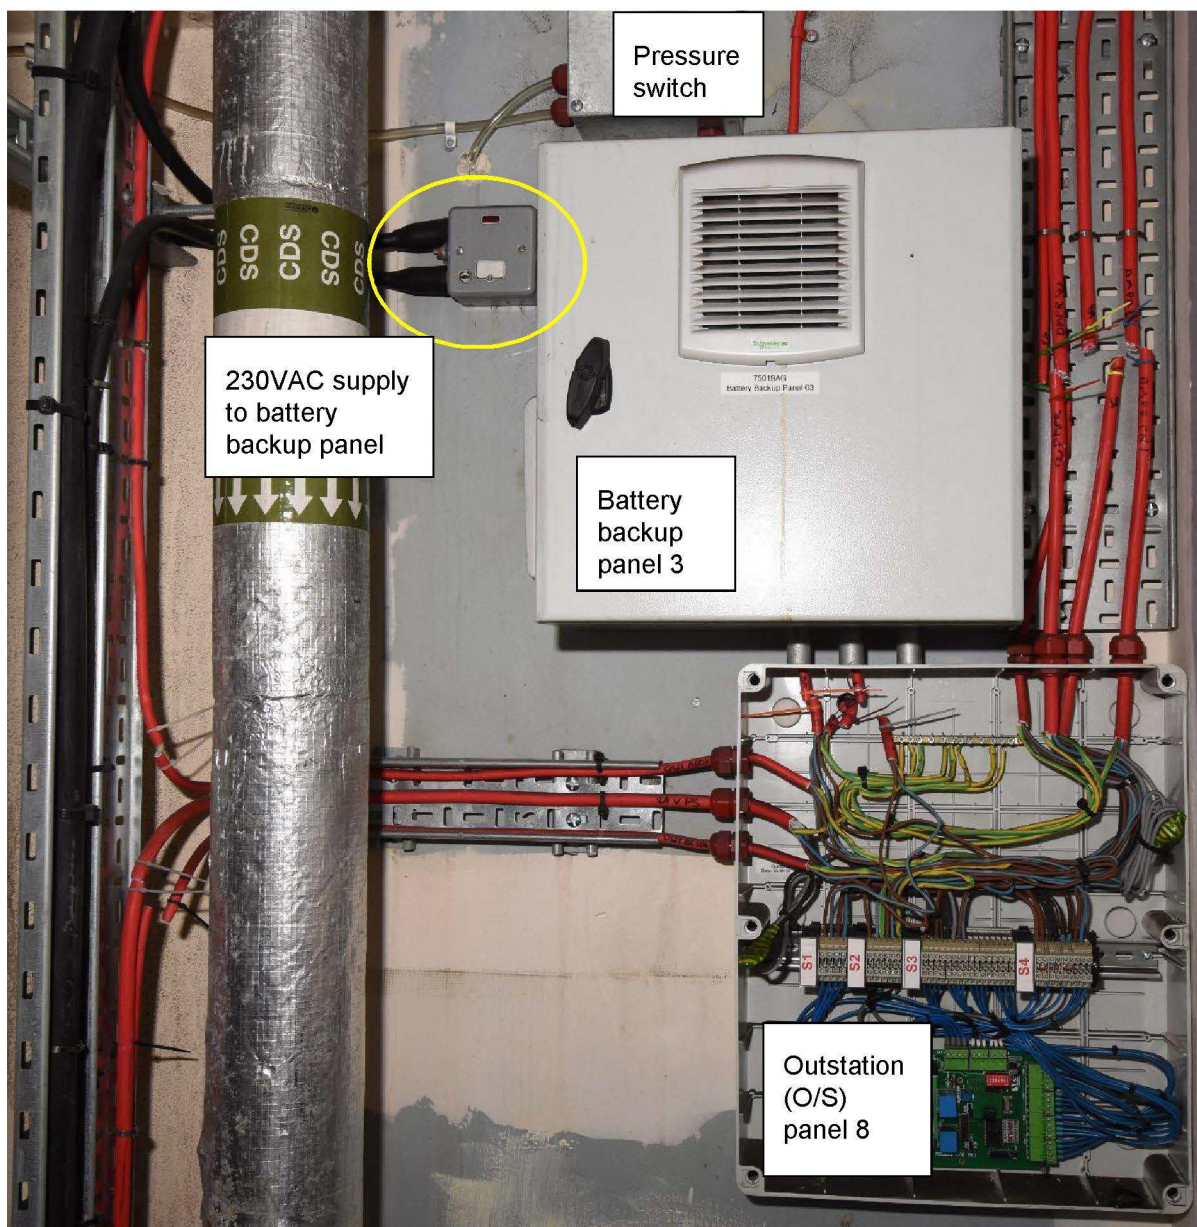
Figure 13: Cables to external devices from Outstation O/S 8 tagged and cut prior to removal of Outstation O/S panel

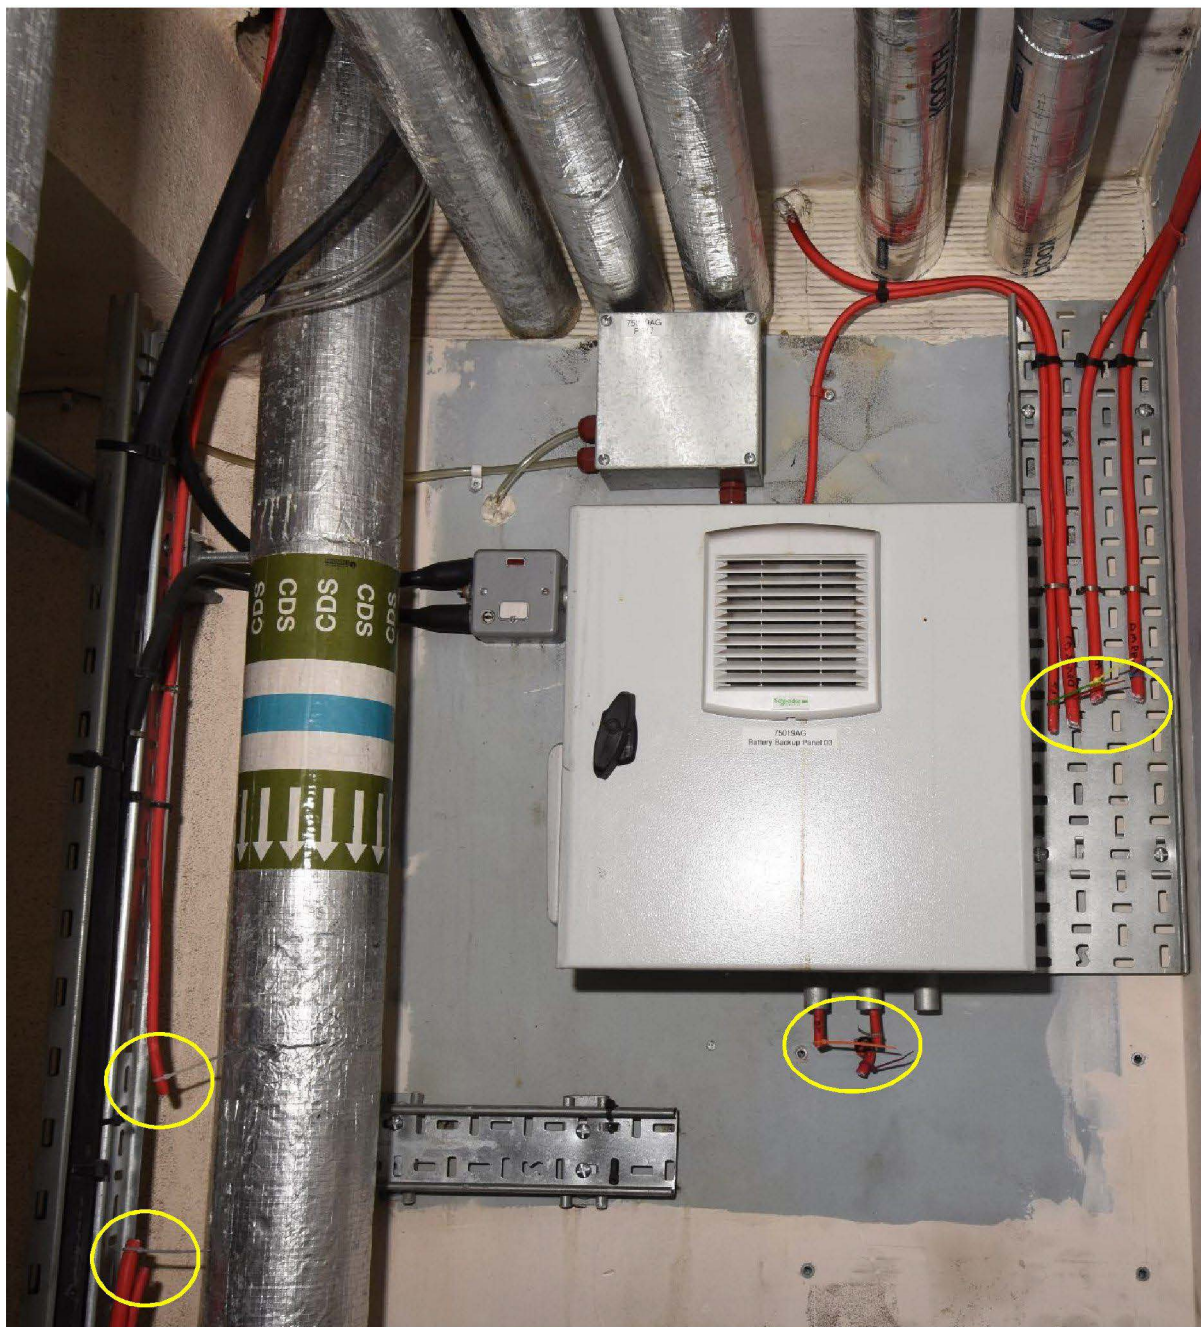
Figure 14: Outstation O/S 8 removed leaving behind cut cables to external devices

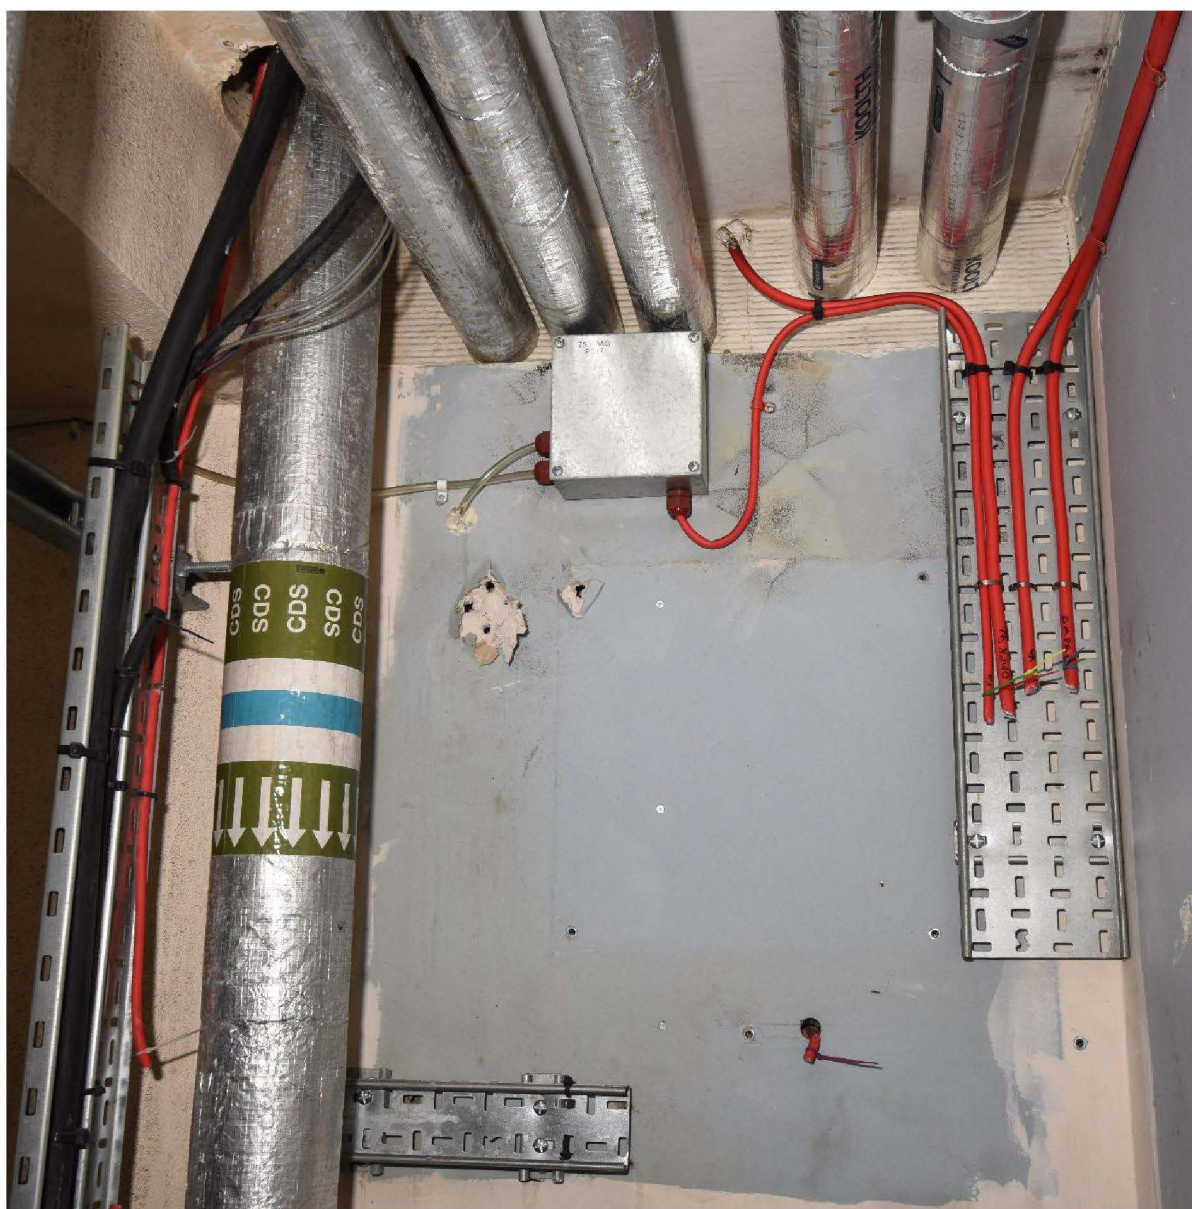
Figure 15: Outstation O/S 8 panel and Battery Backup Panel 03 removed

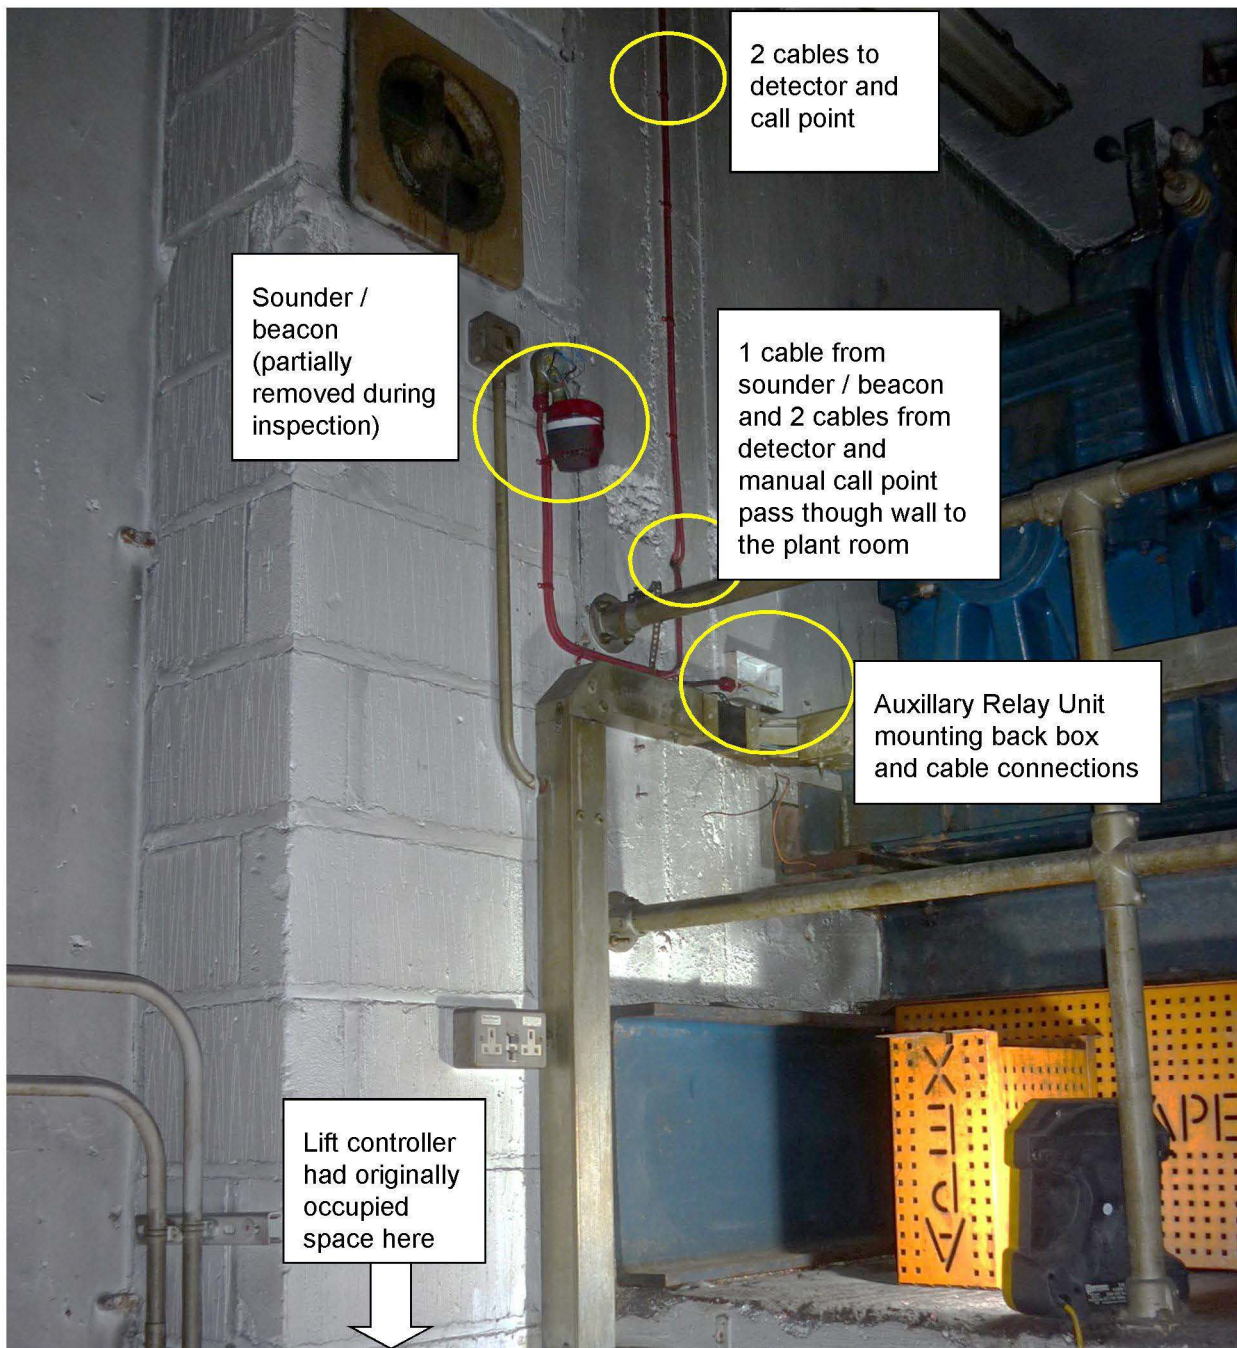
The lift motor room had a fire detector attached to the ceiling, a manual call point close to the entrance door and a sounder/beacon on the wall close to the location of an 'Auxillary Relay Unit' mounting back box (see Figure 16 and Figure 17). The Auxillary Relay Unit had been removed as a Police Exhibit but its

Figure 16: Cables, sounder / beacon and Auxillary Relay Unit mounting back box adjacent to position of lift controller

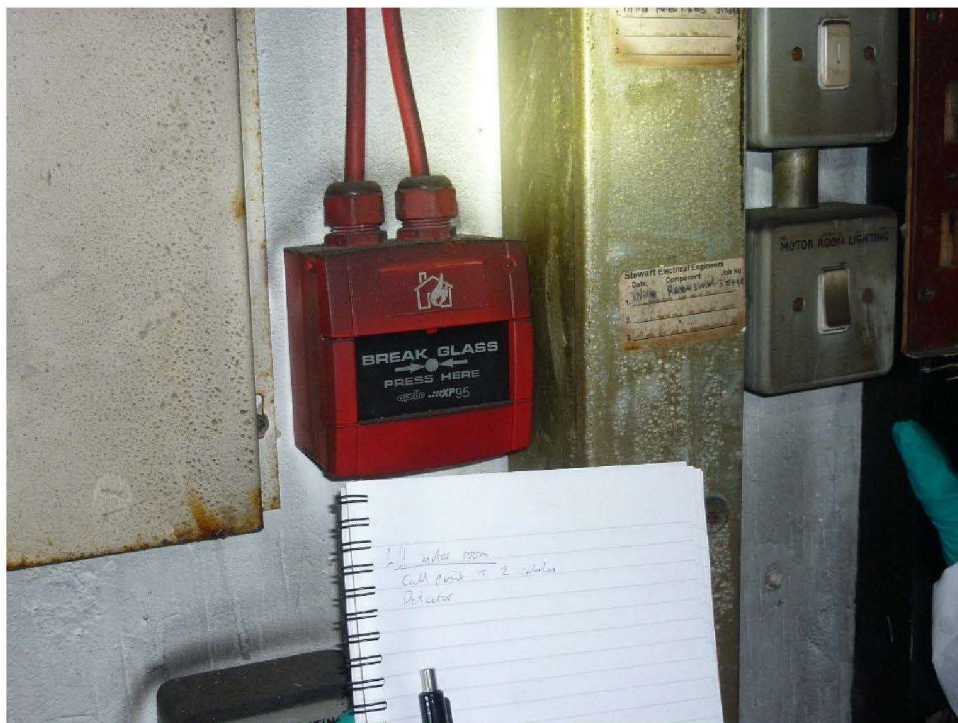
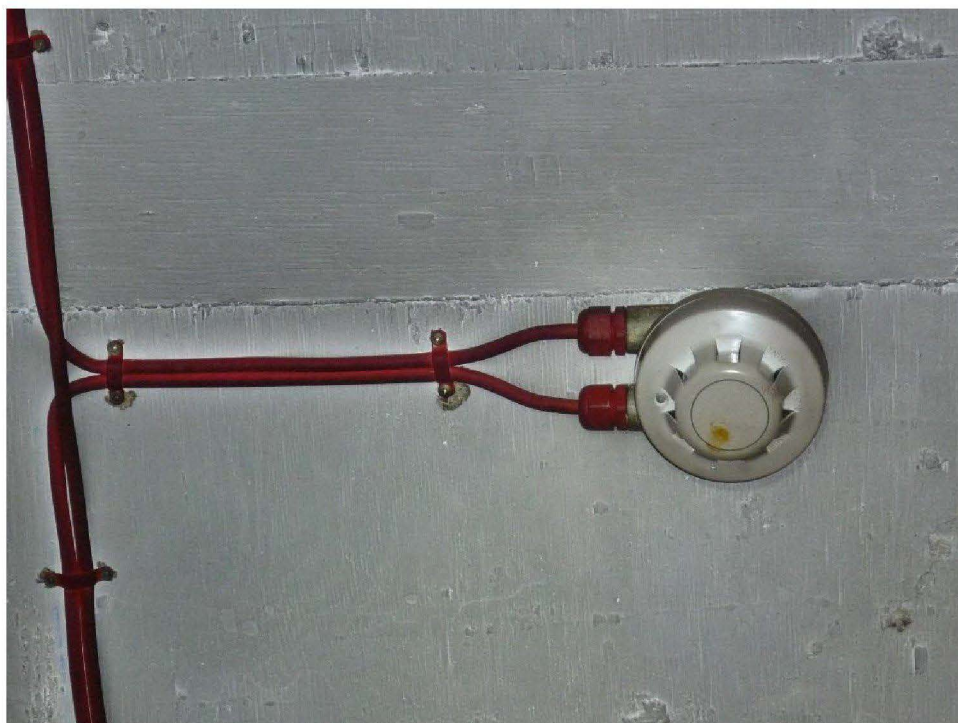
Figure 17: Manual call point and smoke detector in lift motor room
