Prepared for:	Martin Tucker
Date:	10 February 2020
Report Number:	P116337-1001 Issue: 1

This report summarises the work done, and observations made on site by BRE in February 2019 in relation to the fire detection system installed in Grenfell Tower.

The overall objective of this work was to gain a greater awareness of the operation of the smoke detection system; determine why the lift did not return to the ground floor upon activation of the smoke detection system; and determine why the smoke vent opened on the 11th floor.

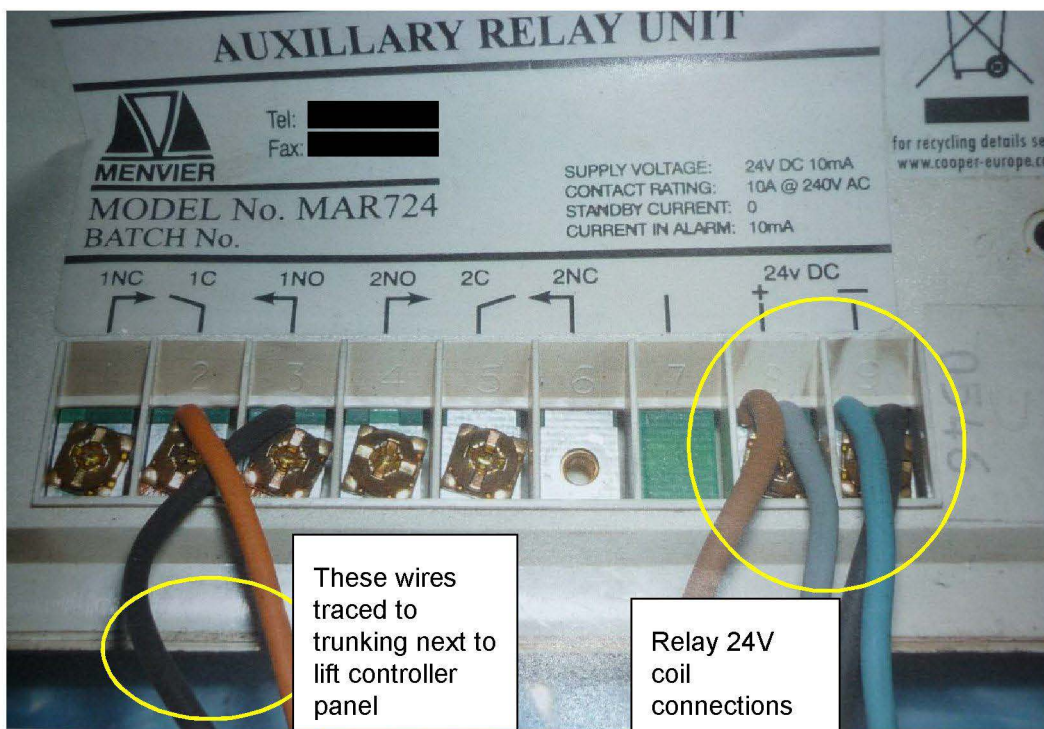
Figure 18 shows a black wire and a brown wire connected to the 1NO and 1C relay contacts. These wires were traced visually and by an electrical continuity tester from the auxiliary relay mounting back box (auxiliary unit removed) to the black and brown wires in the metal trunking cut close to where the trunking would have met the lift controller panel (See Figure 19).

Figure 18 shows 2 pairs of wires (24V DC+ brown and grey / 24V DC - black and blue) connected to the 24V coil of the Auxillary Relay Unit. These wires were part of a 4 core cable which was traced from the Auxillary Relay Unit mounting back box to the sounder/beacon located on the same section of wall. The connections at the base to the sounder/beacon are shown in Figure 20. The brown and blue wires from the Auxillary Relay Unit mounting back box are seen to pass into and out of the sounder / beacon. The brown and blue wires coming out of the sounder / beacon are part of a second 4 core cable that passes through the wall from the lift motor room to the next-door plant room (containing large water tanks). The black and grey wires bypass the sounder / beacon and are joined to the second cable that carries the brown and blue wires from the sounder / beacon. Electrical continuity testing confirmed that the sounder / beacon was connected to the to the Auxillary Relay Unit coil (brown and blue wires). Therefore, energisation of the Auxillary Relay Unit would also cause the sounder / beacon to operate.

Figure 18: Auxillary Relay Unit

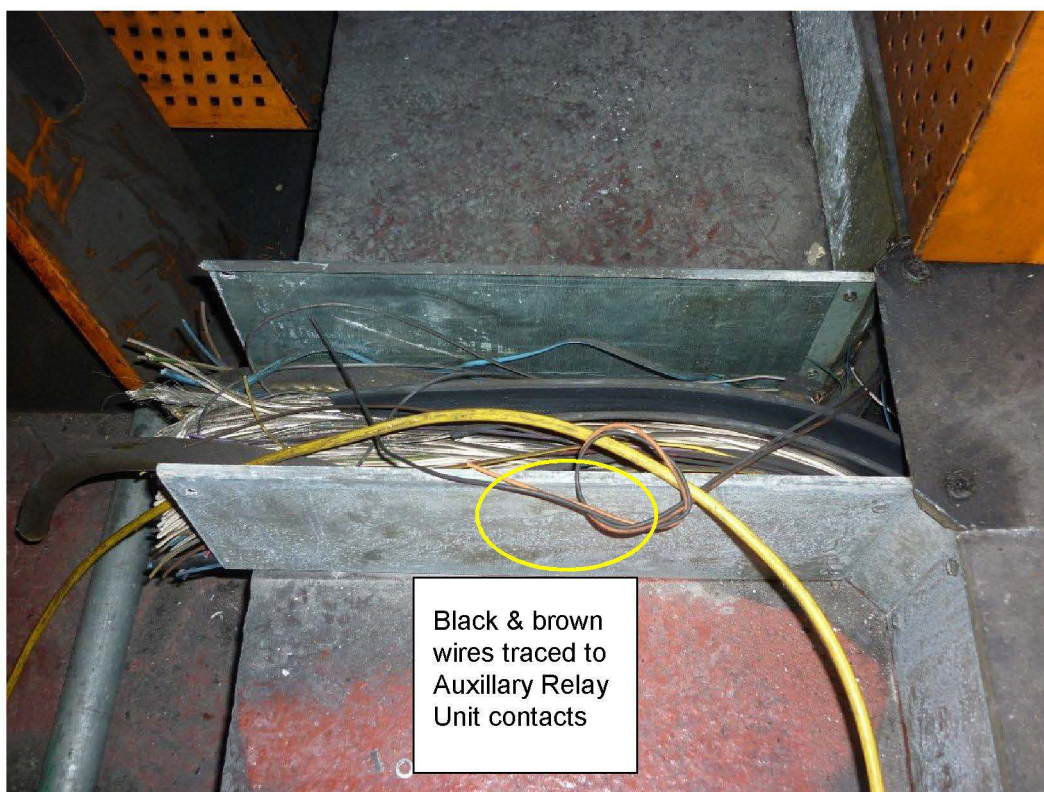
Figure 19: Metal trunking containing cables and wires to lift controller

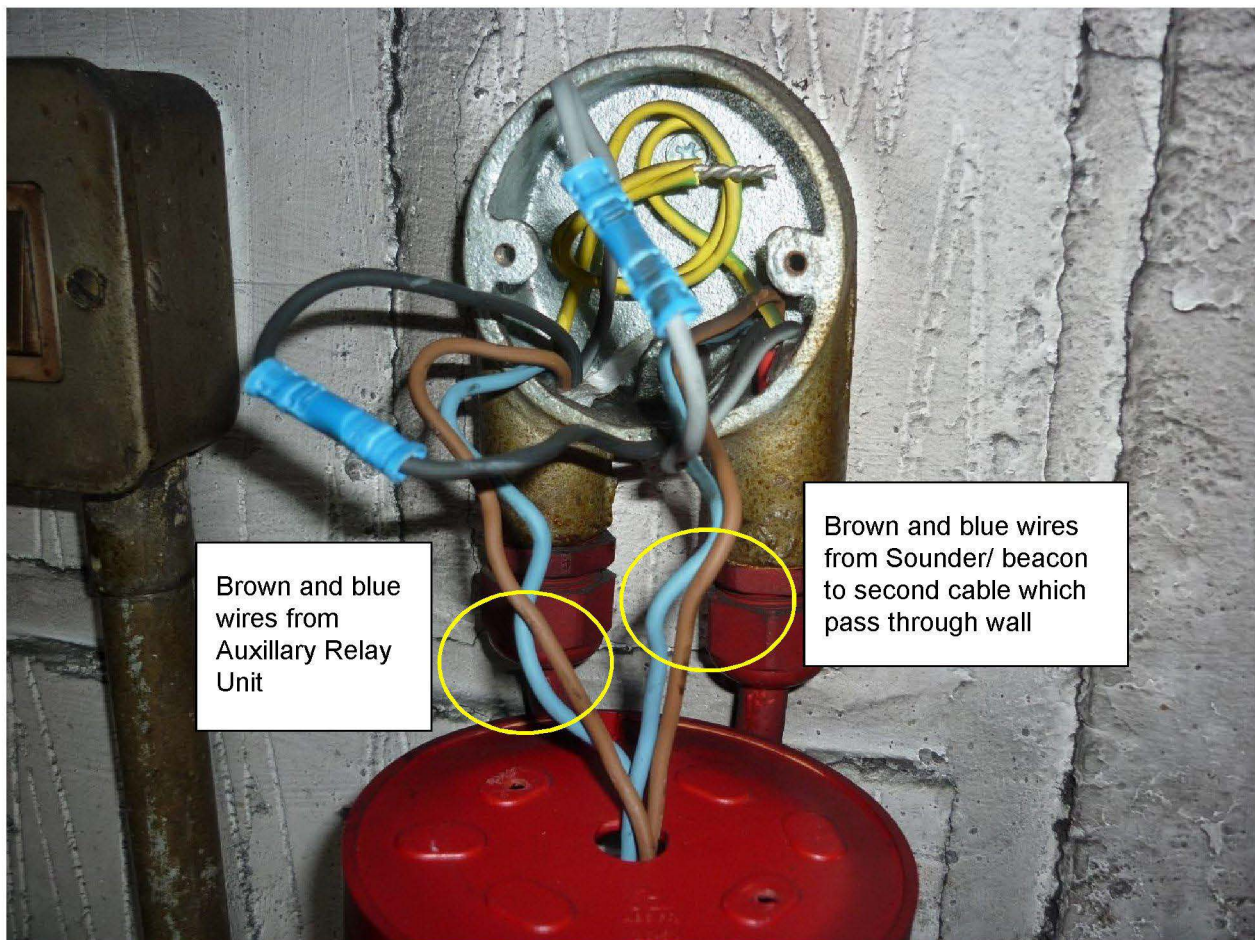
Figure 20: Cable connections at base of sounder / beacon in lift motor room

Note: Left hand side, 4-core cable from Auxillary Relay Unit. Right hand side, 4-core cable passes through wall to next-door plant room

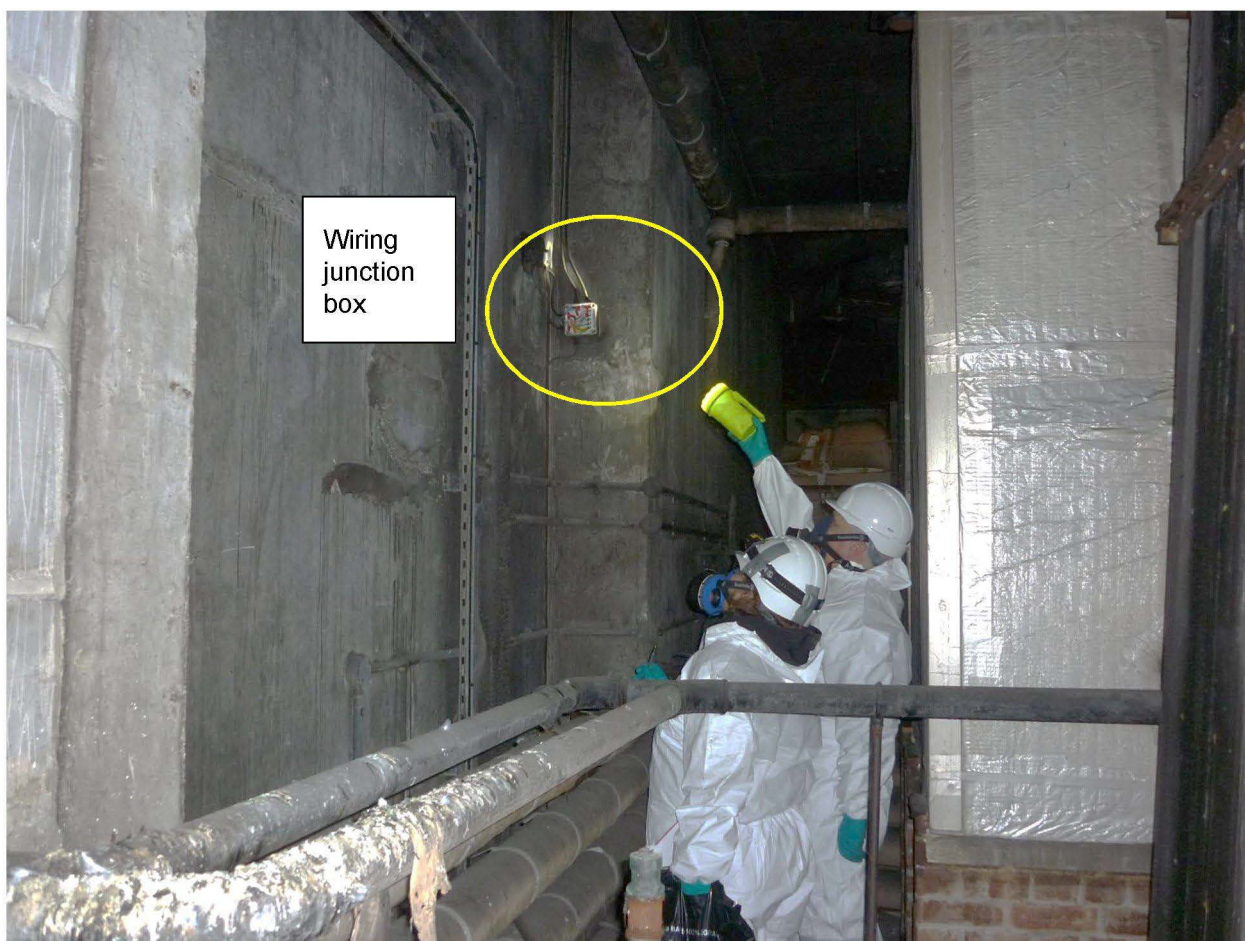
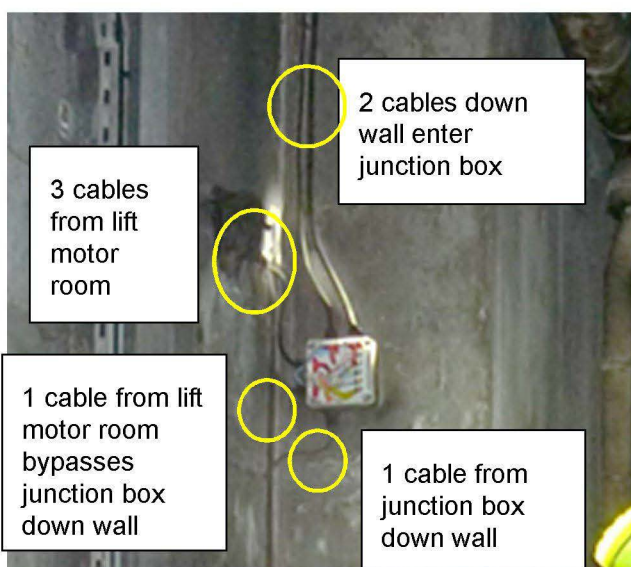
The 3 cables from the lift motor room sounder / beacon, detector and manual call point passed through the wall to the next-door plant room containing large water tanks (see Figure 21). Tracing these cables to the adjoining plant room showed one cable descended down the wall and 2 of 2-core cables entered a wiring junction box mounted on the wall. A 2-core cable exited the bottom of the wiring junction box and ran down the wall alongside a second cable that ran directly from the lift motor room. Electrical continuity testing confirmed that the cable running directly from the lift motor room was the 4-core cable that was connected to the Auxillary Relay Unit and the sounder / beacon in the lift motor room.

Figure 21: Wiring junction box on wall in water tank room next to lift motor room, showing 3 cables from lift motor room

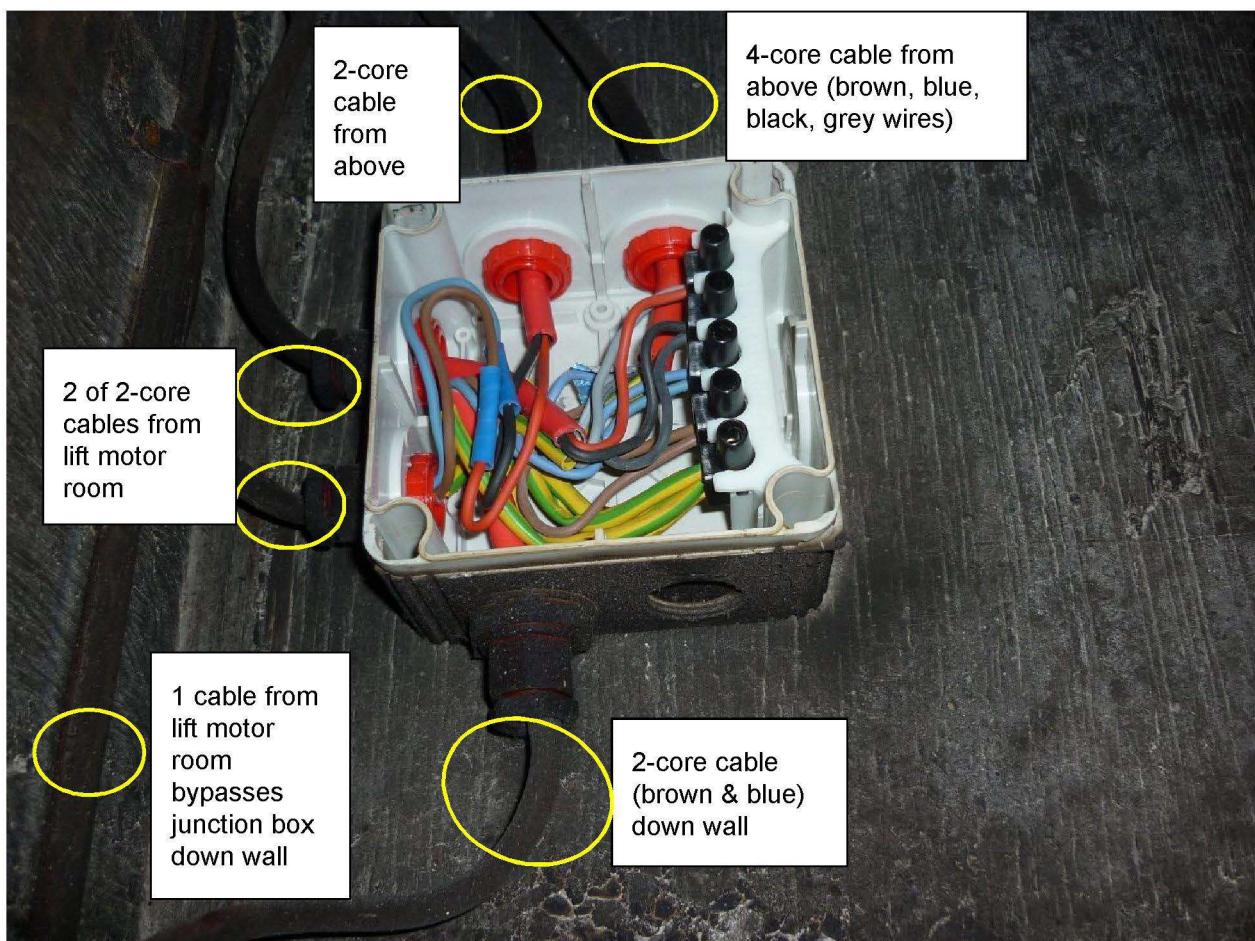
The two cables (one 2-core cable from the junction box, one 4-core cable from Auxillary Relay Unit via sounder/beacon) (See Figure 21 and Figure 22) were traced visually and appeared to pass through the floor to the 23rd floor below. The cables were traced visually from the 23rd floor down each floor until the ground floor riser (see Figure 23). These cables were traced physically from the ground floor riser to the plant room by physically pulling them upwards and removing in sections on a floor by floor basis.

Figure 22: Wiring junction box

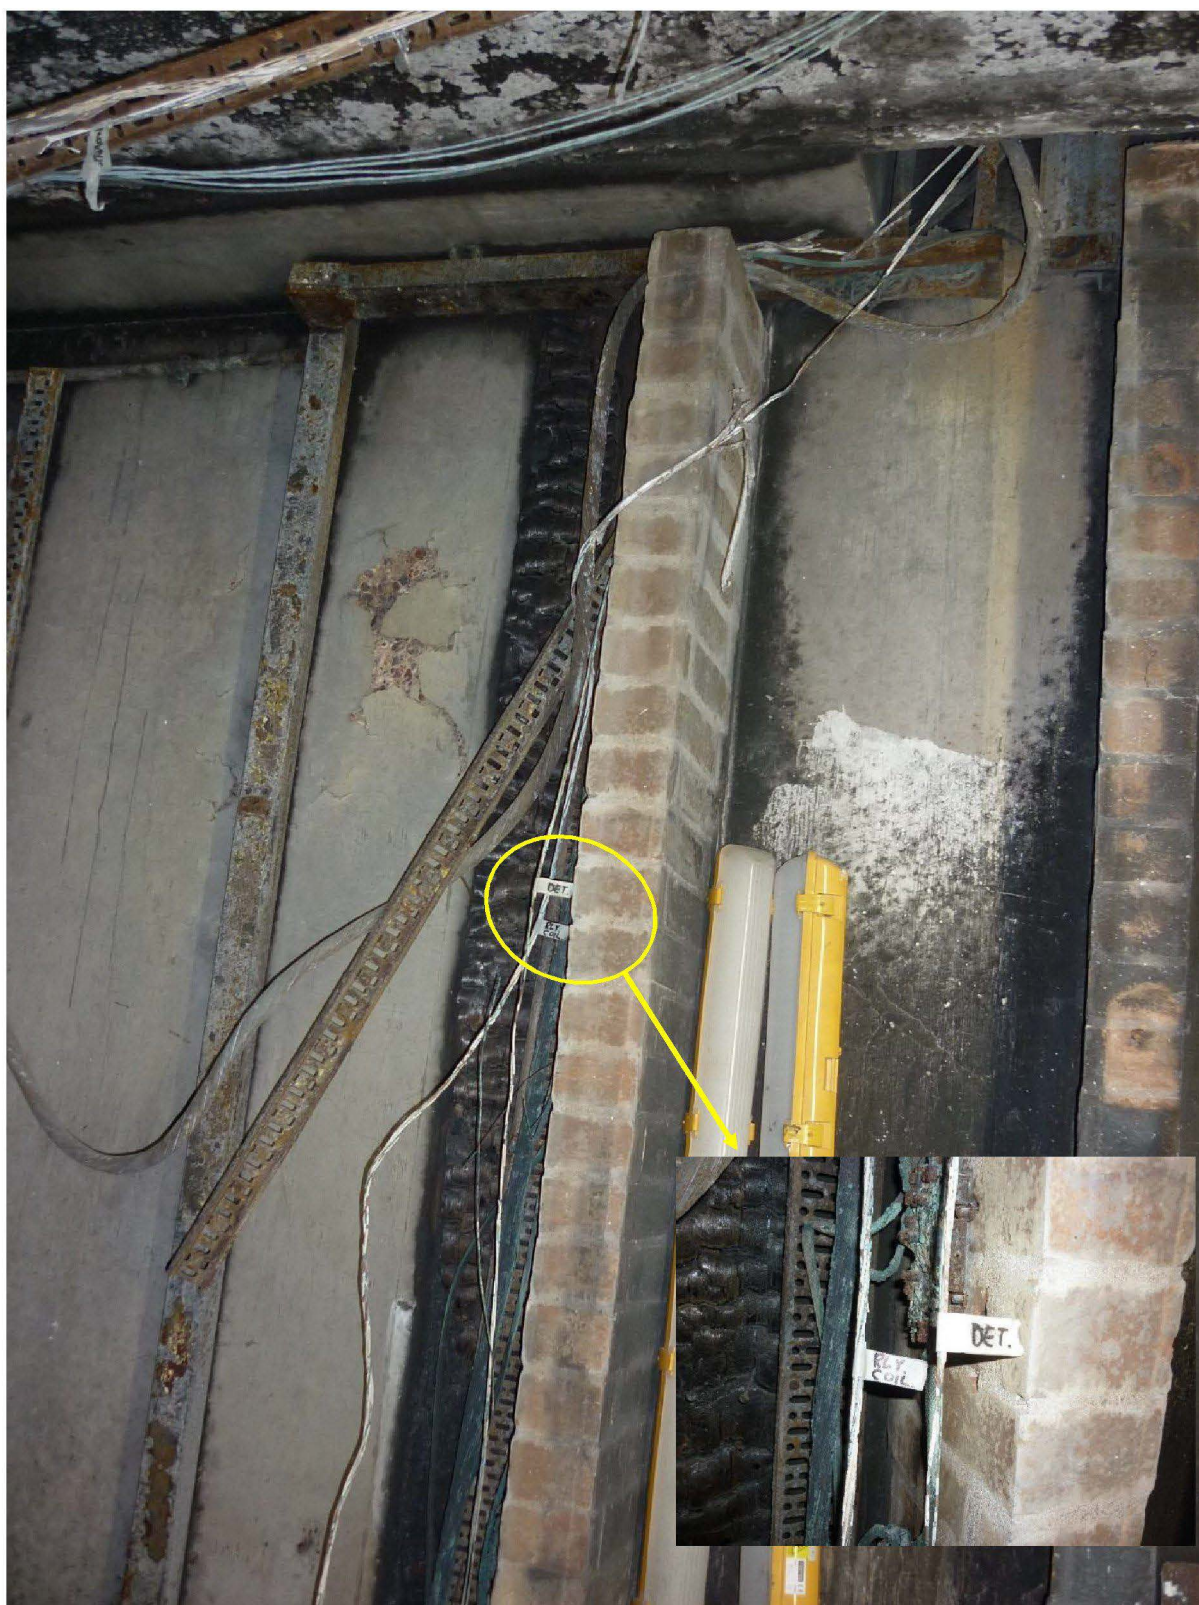
Both these cables terminated unconnected inside the ground floor riser, with straight cut ends (no protection from unintended electrical connection), see SOCO photographs. There was also a third unconnected cable. None of these cables were labelled.

Figure 23: Cables from Lift Motor Room descended the building floor, labelled Relay Coil and Detector

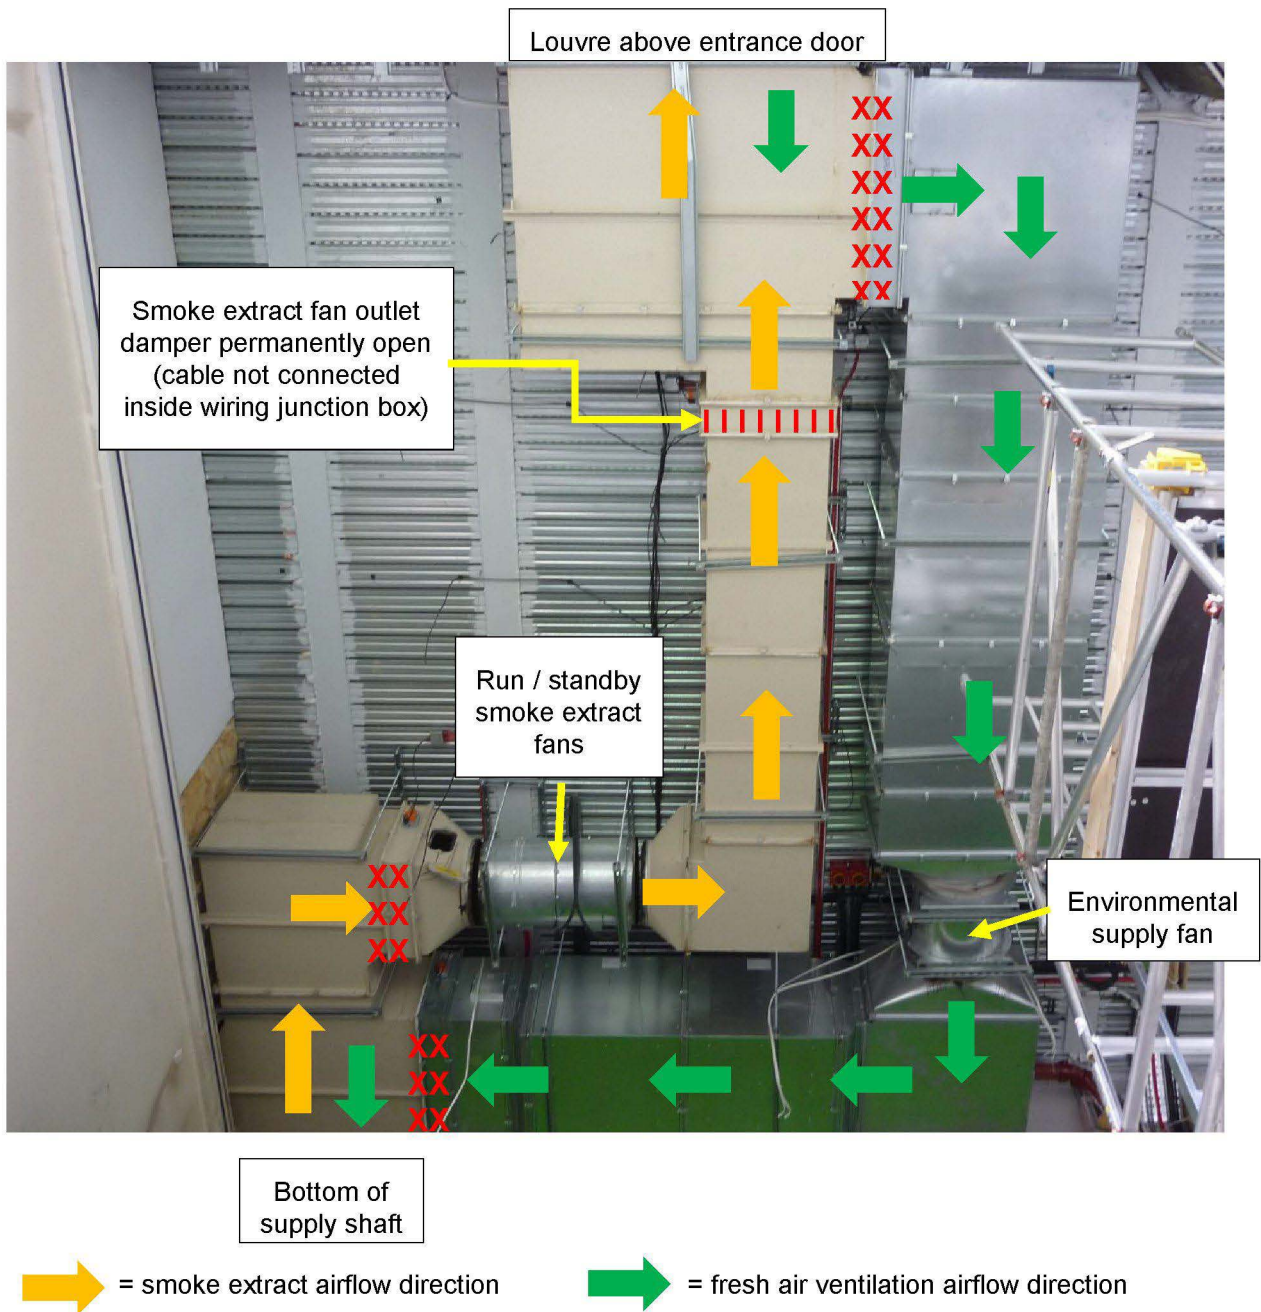
It was confirmed that the Environmental Fan inlet and outlet dampers were both connected by cable to a single set of terminals in a wiring junction box to a cable from Inverter Panel 1. This confirms that the intended operation was for both dampers to operate simultaneously.

The Smoke Extract Fan inlet damper was confirmed to be connected to a cable from Inverter Panel 1 but the Smoke Extract Fan outlet damper was NOT connected inside the wiring junction box (see SOCO photographs). It was therefore presumed that it was intended for the Smoke Extract Fan outlet damper to be permanently open. Note that the Smoke Extract Fan outlet damper was open but the other three dampers were closed, when inspected by BRE in July 2017

Figure 24: Smoke extract and environmental supply ductwork above entrance lobby

(As found damper (July 2017) open/close status indicated)
