Metropolitan Police Service London, UK

HVAC Logic and Functionality Testing

Reconstruction and testing of Grenfell Tower smoke extraction system

Report No. 2020-0400 Rev. 1

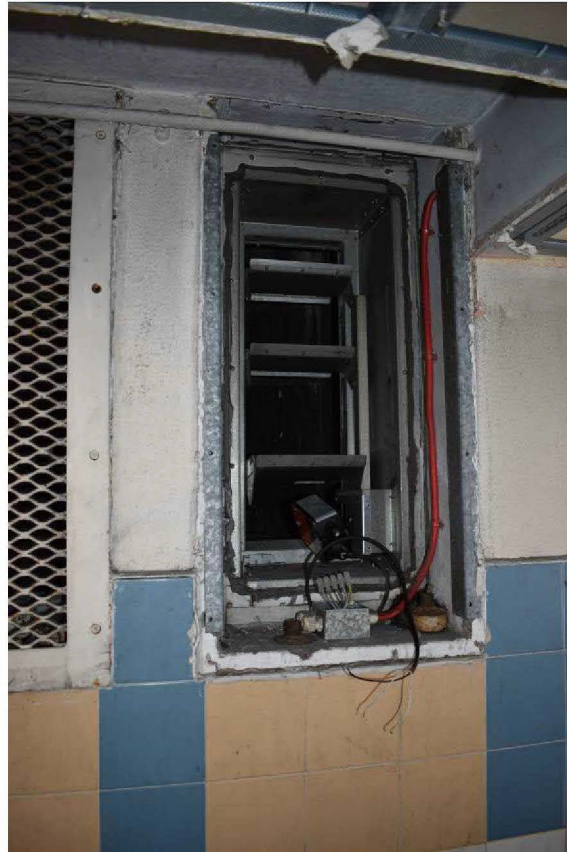
One smoke damper was investigated on site by RINA. This smoke damper was located on the floor 6, north side, on the right-hand side. The damper as found, on site, is shown in Figure 3.1. The actuator (Belimo part number BLE24) had been disconnected following the fire both mechanically and electrically from the damper. The actuator is shown in Figure 3.2.

Figure 3.1: North dampers on floor 6 in Grenfell Tower

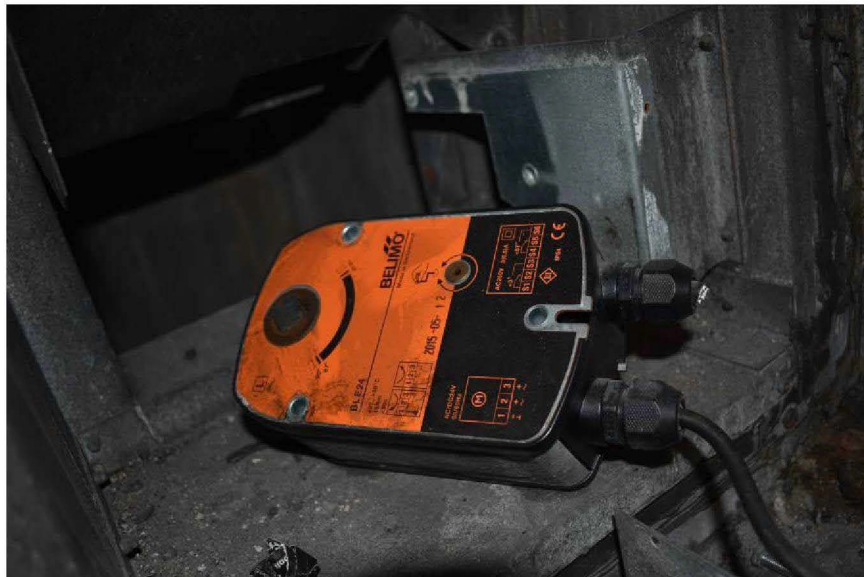
The actuator was marked with diagrams indicating the position of the damper blade and wiring diagrams. There were two cable tails exiting the actuator, one 3-core cable on which the electrical insulation had been stripped back to attach the conductors to a terminal block, and a 6-core cable, which had been cut flush, within 10 mm of exiting the cable gland. The 3-core cable controls the opening and closing of the damper and it would have been connected to the outstation, while it is understood the 6-core cable was designed to be able to report the open or closed position of the damper, however, this function was not used in the installation.

For testing in the tower, the mechanical linkage was re-attached, and the actuator was held in place as it would have been when installed. The 3-core cable was connected to a 24 V power supply to replicate the supply voltage that would be delivered during normal operation, and the opening and closing time of the damper was recorded at 26 seconds, and the current was recorded at 120 mA. This supported the information found online from the manufacturer's datasheet [3]. Information printed on the unit and on the manufacturer's datasheet lists the operating temperature range to be "–30 C to 50 C". This actuator was removed from the tower and retained by RINA for further testing.

Figure 3.2: The actuator from the right-hand side north damper on floor 6 in Grenfell Tower

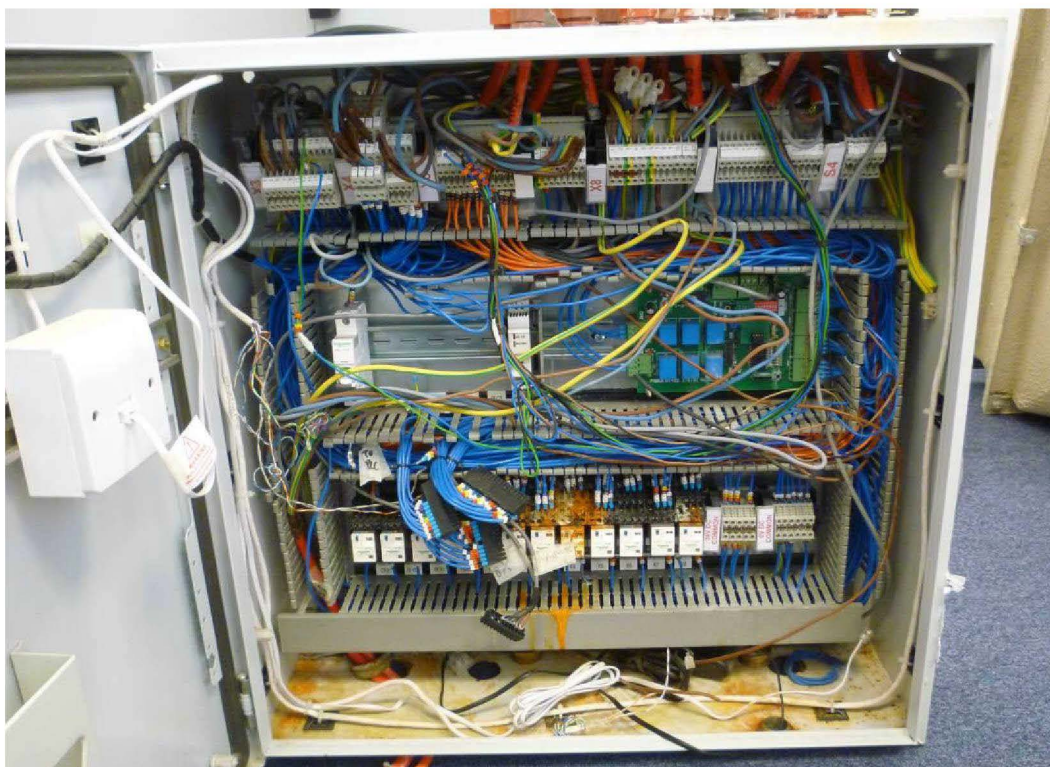
The Master Panel unit was located on the ground floor Hub Room of the tower. This unit contained the Programmable Logic Controller (PLC), one Modbus board, twelve 24 V d.c. relays, terminal blocks, and the fire service auto-dialler. The Master Panel was delivered to RINA with the PLC removed. The opened Master Panel is shown in Figure 4.1. The empty space in the middle left of the panel was where the PLC was located. The PLC was delivered to RINA as a separate exhibit. The PLC was an IDEC unit consisting of four modules combined together, shown in Figure 4.2 and Figure 4.3. There was corrosive damage to several of the 24V d.c. relays which were located at the bottom of the Master Panel, and that damage was presumed to be as a result of water damage that occurred during the fire. There was no evidence of external damage to the PLC.

Figure 4.1: Master Panel as received by RINA (opened)

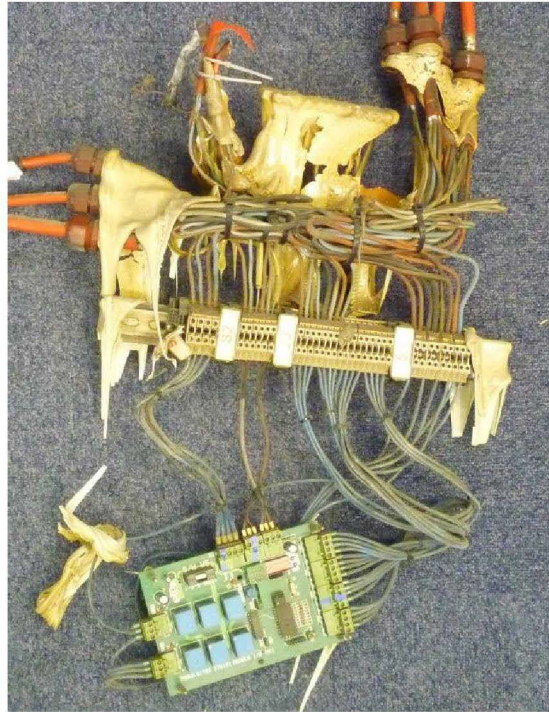
While being tested at RINA, O/S 12 was unresponsive, and O/S 22 was found to be responding on the O/S 12 address, it is therefore considered possible that the inputs given in Table 5.1 for O/S 12 might have been reported from O/S 22.

severely damage outstation (O/S 13) is shown in Figure 6.2. A close-up of the front view of the Modbus I/O board from O/S 5 is shown in Figure 6.3.

Figure 6.2: O/S 12, a severely damaged outstation

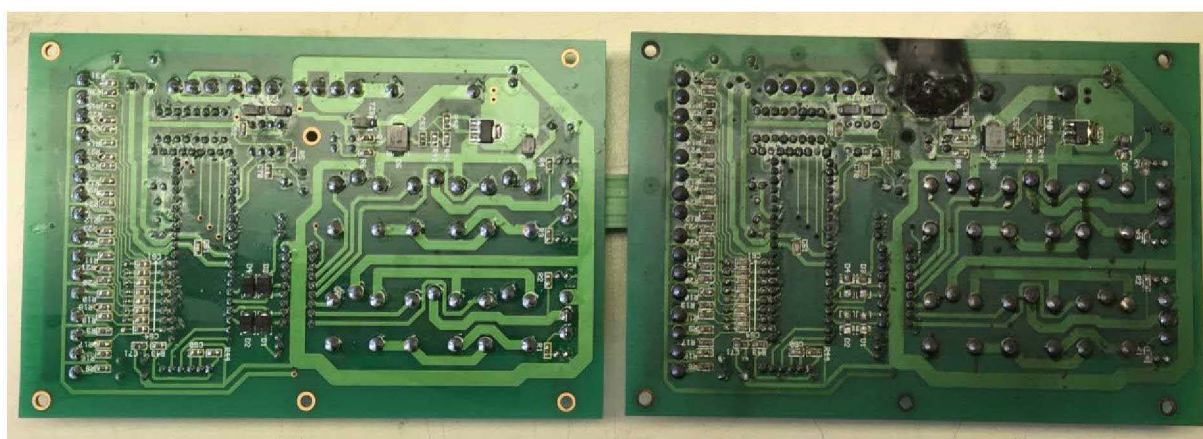
The PLC, the HMI, and the Modbus boards were connected as they were in the tower, based on the removal notes and labelling on the cables [2]. Due to fire damage, six of the outstations were not operational. One of these, O/S 13, did not power up, as the printed wiring board tracks to the power terminal were open circuit. The underside of the O/S 13 Modbus board showing the burned-out tracks compared with a board in good condition is shown in Figure 7.1. This appeared to have been caused by an electrical short circuit which on the balance of probability occurred following the fire. To bypass this and power up the board, the cables were soldered directly on to the tracks. Four of the outstations, O/S 12, 14, 20, and 21 appeared to power up, but did not respond to communications. One of the outstations, O/S 22 was responding on a different address (for O/S 12) than specified by the labelling on the board, and the logic program. As the switches on the board were set correctly, it is most likely that this damage occurred as a result of the fire due to damage to the board. A summary of the non-operational boards is shown in Table 7.1.

Figure 7.1: Modbus I/O board in good condition (left), O/S 13 Modbus I/O board (right)

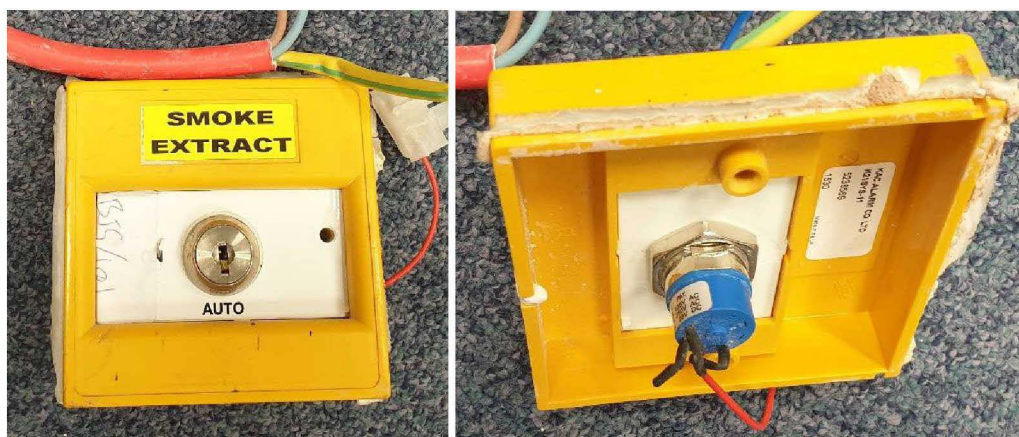
The FOS on the HMI panel was recorded in-situ after the fire with the key present in the device, and turned to the ON position, with the touch screen of the device showing it having switched to the override mode, and dampers open on the 18th floor [2]. Information from MPS was also received that none of the FOS in the lift lobbies were activated by the firefighters. Despite this, the records from the PLC show that it had received input from the FOS on several floors. Examination of a FOS from the second-floor lift lobby showed simple construction, with a key operated switch (Figure 8.1). A sticker on the back of the unit identified as a "KAC Alarm Co. Ltd K21SYS-11". A datasheet found online from the manufacturer lists electrical and environmental specifications [6]. The electrical properties were suitable for its application. The environmental properties specified an operating temperature of " -20°C to 55°C ", and an ingress protection of "IP24". An x-ray image of the FOS from floor 2 is shown in Figure 8.2 and the red arrow in this x-ray image indicates the spacing between the contacts.

Figure 8.1: Firefighter's override switch from floor 2

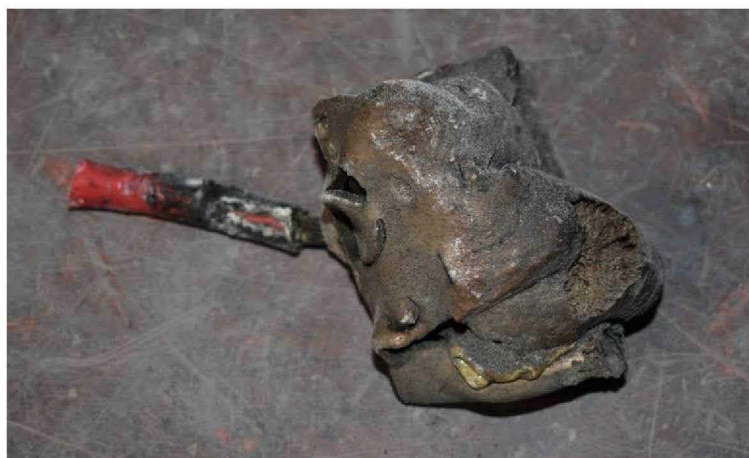
Severe fire damage to the FOS on floor 11 had caused the casing to melt (Figure 8.3). This was taken by RINA to be x-rayed, but it was found that the switch components were not within the melted casing.

Figure 8.3: FOS from floor 11

1. Smoke was detected on floor 4, where the fire started;
2. The dampers opened on floor 4, and closed of the remaining floors;
3. As the fire progressed, the FOS on floor 11 melted, shorting the contacts;
4. The dampers closed on floor 4, and opened on floor 11;
5. Fire damaged the cable junctions or all four actuators on floor 11, preventing them from moving;
6. The FOS on floor 11 fell away from the casing, causing it to deactivate;
7. Fire damaged the cables, cable connections, or both actuators for the dampers on the north side of floor 18;
8. The FOS on floor 18 melted, shorting the contacts;
9. The dampers remained open on floor 11 due to damage;
10. The dampers opened on floor 18 (south side only due to damage on the north side);
11. FOS switches on other floors melted or short circuited due to fire damage;
12. Dampers remained in this position for the remainder of the fire.

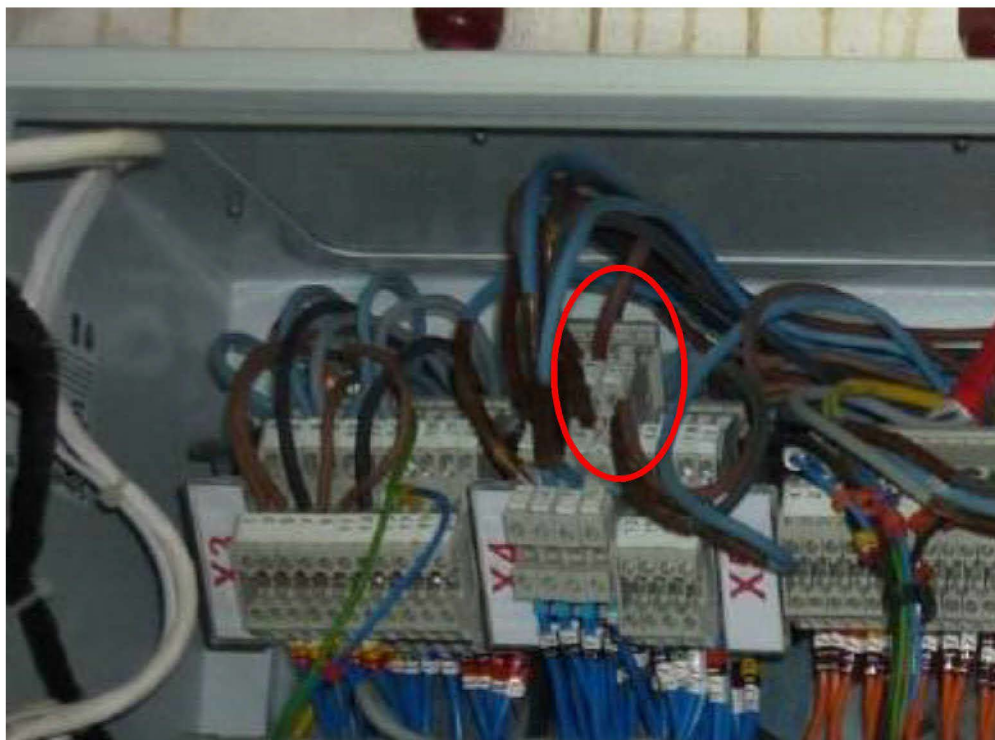
- The X4/12 cable output to the first floor lift lobby smoke damper was found to be resting inside the terminal X4/11 terminal. From the photos in the BRE report [2], shown in Figure 10.1 below, it appears that this was as in-situ on site. This would have prevented these dampers from opening.

Figure 10.1: Master panel photographed in-situ [2], wiring error circled in red

Some faults were noted which would not have influenced the performance of the system during the 2017 fire. Fire zones 25 and 26 appeared to be “half-programmed”, such that while as fire could be detected in these zones the FOS and fan speeds were not set-up correctly for these zones. In addition to the wiring errors already reported to MPS, a loose wire was noted in the master panel which would have prevented the first floor lift lobby smoke damper from opening.
