SECTION 6

FAILURES IN QUALITY CONTROL

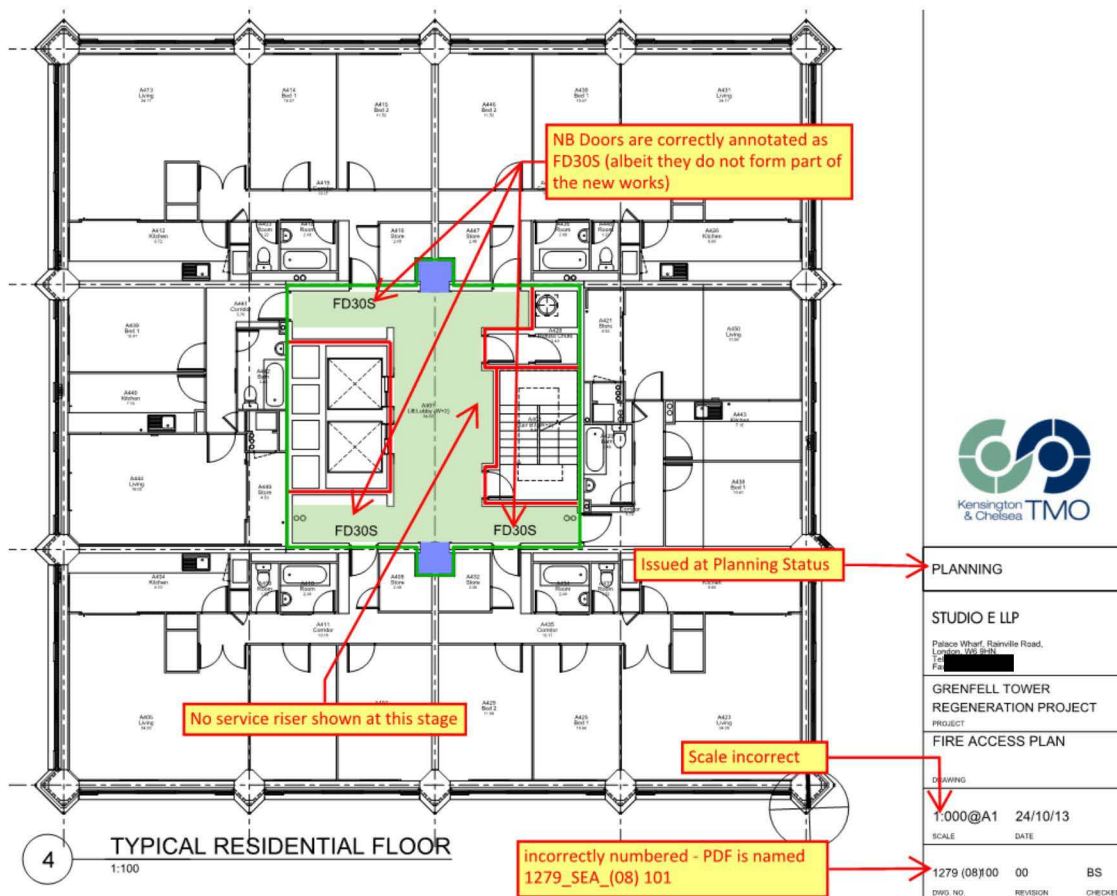
Figure 6.3: Extract from the drawing 1279 (08) 100 Rev 00 'Fire Access Plan' {EXO00000428} contained within the email correspondence between Studio E and Building Control 25.10.2013 {EXO00000427}

6.4.1 The first two issues of the Studio E Fire Strategy Plans contain errors and anomalies. The two drawings exhibited below, as prepared by Studio E, have been annotated to show examples in this respect:

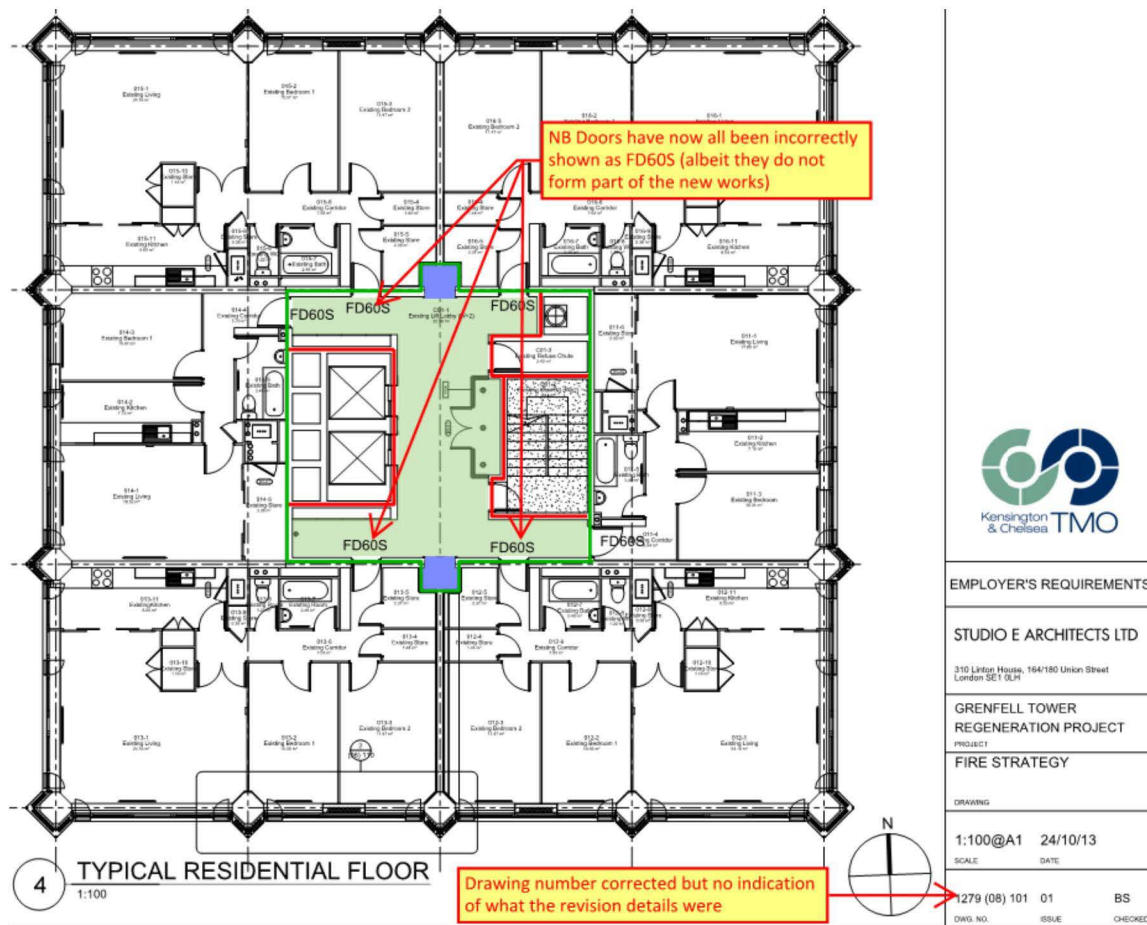
Figure 6.5: Extract from the drawing 1279 (08) 101 Rev 01 'Fire Strategy' {RYD00018761}

6.4.2 The next two issues of the Studio E Fire Strategy Plans, as exhibited below, contain a series of corrections but also introduce some further errors and omissions which have been highlighted in yellow. These errors and omissions continue unamended through to the Issue 5 'As Built' version of the drawings.

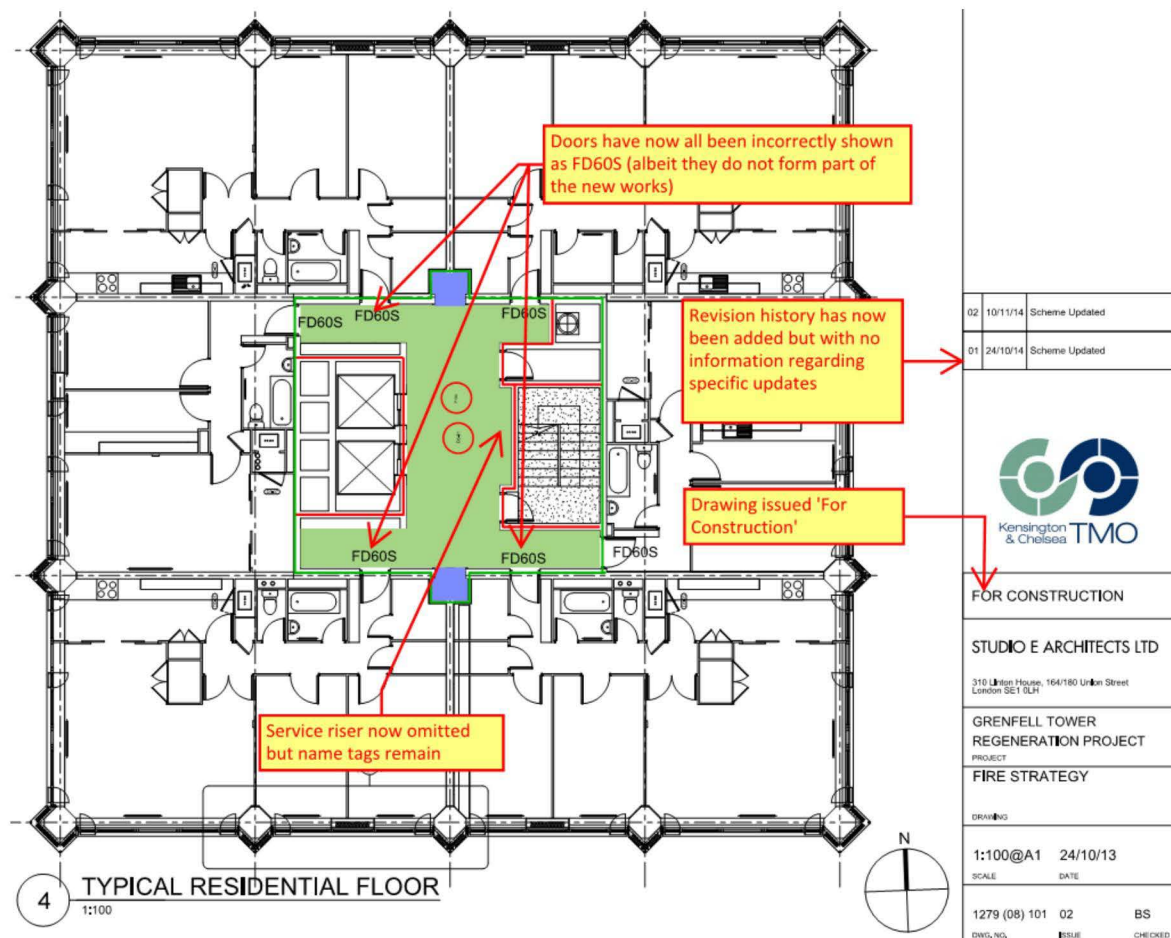
Figure 6.6: Extract from the drawing 1279 (08) 101 Rev 02 'Fire Strategy' {RYD00023253}

- 6.4.3 It is also notable that within Figure 6.6 although the revision note has been included (see above drawing title box), the changes that have been made under that revision have not been recorded. The revision description merely states '*Scheme Updated*'. Normal protocols with respect to revisions are for the revision to be described, albeit briefly, in the space adjoining the revision number above the title box, and for the drawing for that issue only to be annotated with a '*balloon*' around the revision or revisions that clearly highlights the amendment. This simple and widely adopted protocol was not generally adopted for the over-cladding drawings, albeit Studio E did adopt it extensively elsewhere for the 2012-16 Works. As a result, there was usually no indication and/or location to notify recipients of the drawings as to what specific changes had been made.

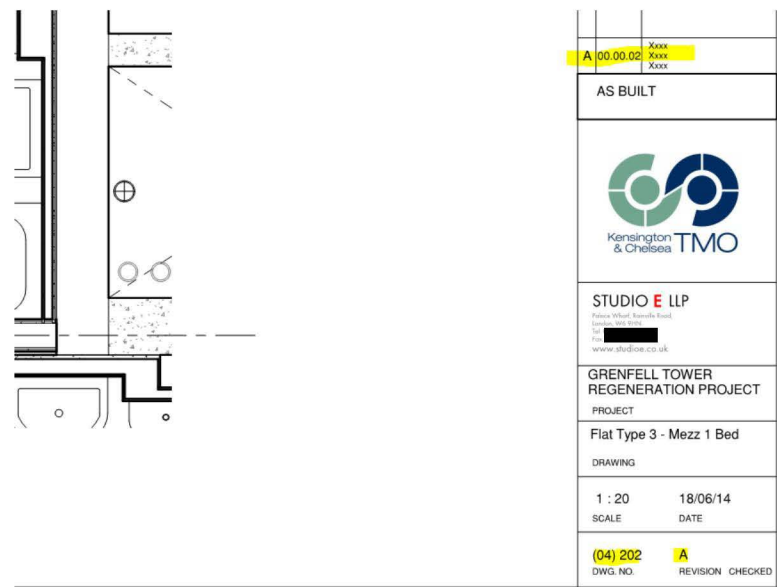
Figure 6.13: ‘As Built’ drawing (04) 202 Revision A {RYD00000435} (page 13 of document) and at {SEA00003419}

- a) There is no initial in the '*checked*' part of the drawing title block for either drawing – a frequent failing across Studio E drawings.
- b) The revision section of the first exhibit – as highlighted - carries no date or description of whatever constituted revision A.

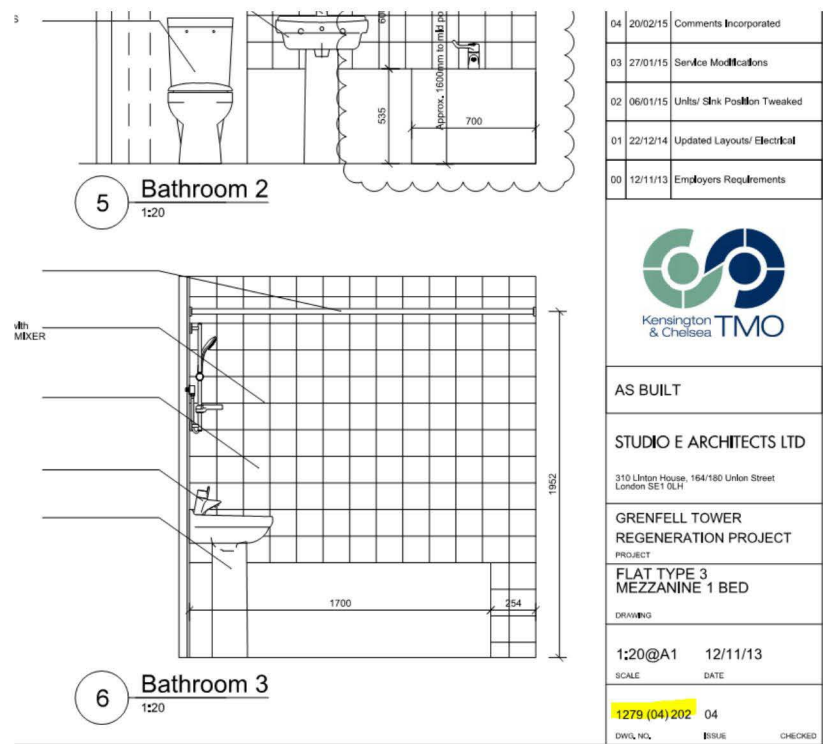
Figure 6.14: ‘As Built’ drawing (04) 202 Revision 04 {RYD00000435} (page 12 of document) and at {SEA00003457}

The revision section of the second exhibit shows some four revisions listed in orderly fashion across a timespan of four months, which means that those on the distribution list each had opportunity to identify the concurrency issue upon receipt albeit I would not necessarily expect the recipient to spot the error.

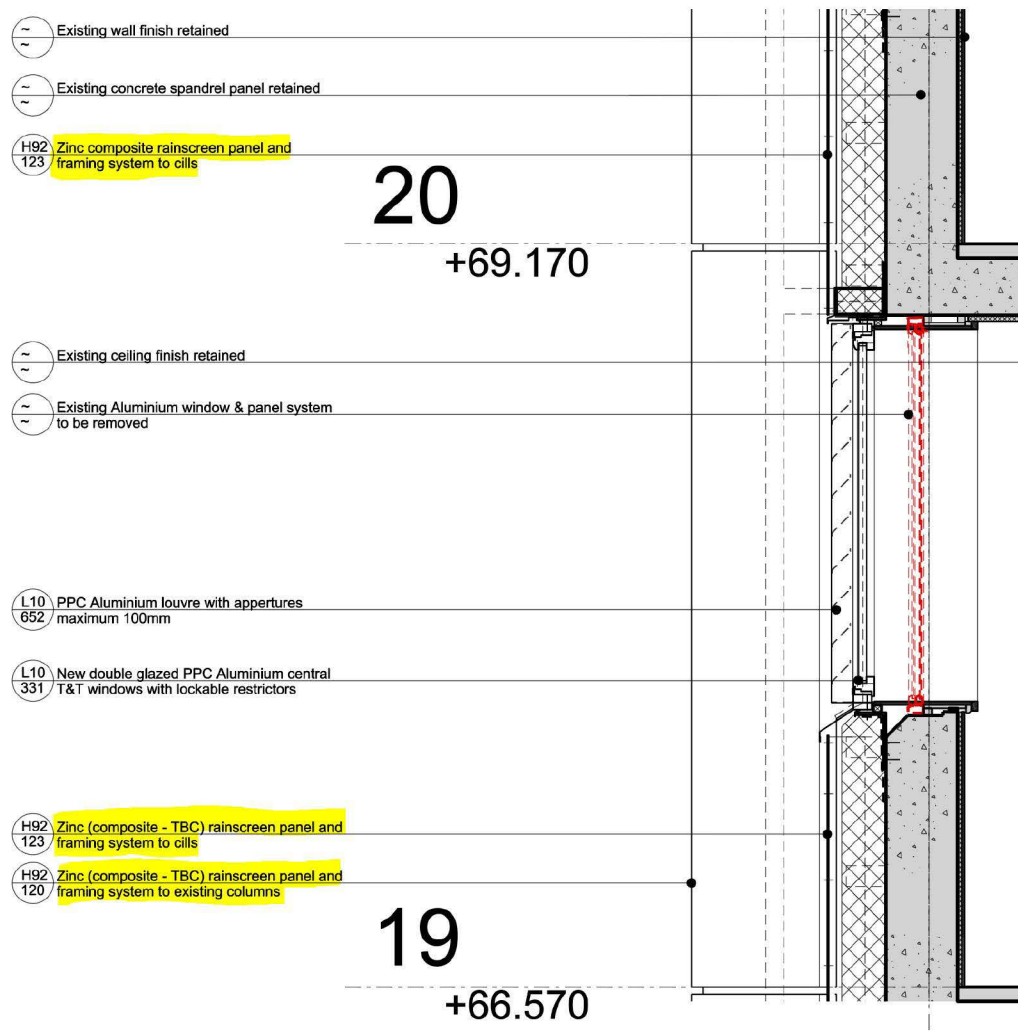
Figure 6.15: Drawing 1279 (06) 120 Rev 00 – ‘Detail Section Sheet 1’ {RYD00000435} (page 27 of document) and at {SEA00003436}

- 6.6.18 The drawing exhibited below began its *'life'* as one of the *'Employer's Requirements'* set (Snap-Shot 2 stage) and is still current as part of the *'As Built'* record.

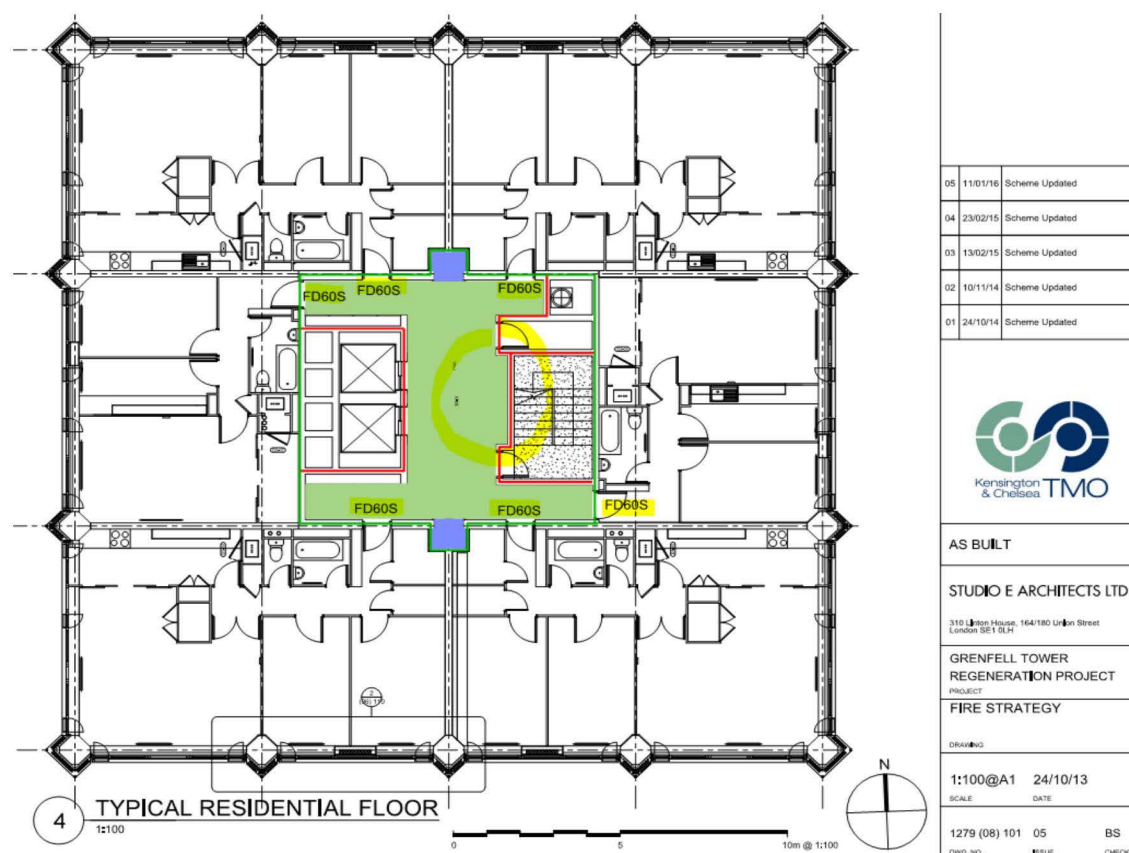
Figure 6.16: Extract from Drawing 1279 (70) 100 Rev 05 – 'Fire Strategy' (Typical Residential Floor) {RYD00000435} (page 31 of document)

- g) Whilst there are strict requirements in terms of sealing around the services as they pass through floor it is an important part of any fire safety strategy that the riser enclosure, that is the '*cupboard*' through which they pass, is itself constructed of materials and components (wall and doors) which combine to provide the level of fire protection set out as guidance in ADB2. This enclosure was missing in the fire strategy drawings.

- h) Here we have an example of '*sloppy*' drafting omitting the entire services '*cupboard*' enclosure. The significance of such an error can hardly be overstated. As stated earlier, errors are inevitably made, but that such an error could remain on a drawing over such a long period and indeed even be carried into the '*As Built*' record set and O&M manual is unacceptably lax.

- i) It is also to be noted in the revision box that revisions are recorded as '*Scheme Updated*'. Normal convention is to provide at least a simple narrative that is indicative of change and I am critical of Studio for failing to do this because such information is useful to those involved in quality checking as it guides them swiftly to the point of change.

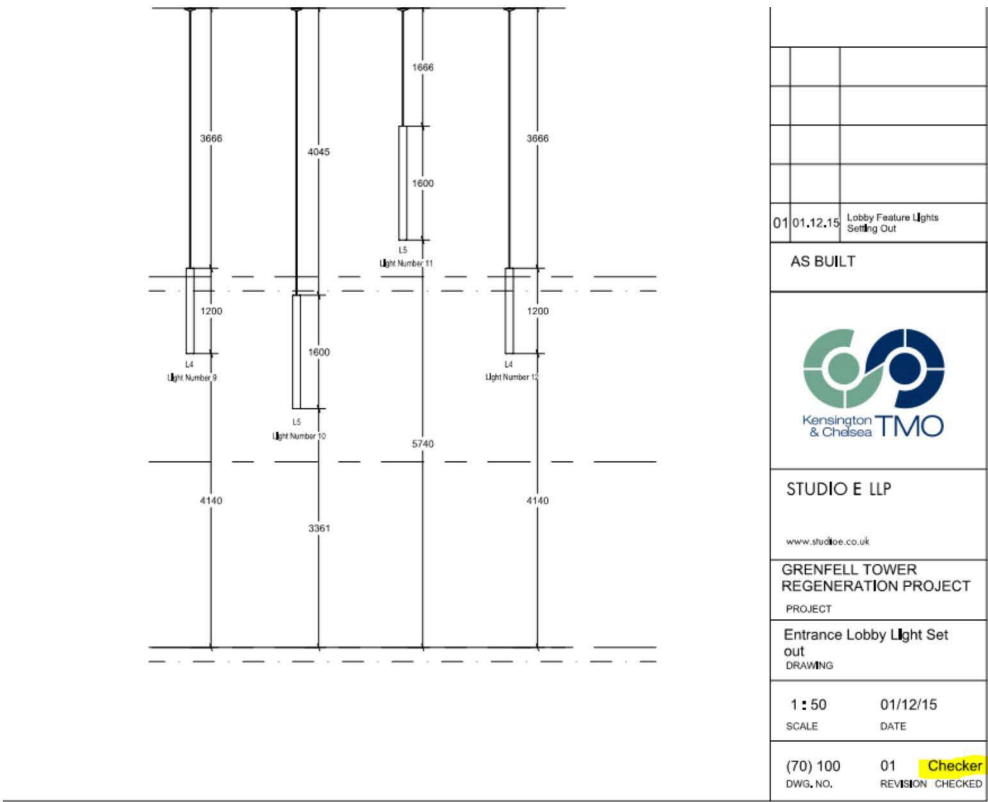
Figure 6.17: Drawing 1279 (70) 100 – ‘Entrance Lobby Light Set out’ {RYD00000435} (page 54 of document) and at {SEA00003434}

6.6.24 This example relates to another failure in the maintenance of the Drawing Register. In this instance a drawing has been prepared and issued, on this occasion as part of the 'As Built' record set, but the drawing is simply not recorded on the register.

6.6.26 My overall impression is that there was a 'sloppiness' in the way in which the 'As Built' register was compiled and maintained.

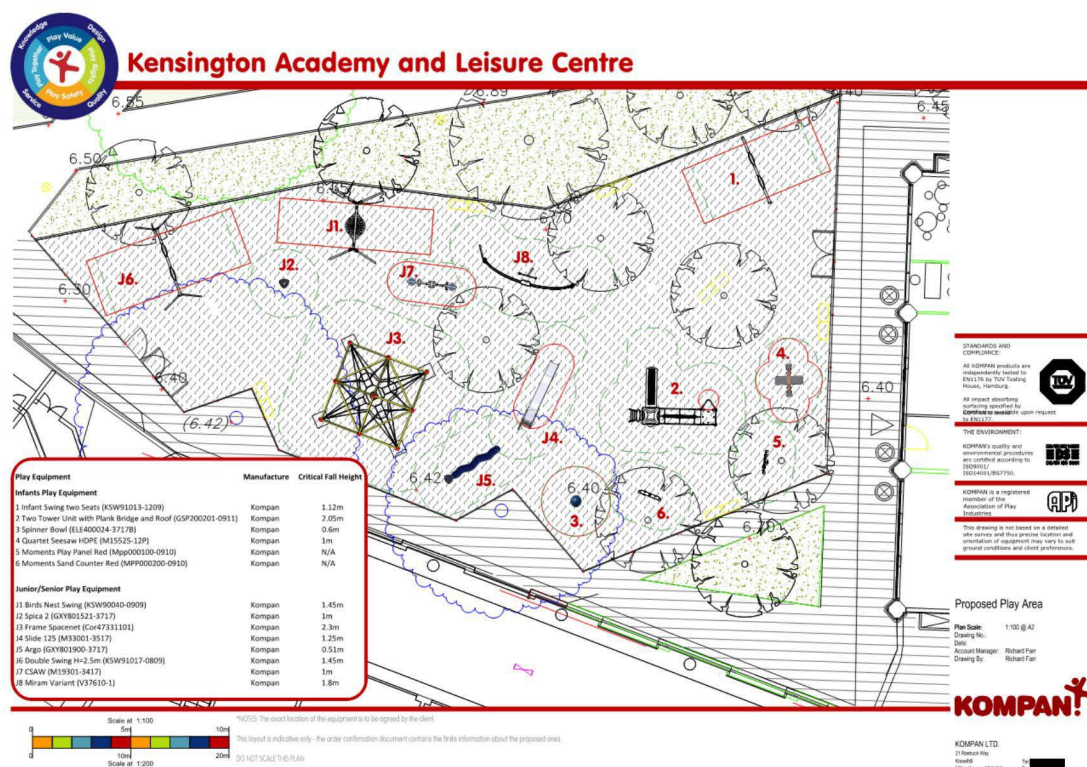
Figure 6.18: Kompan Kensington Academy and Leisure Centre ‘Proposed Play Area’
 {RYD00000435} (page 62 of document)

6.6.28 However, the exhibit below at Figure 6.17 shows a drawing from another project by another firm.

6.6.29 I have no idea how a drawing for another project by another consultant could ever get into the Studio E 'As Built' record set that represents the Grenfell Tower project. That said, little turns on this drawing, which relates to trees and landscaping somewhere else but again, it is indicative of poor checking processes.
