Subject	Briefing Note		
Date	1 March 2019	Job No/Ref	258294

Briefing Note (legally privileged and confidential)

This briefing note is a record of witnessing inspections of a fire control switches taken from Level Ground and 2 in Grenfell Tower; as well as an exemplar fire control switch, for comparison purposes.

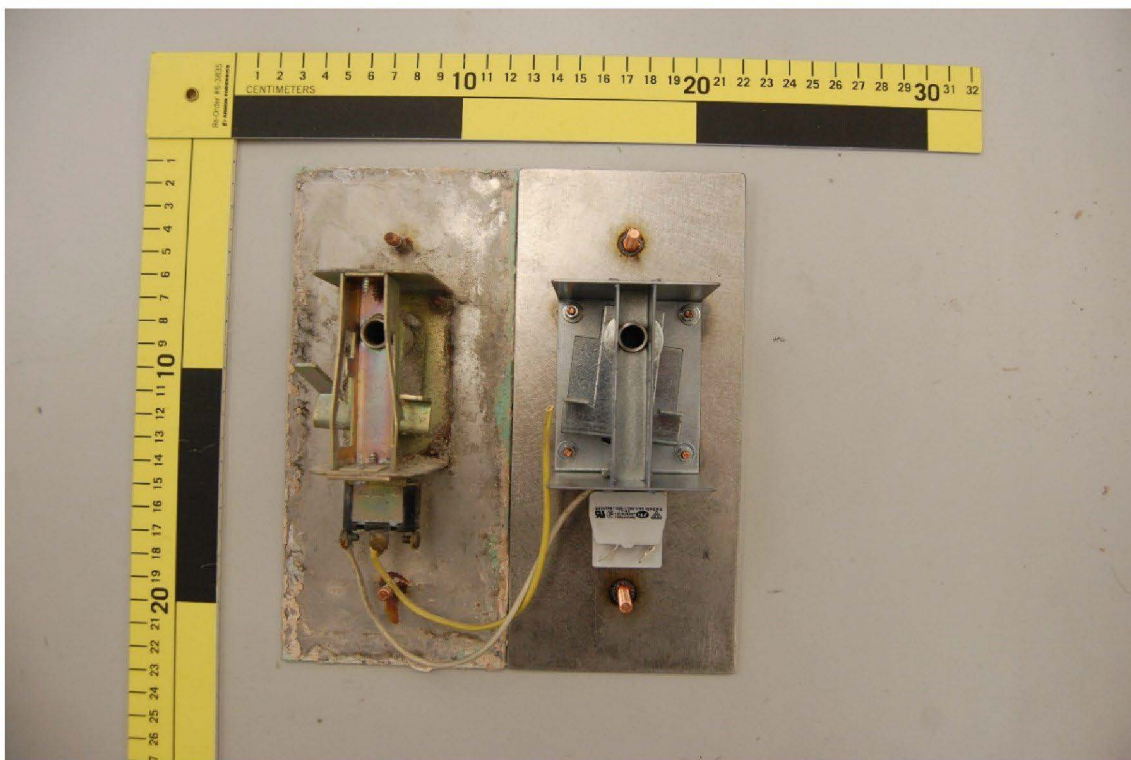
Photo 12 Comparison of fire switch BJG/74 (left) and ER/2 (right)

The examination of BJG/74 indicates deformation of the 'side wards' when compared with ER/2. In my opinion, this deformation could not have occurred during removal.

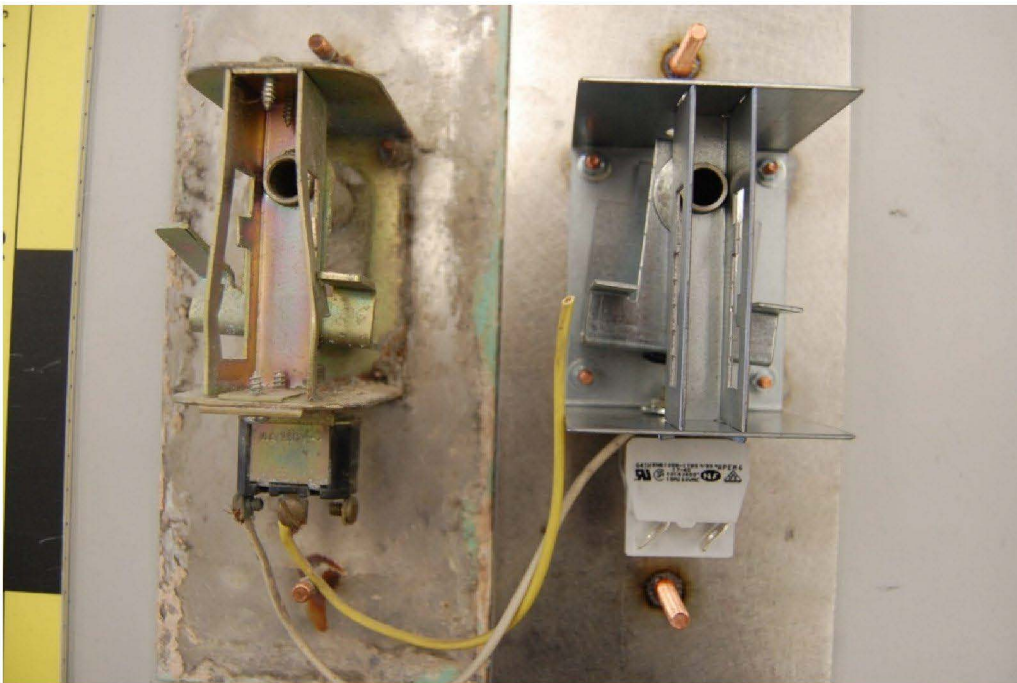
Photo 13 Deformation of ‘side wards’ to fire switch BJJ/74 (left) compared with ER/2 (right)

In my opinion, the damage to the 'side wards' was caused by an incorrect drop key being used, which subsequently deformed the 'side wards', or by an 'express' drop key being inserted too far in the barrel and a high twisting force damaged the 'side wards'.

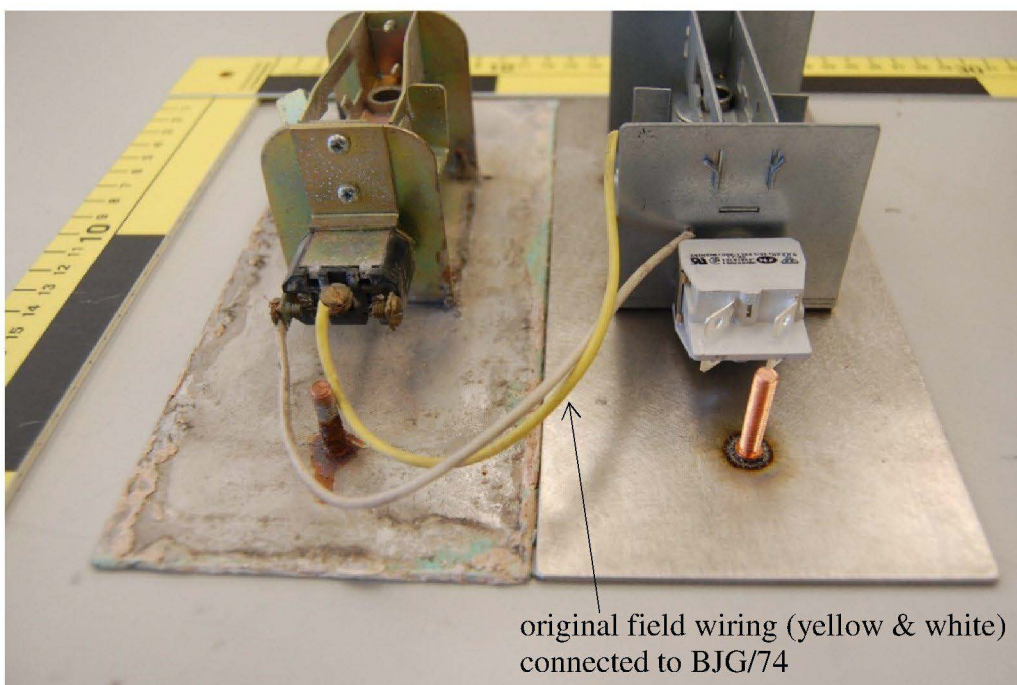
Photo 14 BJJ/74 (left) and ER/2 (right) – View from bottom showing electric micro switch

- The MPS visual examination of BJK/74 indicate a build up of builders’ material on the switch casing and also the micro switch (**Photo 14**) was jammed. It appeared to be a wall plaster used during the works.
- During the examination the micro switch became free and the microswitch operated. It is not known what caused the micro switch to jam, but there were plaster grains on the work bench.
- It is considered that the build up of builders’ material on the top of the switch was from the original works and not caused by the extraction of the switch. This is also my opinion.
- The micro switches installed on BJK/74 and ER/2 operated correctly when the jam was cleared. This was proved by using a digital multimeter provided by BRE.

The micro switch to BJJ/74 initially was jammed and did not operate. During the examination this switch became free and operated correctly. It is not known what caused this micro switch to jam. It is not known if the micro switch was jammed on the night of the fire.

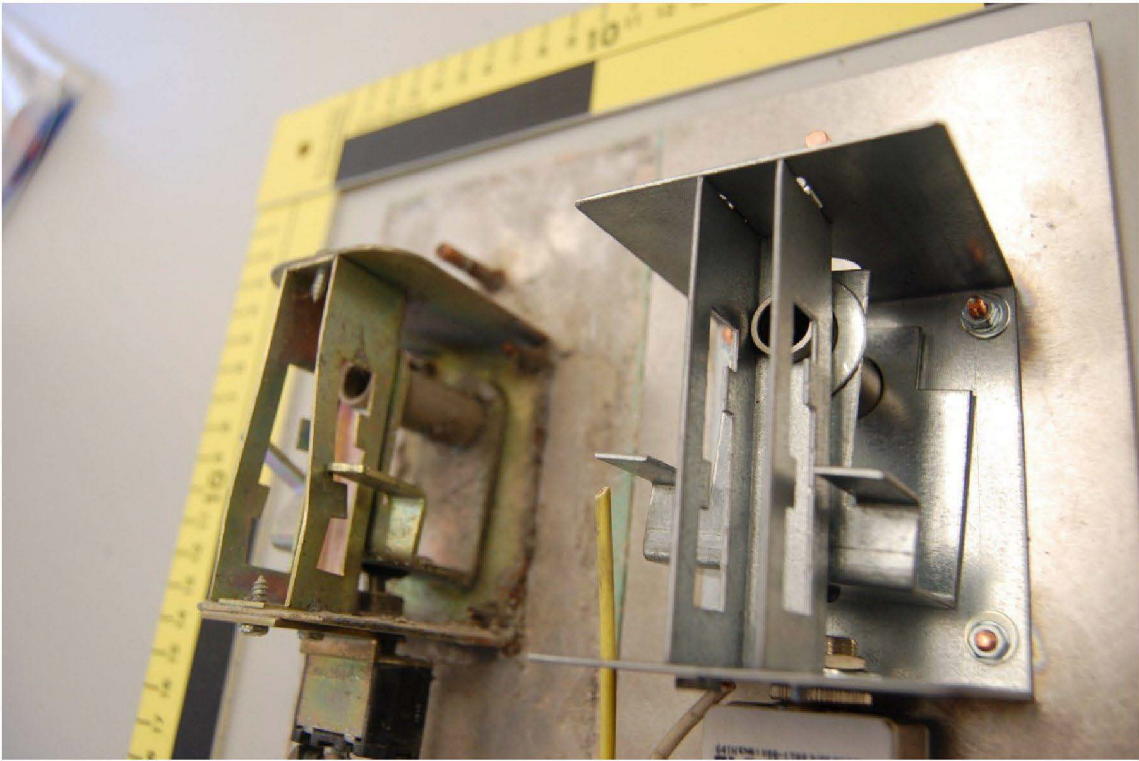
Photo 15 BJD/74 (left) and ER/2 (right) – Side view detailing deformer ‘side wards’

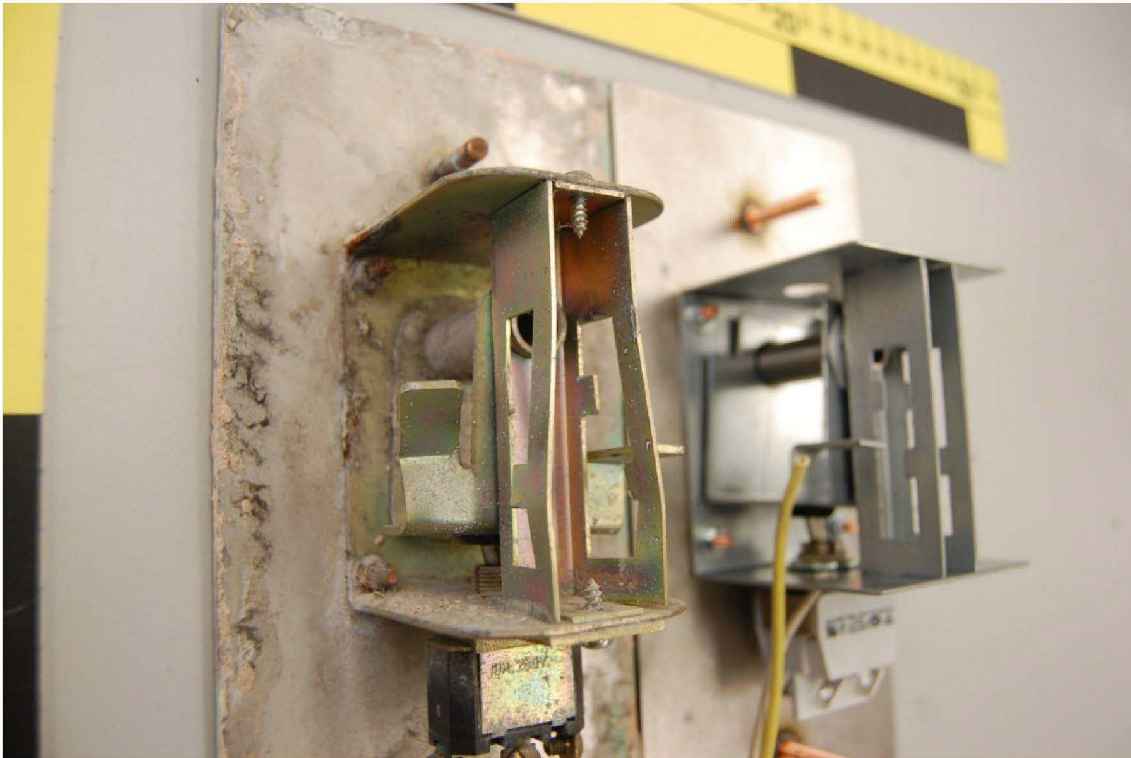
Photo 17 Comparison of ‘side wards’ BJK/74 (left) and ER/2 (right)

The 'side wards' to BJG/74 deformed due to most, probably, by an incorrect drop key being used or an 'express' drop key being inserted too far in the barrel and a high twisted force damaged the 'side wards'.

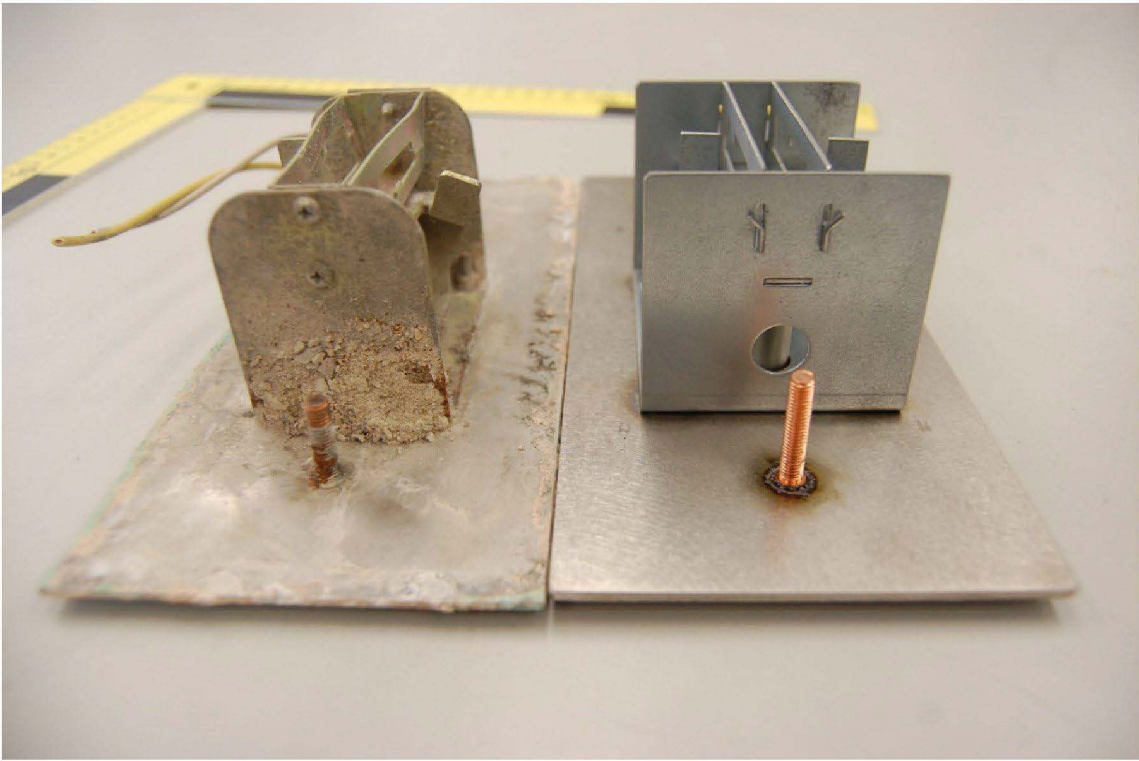
Observation: there is ‘green’ wall paint visible on the side and on the bottom of the fire control switch. It is not known the age of the paint.

Photo 18 Builders’ material on top of fire control switch BJJ/74 (left) and new fire control switch ER/2 (right)

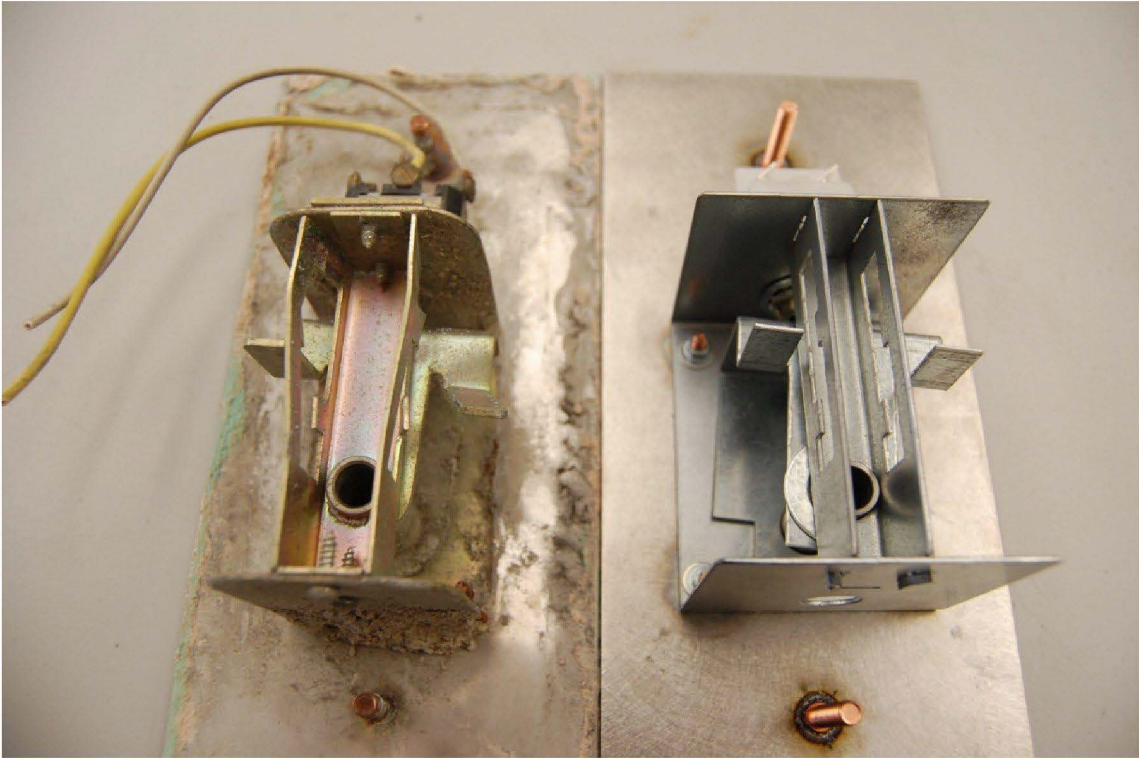
Photo 19 Comparison of BJJ/74 (left) and ER/2 (right) - Detailing builders’ material build up on BJJ/74

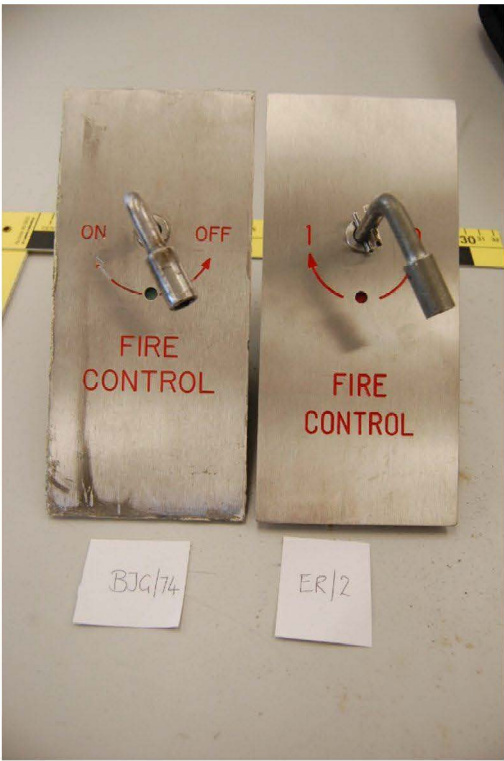
It was noted that fire switches BJG/74 and ER/2 have different engraving (ON/OFF – 1/0) and status colours (red and green) when in same position.

In my opinion, this could cause confusion to the Emergency Service on the night of the fire.

Photo 22 Different engraving (ON/OFF–1/0) and status colours BJG/74 (left) is green and ER/2 (right) is red

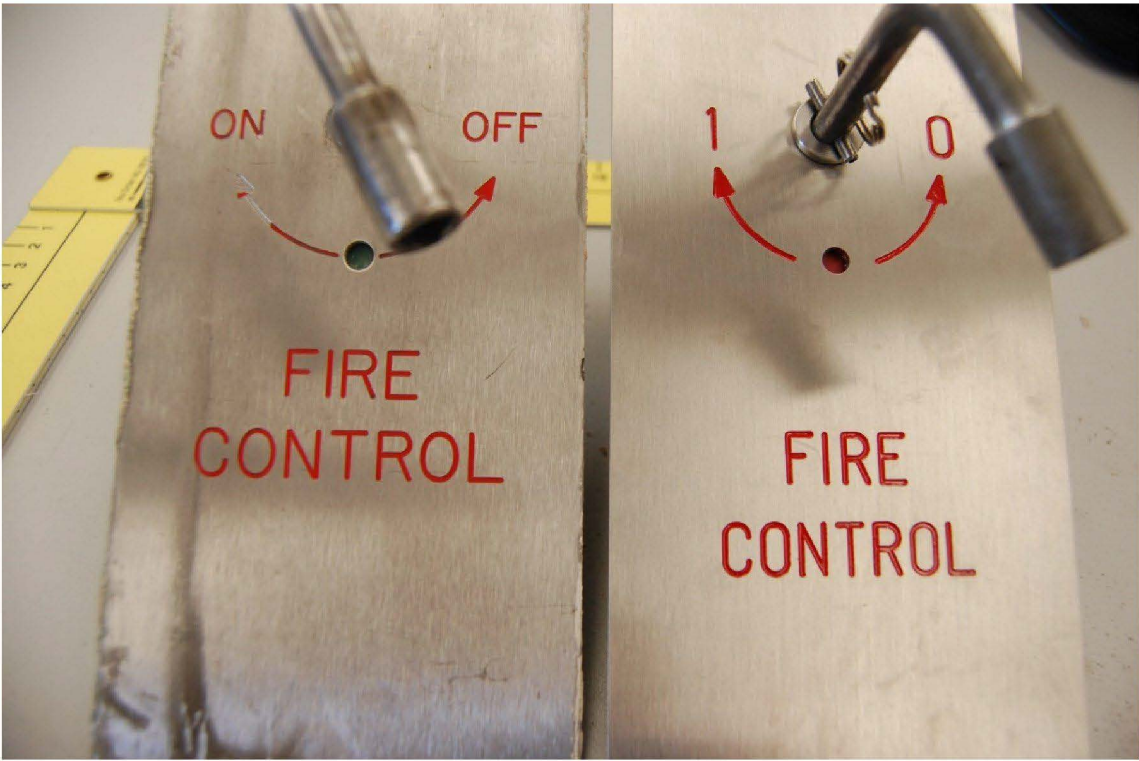
Photo 23 Different engraving (ON/OFF–1/0) and status colours BJG/74 (left) is green and ER/2 (right) is red

BJG/74 the mechanical switch during the examination was found to be stuck in the 'OFF' position, indicating the electrical circuit was open.

The coloured indicator was showing 'GREEN', indicating the electrical circuit was open. This is the opposite of ER/2.

In my opinion, this could cause confusion on the night of the fire.
