Report of Roger Howkins

Concerning the lifts at

Grenfell Tower

For the Grenfell Tower Inquiry

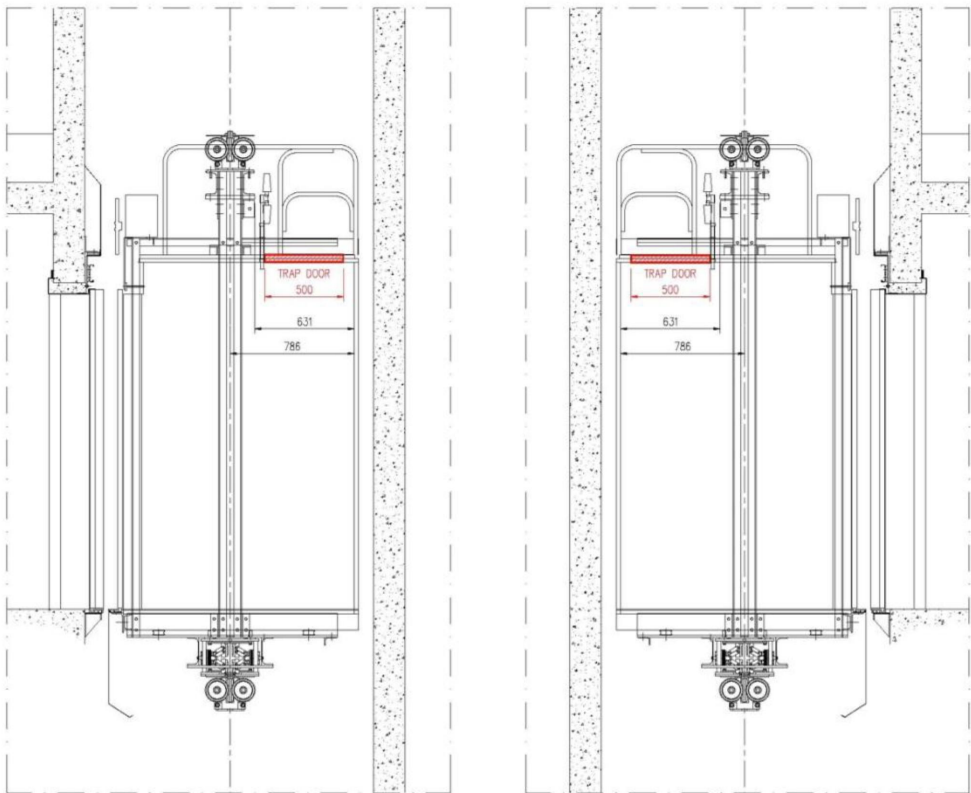
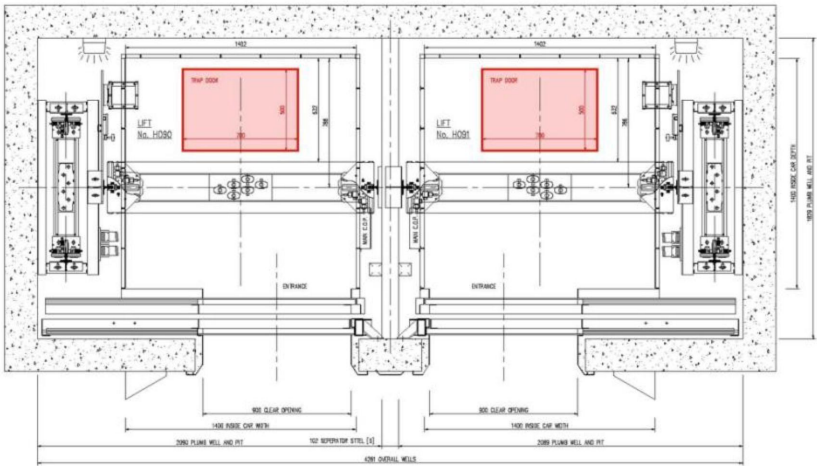
303. The provision of an emergency trap door would in my opinion have been straightforward and at little additional cost at the point when the lift cars were replaced with larger versions in Project 1.
304. I have considered this issue in some detail and, below, I have created drawings which demonstrate where a trap door could have been incorporated, demonstrating its feasibility.

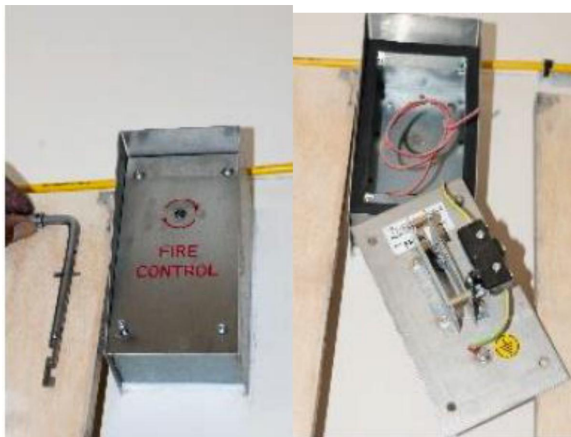
553. This examination found that the switch was not connected. I believe this is the switch which was temporarily installed on the walkway floor for the duration of the Project 2 works. In my opinion, this second switch should have been removed when Project 2 was completed.

554. The following photographs are taken from the WSP report.

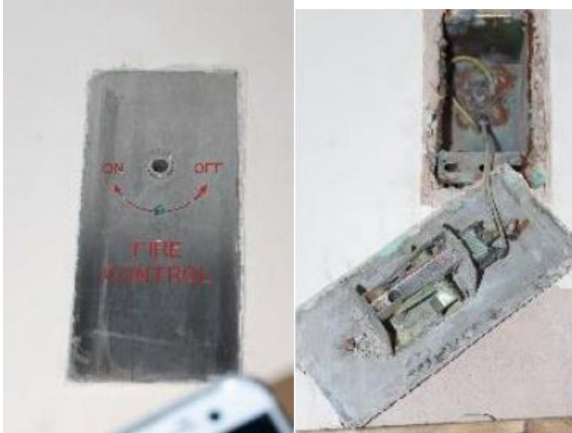
Q.3.2. Ground floor switch

555. The following findings were made on page 16 of the WSP report, following inspection of the ground floor switch:

2. *The fireman's switch was difficult to operate.*
3. *The faceplate was removed to determine the reason for failing to operate the switch.*
4. *We discovered that the mechanism was seized and damaged/deformed.*
5. *The contacts were open circuit when checked with a multimeter.*
6. *The wiring was coloured yellow and grey."*

556. The following photographs are taken from the WSP report.

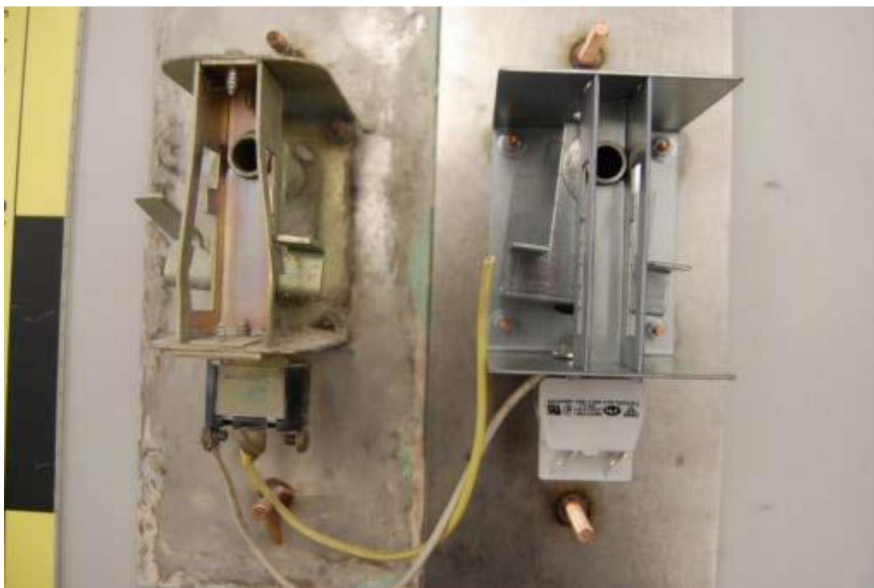
557. A further examination of the switch took place detailed in the BRE Briefing Note appended at Appendix 5 of my report, dated 1 March 2019. As noted particularly in the photographs within that report, the side wards of the switch recovered from the ground floor at Grenfell Tower (BJG/74) were deformed. Below is photo 13 from the BRE Briefing Note showing BJG/74 from Grenfell Tower compared to an example switch, ER/2.

558. The Briefing Note also notes, as noted in the WSP report, that BJG/74 was jammed. On examination, it appeared that this jam was caused by a build up of builders' material.

During examination the jam was cleared and the switch operated correctly. It is not known how or why the jam occurred.

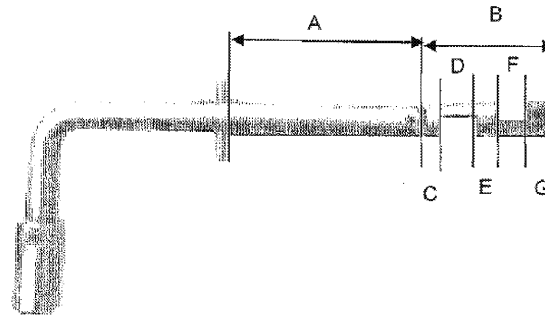
- 591.3. ER/1 – Express Drop Release Lift Key.
 - 591.4. LJH/67 – the lift key sent by Ricky Nuttall.
592. Andre Horne's testing found a significant difference in dimension between LJH/67 and the other three keys – DER/22, SJG/01, and ER/1. This difference rendered LJH/67 unuseable in fire control panel BJG/74 and the exemplar fire control panel ER/2. It should be noted that all of the keys were of different dimensions. The table setting out the measurements in his report is reproduced below:

A	B	C	D	E	F	G
DER/22	57.5	35.26	4.5	10.24	5.24	9.94	5.90
SJG/01	55.79	35.55	4.54	10.13	4.63	10.00	6.76
ER/1	58.72	35.29	4.00	10.29	5.04	10.12	6.0
LJH/67	55.15	36.41	7.69	10.06	4.28	10.08	4.53

593. Furthermore, Andre Horne concluded that DER/22 was slightly ill-fitting and that it could have been responsible for the damage to the side wards found on BJG/74. He found: *"If a fire control panel with the same dimensions as Item BJG/74 is encountered and a drop key such as the one in Item DER/22 is used, it may cause the same problems encountered during the response to the fire in Grenfell Tower."* He also found that DER/22 would not have worked normally even if BJG/74 had not had bent side wards.
594. SJG/01 worked normally in both fire control switches.
