Report of Roger Howkins

Concerning the lifts at

Grenfell Tower

For the Grenfell Tower Inquiry

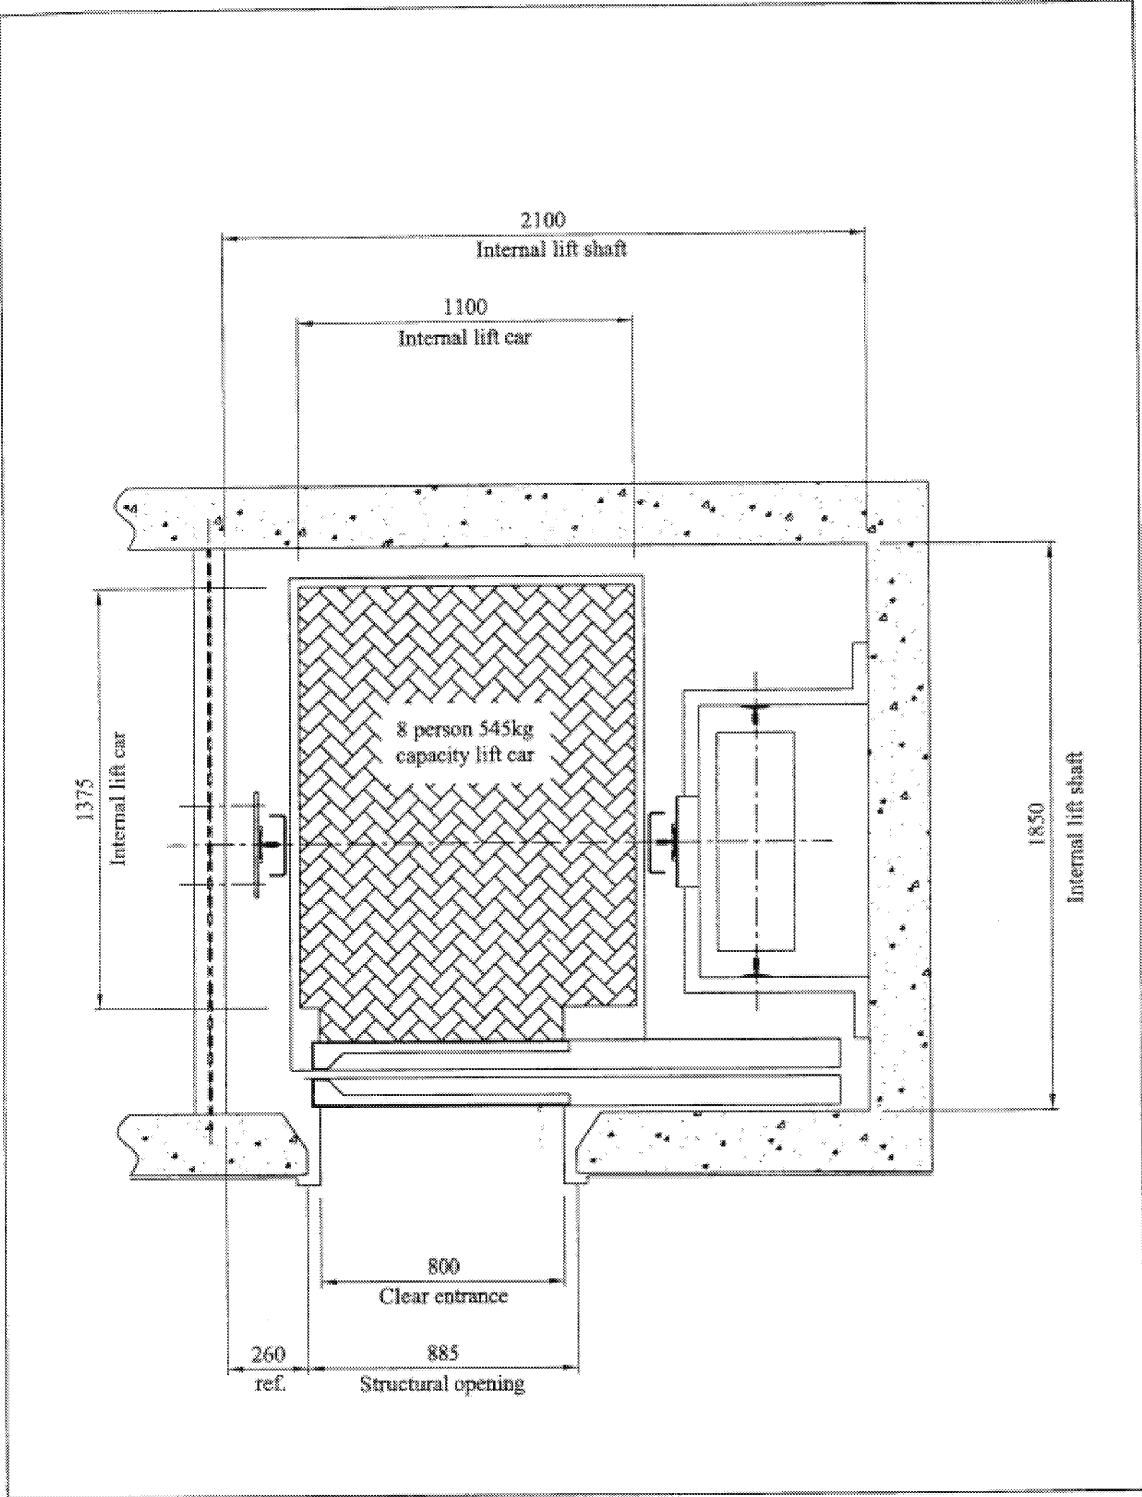
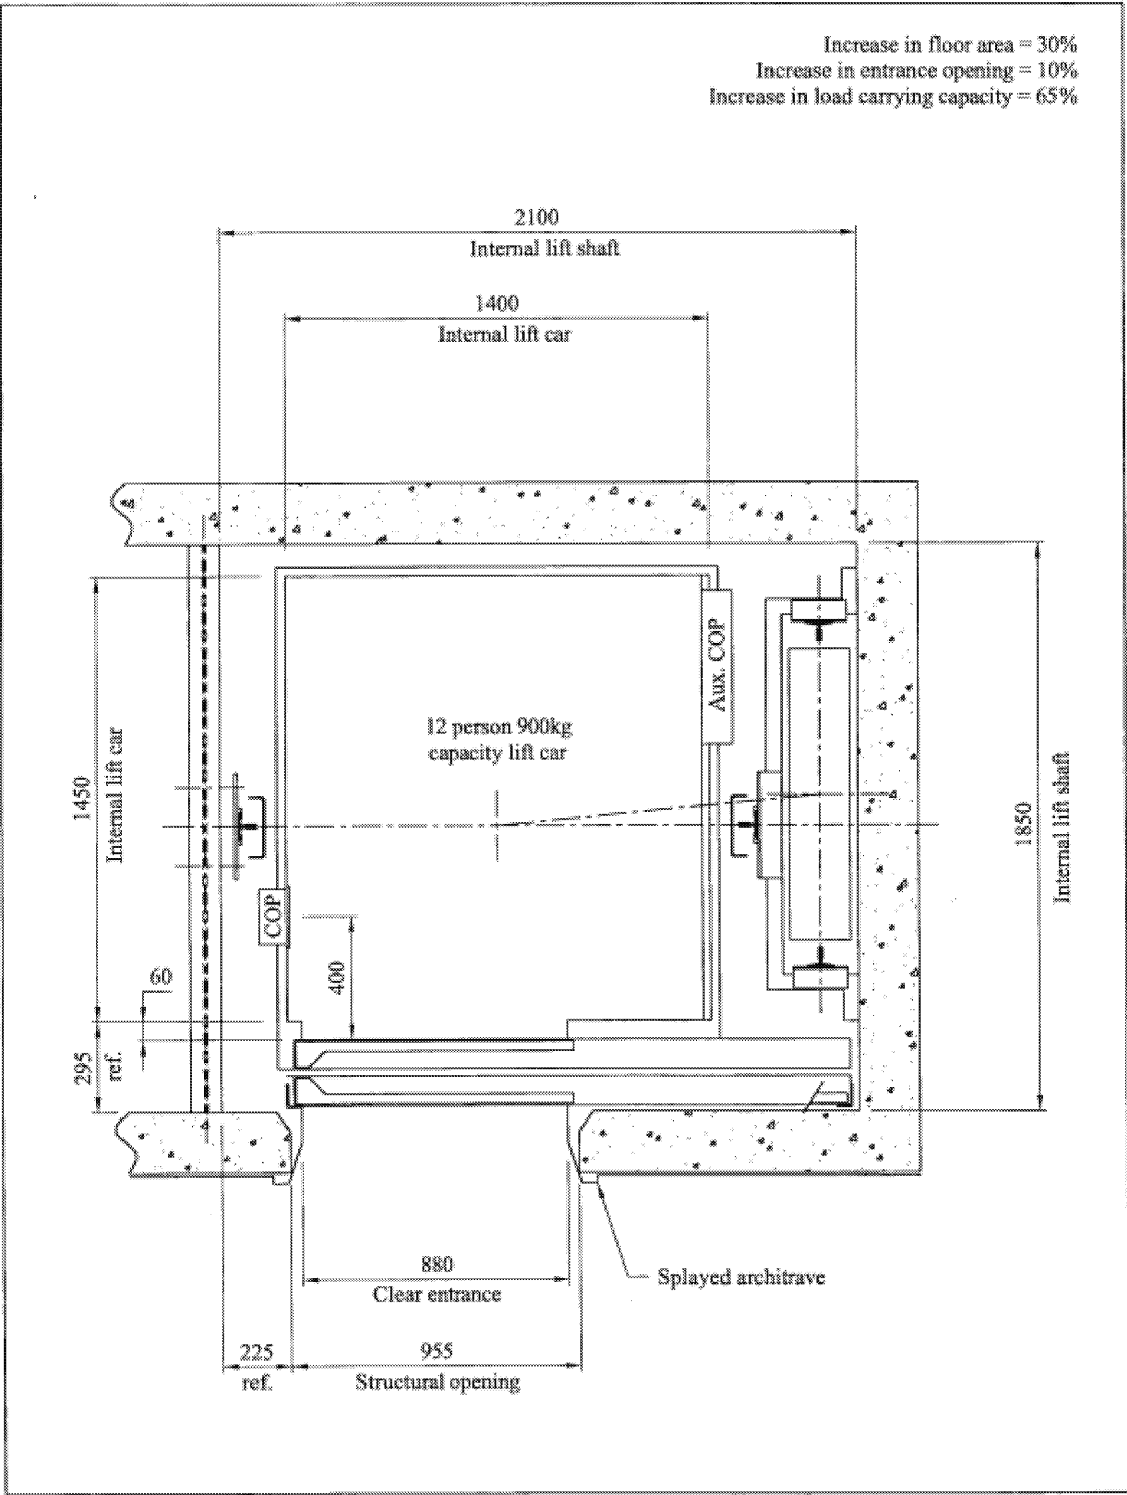
235. These drawings show that the existing lift was 8 person, 545kg capacity and the new lift was 12 person, 900kg capacity.
236. In the pre-refurbishment drawings, two car guide rails can be seen on either side of the lift car. In the post-refurbishment drawings, two car guide rails can also be seen on either side of the lift car. The car guide rails on the counterweight side must have been relocated together with new guide fixings, because the car size was increased and also the counterweight size was increased. As for the car guide rails on the other side, they are fixed to the structural wall of the lift well. It is not clear from the drawings or other documentation if those car guide rails were left in the same position or whether they were relocated.
237. The minutes of a Contract Progress meeting dated 22 June 2005 {APX00005531} say that guides were relocated:
