## Appendices to the Report of Roger Howkins

### Vertical Transportation Engineer | Lifts | Arup

### Grenfell Tower Inquiry | September 2020

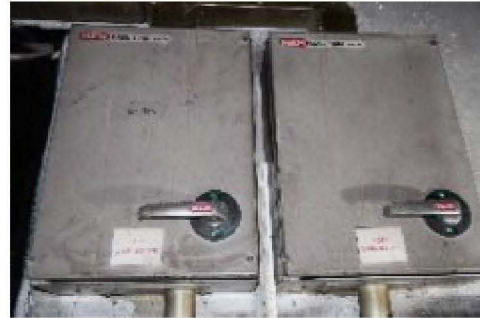
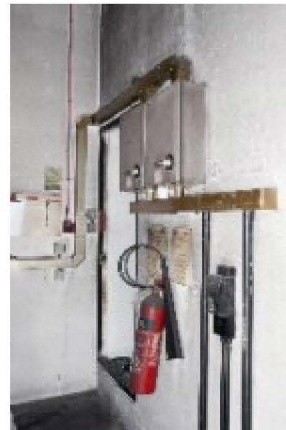
- ☞ The lift main isolators were located adjacent to the machine room access door.

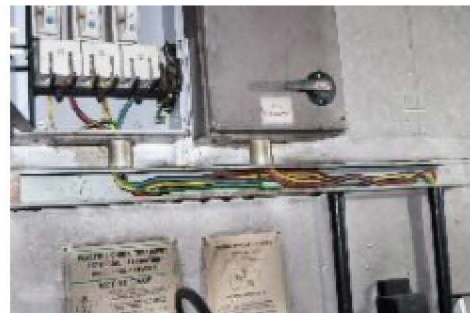
- ☞ The trunking lids were removed (during this visit) from underneath the mains isolators in order to check the condition of the mains cables.

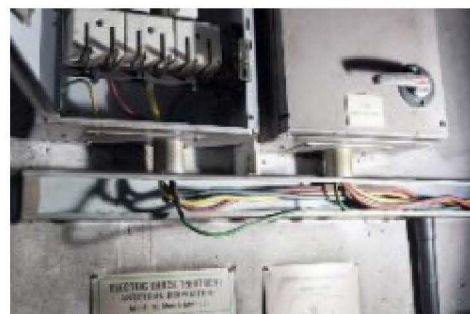
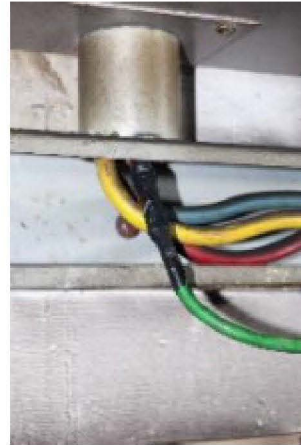
- ☞ The incoming earth wire to the left hand isolator, Lift H091, was wrapped with insulation tape which was hidden inside the conduit. The earth wire was possibly too short and had been extended.

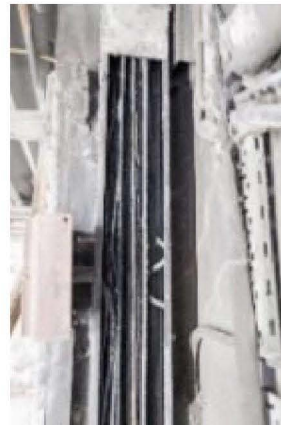
- ⌋ An attempt was made to determine the route of the incoming mains wire at the top floor riser but extensive fire damage prevented a positive identification.

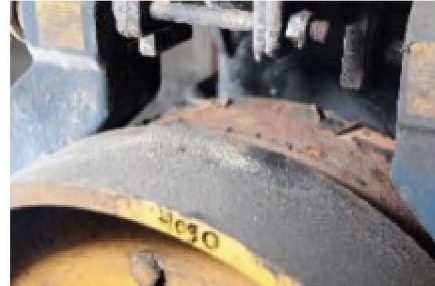
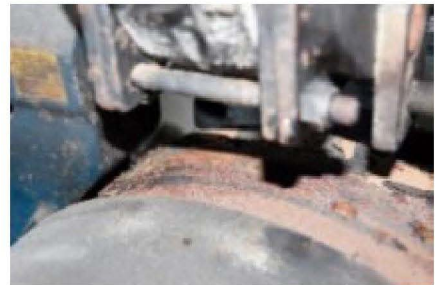
- ⌋ Guarding to hand winding wheels was removed.
- ⌋ Both brake couplings were corroded with evidence of flaking on top of the brake coupling on the left hand lift. Therefore the brake may not be in a suitable condition to stop the lift car if operated whilst on site.

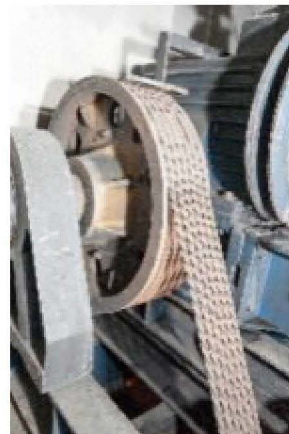
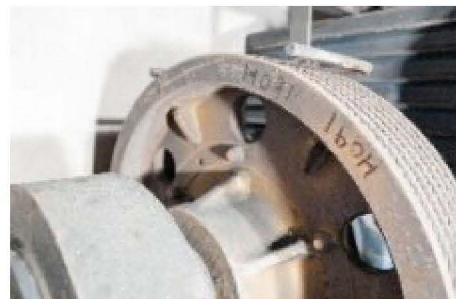
- ⌋ The traction sheaves show signs of heat damage as there were very little signs of any yellow paint.

- ⌋ The traction sheaves and grooves were corroded.

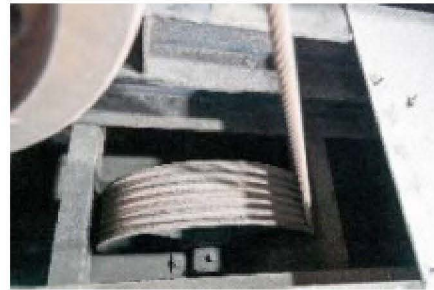
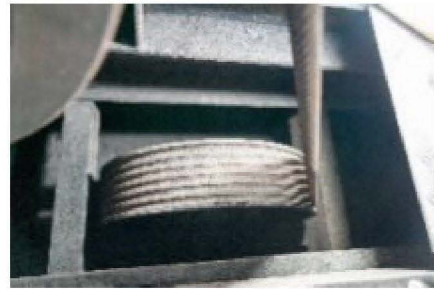
- ⌋ The diverter sheaves were corroded and indicated signs of heat damage.

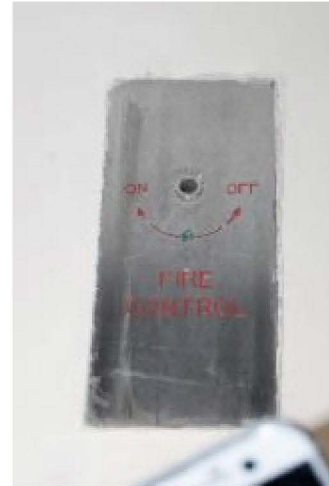
- ⌋ A green flag could be seen through the hole in the faceplate.

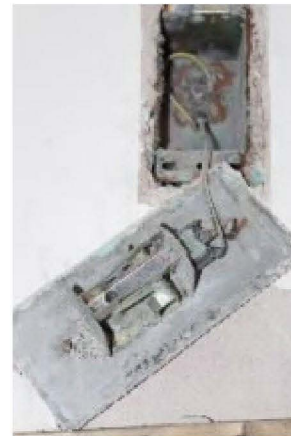
- ⌋ The fireman's switch was difficult to operate.
- ⌋ The faceplate was removed to determine the reason for failing to operate the switch.

- ⌋ We discovered that the mechanism was seized and damaged/deformed.
- ⌋ The contacts were open circuit when checked with a multi-meter.
- ⌋ The wiring was coloured yellow and grey.

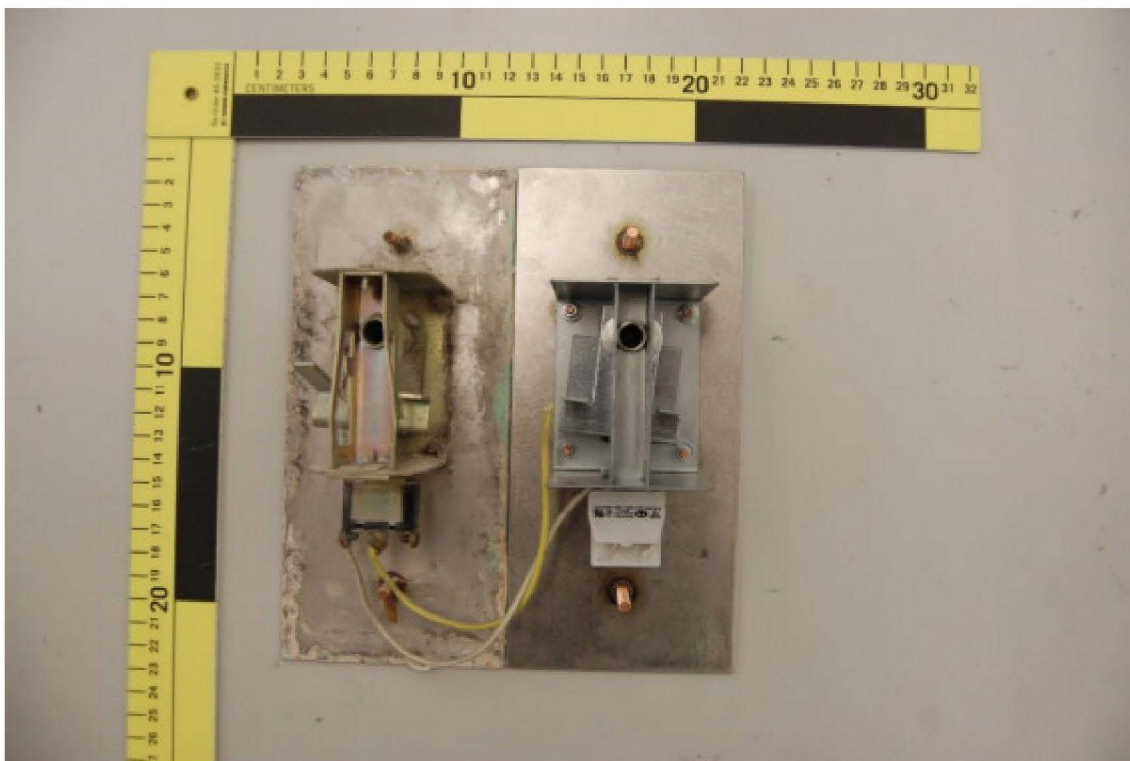
**Photo 12** Comparison of fire switch BJG/74 (left) and ER/2 (right)

The examination of BJG/74 indicates deformation of the 'side wards' when compared with ER/2. In my opinion, this deformation could not have occurred during removal.

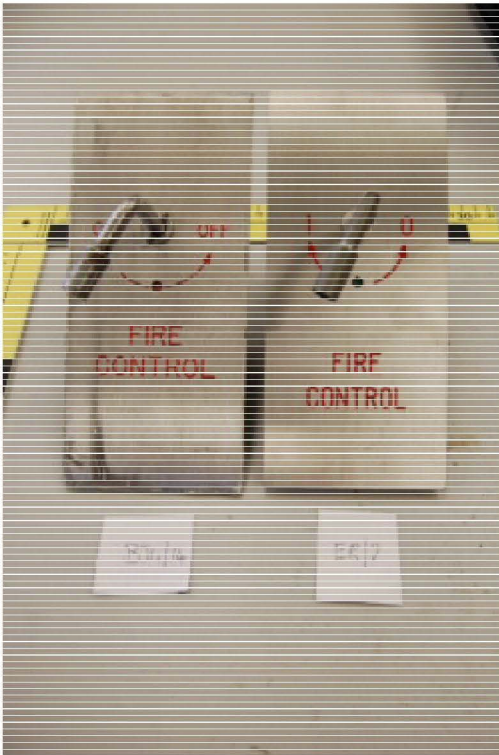
**Photo 21** BJG/74 (left) and ER/2 (right) with ‘express’ drop keys

It was noted that fire switches BJG/74 and ER/2 have different engraving (ON/OFF – 1/0) and status colours (red and green) when in same position.

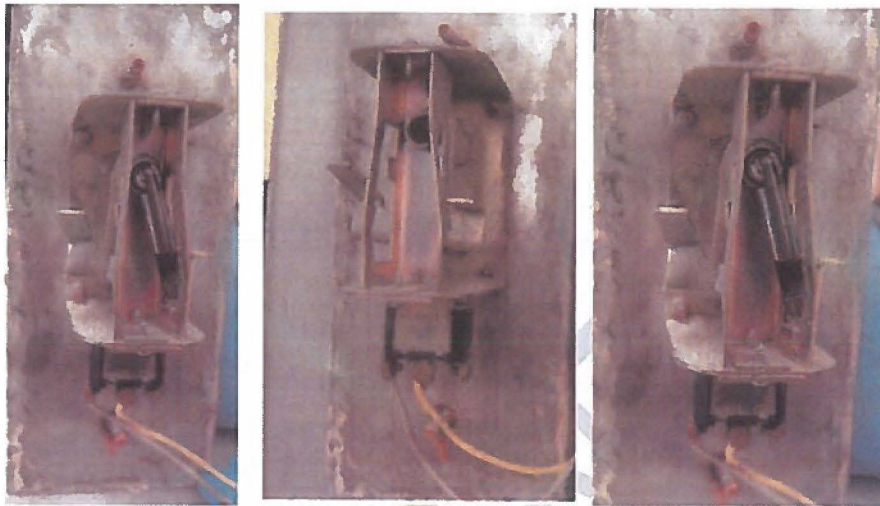
Figure 2. 'Fire Control' switch with deformed frame elements [2].

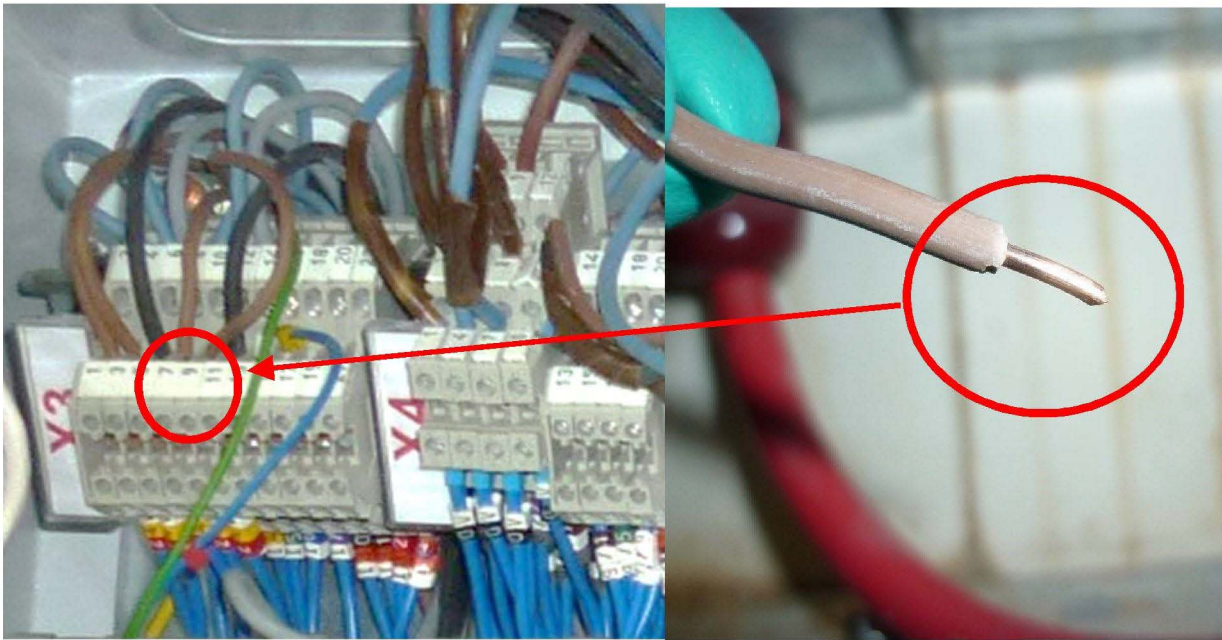
**Figure 9: Master Panel - Unsecured wire in Terminal X3/7 failed continuity test**

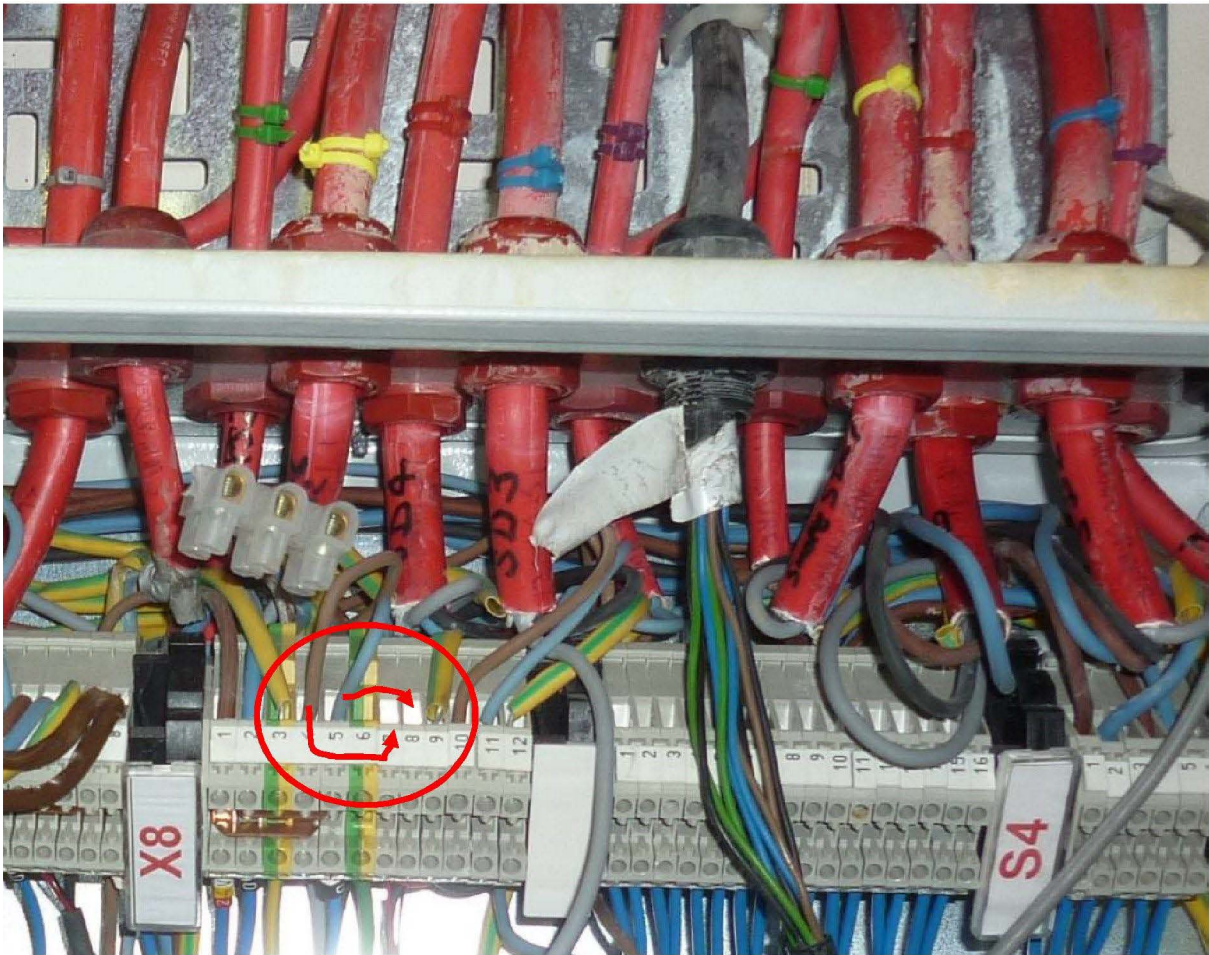
Figure 10: Master Panel - Details of error made when reinstating wires after continuity test

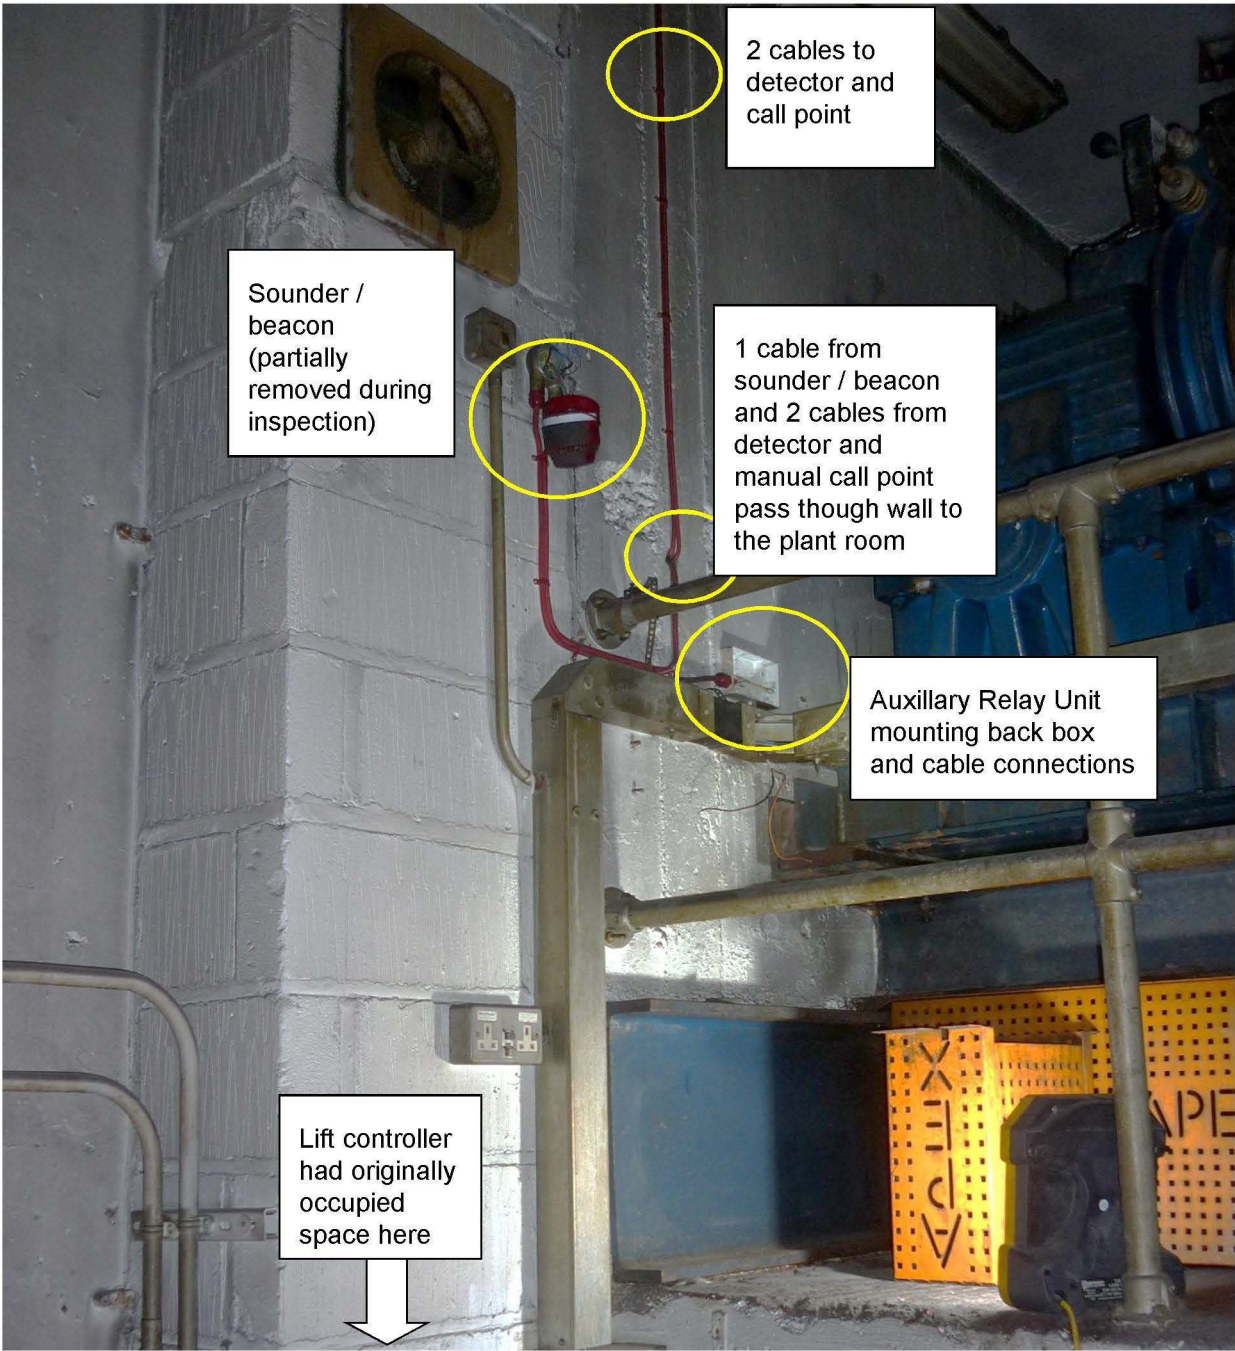
Both these cables terminated unconnected inside the ground floor riser, with straight cut ends (no protection from unintended electrical connection), see SOCO photographs. There was also a third unconnected cable. None of these cables were labelled.

Figure 16: Cables, sounder / beacon and Auxillary Relay Unit mounting back box adjacent to position of lift controller

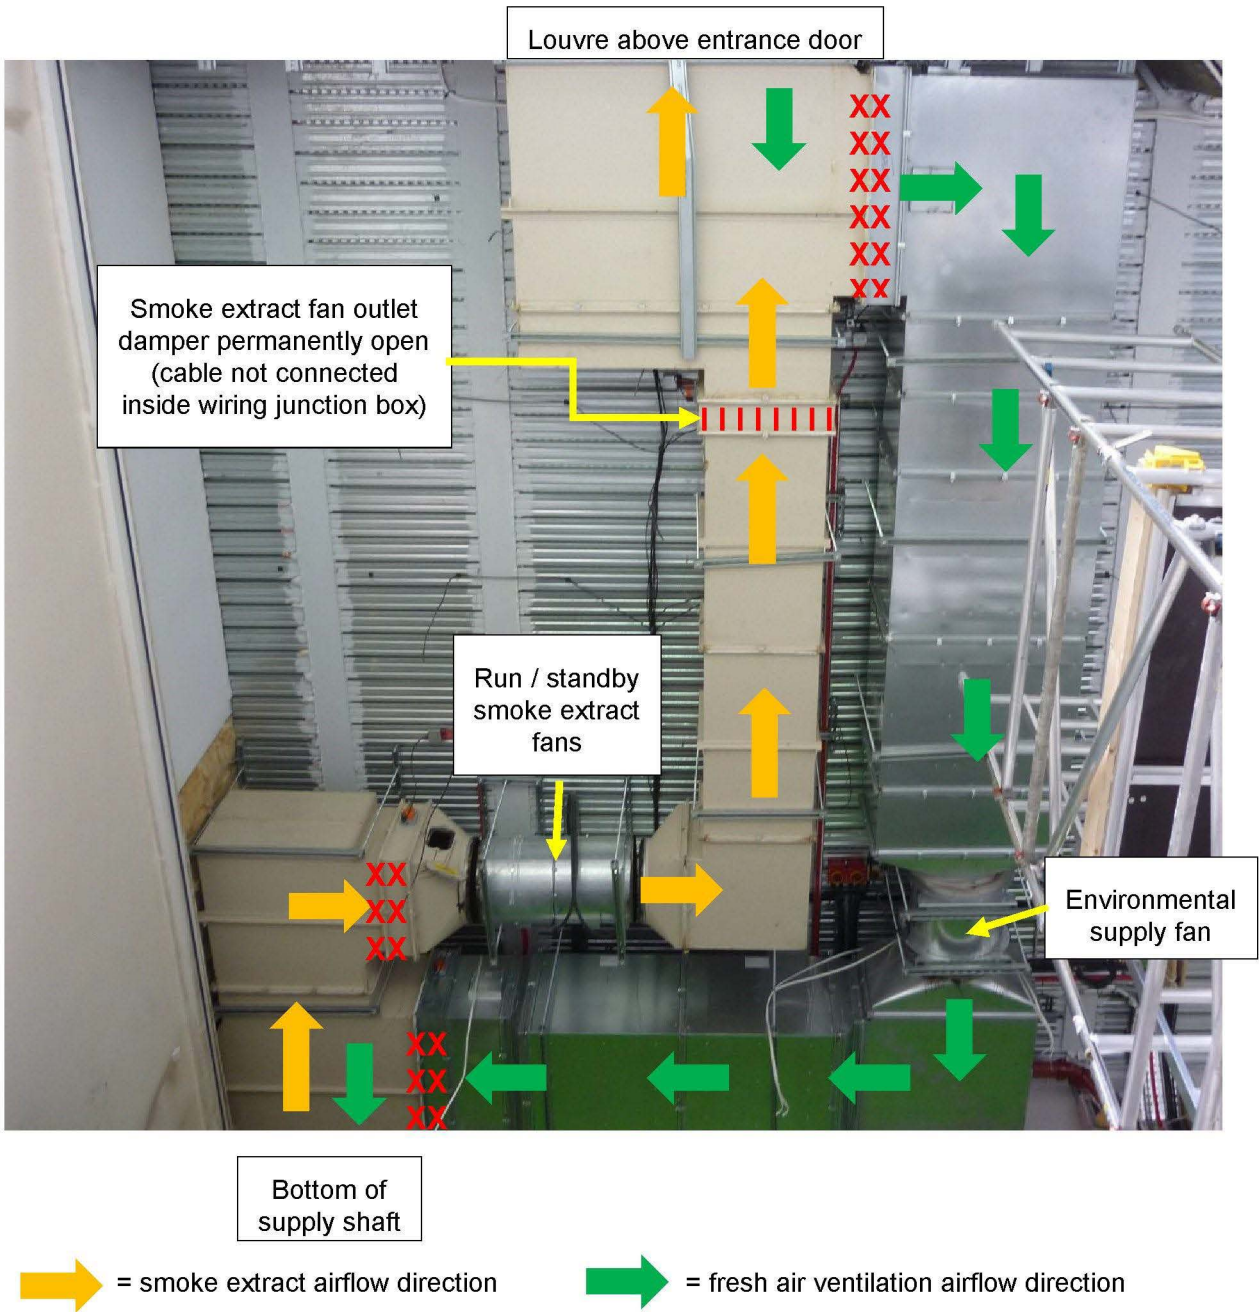
The Smoke Extract Fan inlet damper was confirmed to be connected to a cable from Inverter Panel 1 but the Smoke Extract Fan outlet damper was NOT connected inside the wiring junction box (see SOCO photographs). It was therefore presumed that it was intended for the Smoke Extract Fan outlet damper to be permanently open. Note that the Smoke Extract Fan outlet damper was open but the other three dampers were closed, when inspected by BRE in July 2017

Figure 24: Smoke extract and environmental supply ductwork above entrance lobby

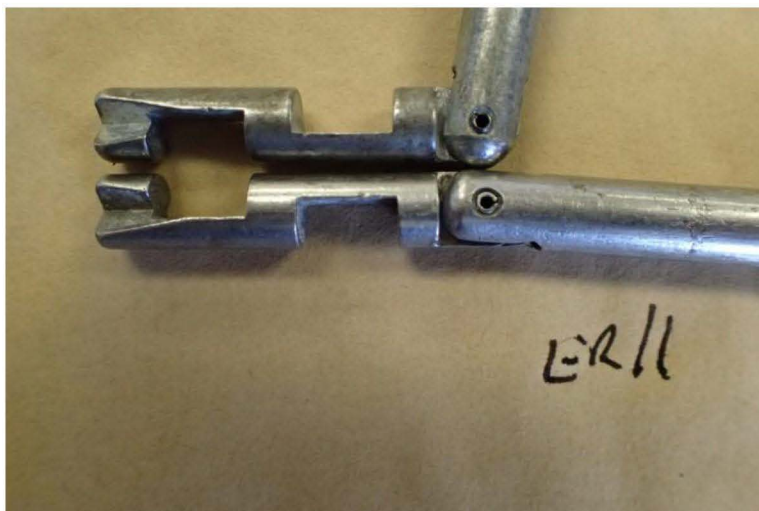
In my opinion the key, Item DER/22, could also be considered as a slightly ill-fitting key for the Fire Control panel, Item BJG/74 (as described in my report dated 12 November 2019), and had such a key been used it could have been responsible for the damage observed on the Fire Control panel side wards of Item BJG/74.

Key DER/22 at the top and  
Key ER/1 at the bottom

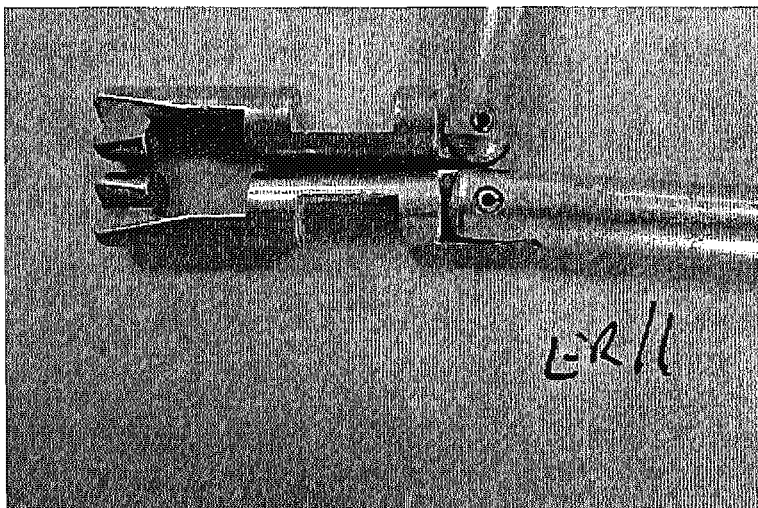
In my opinion the key, Item DER/22, could also be considered as a slightly ill-fitting key for the Fire Control panel, Item BJG/74 (as described in my report dated 12 November 2019), and had such a key been used it could have been responsible for the damage observed on the Fire Control panel side wards of Item BJG/74.

Key DER/22 at the top and  
Key ER/1 at the bottom

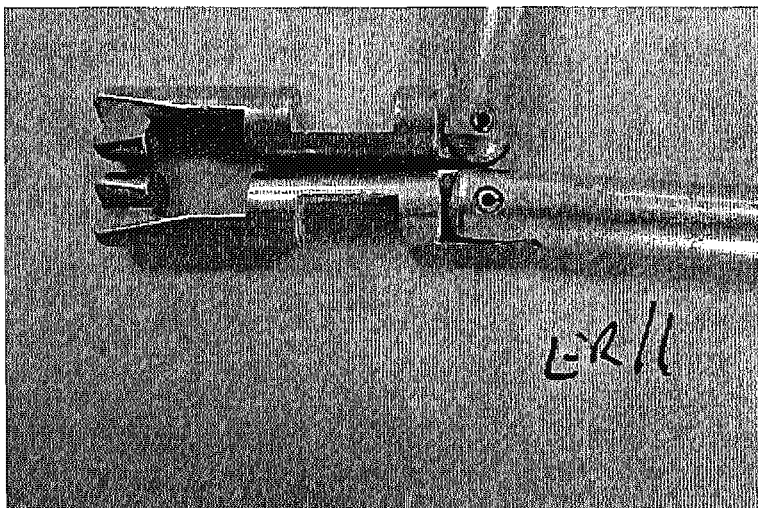
In my opinion the key, Item DER/22, could also be considered as a slightly ill-fitting key for the Fire Control panel, Item BJG/74 (as described in my report dated 12 November 2019), and had such a key been used it could have been responsible for the damage observed on the Fire Control panel side wards of Item BJG/74.

Key DER/22 at the top and  
Key ER/1 at the bottom

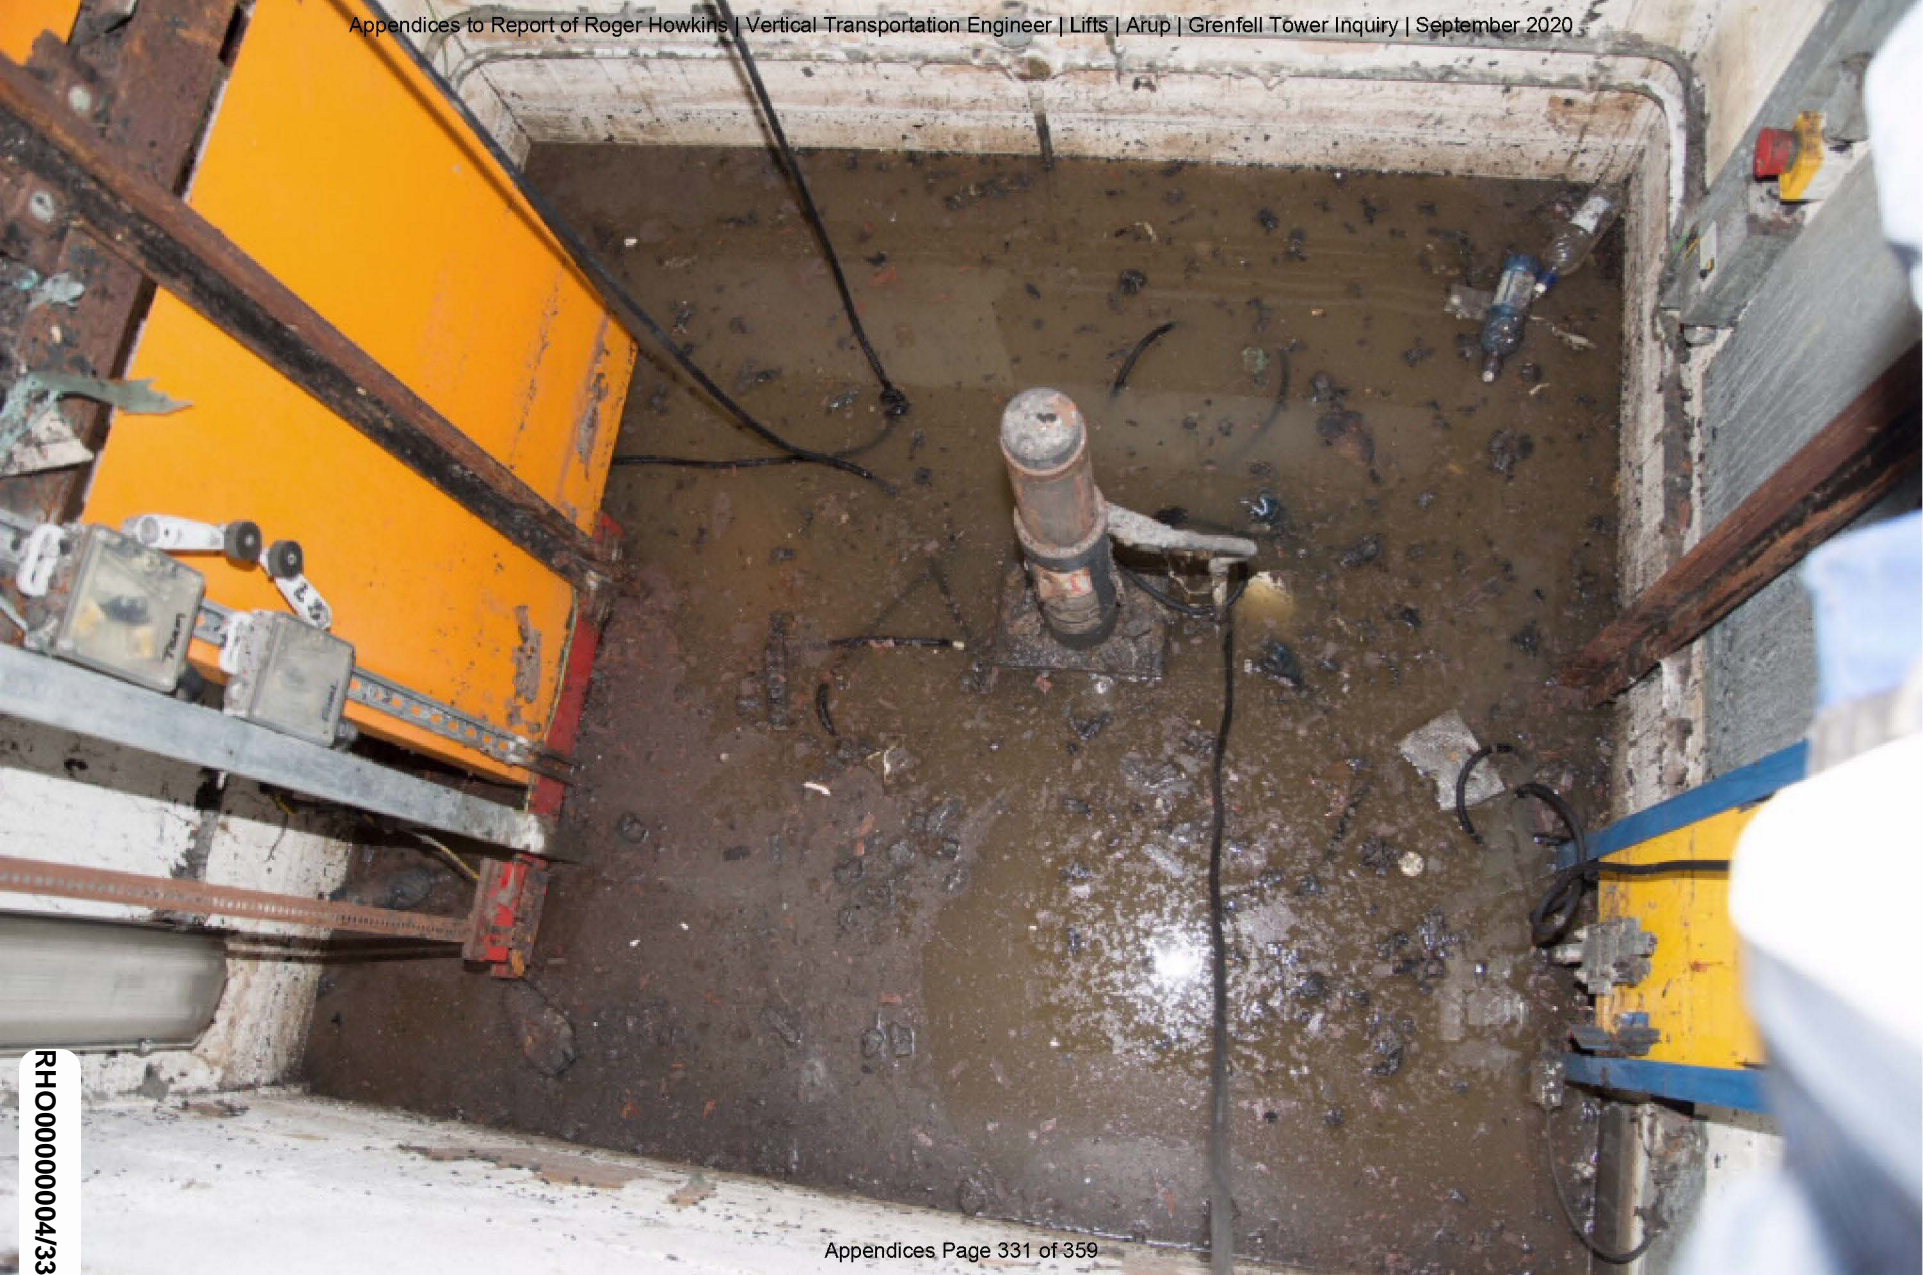
### **MET00065229 – Lift pit with water**
