Supplementary Report of Roger Hawkins

Concerning the lifts at Grenfell Tower

For the Grenfell Tower Inquiry

April 2021

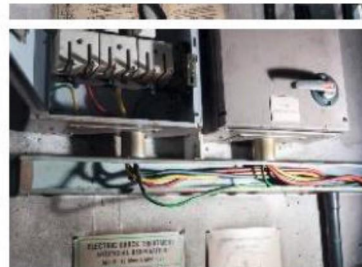
- The incoming earth wire to the left hand isolator, Lift H091, was wrapped with insulation tape which was hidden inside the conduit. The earth wire was possibly too short and had been extended.

“The incoming earth wire to the main isolator of lift H091 was extended and wrapped with insulation tape before being concealed inside the conduit. This is poor / bad practice. The earth wire should have been replaced during the modernisation works.”

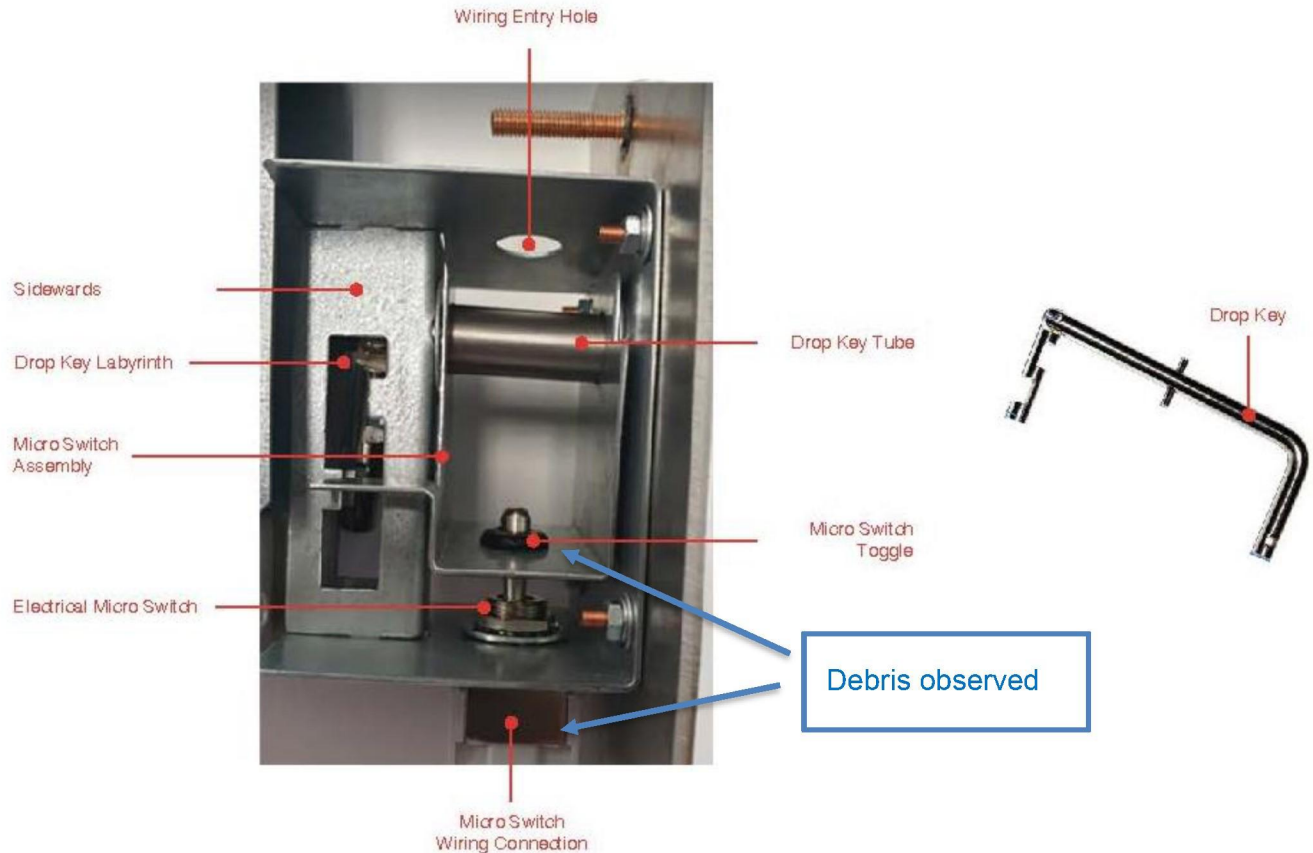
"Internal examination - The micro switch to BJG/74 initially was jammed and did not operate. During the examination this switch became free and operated correctly. It is not known what caused this micro switch to jam. It is not known if the micro switch was jammed on the night of the fire." {RHO00000004/234}.

158. We observed deformation of the side wards which is discussed separately in my previous report and the other reports in the Appendices. As set out above, we also observed debris on the switch casing and the micro switch. I have indicated in the diagram where this debris was observed.

159. At this testing, we inserted an express drop key into the switch. The switch did not immediately operate but with some manipulation the debris on the micro switch cleared and we were able to operate the fire control switch. By 'manipulation' I mean that we turned the drop key left to right a few times, i.e. we toggled the switch, and the debris cleared. We did not clear the debris by cleaning the micro switch itself, the debris was cleared when we operated the fire control switch with the drop key.
