# **GRENFELL TOWER INQUIRY**

## **Final Report of**

**Rodney Denver Hancox B.Sc., C.Eng, MIGEM**

## **Gas Engineering**

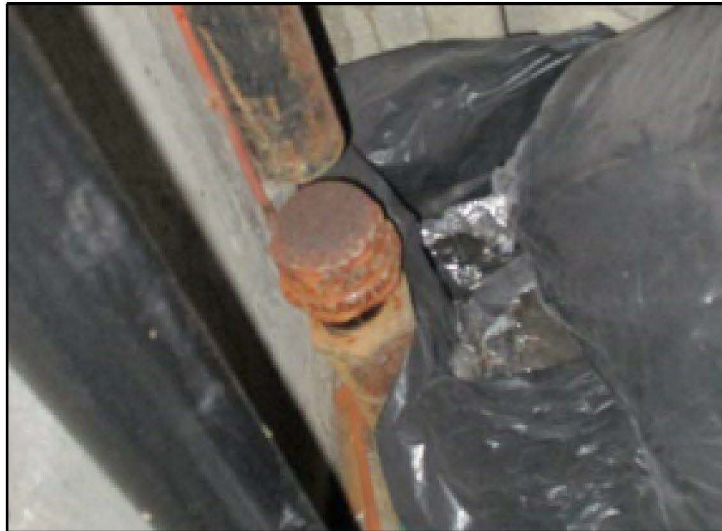
south east of the building was observed to have been isolated and capped on the ground floor; see Figure 17.

**Fig. 17 - : Capped riser pipe at low level on the Ground Floor**

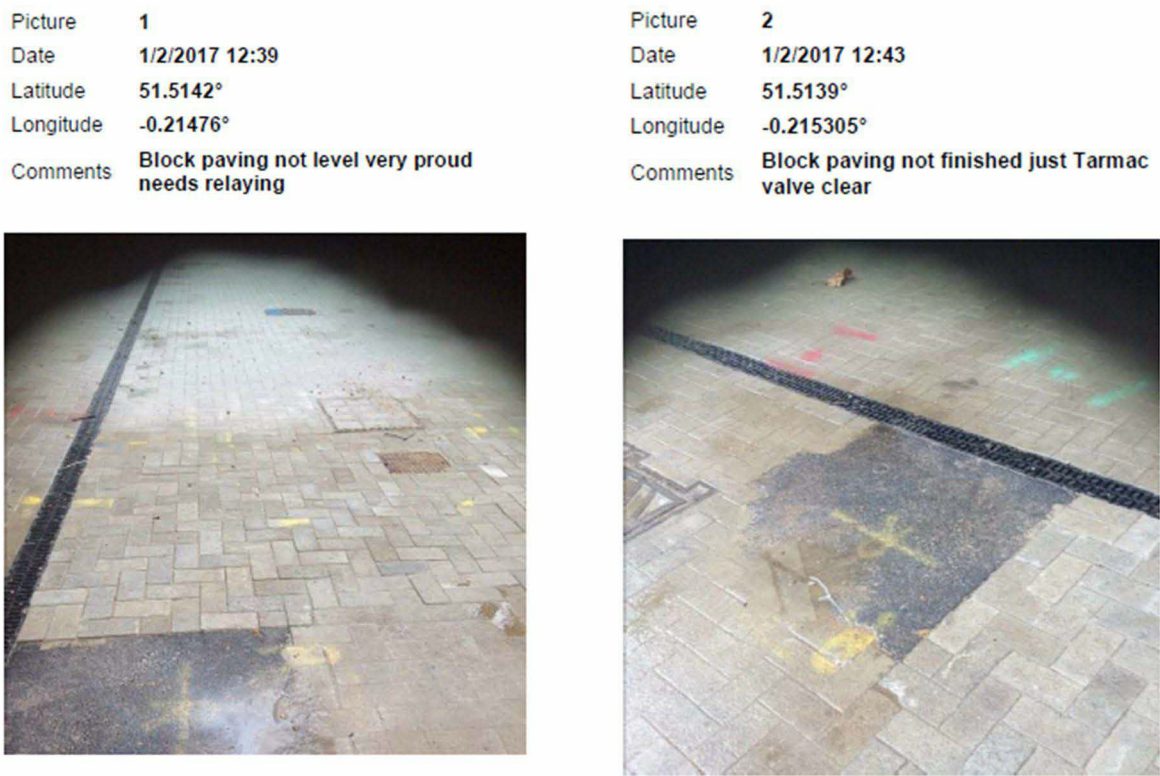
by the inspection which was carried out on 1<sup>st</sup> February 2017 {CAD00000945} and which recorded the reinstatement as being defective: see comments above both photographs in Figure 40 below.

**Fig. 40 – Reinstatement defect at PIV location {CAD00000945}**

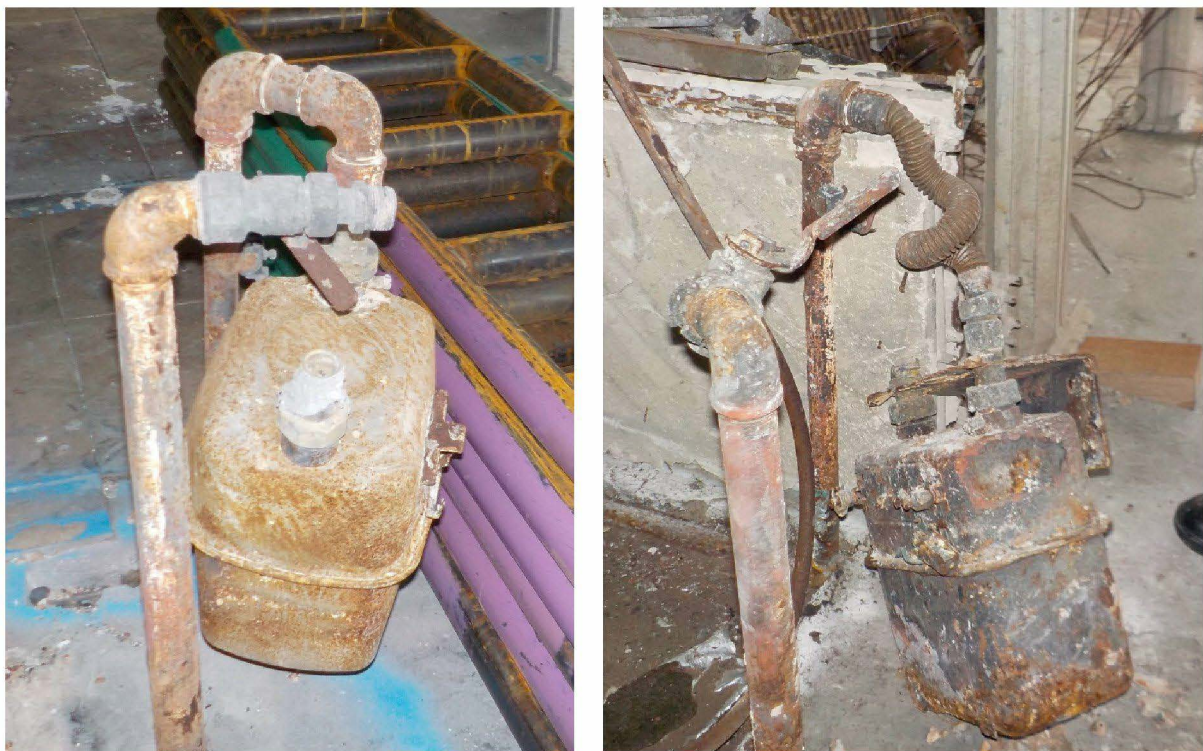
234. During my visits to the Tower I inspected the riser in the stairwell and the branches/laterals in the lobbies. I saw no evidence to suggest that that pipework which constituted Residential Gas Supply No.2 had failed to contain the gas within it during the fire.
235. I observed numerous “burnt out” meter installations<sup>28</sup>, many of them where the Emergency Control Valve was either fully or partially in the “on” position thereby presenting an “open end” through which gas could have fed the fire.

**Fig. 58 – Two examples of burnt out meter installations**

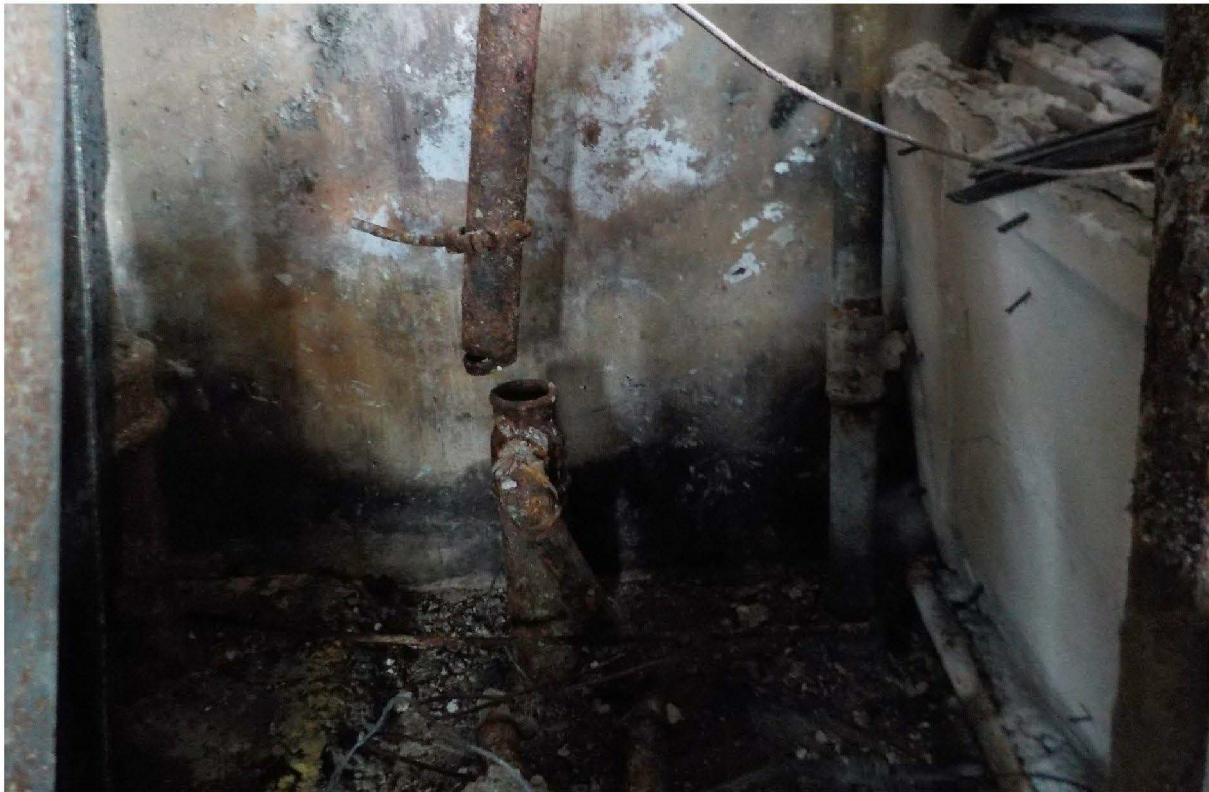
**Fig. 60 – Ruptured 1½” Riser in Flat 5 on 14<sup>th</sup> Floor i.e. Flat No. 115**

242. It can be seen from the above photographs that the rupture occurred on exposed threads immediately outside of a screwed socket connection. There is a further split near the end of the exposed threads. In my experience, poorly protected exposed threads in the vicinity of threaded sockets are a weak point in screwed steel pipe systems due to their susceptibility to corrosion in the medium to long term.
243. I note from Dr Barbara Lane’s report that Flat No 115 (i.e. Flat ending with the number 5 on the 14<sup>th</sup> Floor) had a missing entrance door.
244. {CAD00002970} includes slides in which flat numbers containing live meter point reference numbers<sup>29</sup> have been superimposed on to photographs of the Tower i.e. flats known to be being supplied with gas. The following two slides illustrate the extent of the fire in flat 115:

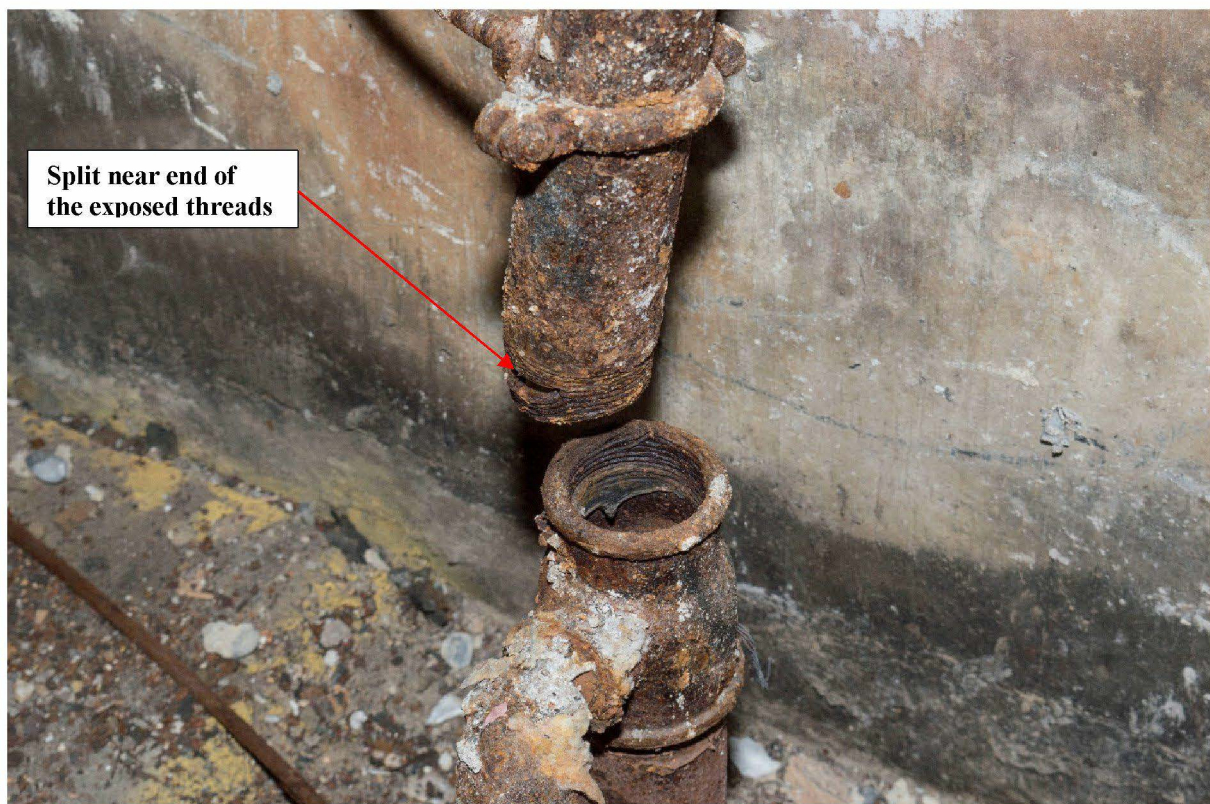
Fig. 61 – Magnification of Rupture {MET00016615}

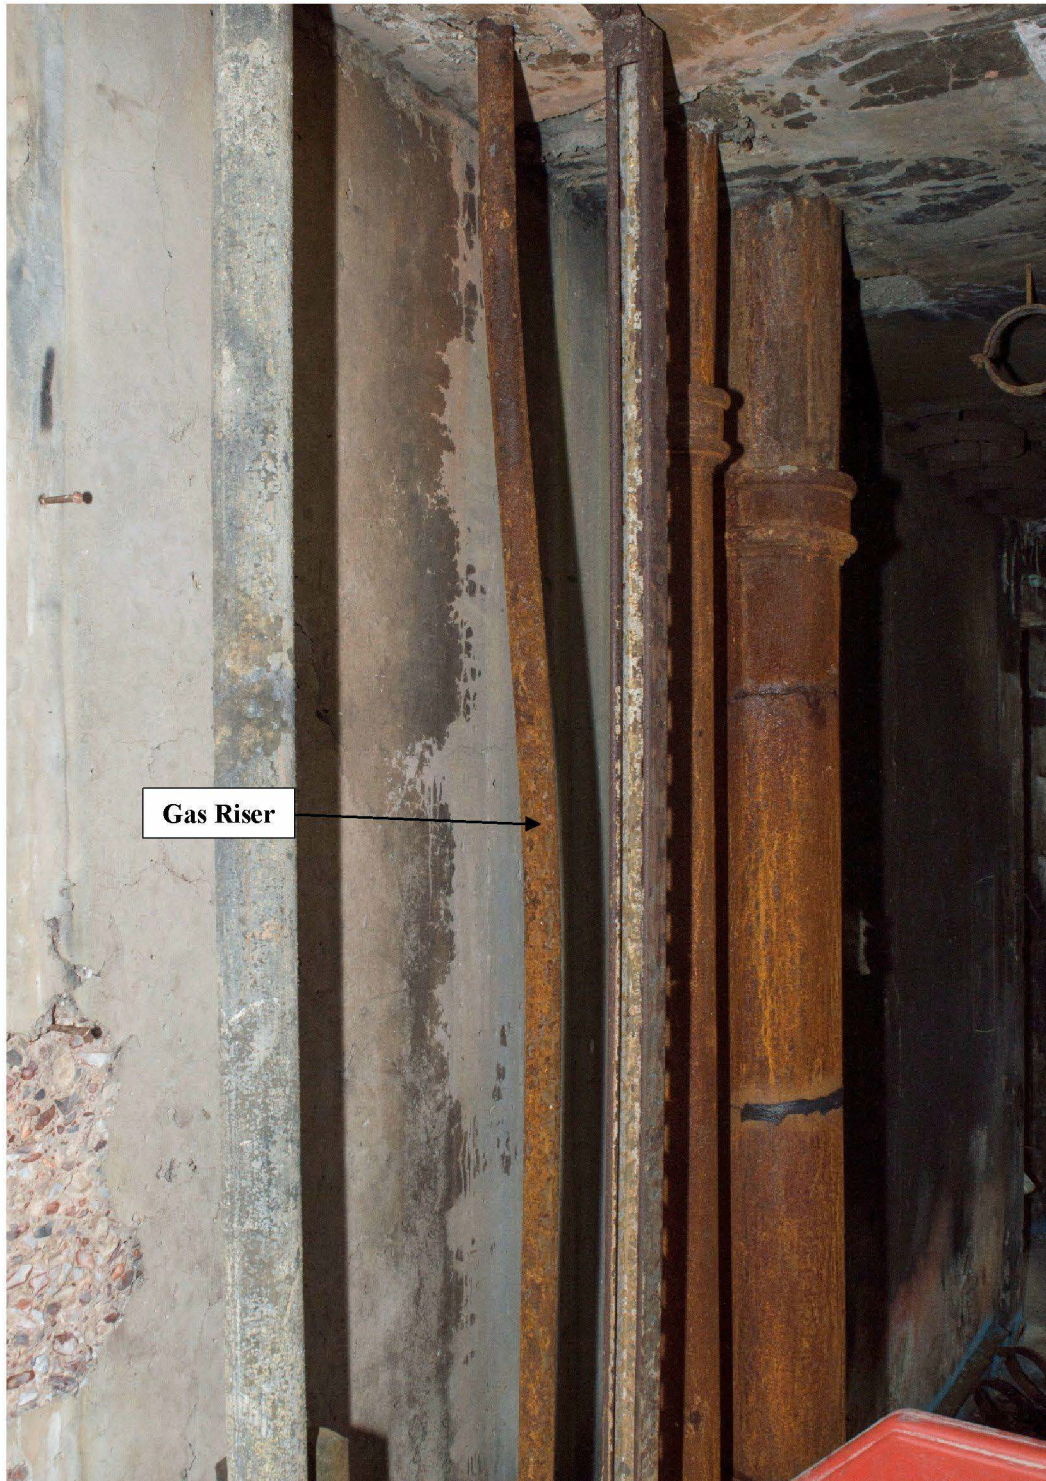
246. The following photograph shows the distorted/warped riser serving flat No 193 on the 22<sup>nd</sup> floor.

**Fig. 64: Distorted/Warped Riser serving flat No 193 on the 22<sup>nd</sup> floor {MET00016575}**

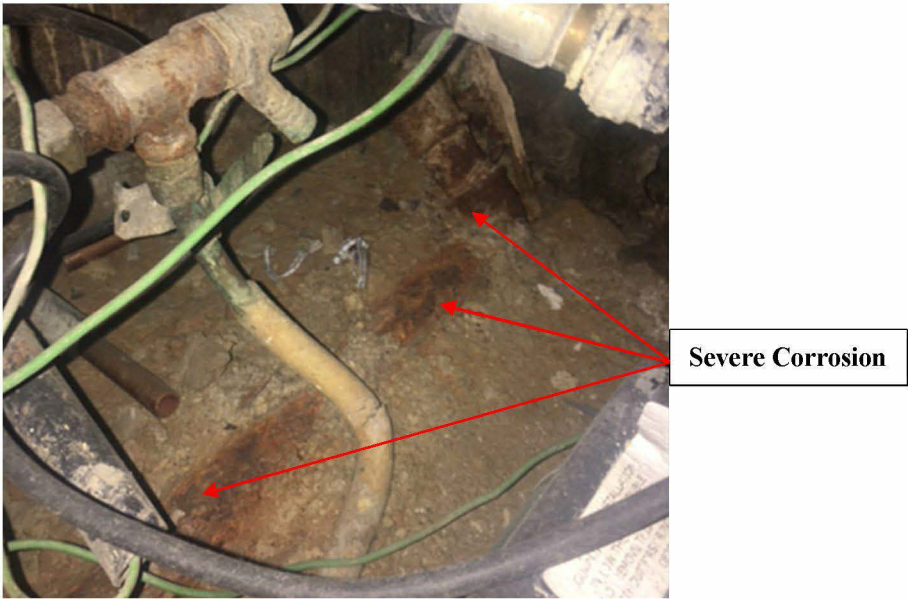
248. Cadent Gas Ltd’s Riser Survey Report of 30<sup>th</sup> September 2016, {CAD000000031}, recorded the identification of severe corrosion on the lateral within Flat No. 165, which I understand to be the Flat with the number ending in 5 and which is located on the north west corner of the 19<sup>th</sup> Floor of the Tower. The Cadent Gas Ltd surveyors attributed the corrosion to a water leak emanating from an old hot water tank located above the pipe. The Cadent Gas Ltd surveyors also identified moderate/severe corrosion on the lateral within Flat No. 105, which I understand to be Flat 5 on the 13<sup>th</sup> Floor.

**Fig. 65 – Severe Corrosion on Lateral within Flat No. 165 {CAD000000031}**

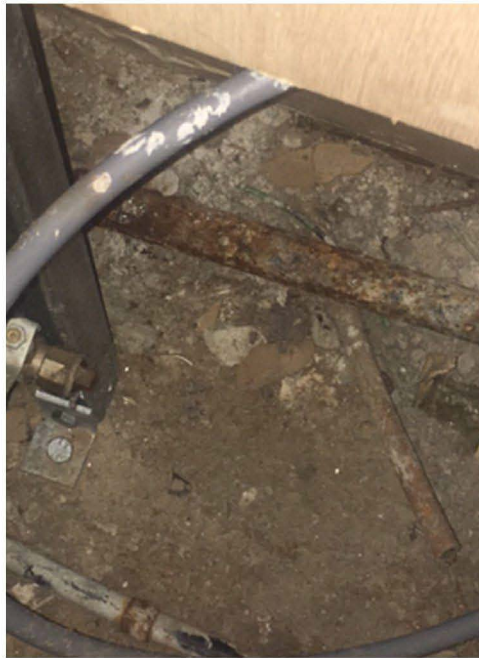
**Fig. 66 – Moderate/Severe Corrosion in Flat 105 {CAD00000031}**

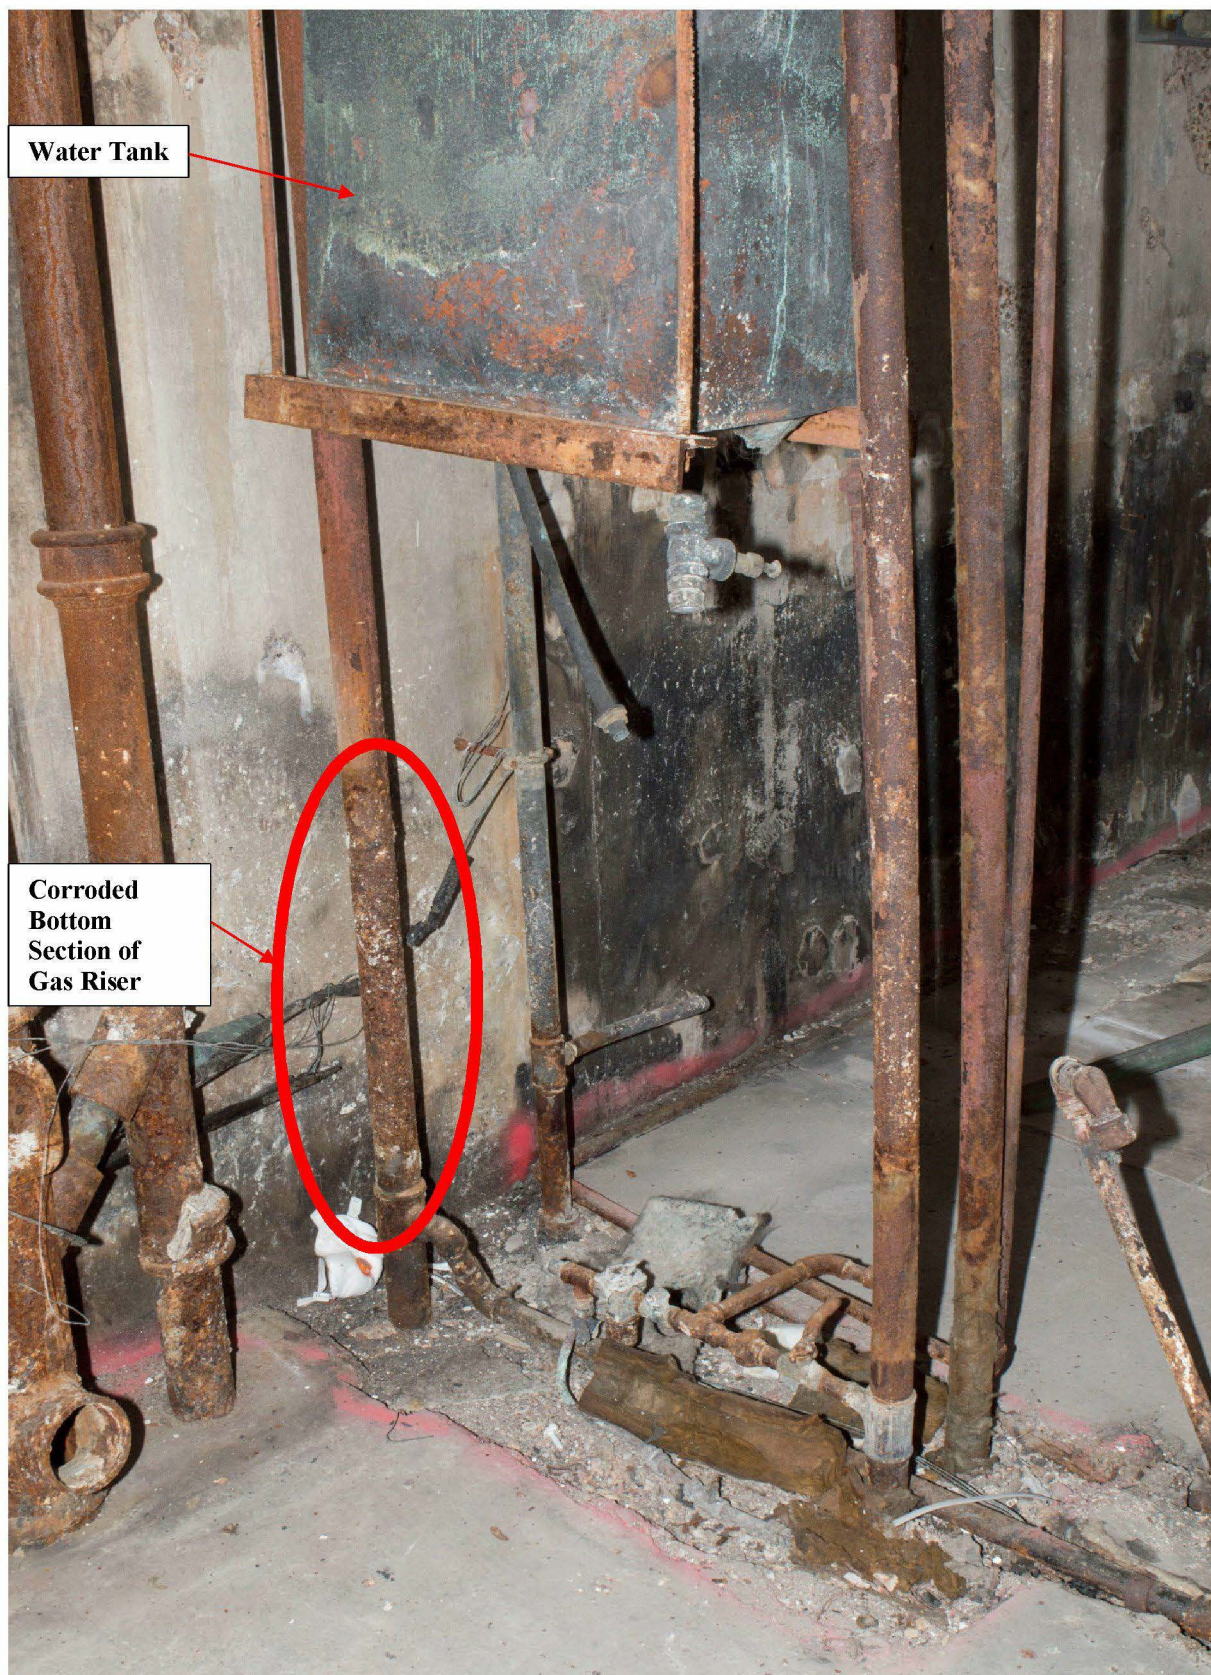
**Fig. 67 - Water Tank & Corrosion on Bottom  $\frac{1}{3}$  of Riser in Flat 105 {MET00016564}**

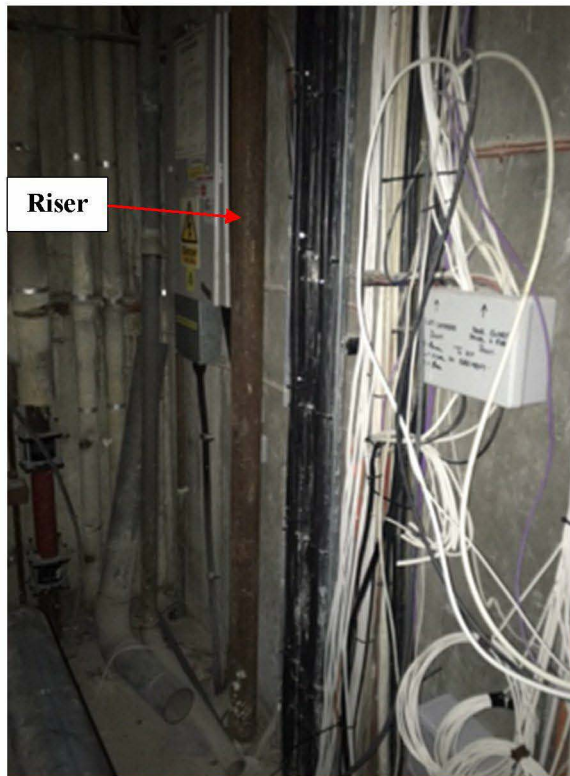
a) Riser in service cupboard showing superficial corrosion

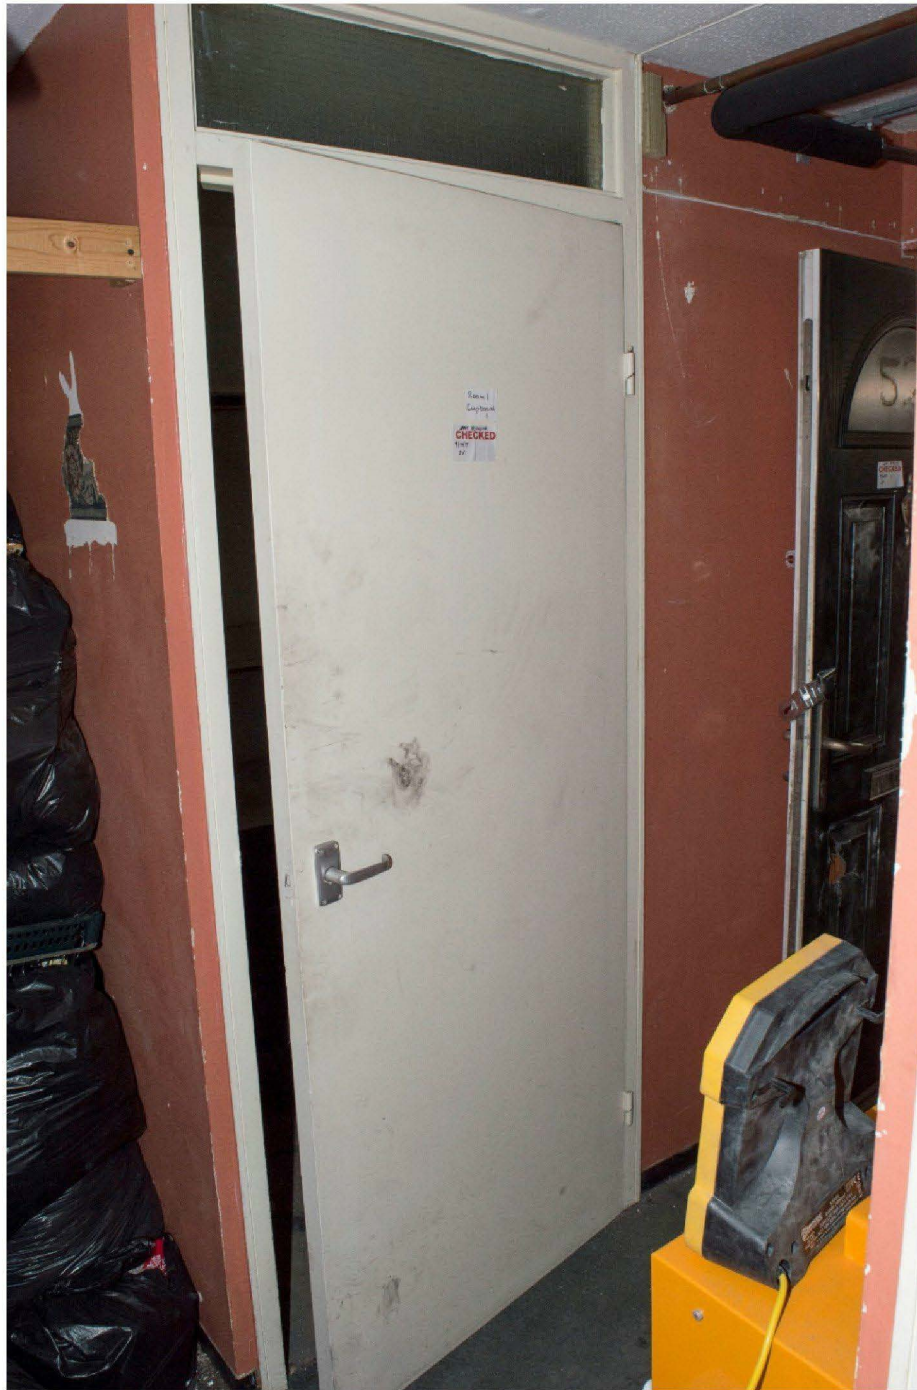
**Fig. 85 – Cupboard for Repositioned Gas Meter in Flat No. 52 {MET00016558}**  
(Note rising hinges and non-closure of door)

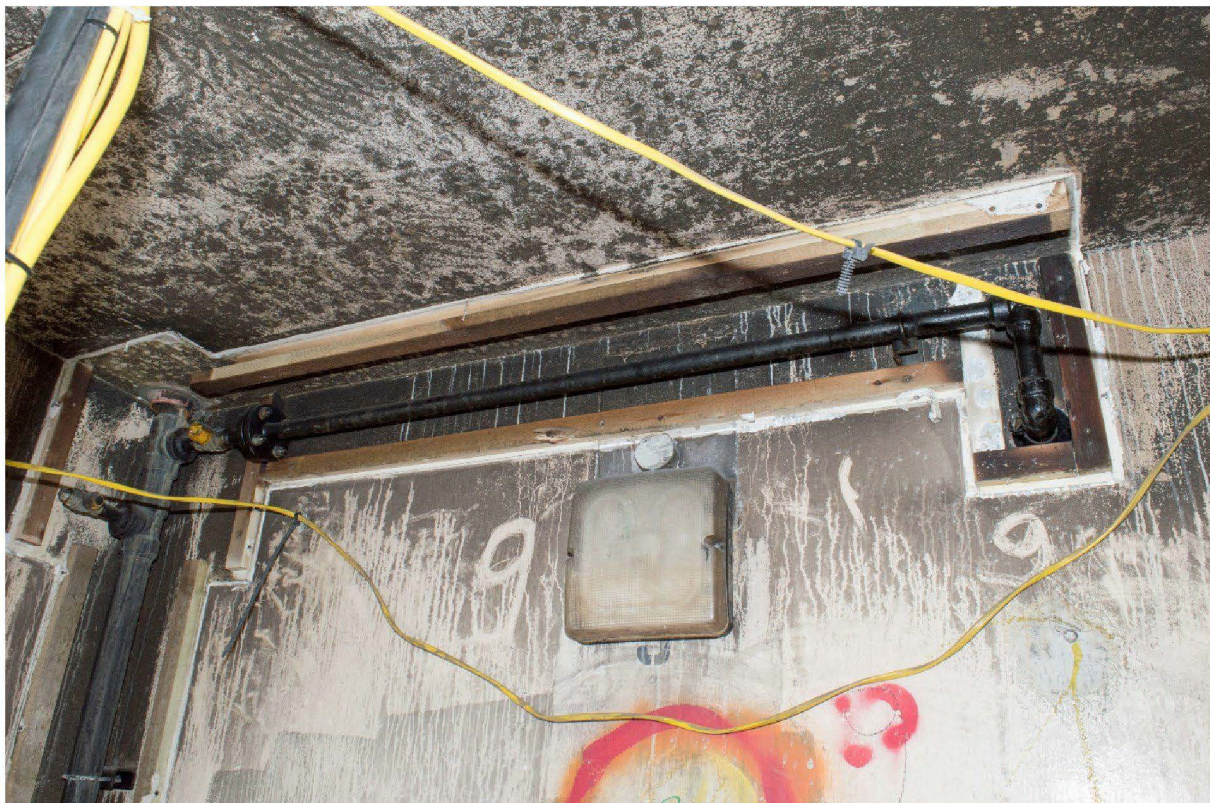
Photograph {MET00016722} indicates that smoke entered the boxing from the lobby at this level via the oversized penetration of the compartment wall through which the gas pipe passed. Boxing appears to have been intact at the time of the fire. There is no reason to suspect that smoke was able to enter the stairwell at this level from the boxing.

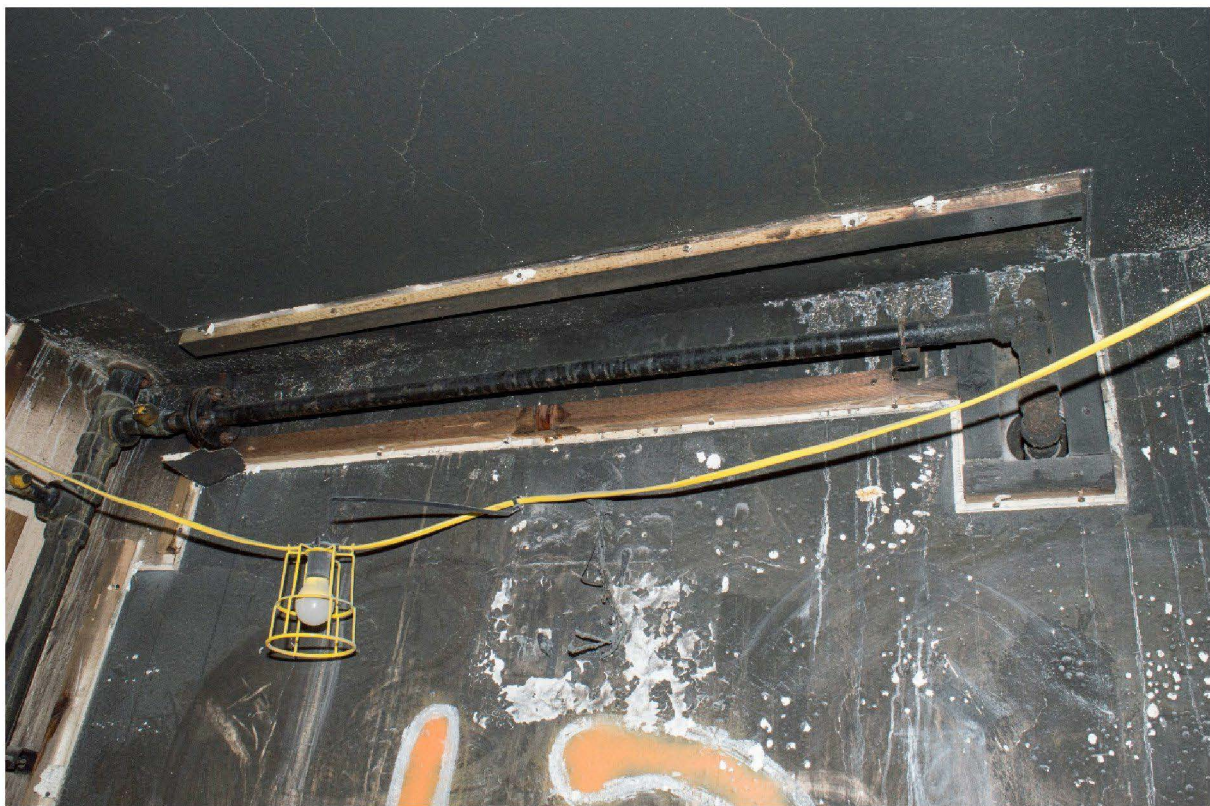
Photograph {MET00016560} indicates that smoke entered into and/or exited from the boxing at this level via the oversized penetration of the compartment wall through which the gas pipe passed.

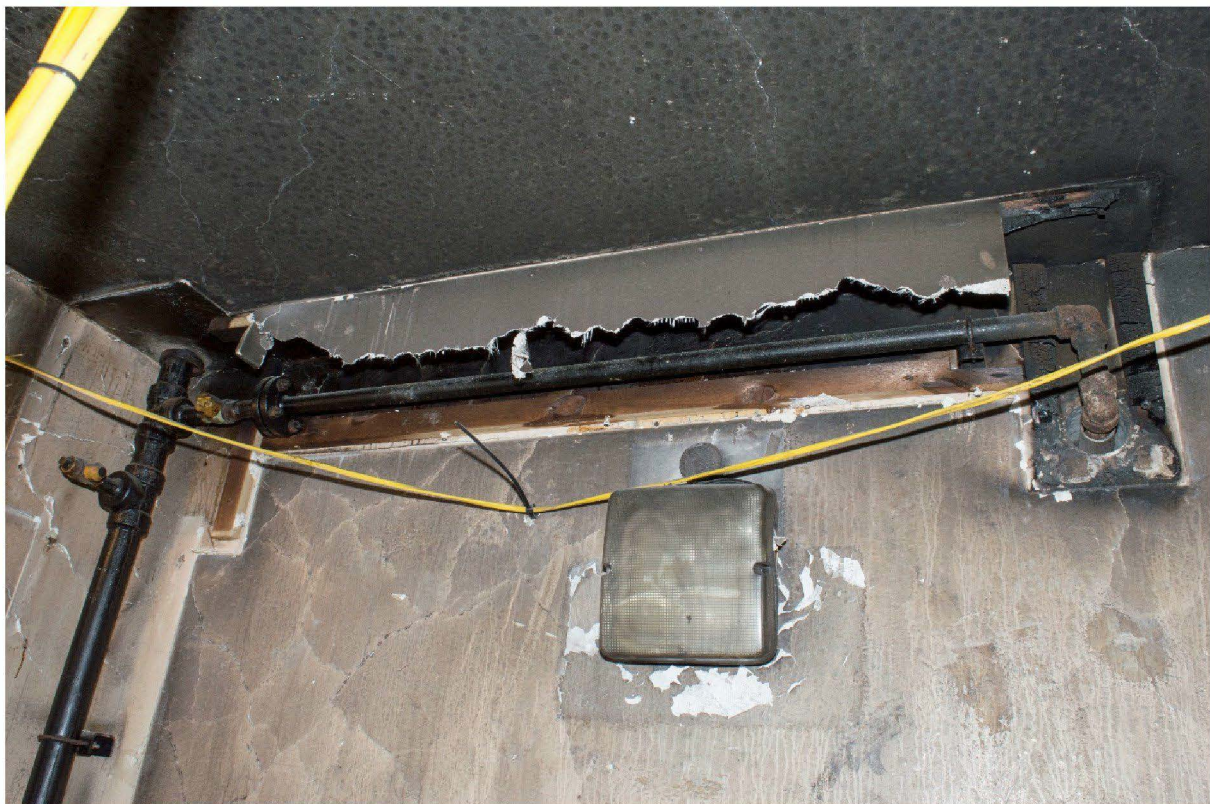
Photograph {MET00016549} indicates that smoke entered the boxing from the lobby at this level via the oversized penetration of the compartment wall through which the gas pipe passed. I note the vertical section appears to have been smoke free.

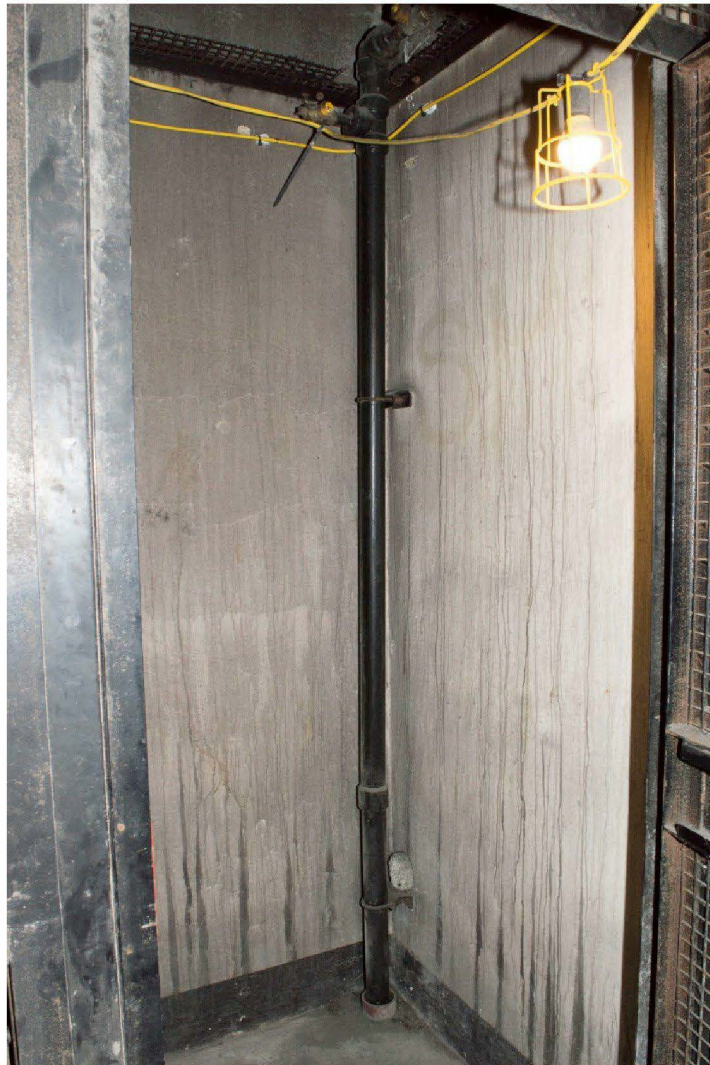
Boxing in had not been completed at this level at the time of the fire.

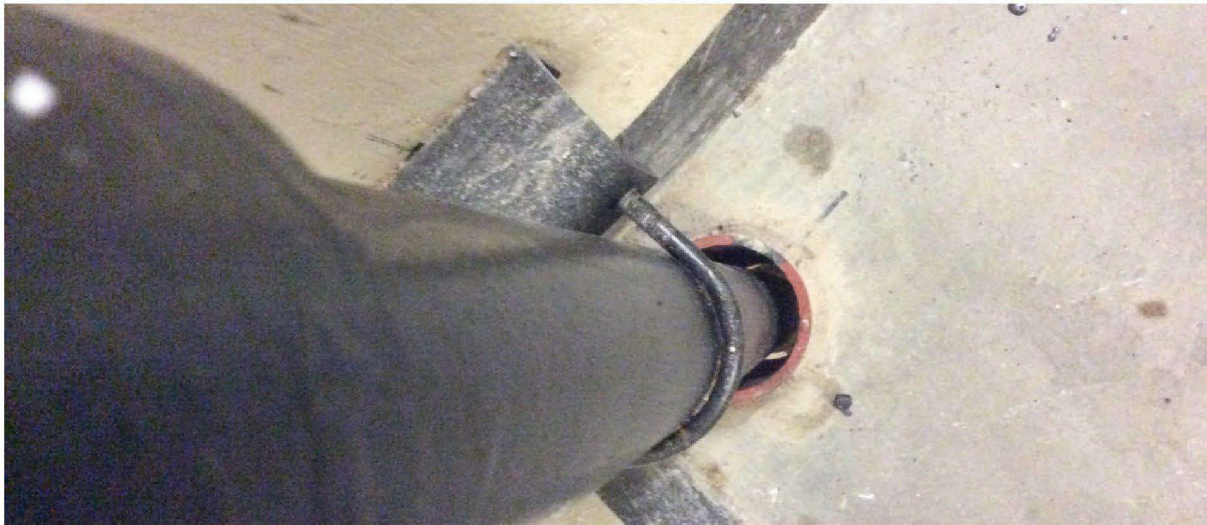
**Fig. 92 – Unsealed Sleeve in Floor {CAD00001910}**

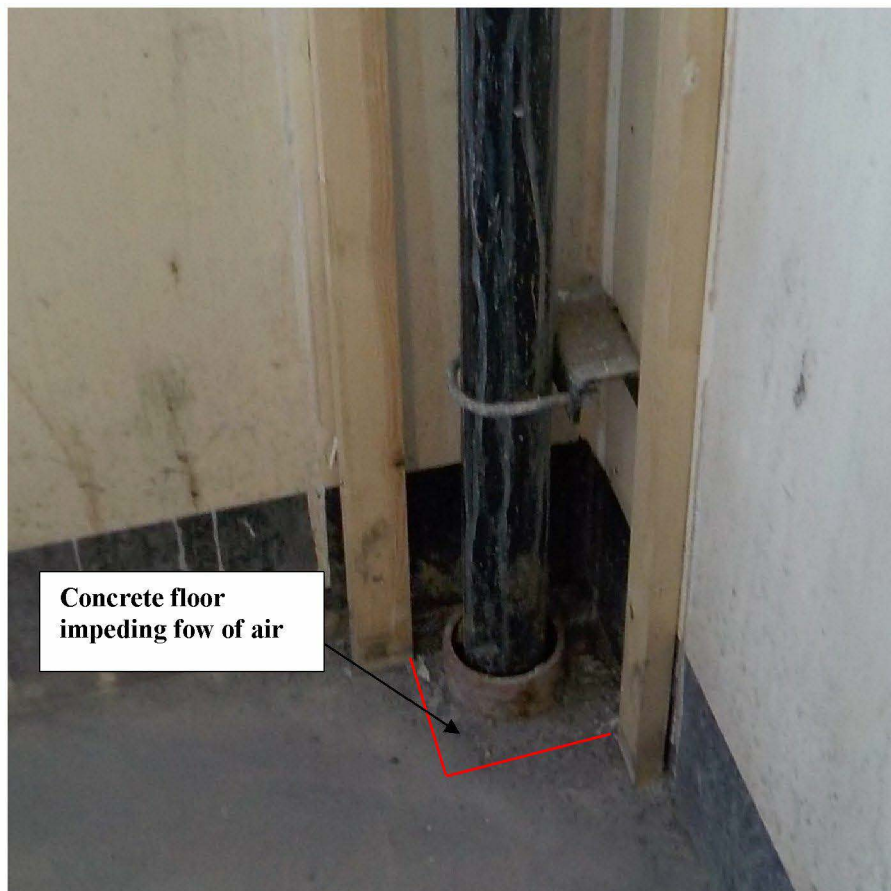
**Fig. 93 – Retained Floor Impeding Air Flow Up Through Riser Shaft**

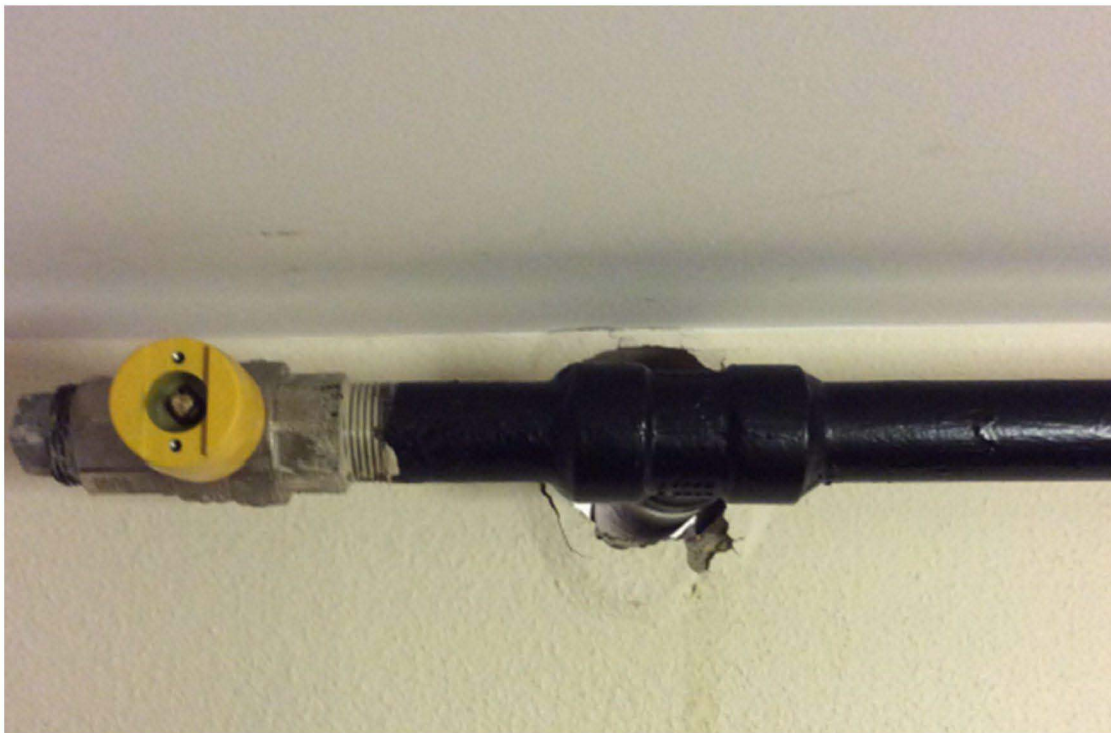
**Fig. 93 – Unprotected Exposed Threads on Otherwise Protected Pipe {CAD00001718}**

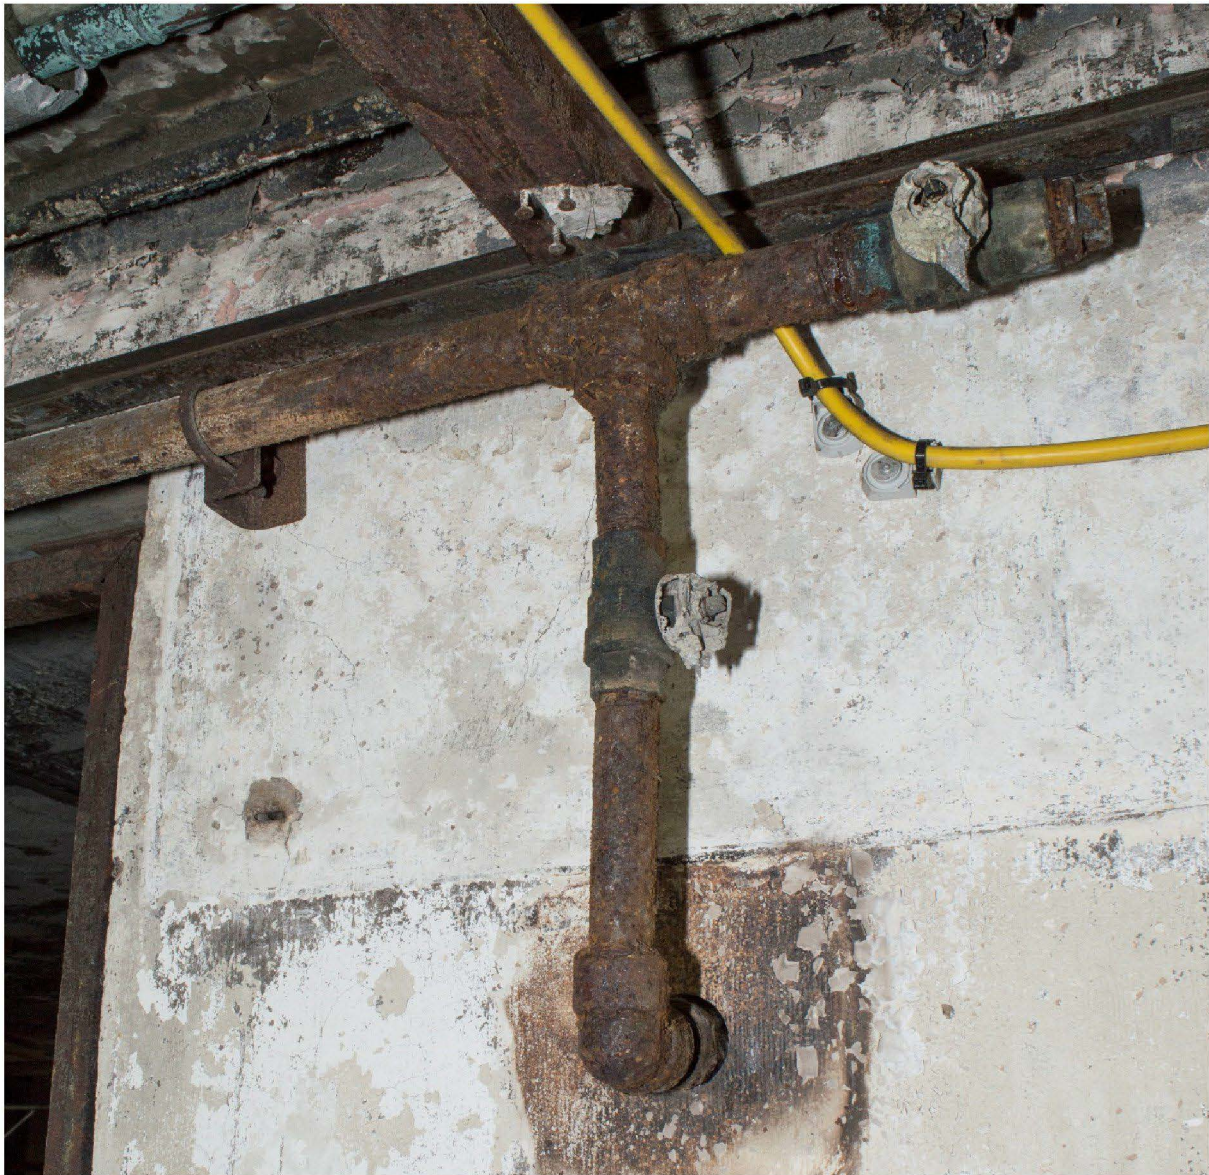
**Fig. 97 – Pipework on 21<sup>st</sup> Floor after the Fire**
