WORKS PROGRESS REPORT for KCTMO GRENFELL TOWER - No 5

Project Name / Address	KCTMO Improvements and Enhancements to Grenfell Tower		Ref. 7654
Client	KCTMO	Project Manager	Claire Williams
Week Commencing	02/03/2015	Main Contractors	RYDON
Contract Commencement Date	02/06/2014	Contract Completion Date	04/09/2015 (Might be 23/10/15 showing a 7 week delay) yet to be agreed

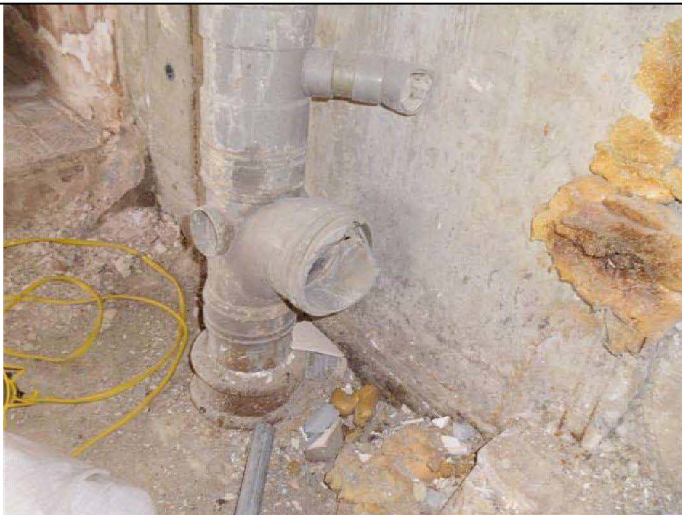
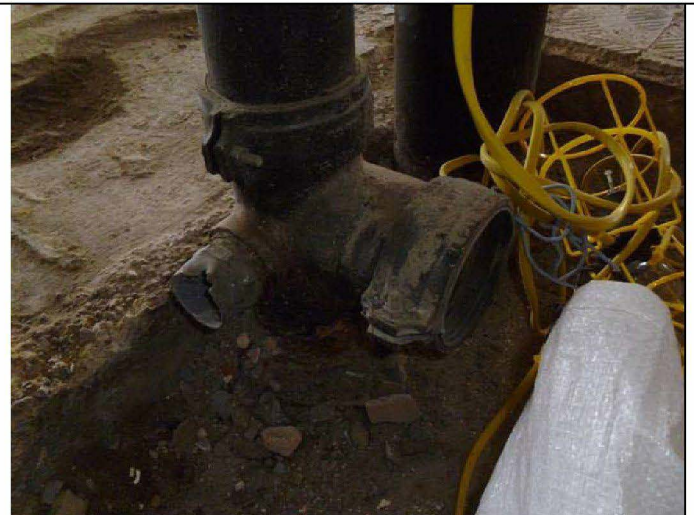
Existing soil and vent drainage has open ends	 	Existing soil and vent drainage has open ends	 
Existing soil and vent drainage has open ends	 	Aerial cabling has been installed into lighting and power cabling runs	 
Aerial cabling has been installed into lighting and power cabling runs	 	Existing soil and vent pipes within the dry lined walls will require acoustic insulation	 
Existing soil and vent drainage has open ends	 	Ventilation fire sleeve is NOT within the fire wall and these need to be mechanically secured with the

angle brackets shown on the fire sleeve

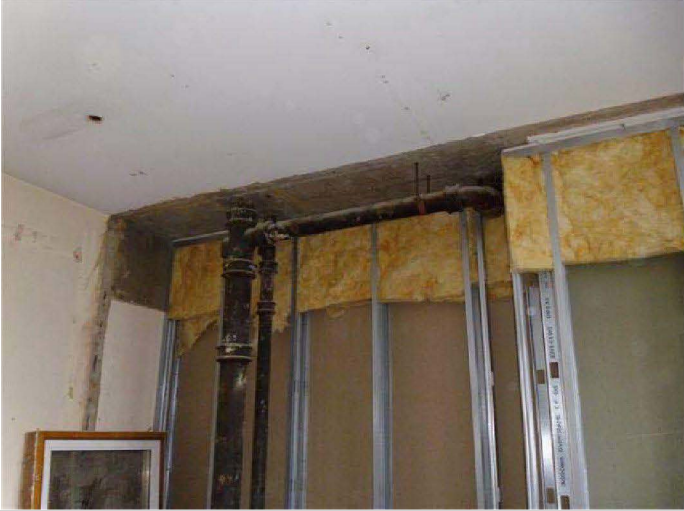
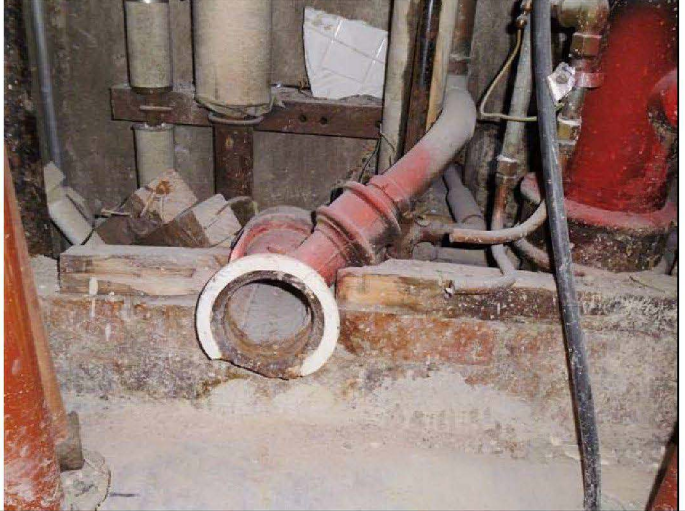
Existing soil and vent pipes within the dry lined walls will require acoustic insulation		Existing soil and vent drainage has open ends
