WORKS PROGRESS REPORT for KCTMO GRENFELL TOWER - No 20

Project Name / Address	KCTMO Improvements and Enhancements to Grenfell Tower		Ref. 7654
Client	KCTMO	Project Manager	Claire Williams
Week Commencing	17/08/15	Main Contractors	RYDON
Contract Commencement Date	02/06/2014	Contract Completion Date	23-10-15

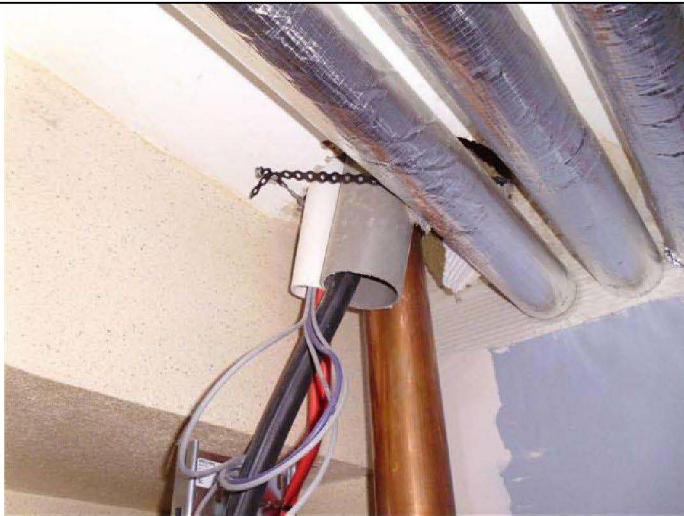
Plastic sleeving used in fire rated service riser is over 40mm diameter and requires an intumescent sleeve as per Building Regulations Part B and BS 476

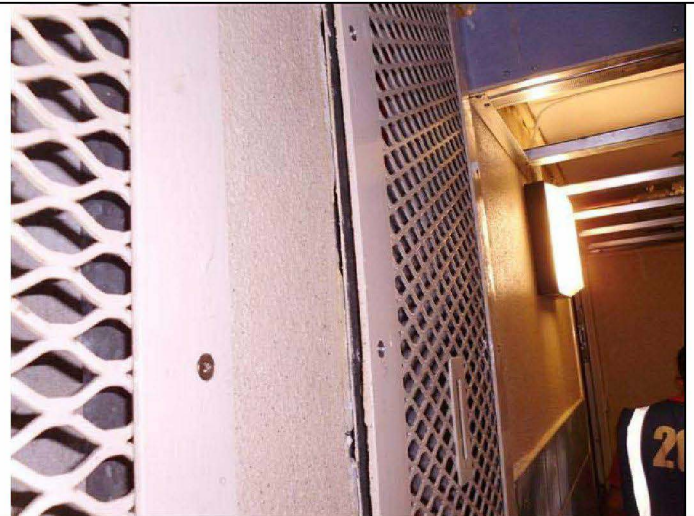
Security screws are missing from a lot of the AOV grilles, this was reported last week

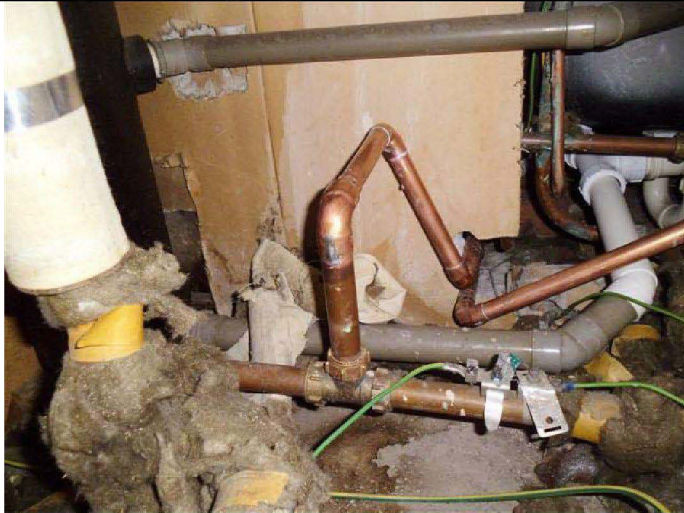
The new hot water pipe from the HIU in the hallway runs under the bath into the existing cylinder cupboard and then is connected onto the existing hot water pipe, as you can see from the photo, this runs up and then back down causing an air pocket, this pipe could be run horizontal

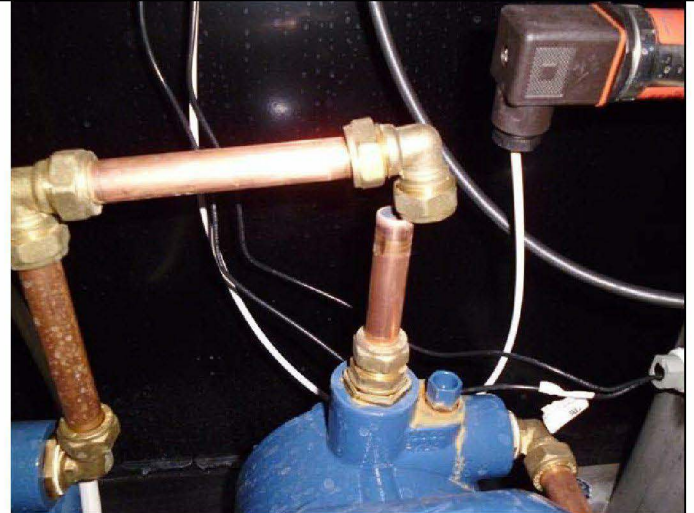
Pipe from the Pressurisation unit in the basement has compression connection blown off, as you can see from the photo, the joint has NOT been tightened up enough, as the copper pipe show no signs of compression from the olive
