WORKS PROGRESS REPORT for KCTMO GRENFELL TOWER - No 4

Project Name / Address	KCTMO Improvements and Enhancements to Grenfell Tower		Ref. 7654
Client	KCTMO	Project Manager	Claire Williams
Week Commencing	26/01/2015	Main Contractors	RYDON
Contract Commencement Date	02/06/2014	Contract Completion Date	04/09/2015 (Might be 23/10/15 showing a 12 week delay)

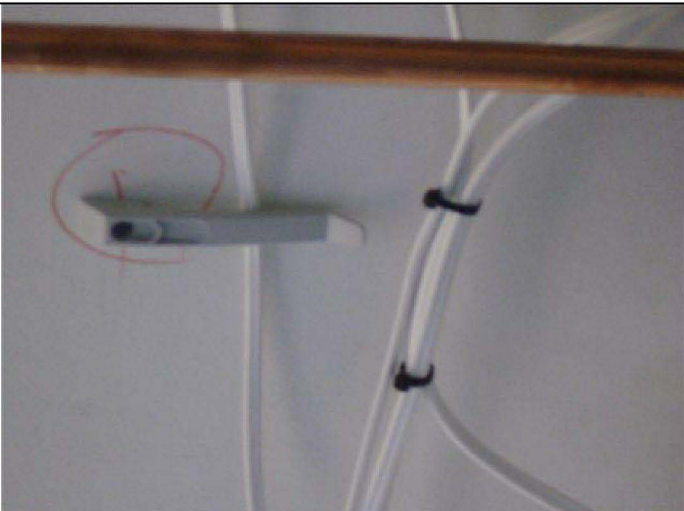
Cable support brackets are NOT being used correctly		Cable support brackets are NOT being used
