SITE INSPECTION REPORT

PROJECT:	Grenfell Towers	REFERENCE:	7654
SITE ADDRESS:	Grenfell Tower, Grenfell Road, W11	CLIENT:	KCTMO
MAIN CONTRACTOR:	Rydons	REPORT NO:	26
INSPECTOR:	Jon White	INSPECTION DATE:	03 December 2015

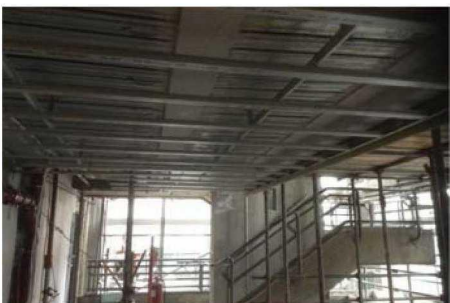
Mezzanine entrance hall, ceiling grid has now started.

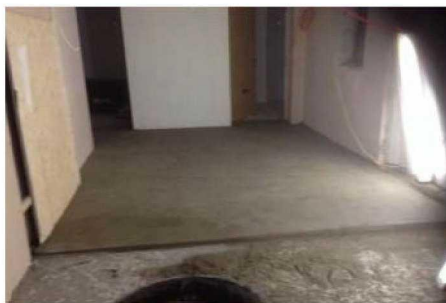
Mezzanine - 50% of the lift lobby now screeded.

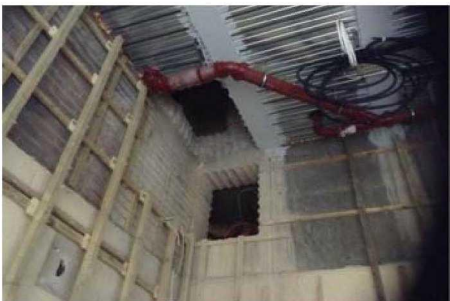
All the AOV holes are cut out except two to do. The extract ducting will not be on site for some 4 weeks.

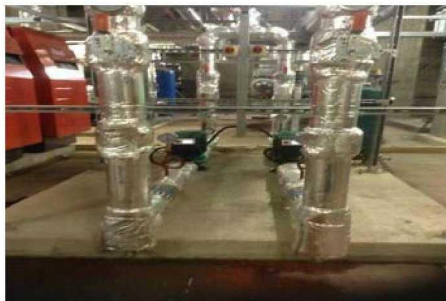
The new pipes to the basement have been lagged, but need to be clad.

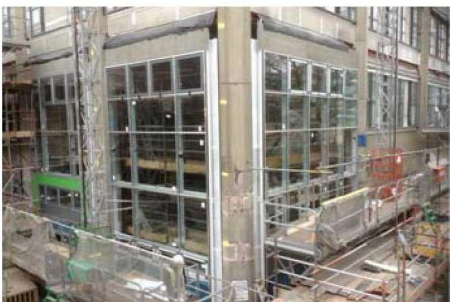
The South East corner the cladding is proceeding, and the glazed panels have nearly finished.

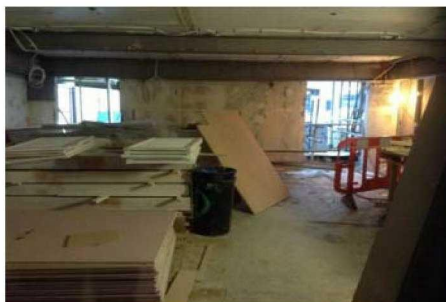
The ground floor openings have been formed, and the partitions and M&E 1st fix have also started.

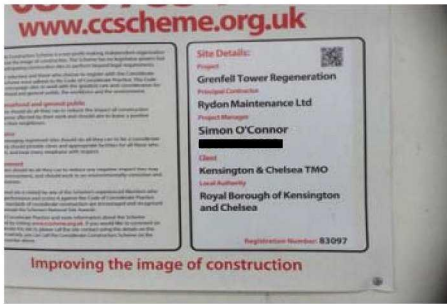
Rydon's still have not changed the hoarding signage for the contact details. Please change.

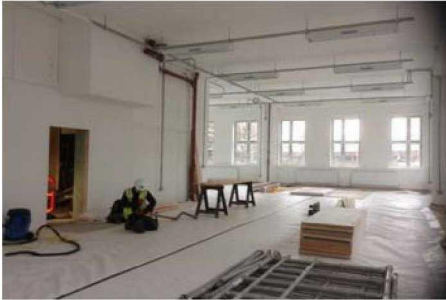
Boxing club AOV's are now installed, above the lift opening. Lighting has started, with the emergency lighting not yet fitted.

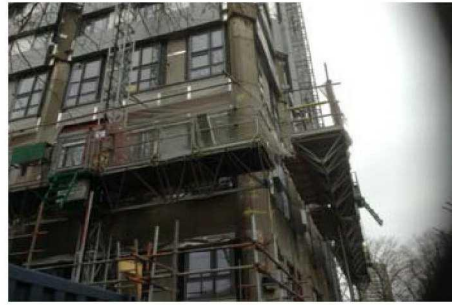
Low level cladding is now progressing.

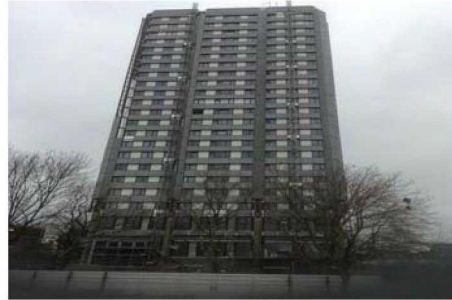
East Elevation - 16 panels out of 296 have to be fitted. 90% of the column brackets have been fitted, with 128 column panels fitted out of 138. (Not including the lower floors). The top canopy has nearly finished. No lower floor panels have been fitted. No mast climber working today.

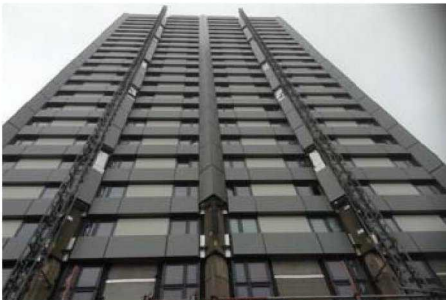
North Elevation - All of the panels have to be fitted. Also 90% of the column brackets have been fitted, and the top canopy is finished. Only the hoist column panels have yet to be fitted. None of the lower floor panels have been fitted yet. One mast climber working today, with 2 operatives.

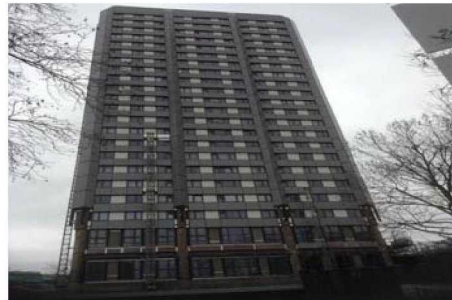
West Elevation - All cladding down to the 3rd Floor, has been finished and snagged, and the mast climbers are also nearly down to that level. No lower floor panels have been fitted yet.

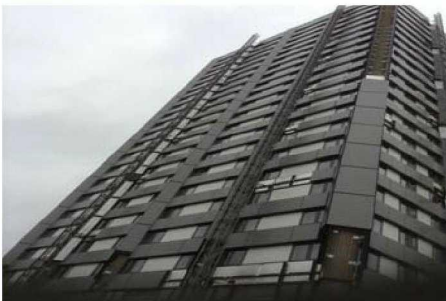
South Elevation - All the cladding panels have been fitted, except the lower levels, and ones that are affected by the hoist ties. Still only 80% of the column brackets and panels have been fitted, and the top canopy is nearly done. Lower entrance framework is now being installed. No mast climbers are working today.

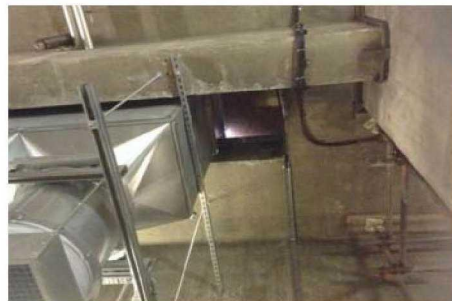
The final commissioning of the new boiler room plant cannot start until all the two ventilation holes have been made good, and all the holes to the new pipes fitted into the main concrete core, so a complete seal is achieved.

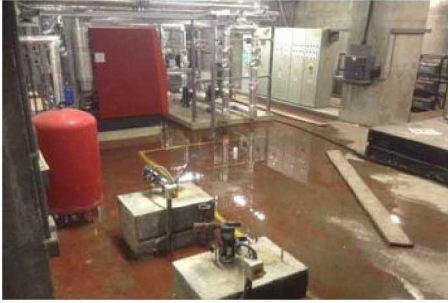
The boilers still have been commissioned, but will have to be commissioned again when the permanent ventilation fans have been fitted. Labelling of all valves, schematic layouts, and general finishing off to all plant to be done. KCTMO have still to resolve the leaking problem.

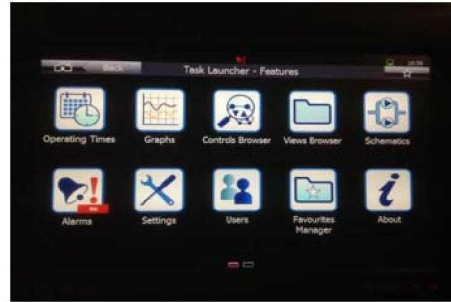
Basement boiler panel is still yet to be installed fully. Can Rydons confirm why 96 alarms have been activated. Still no Schematics have been installed. Rydons have now confirmed the date to start commissioning the boiler controls, etc, has been moved from Friday 13th, to a later date.

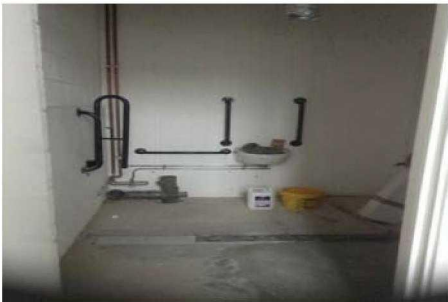
Boxing club disabled WC has not progressed, floor yet to be laid.

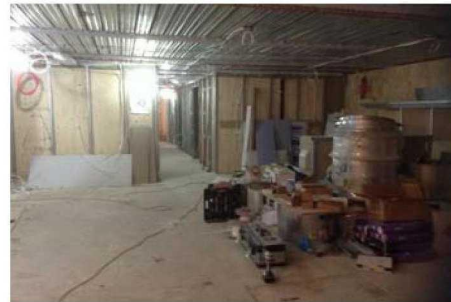
Ground floor area, and nursery area, partition have started one side, 1st fix M&E is still in progress.

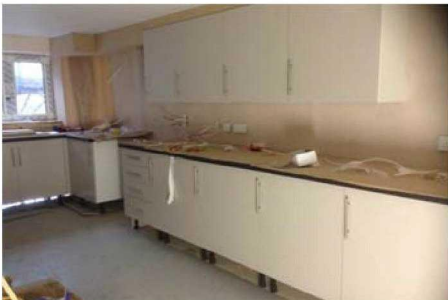
Mezzanine last flat to the South West corner, plastering now done, and 2nd fix carp and M&E and kitchen fittings in progress

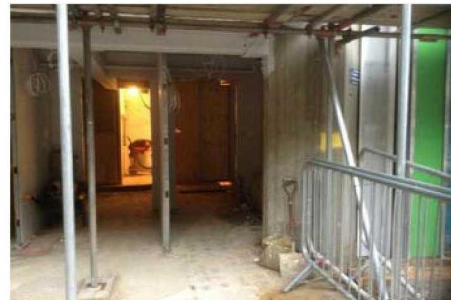
This is the site entrance, no signage for site office, of fire escape, and poor lighting and access, needs to be improved to the ground floor South elevation.
