# SITE INSPECTION REPORT

<b>PROJECT:</b>	Grenfell Towers	<b>REFERENCE:</b>	7654
<b>SITE ADDRESS:</b>	Grenfell Tower, Grenfell Road, W11	<b>CLIENT:</b>	KCTMO
<b>MAIN CONTRACTOR:</b>	Rydons	<b>REPORT NO:</b>	27
<b>INSPECTOR:</b>	Jon White	<b>INSPECTION DATE:</b>	10 December 2015

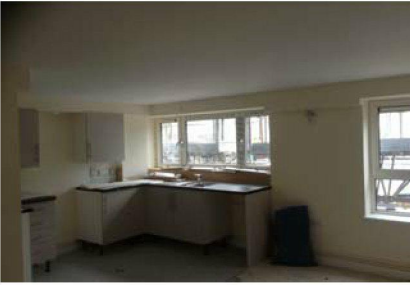
Mezzanine flats progressing well. Max Fordams and Rydons to confirm No heat or smoke detectors are scheduled to be fitted, on all of the mezzanine flats, and this has been approved by building control.

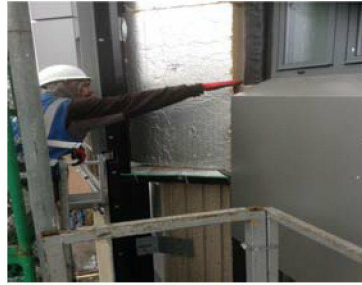
The South Elevation cannot be finished at all, because the access behind the West climber on the South Elevation, is totally unsafe. This needs to be resolved by Rydons and the cladding fixers. This has been an issue for months. This item is on the critical path.

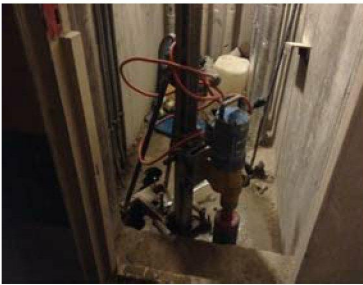
All the AOV holes are cut out except the last one being cut out today. The extract ducting is not yet on site.

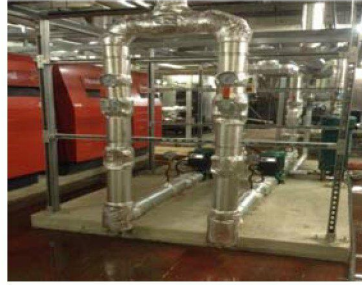
The new pipes to the basement have been lagged, and has started to be clad.

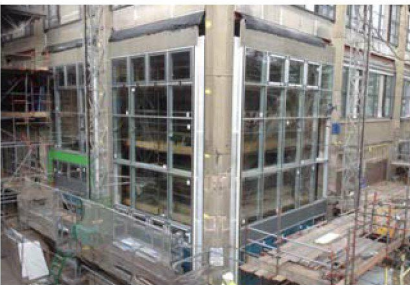
The South East corner the cladding is proceeding, and the glazed panels have nearly finished. The column trims are now being fitted.

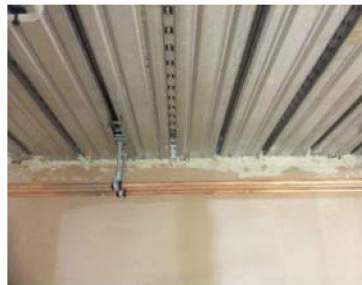
Ground floor fire seal needs to be improved before being approved, top of partition, just north of the concrete core.

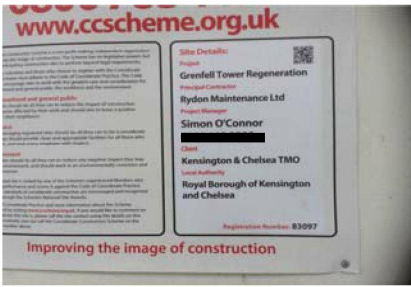
Rydots after 6 weeks, still have not changed the hoarding signage for the contact details. Please change.

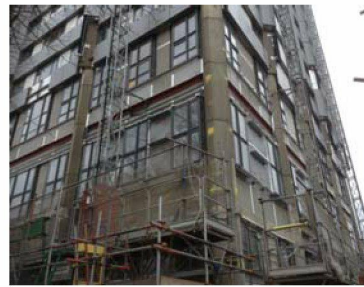
Low level cladding is progressing slowly. Picture of the North East corner.

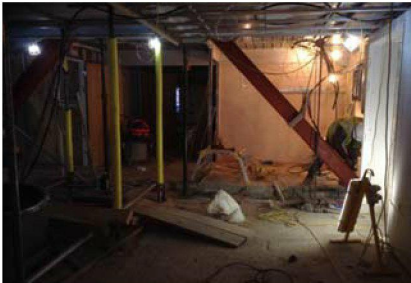
The two steel supports to the ground floor entrance hall are being fitted today.

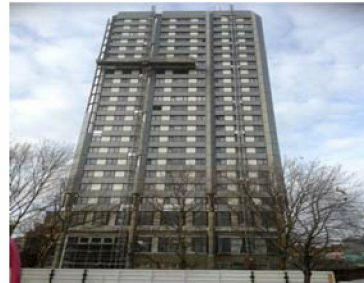
East Elevation - Still 16 panels out of 296 have to be fitted. 90% of the column brackets have been fitted, with 112 column panels fitted out of 138. (Not including the lower floors). The top canopy has nearly finished. No lower floor panels have been fitted. Snagging only to the North climber started today.

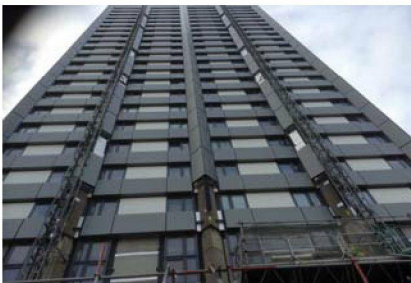
North Elevation - has been snagged and de snagged down to level 3, all finished apart from the panels around the hoist ties. Master climber has not started to come down. Lower panel have made a start.

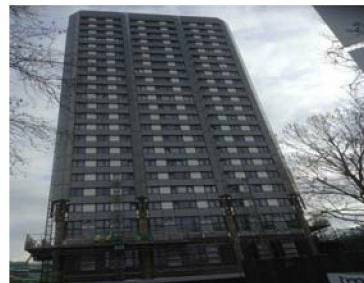
West Elevation - has been snagged and de snagged down to level 3. Both master climbers have come down to level 3. Lower floor cladding has now started.

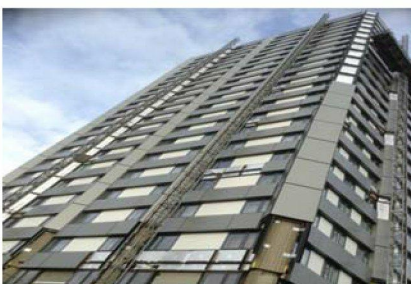
South Elevation - All the cladding panels have been fitted, except the lower levels, and ones that are affected by the hoist ties. 90% of the column brackets and panels have been fitted, and the top canopy is nearly done. Lower entrance framework is now being installed. One panel behind the North climber can't be accessed from the ground all the way up to the roof.

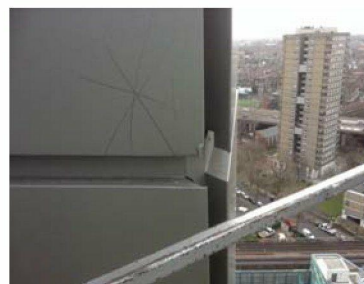
The East elevation as snagged today. A further 3 cladding panels were damaged and need replacement. A total 16 panels have needed to be replaced so far.

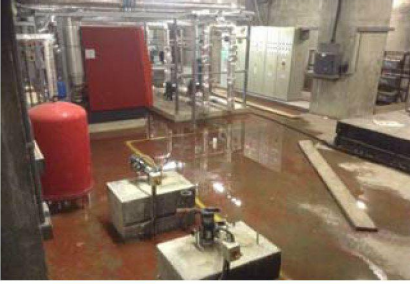
The water/leaking problem still has not been resolved. The boilers still have been commissioned, but will have to be commissioned again when the permanent ventilation fans have been fitted.

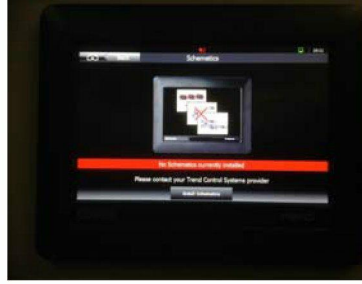
Basement boiler panel is still yet to be installed fully. We still have 122 alarms activated. Still no Schematics have been installed.

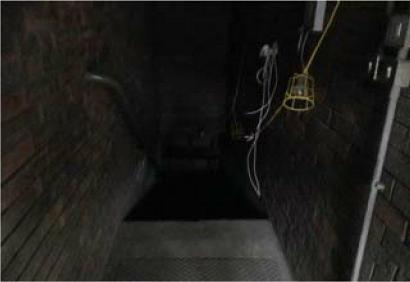
<b>RISK ITEMS (E.G. HEALTH &amp; SAFETY, ETC.):</b>	
<b>Note:</b>	
Site access and egress needs to be improved, especially the access in and out of the site office and ground floor entrance. The temporary lighting accessing the basement was again unplugged. This is very dangerous. Rydons to fix a dedicated light so it cannot be turned off. Rydons H&S inspector last visited site on the 19th November. General housekeeping still needs to be improved, and the general lighting to the lower flats need to be improved for the workers, with the welfare facilities also needs to be better. HSE no visits No accidents this month Last tool box talk, two weeks ago.	
<b>QUERIES / INFORMATION REQUIRED (DATE):</b>

This is the entrance down into the basement, no lights again, very dangerous, make temporary lights unpluggable, so this cannot happen.

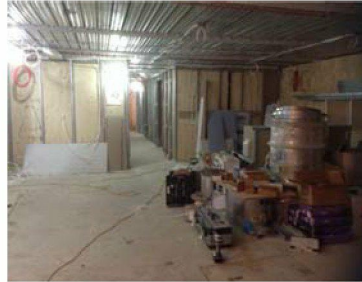
Ground floor area, and nursery area, partition have started one side, 1st fix M&E is still in progress.

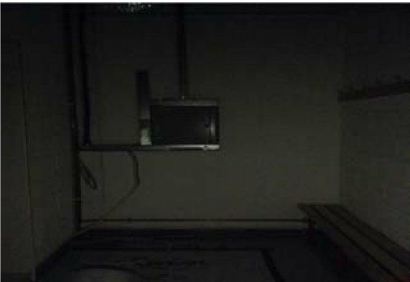
Both the boxing club and nursery electrical meters have not been fitted yet. Rydons to confirm when this has been booked in.

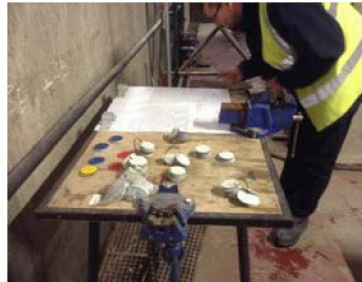
The labelling to the boiler plant room has now started. Other commissioning to follow.
