C S Stokes and Associates Limited

Subject: Grenfell Tower Grenfell Road London W11 1TQ

Thank you for asking me to visit the above premises yesterday, Thursday the 9th April 2015, to look at the flat/lift area to staircase fire doors which a contractor has recently routed out along the door edges and fitted cold smoke seals into and also fitted new hinges on these doors. The doors on all floor levels have been worked on.

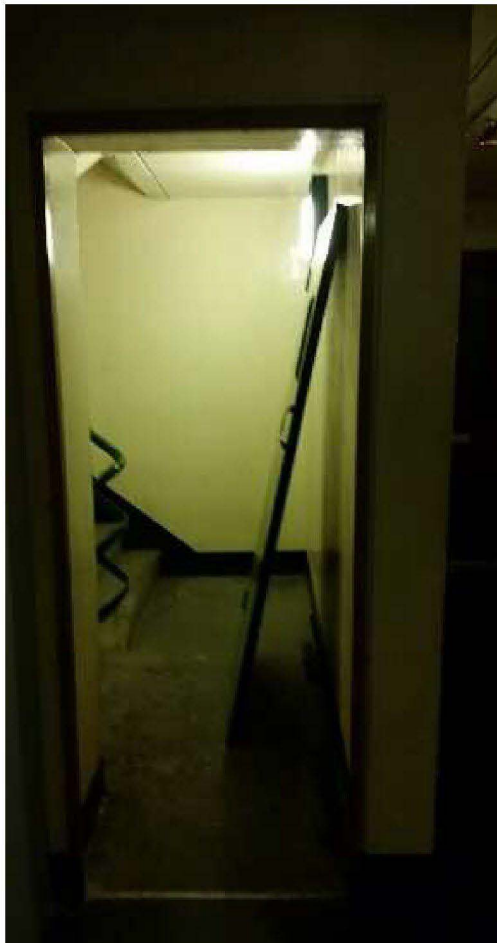
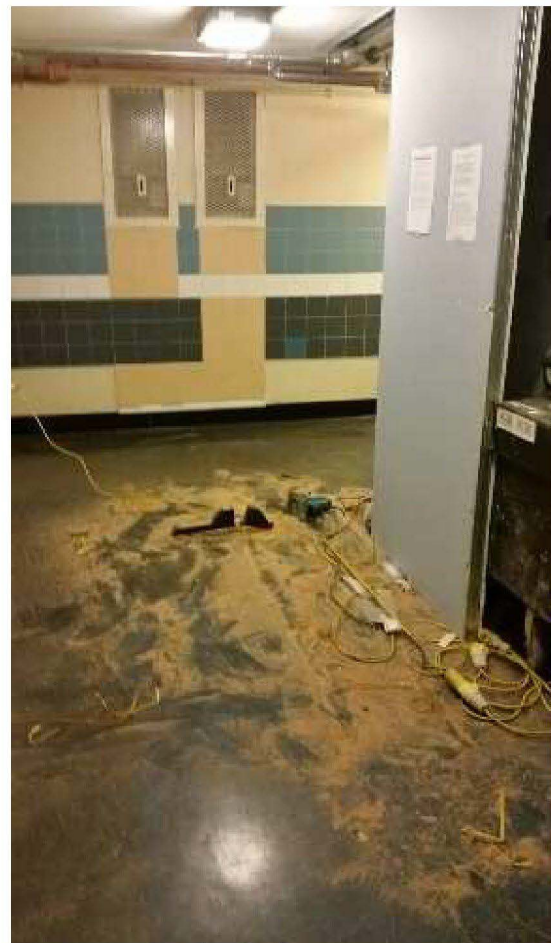
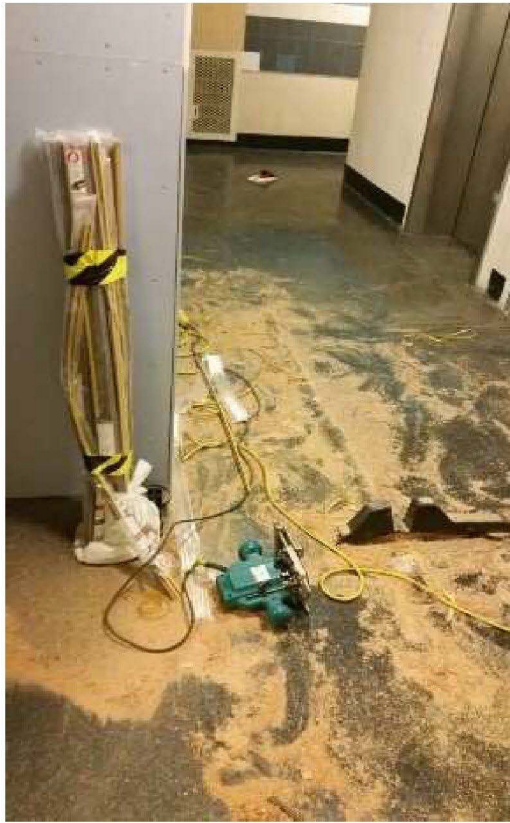
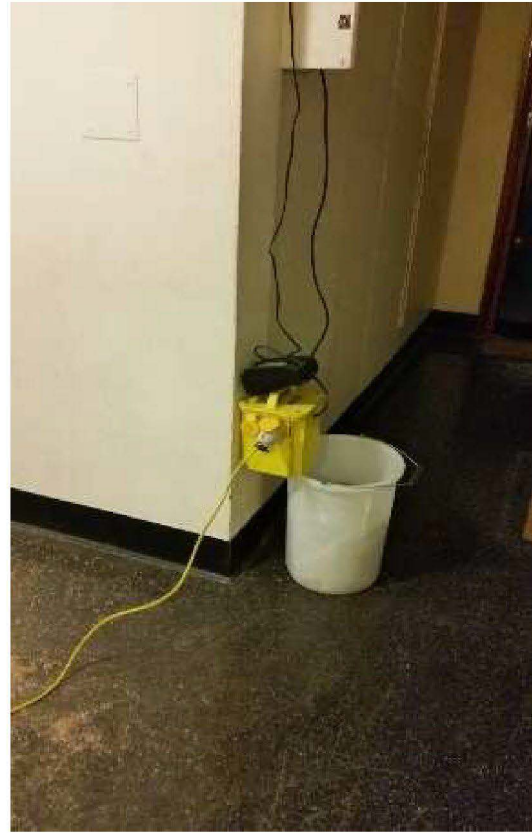
The work on the flat/lift area to staircase fire doors in this building was started on the 19th March 2015, these are photographs of the work being undertaken, as you can see the doors were removed without any attempt to maintain the fire protection of the staircase. Doors were taken to a particular floor levels where the work was undertaken, the installed smoke detectors on the flat/lift lobby areas were not covered over or isolated in any way. Also the contractor undertaking the work did not inform any TMO employee or any Rydons employees that the work was being undertaken.

1. I would recommend that the contractor responsible for undertaking the above work is asked to provide in writing that the person (s) who has undertaken the work is suitably qualified to carry out the work. This information may be required if the Fire Authority challenge the workmanship of the fitting of the cold smoke seals etc and there is any future court case.

2. I would recommend that the contractor who has undertaken the work on these flat/lift lobby area to staircase fire doors is asked to provide in writing that each of these doors, a full door schedule should be provided, is still a 30 minute fire rated door. This information may be required to be used as evidence if the Fire Authority in the future asks about the fire rating of these doors or there is a court case after an audit or fire within this building.

3. I would strongly recommend that the contractor who undertook this work is asked to provide a full list of any fire doors that they have retrospectively fitted with intumescent strips or cold smoke seals in any other TMO premises and that these doors are inspected for workmanship etc as soon as possible.

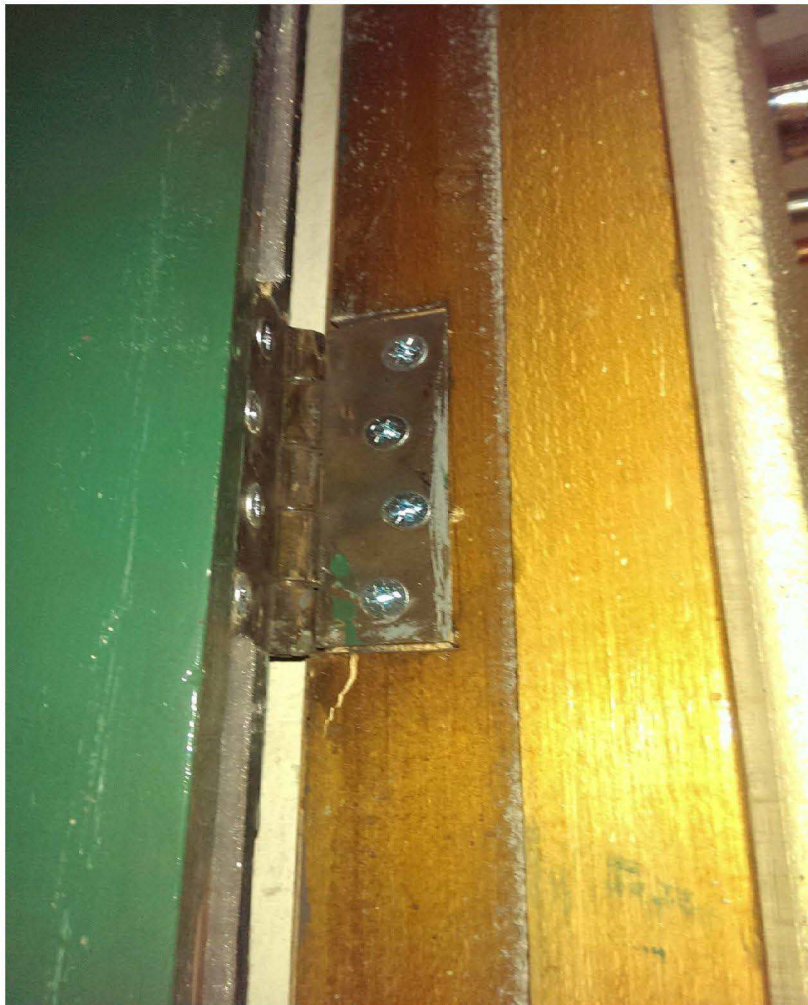
As well as fitting of the intumescent strips and cold smoke seals on the flat/lift lobby area to staircase fire doors new hinges also appear to have been fitted, as can be seen below, there is also some damage to the door frames where the new hinges have been fitted.

6. It appears that there are no intumescent strips fitted under the hinges of the doors, as required by the British Standard. I would recommend that the contractor who undertook the work on the flat/lift lobby area to staircase doors is asked to confirm that there are intumescent strips under each and every hinge on each door? This conformation should be in writing and with photograph evidence also provided.
7. I would recommend that the contractor who undertook the work on the flat/lift lobby area to staircase doors is asked to confirm in writing that the correct fire rated hinges have been used on these doors? Copies of the manufactures information sheets for the fitted hinges with the British Standard numbers shown should be forwarded and kept on file.

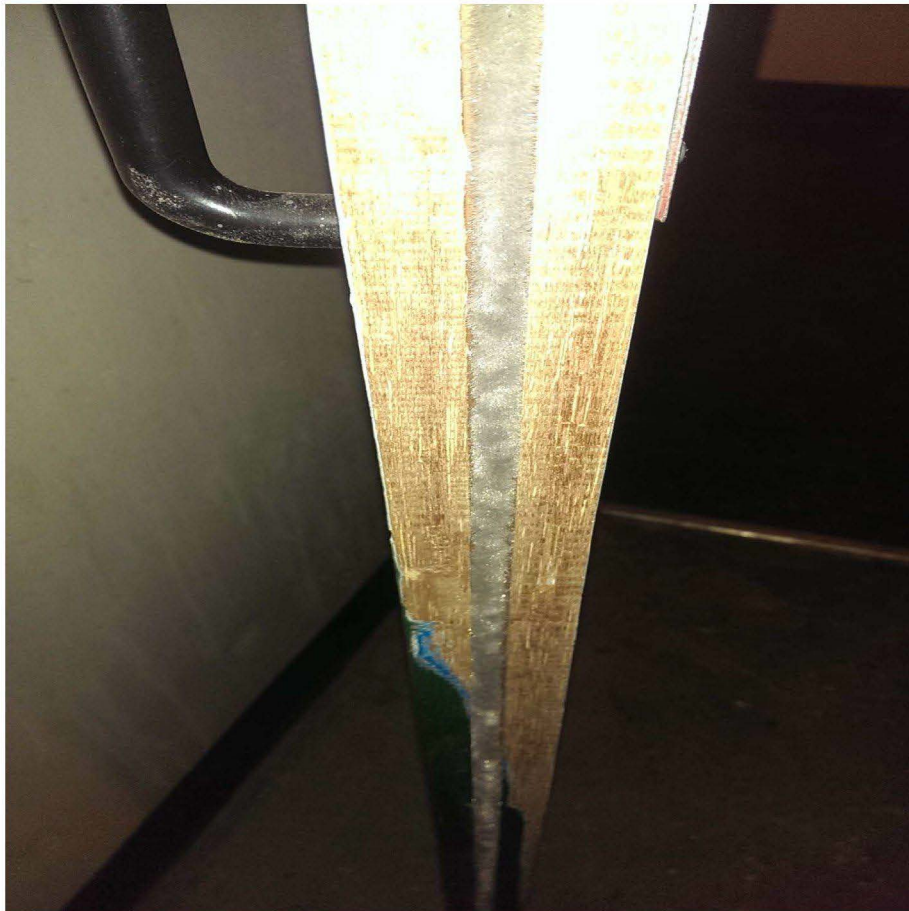
Whilst the intumescent strips and cold smoke seals on the flat/lift lobby area to staircase fire doors were being fitted it can be seen that some of the door edging was planed off, this has resulted in the door now not being as wide as it originally was. The original painted door edge can be seen lower down the door and the exposed non painted door edge on the upper part of this photograph of the door edge.

8. Is the contractor who undertook the work on these flat/lift lobby area to staircase doors going to repaint/make good the doors where parts of the door were removed?

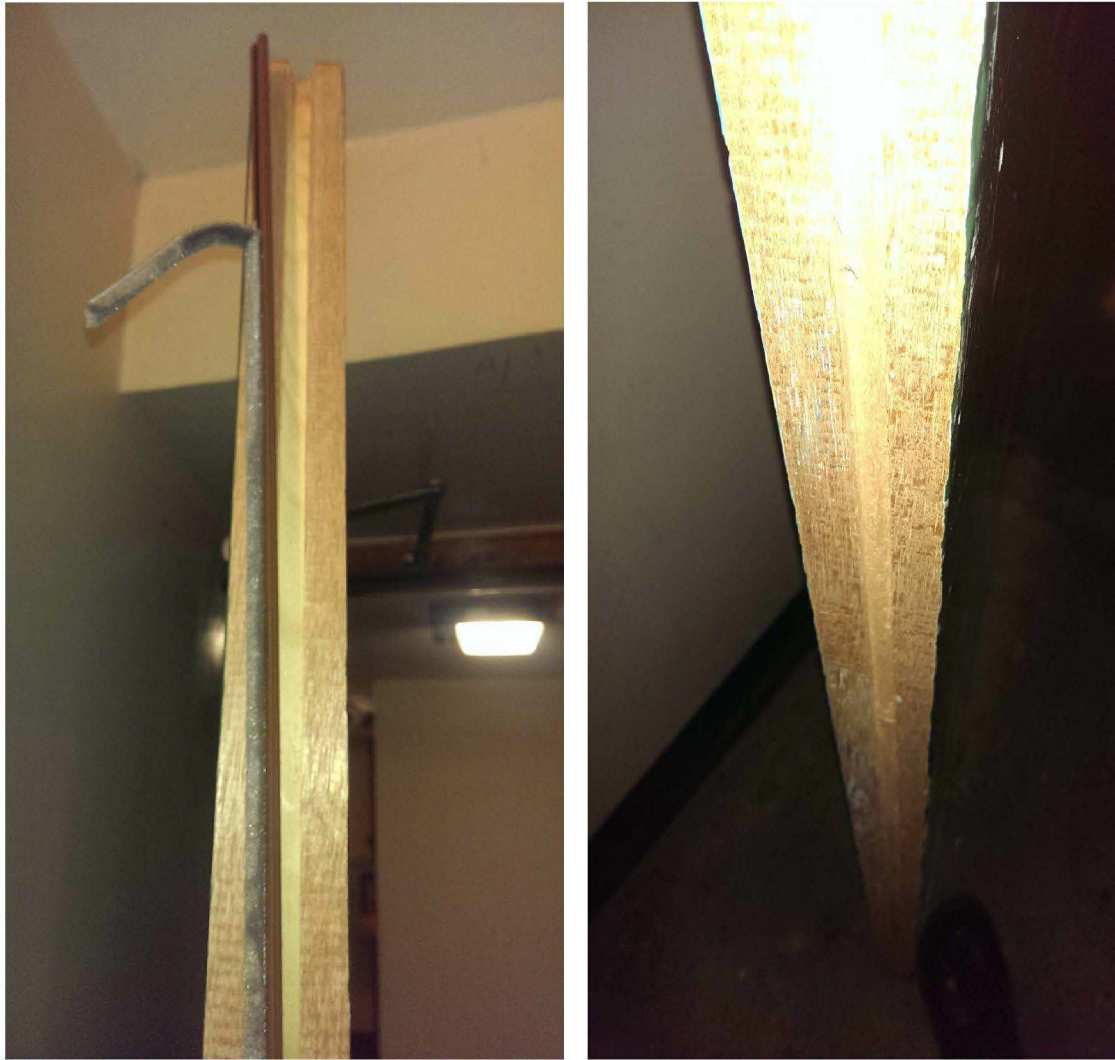
The work undertaken on these flat/lift lobby area to staircase fire doors is less than 1 month old but as can be seen from the photographs taken yesterday some strips/seals are already coming out of the grooves routed out or are missing altogether.

9. The photographs above show that the standard of workmanship in the fitting of the strips and seals appears not to be as it should be, as in less than 28 days the fitted strips and seals are not in place or are coming off. The contractor who undertook this work should be asked why the strips and seals fitted are coming out or are missing.

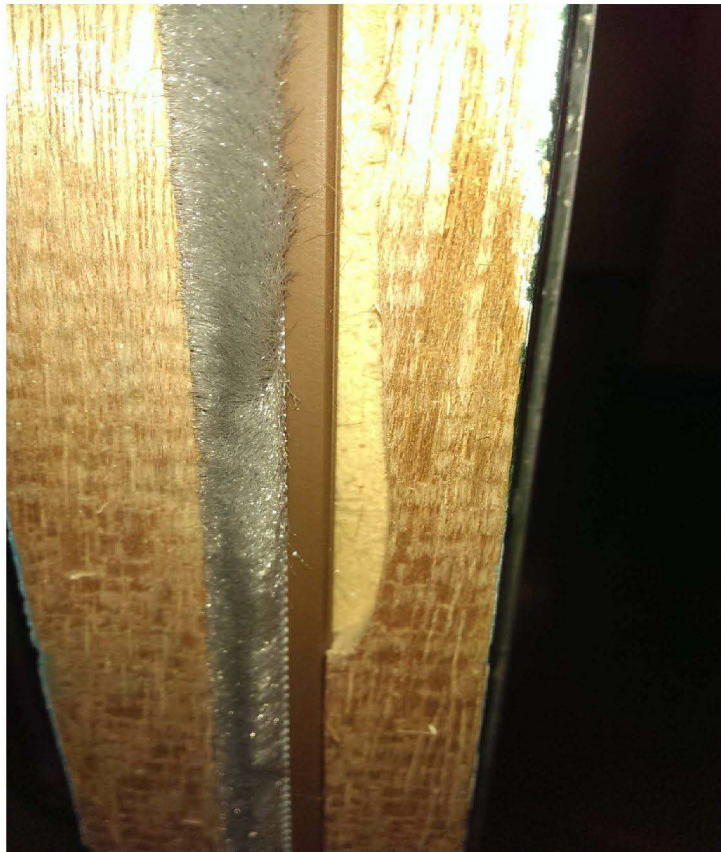
Depending on the answers received back from the ventilation consultants working for Rydons, the cold smoke seals fitted to the flat/lift lobby area to staircase fire doors may have to be removed and the fire doors made good or the contractor who undertook the work may have to provide new certified 30 minute fire rated doors in these locations. This is because were the contractor has removed/planed off the edges of the doors the gap between the door and the door frame is now wider that it originally was before the contractor undertook the work on the fire doors. Also there are damaged areas on the door edges caused when the grooves were routed out, as can be seem below in the photograph.
