C S Stokes and Associates Limited

18th March 2014

Premises: Grenfell Tower, Testerton, Barandon and Hurstway Walks on the Lancaster West Estate

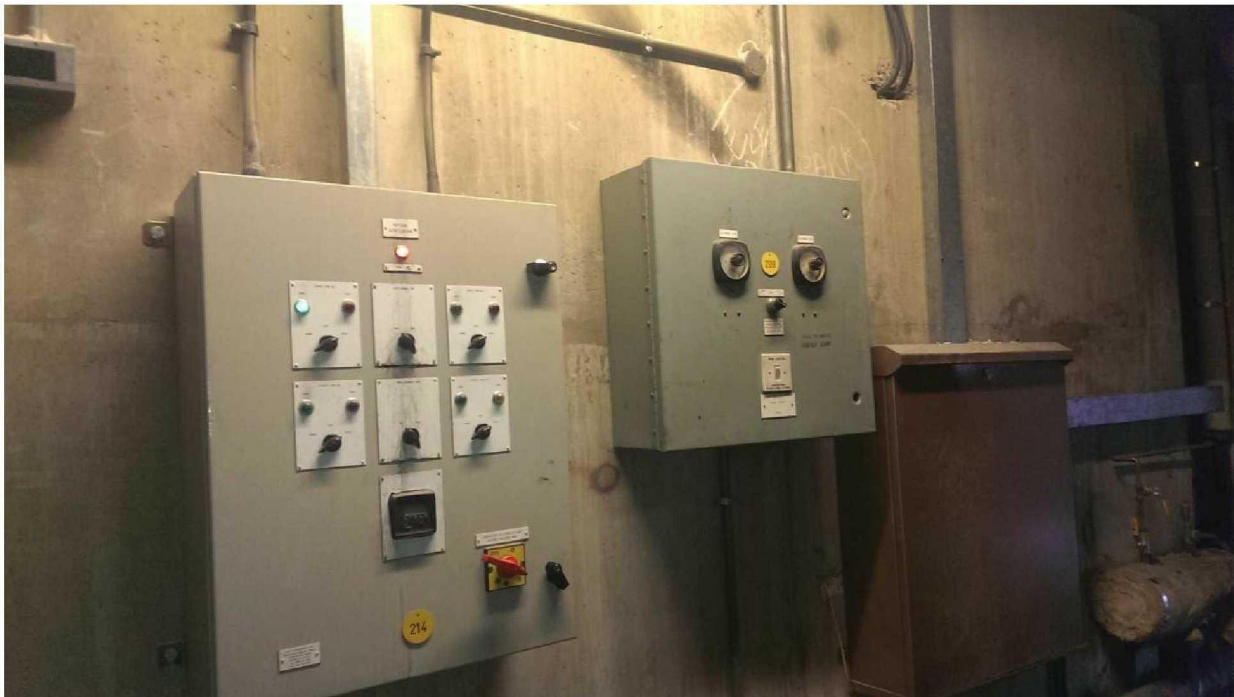
The emergency smoke control extract panel was showing healthy when looked at yesterday with the switch in the auto position. The flat/lift lobby extraction system is activated by the automatic fire detection device on each of the flat/lift lobby area ceilings. The extraction system works by the vents on one side of the flat/lift lobby area expelling the smoke with inflow air coming in through the vents on the other side of the lobby area.

This smoke extraction system is on a planned preventive maintenance programme with RGE, this contractor last serviced this system according to their on site log book on the 15/15/13 *sic*. Please see appendix A below, the previous loose page in the logbook was full and the service before this one was in September 2013 so I am assuming that the 15th month is a mistake and the engineer meant the 12th Month. As can be seen the engineer checked all of the items in the quarterly check list and the only fault recorded was 19th floor relay.

Refuse chute room extraction control panel on the left with the flat/lift lobby areas control panel on the right hand side.

As the next quarterly service is imminently due on this smoke extraction system I would recommend the contractor is asked to service the system and any findings etc made are actioned.

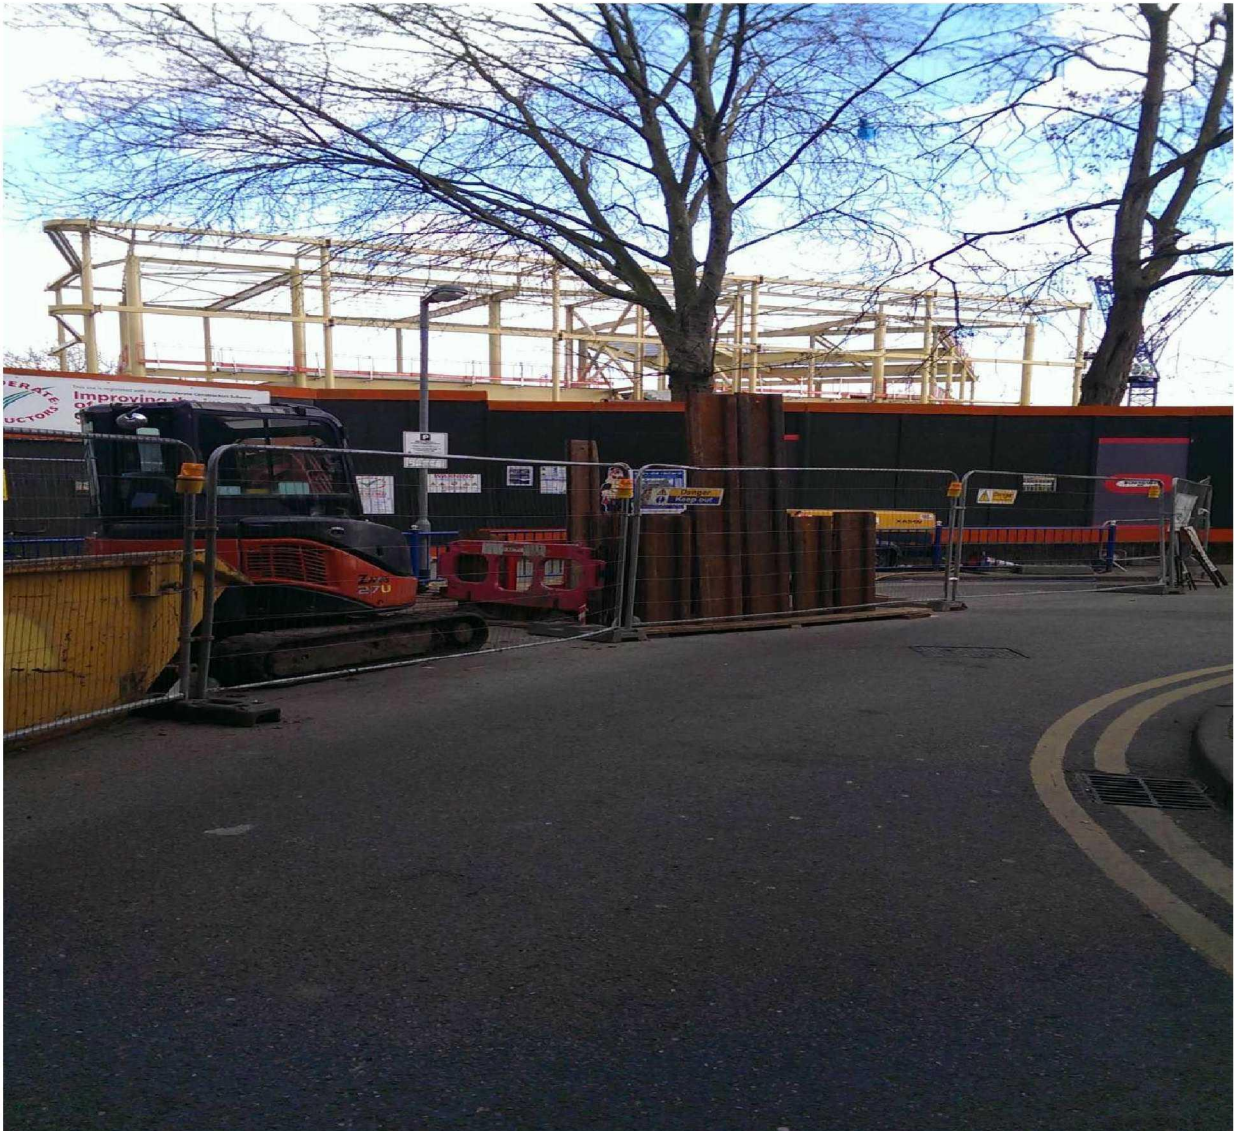
Outside of this building there is a public road with a small gated controlled area along the side of the tower, please see the recommendations below, but this is a public road

and the TMO have not control of the public highway. Presently there is working being undertaken in this public road, please see the photograph.

The contractors undertaking this work are responsible for any obstruction and congestion, if the LFB are highlighting problems the this issue should be raised with the contractors involved and the LFB should be asked to contact the contractors directly.

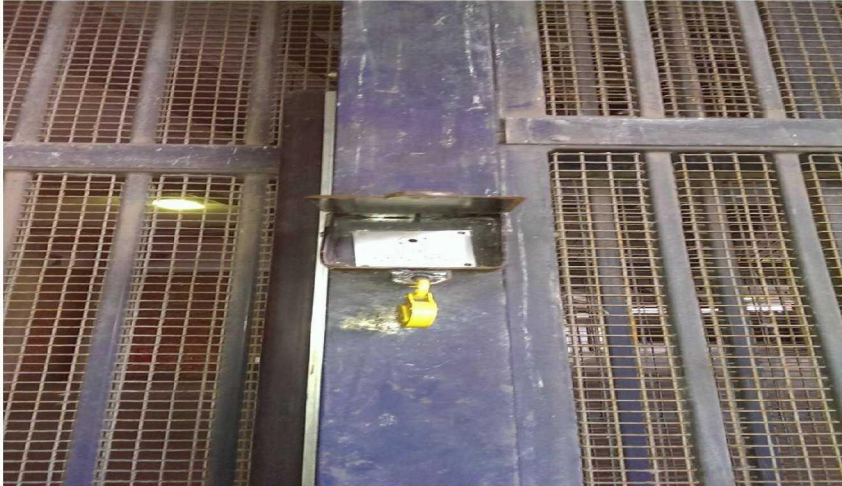
Fire fighter over ride switch in box fitted to vehicle gate

11. The fire fighter over ride switch in box fitted to vehicle gate which gives access to the lower ground floor level roads is damaged and does not open the gate, this over ride switch should be repaired or replaced so that it opens the vehicle gate when used.

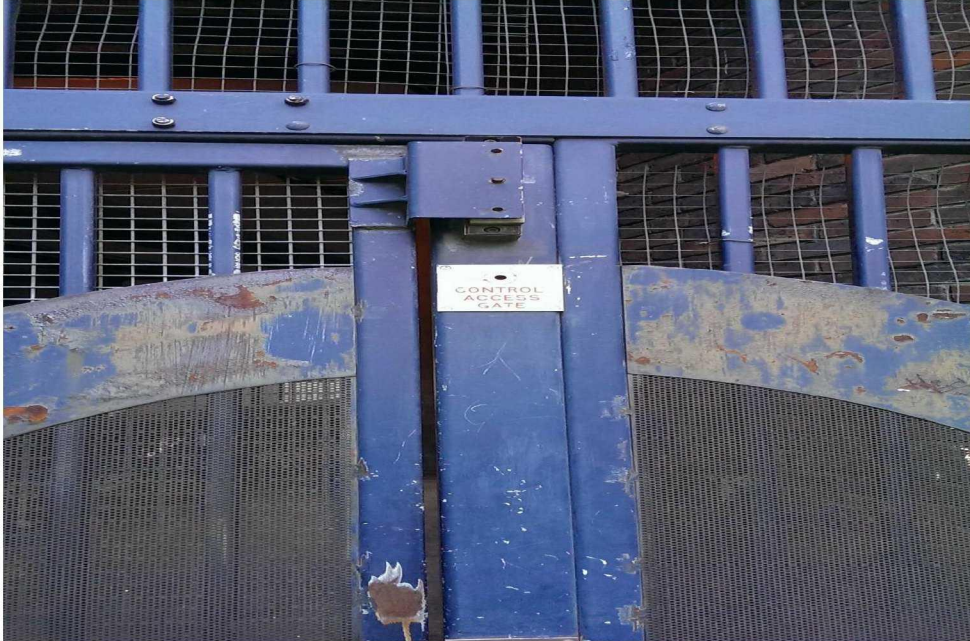
Fire fighter over ride switch fitted to pedestrian gate

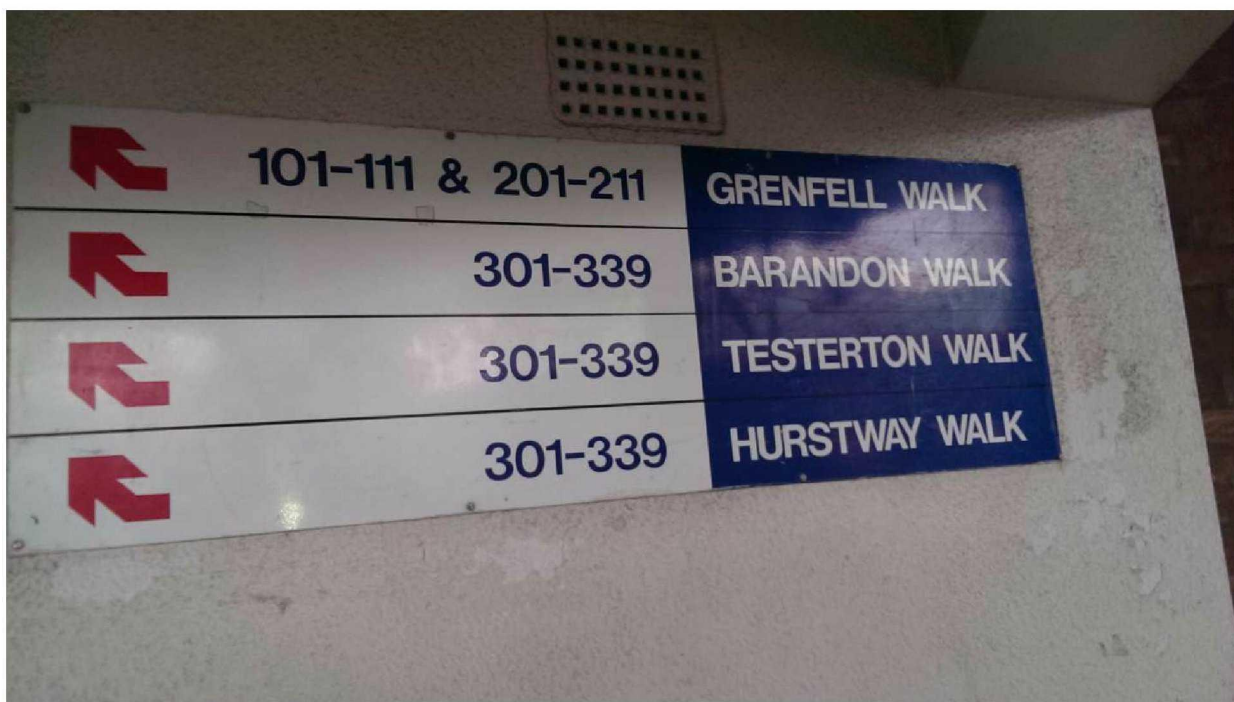
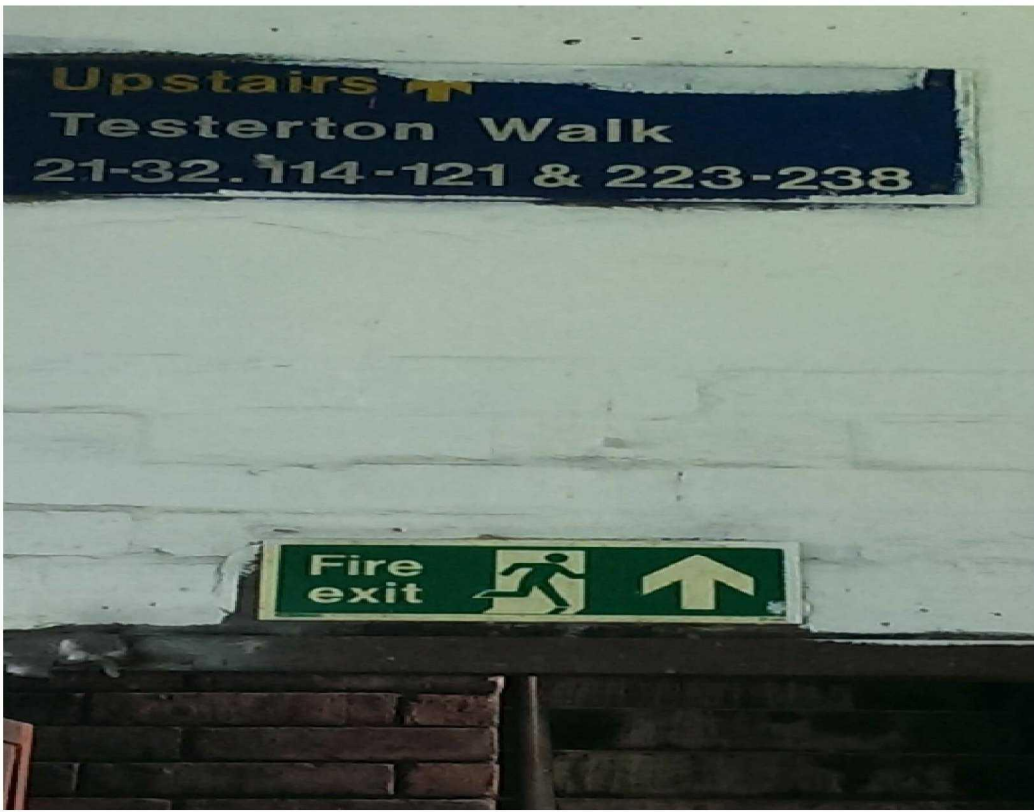
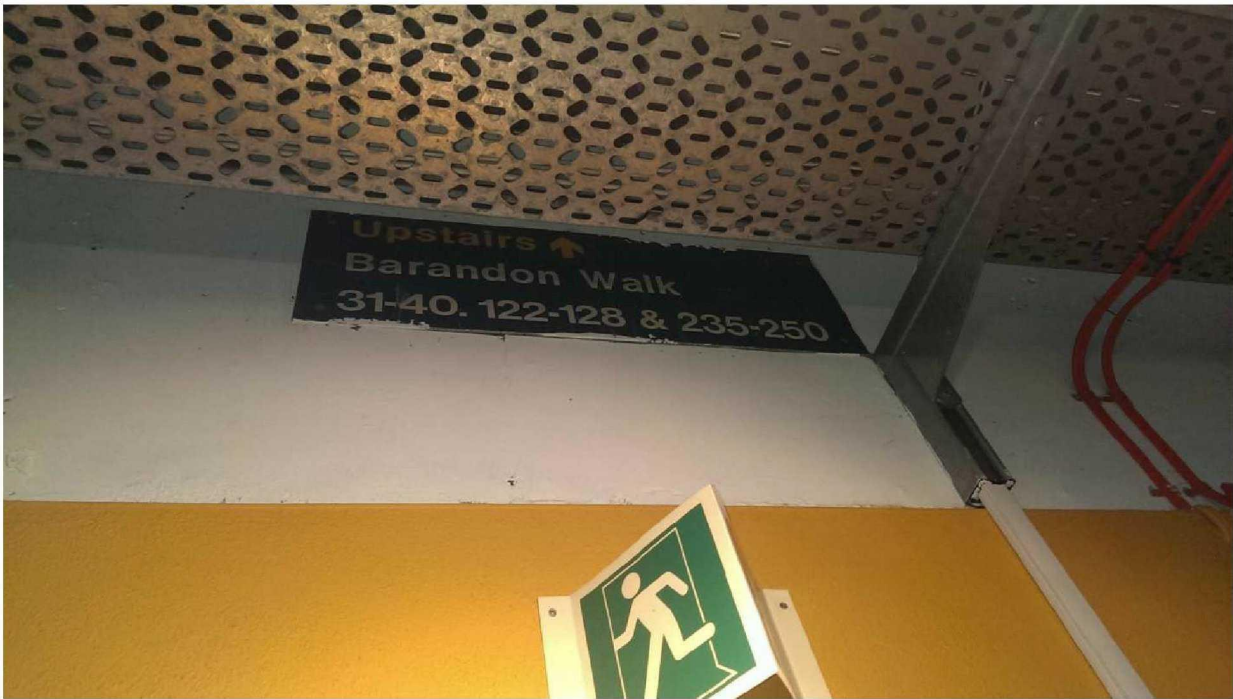
Fire officer Dan Hussey commented about the signage from the lower ground floor levels indicating the flats located above and accessed from particular staircases, please see the photographs below. I believe that the current signage is sufficient from Testerton and Hurstway roads, there is some paint on the signs but this paint does not obscure the information. There is also emergency escape exit signage displayed, some exit signs are flat to the wall others stick out, the signage which sticks out is more prominent. But only authorised persons have access to these lower ground floor areas, no members of the public so where flat signage is displayed I believe that this is sufficient. There has recently been redecoration work undertaken in Barandon Walk and because of this some new signage should be provided to show flat locations above. If the LFB require additional information this can be asked for under the 7.2 D process and then they can draw up plans showing any operational information that they require.

14. Redecoration work has been undertaken in Barandon Walk and some of the original signage indicating the flats located above and accessed from particular

staircases has been obscured or removed. New signage should be provided in Barandon Walk where needed indicating the flats located above and accessed from particular staircases, this signage should not be obstructed in anyway.

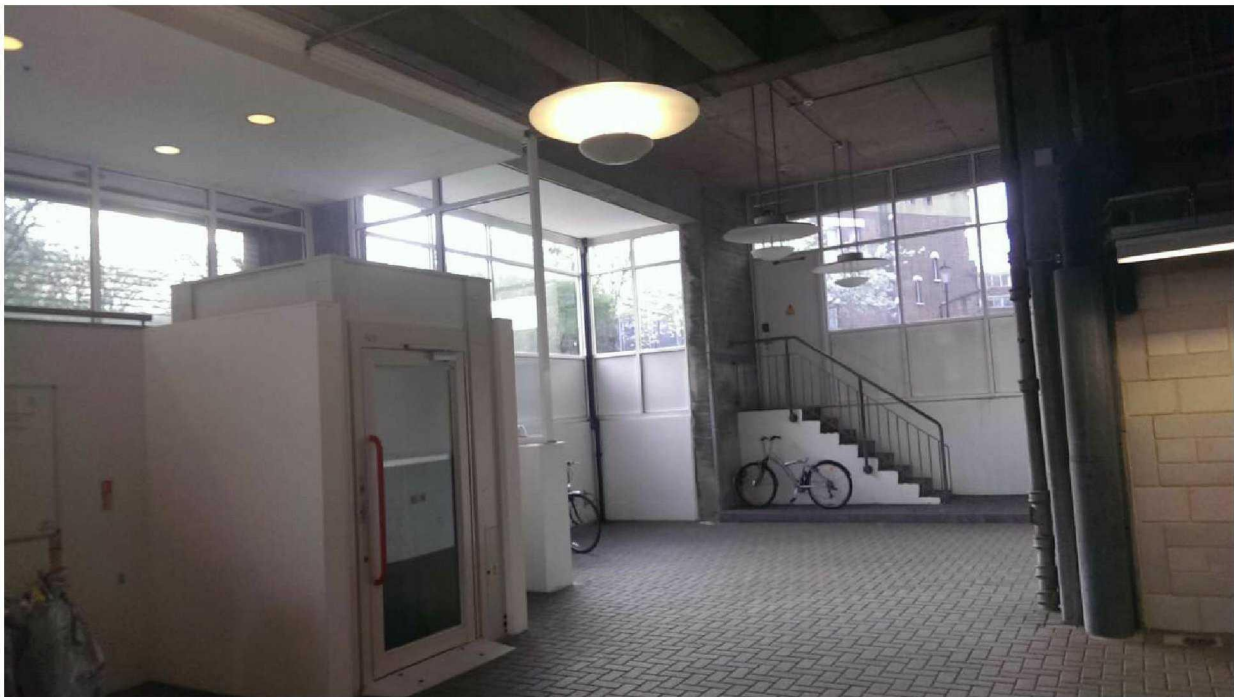
I am assuming that the fire offices did not visit Barandon Walk lower ground floor area which is totally enclosed, this area has been converted from garages to office accommodation and there is no natural ventilation in this area. If it is acceptable to have no natural ventilation in Barandon Walk then the limited natural ventilation of Testerton and Hurstway roads is an improvement. Therefore I believe that no action is needed in respect of the question of cross ventilation of the garage areas.

Barandon Walk, lower ground floor area which is fully enclosed

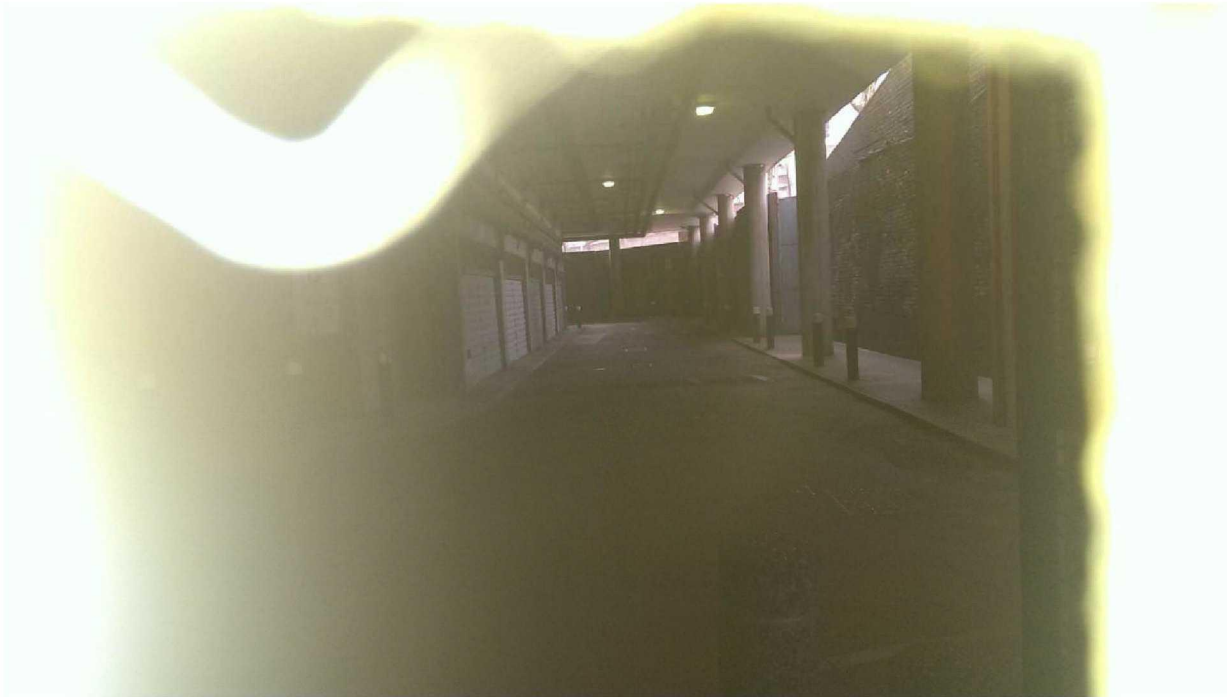
The fire officers commented on the cross ventilation of the garage areas of Testerton and Hurstway roads at the lower ground floor levels, at the ends of each of these roads there are large open areas at high level. Please see the photographs, this was how these areas were constructed. I know that some additional boarding has been fixed

above the doors of the garages for security reasons and this could reduce cross ventilation of these areas but the ends of the roads are open. There is also a 3 metre void area above the garage doors which will act as a smoke reservoir in the event of a fire in these areas. This smoke reservoir runs the whole length of these lower ground floor level areas and the fire loading of a garage would not fill this whole smoke reservoir.

The garages on the lower ground floor areas of Testerton and Hurstway walks, (sorry about the quality of this photograph)
