MEETING MINUTES

GRENFELL TOWER

PROGRESS MEETING #22

PROGRESS REPORT NO. 23

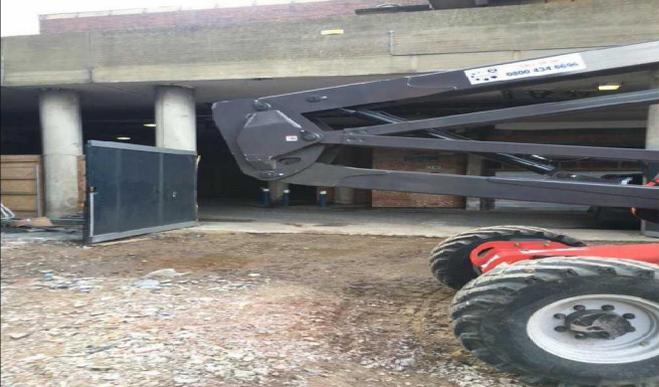
Section 1: Site perimeter not safe / secure		
ITEM	IMAGE	COMMENT
1

Vehicle access gates left open and unattended with plant movements just inside the gate. Risk of unauthorised access into high risk area. Security guard no doing an effective job managing access.
1

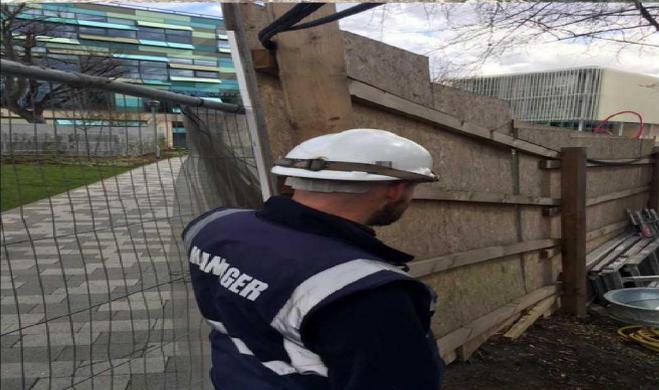
Where the herras fencing meets the timber hoarding the timber posts and panels have suffered wind damage from the recent inclement weather. Remove dangerous panels and replace with herras.

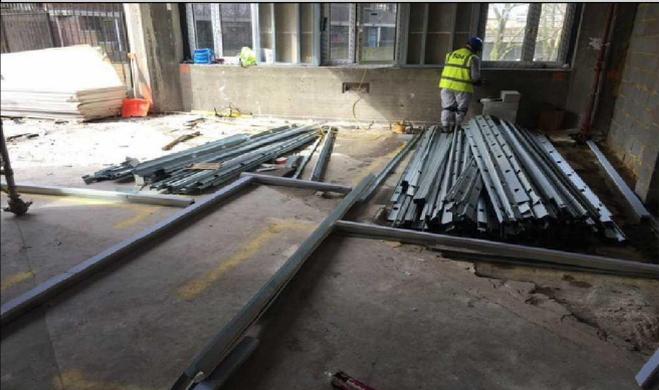
Section 16: Clean floor policy not being observed		
ITEM	IMAGE	COMMENT
105

Housekeeping to the former entrance is poor - both internally and externally. Clear up required.

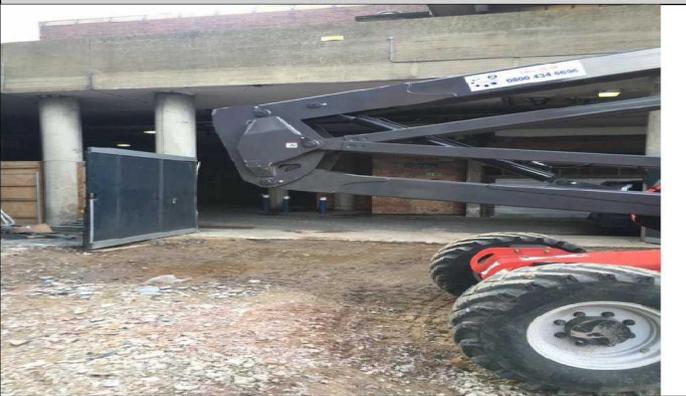
ITEM	IMAGE	COMMENT
112

<p>Cherry pickers do not have barriers around them. Telehandler must have a banksman when maneuvering in the rear yard area.</p>

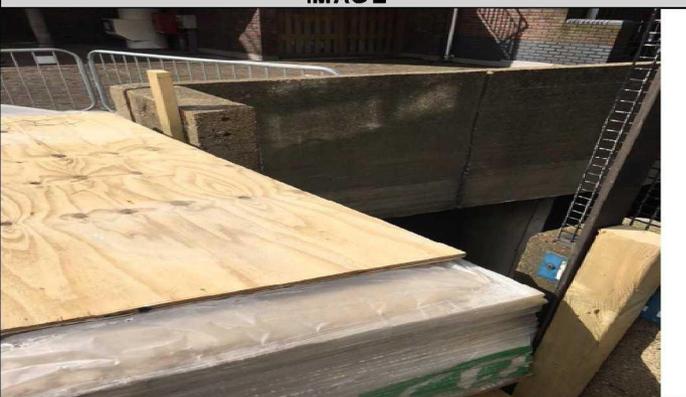
ITEM	IMAGE	COMMENT
127

<p>The gap in the existing concrete edge protection to the old entrance area requires the permanent infill ASAP. Temporary measure to be installed in the meantime. Currently there is a pack of plaster board in front. As this is in a public area this needs to be address today.</p>
