C S Stokes and Associates Limited

30th January 2017

Subject: Grenfell Tower installation of new main gas pipe work.

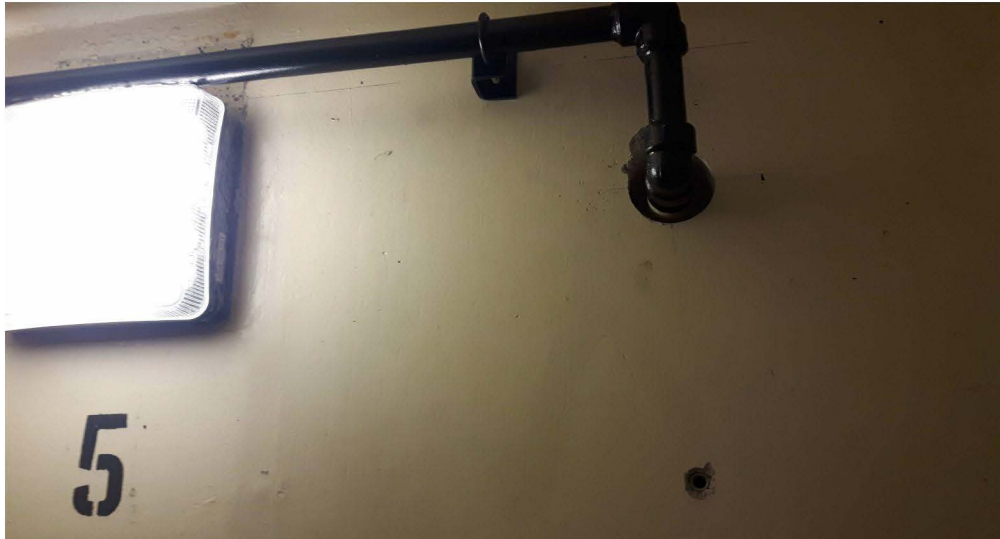
Where the gas pipe penetrates the staircase compartment wall at each floor level there are presently gaps around the pipe, the hole has not been made good. This can be seen in the next 2 photographs.

1. As structural work is being undertaken within this building as part of this project has a Building Regulations application been made for the work/project?
2. All holes in compartment wall must be suitably fire stopped using fire rated materials of a minimum of 90 minutes fire rating.
3. Documentation should be provided by the gas contractor showing the fire rated materials used for the fire stopping of the compartment walls and the fire rating of the fire collars used.

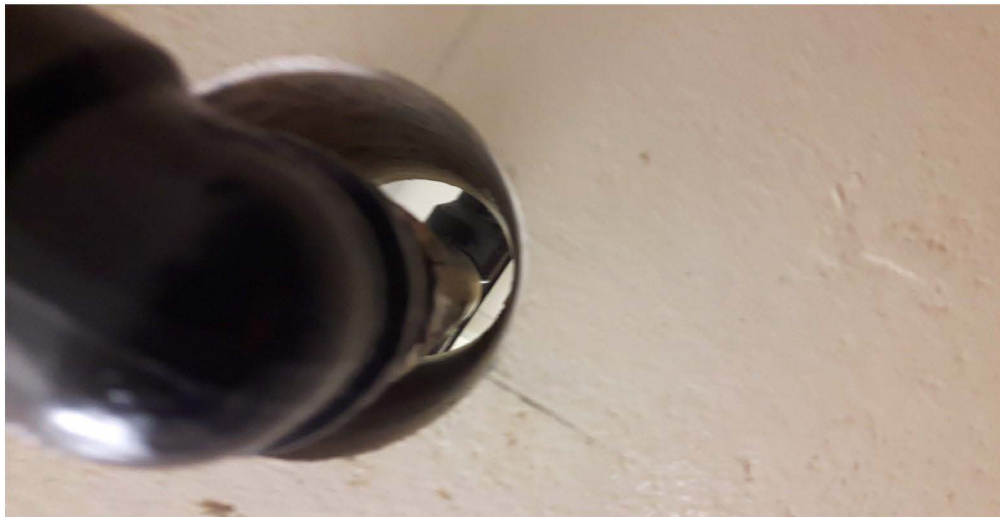
Gas pipe passing through the staircase to lift lobby area compartment wall, no fire collar has been fitted and the hole has not been made good.

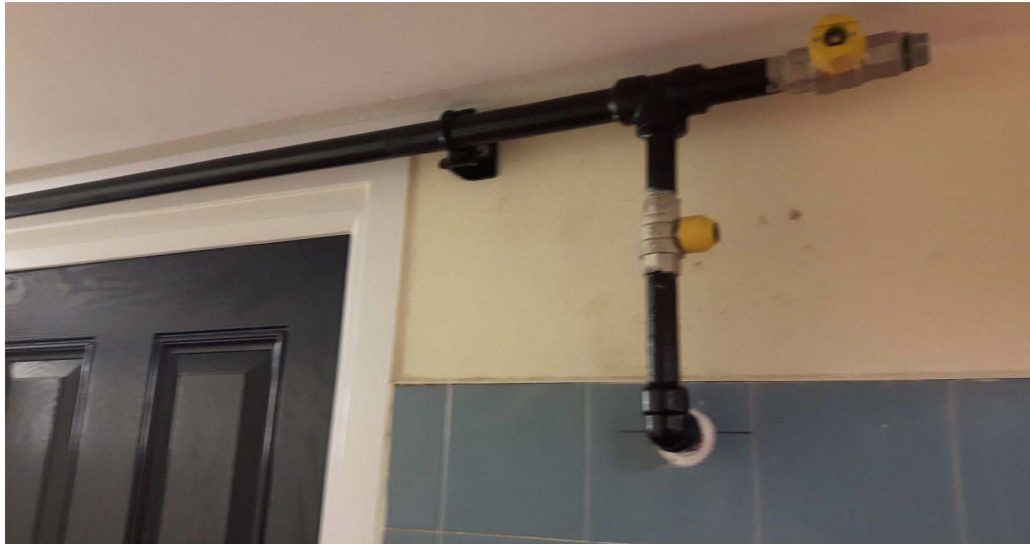
Where the gas pipe passes into the apartments the hole made has been made good, but what materials have been used to undertake this in filling?

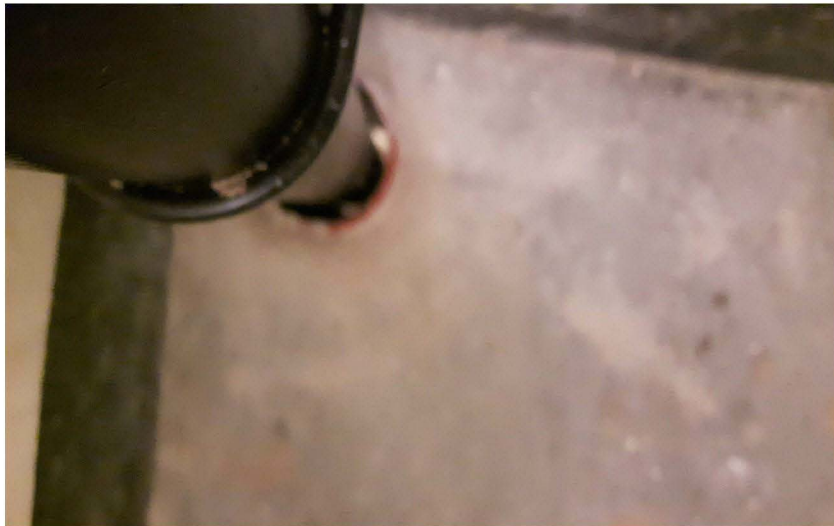
Gas pipe passing through the flat to lift lobby area compartment wall, what fire stopping materials have been used to in fill this hole around the pipe?
