## **Grenfell Tower**

### **Flat Sub-Main Rising and Lateral Supplies Report, 29<sup>th</sup> May 2013.**

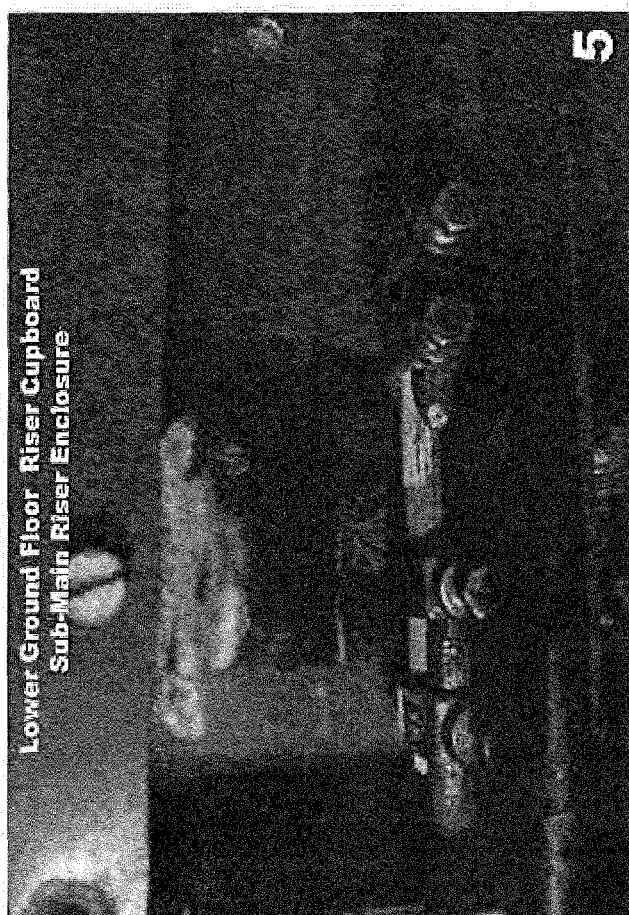
Further investigation found badly damaged enclosure and service cable in the lower ground floor riser cupboard where there is evidence of severe burn and arcing damage

This is concurrent with a Damaged/Broken cable on the sub-main supply side neutral. Connected to incoming service mains for Flats.

On inspection we found loose connections and the neutral cable had melted away from the clamp connections and could have caused a fire within the riser, please see attached photos on the following sheets.

Lower Ground Floor Riser Cupboard  
Sub-Main Riser Enclosure

The Client was informed and witnessed the damage. It was agreed to make a temporary connection in order to restore electrical safety and regain power to all flats above the 10<sup>th</sup> floor. See photos 5 and 6.

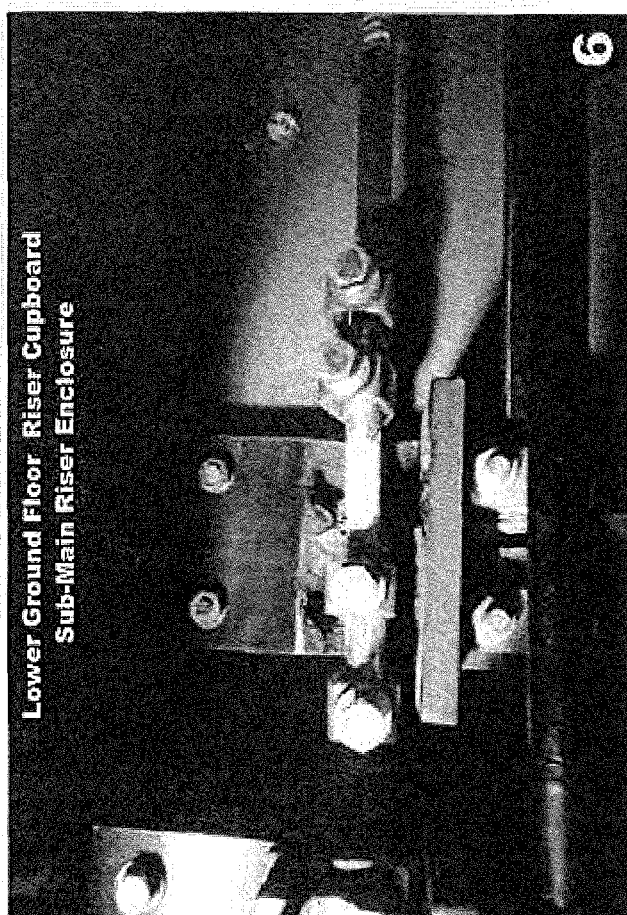
6

Lower Ground Floor Riser Cupboard  
Sub-Main Riser Enclosure
