BRE Global Test Report

Fire resistance test in accordance with BS 476: Part 22: 1987 on a single action, single-leaf timber doorset with one vision panel, mounted in a block-wall supporting construction.

Date: 3rd September 2018

Report Number: P111605-1000 Issue 1

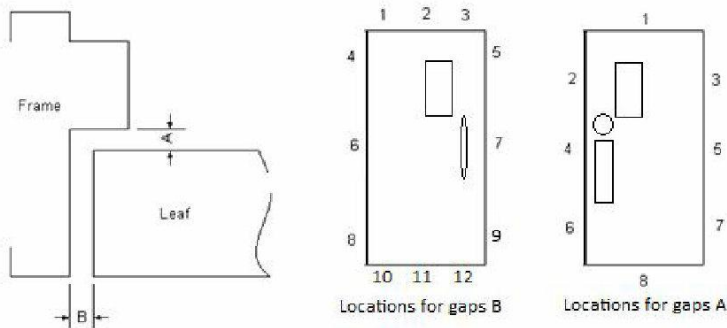
The gaps between the door leaf and frame were measured (in mm) and found to be as given in the sketch and table below.

Location B	1	2	3	4	5	6	7	8	9	10	11	12
Gap - mm	2	2.5	2.5	2.5	2	1	2.5	2	3	5	7	5

Location A	1	2	3	4	5	6	7	8
Gap - mm	8	8	5	7	2	5	5	10

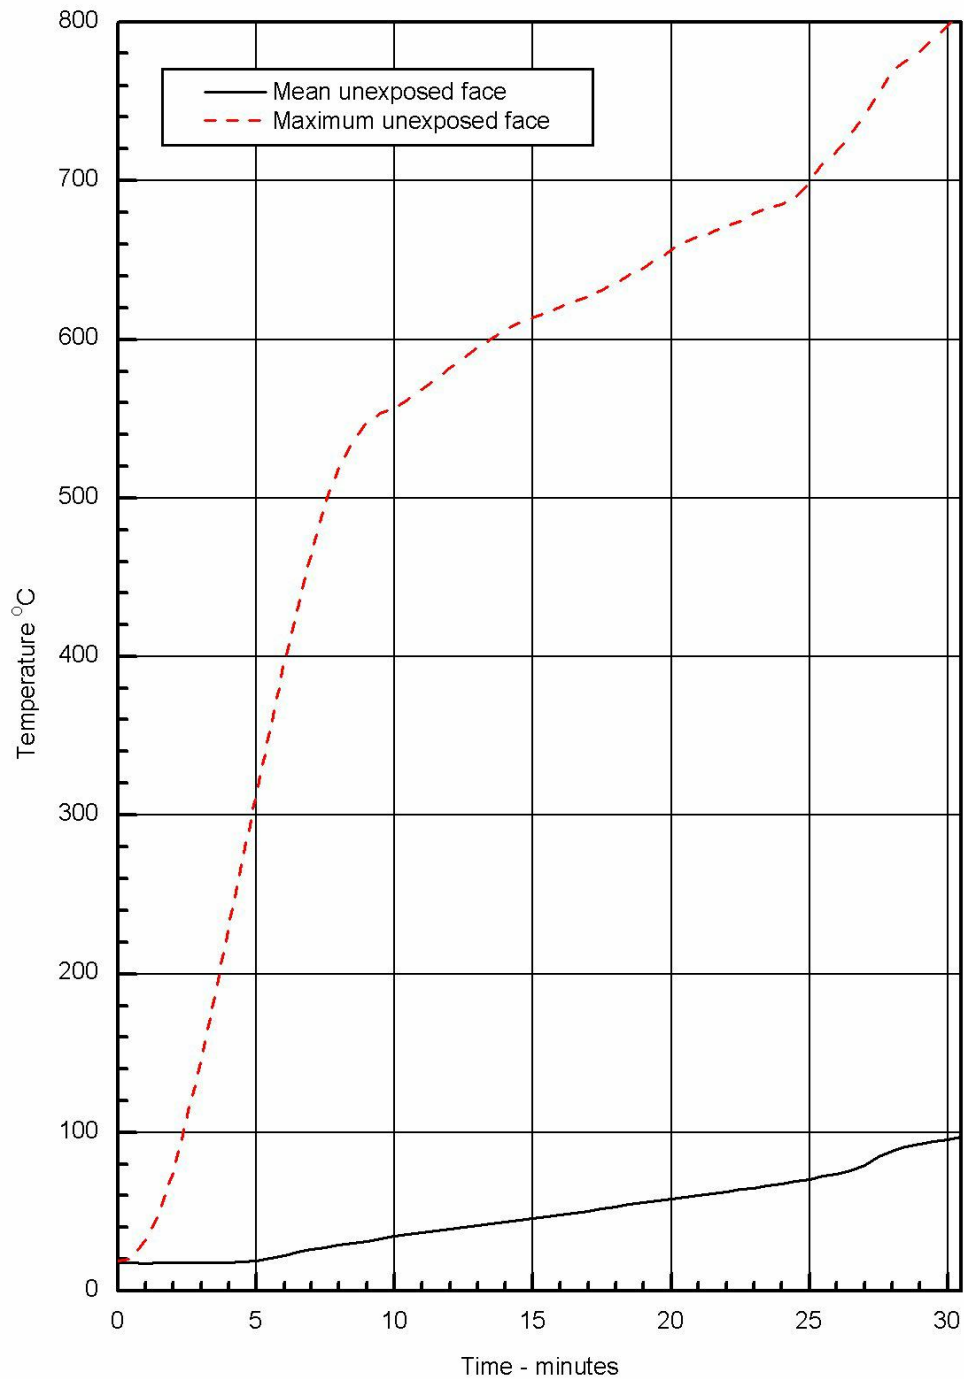
The maximum temperature of the door leaf exceeded the 180°C temperature-rise limit after 3 minutes of the test.

The mean unexposed face temperature of the door leaf did not exceed the 140°C temperature-rise limit during the test.

Mean and maximum temperatures recorded on the unexposed face.

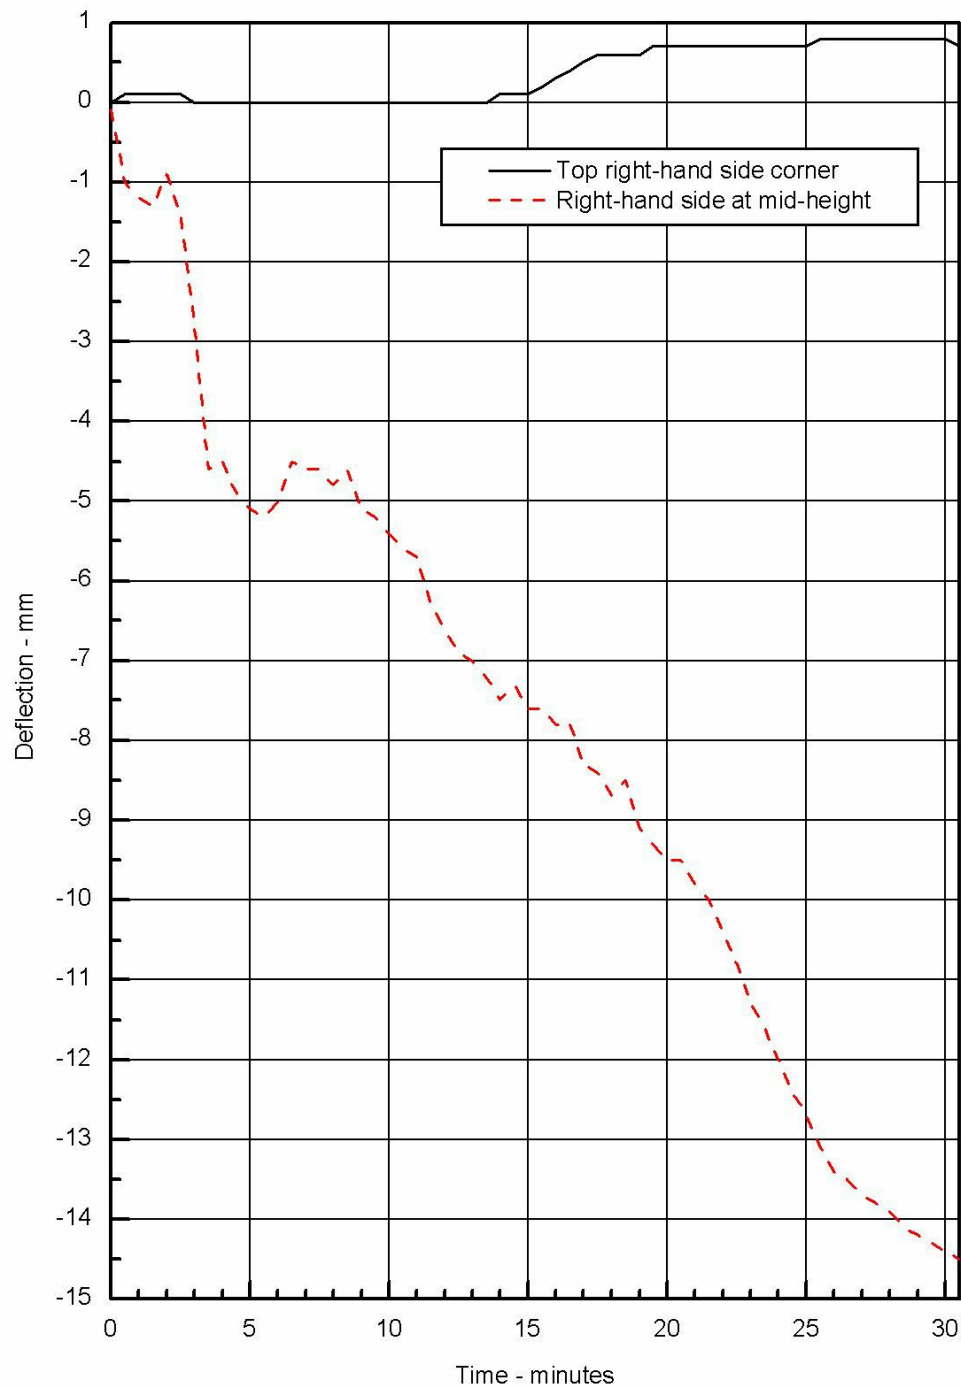
The maximum deflection measured by the transducer attached to the top right-hand side corner of the door leaf was 0.8mm towards the furnace, recorded after 25 minutes of the test. The maximum deflection measured by the transducer attached to the right-hand side of the door leaf at mid-height was 14.5mm away from the furnace, recorded at the end of the test.

Horizontal deflection recorded during the test.

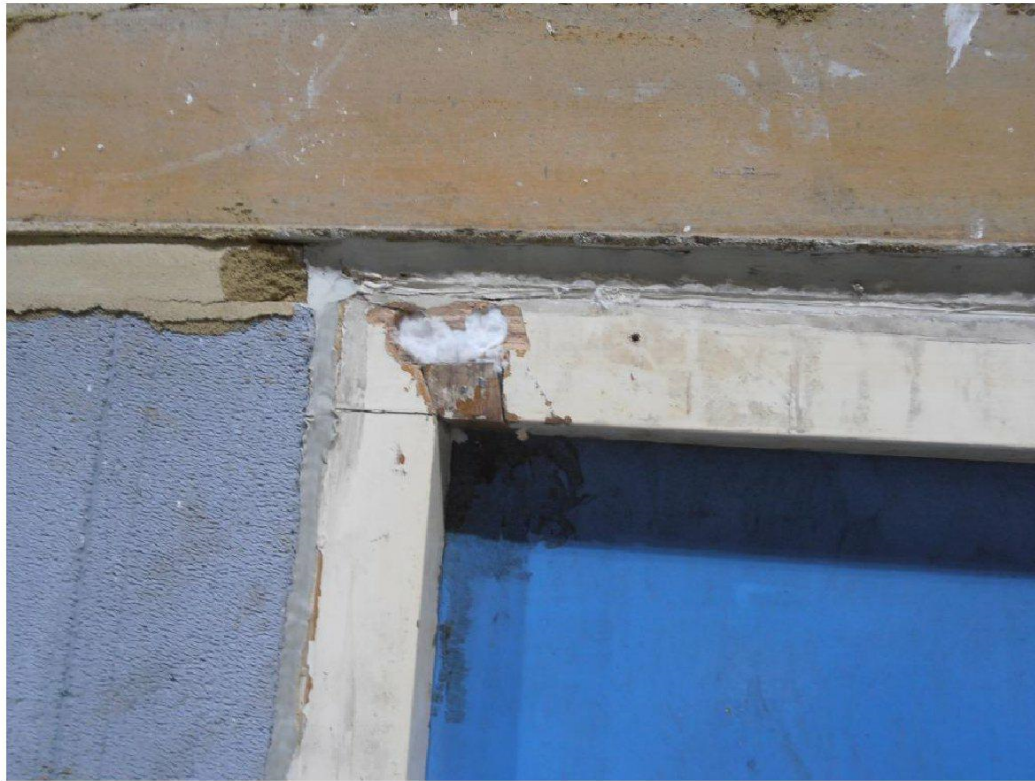
It was noted after installation of the doorset that the top horizontal frame member was damaged near the left-hand side (as viewed from the exposed face). The damage was repaired by the sponsor using a shaped wooden infill and some alkaline earth silicate blanket. A photo of the repaired area of frame is given in the Photographs.

Location of repaired damage on the door frame (before the test).

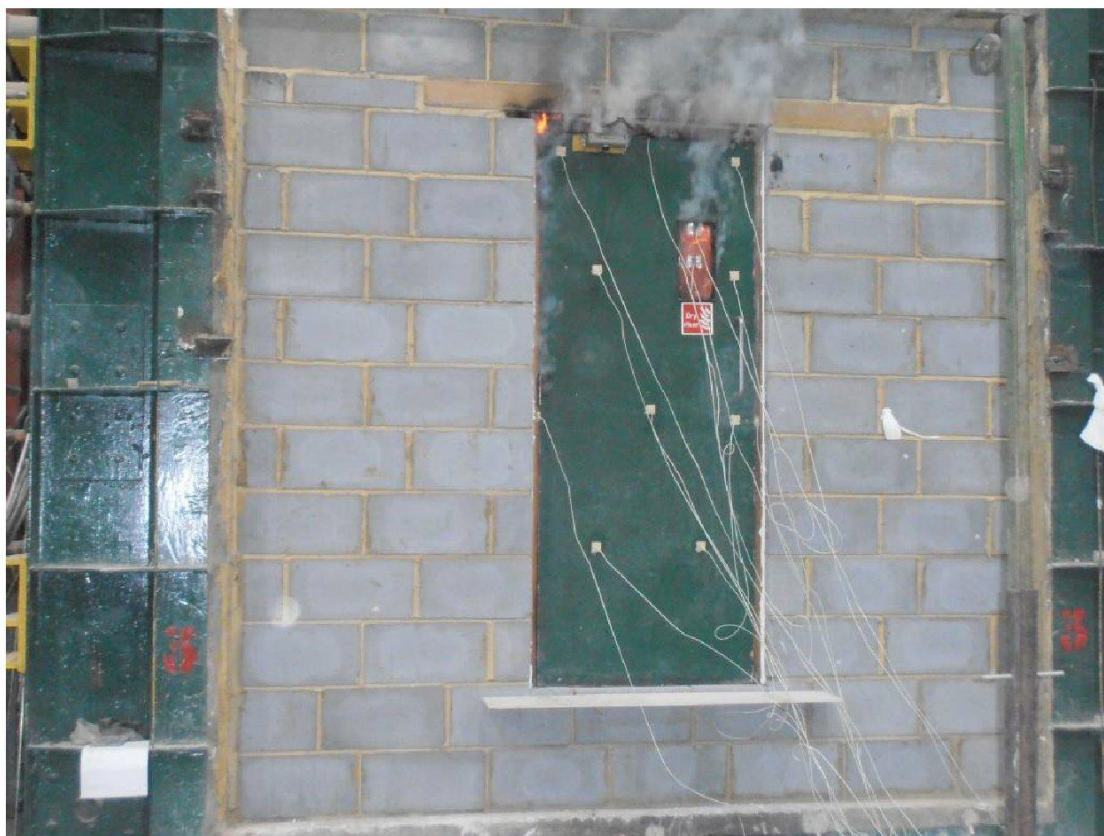
20	Sustained flaming from the top left-hand side corner of the door leaf.
21	Flames are spreading across the top edge of the leaf.
24	Flaming from the door leaf perimeter is increasing in intensity.
24½	Flaming from the top edge of the vision panel opening.
25	The paint on the unexposed face is blistering as it heats up.
26	Flaming from the sides and bottom of the vision panel opening.

Unexposed face of specimen after 16 minutes.

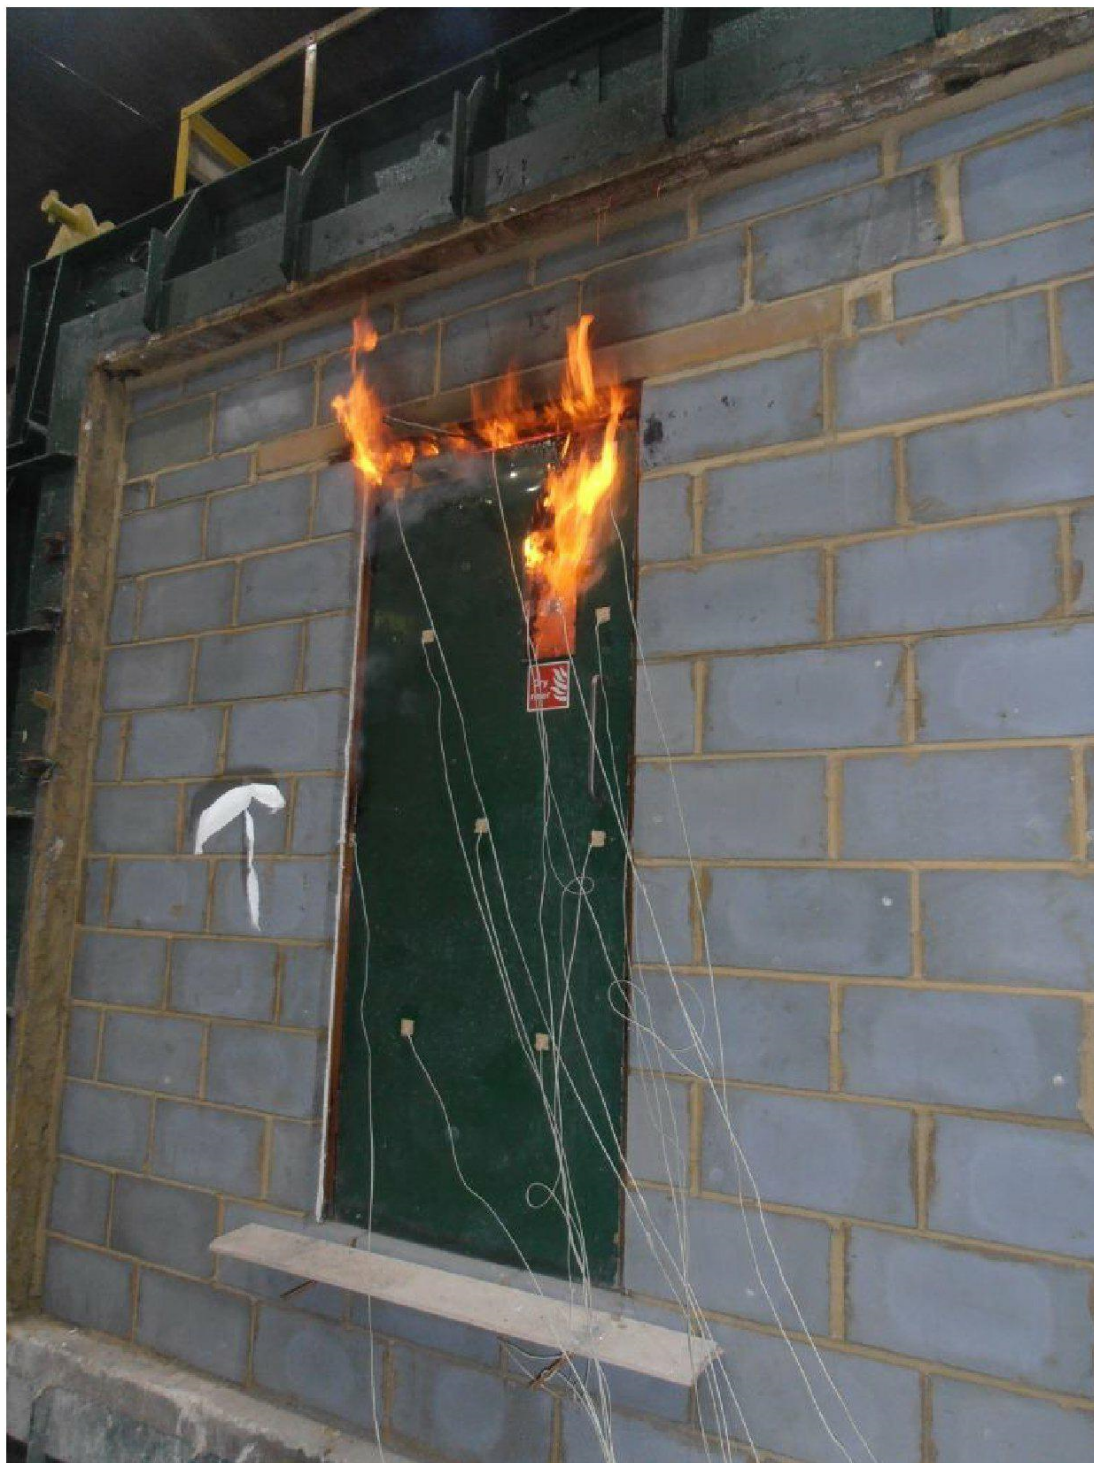
Time minutes	Observation
26½	The glass fell out from the door leaf vision panel.
31½	Test stopped.

Integrity: 16 minutes

Insulation: 3 minutes.

Unexposed face of specimen at the end of the test.
