Grenfell Tower – fire safety investigation:
The fire protection measures in place on the night of the fire, and conclusions as to:
the extent to which they failed to control the spread of fire and smoke;
the extent to which they contributed to the speed at which the fire spread.

Phase 1 Report – Appendix C

Excerpts from site inspection records

Dr Barbara Lane FREng CEng

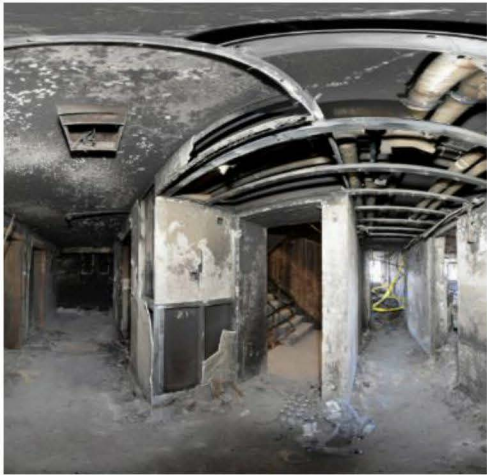
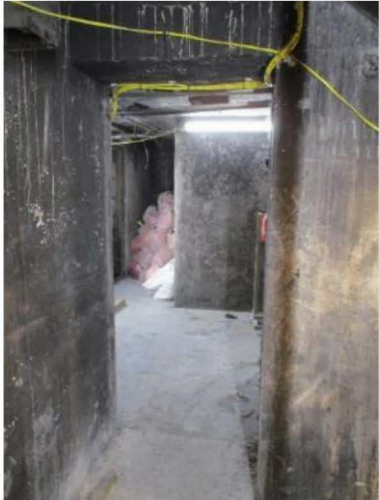
<p>METS00017081</p>

<p>L13-258</p>	<p>Site visit: door missing MPS photo: door missing Conclusion: Door missing</p>

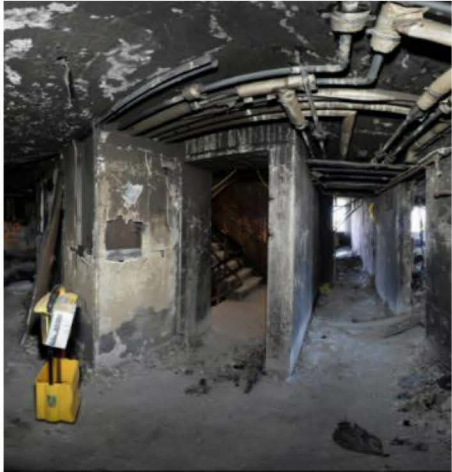
METS00017090	Site visit: door missing MPS photo: door missing Conclusion: Door missing
16

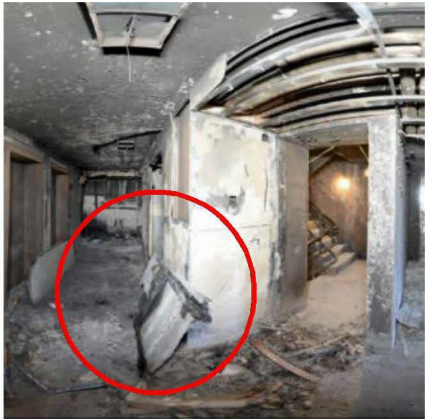
METS00016987	Site visit: door missing MPS photo: door damaged Conclusion: door damaged
18

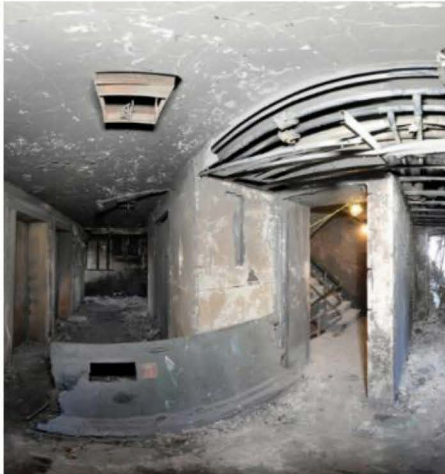
METS00017003	Site visit: door missing MPS photo: door damaged Conclusion: door damaged

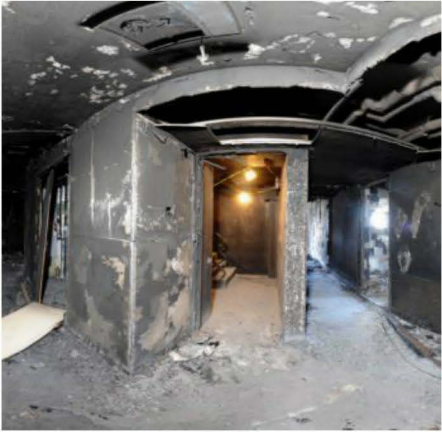
METS00017130	Site visit: door missing MPS photo: door missing Conclusion: Door missing
21

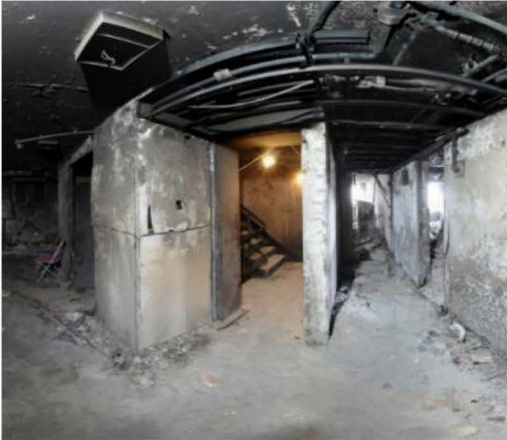
METS00017248	Site visit: door missing MPS photo: door missing Conclusion: Door missing

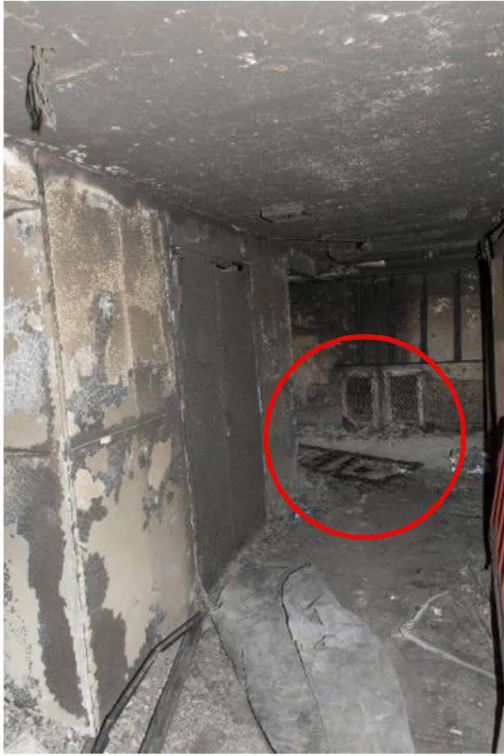
<p>METS00019977</p>	Site visit: door missing MPS photo: door damaged Conclusion: door damaged
23

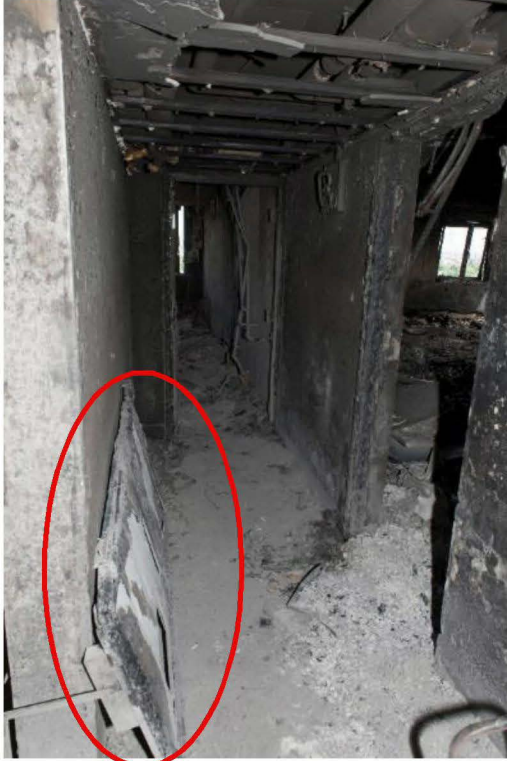
<p>METS00020143</p>	Site visit: door missing MPS photo: door damaged Conclusion: door damaged

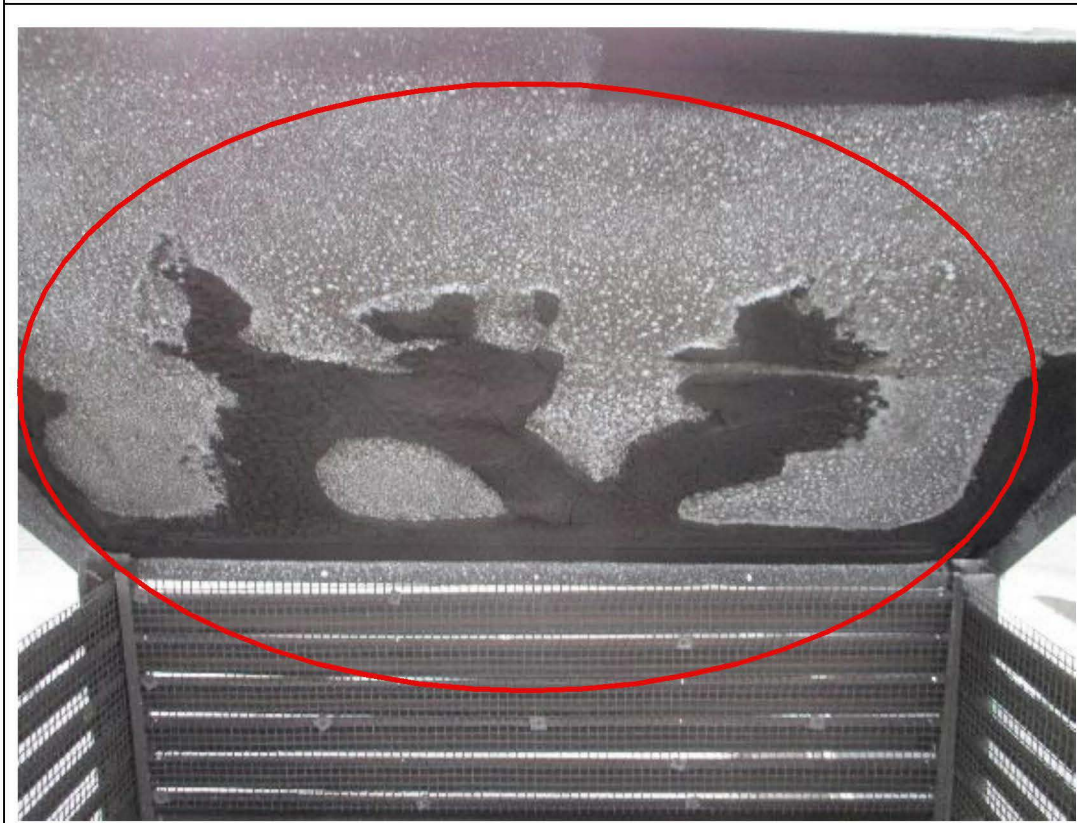
<p>Inside of roof cowl of lobby smoke extract North shaft – lid lifted and photo of underside of lid taken. Dark heat-damaged (possible charring) material visible (circled).</p>

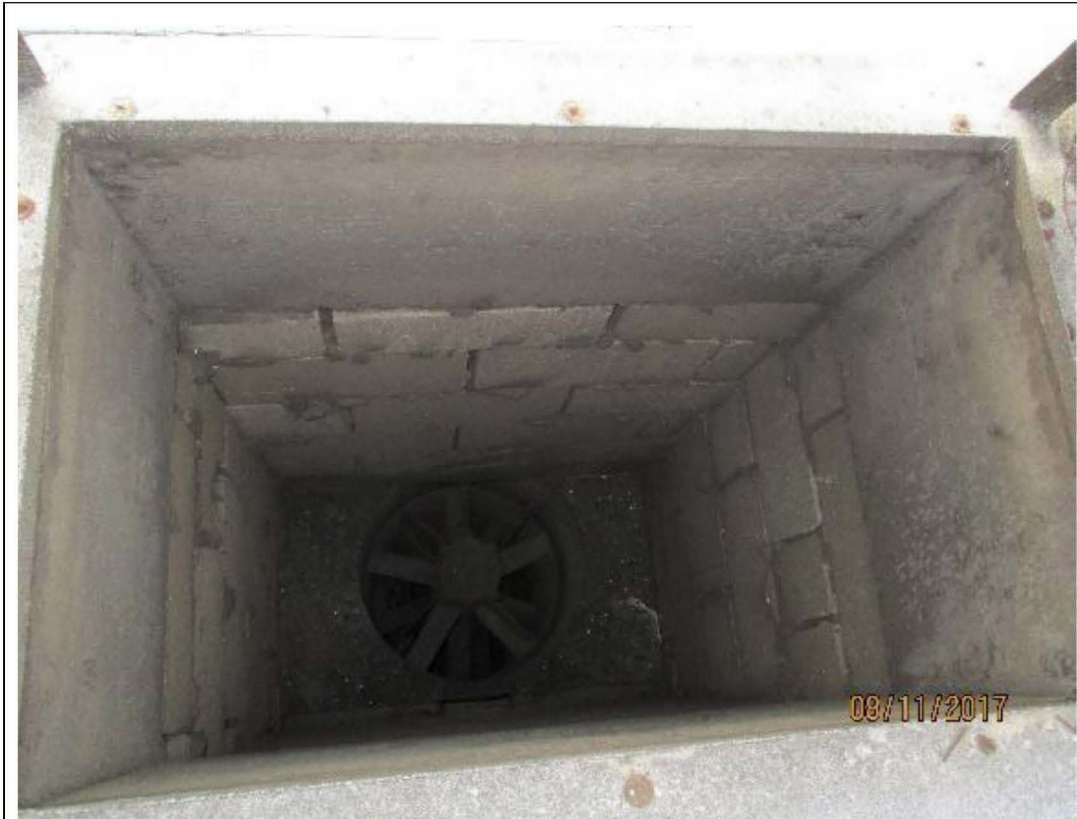
<p>North Lobby Smoke Extract Shaft looking down the shaft. Low quantities of light grey soot were observed.</p>

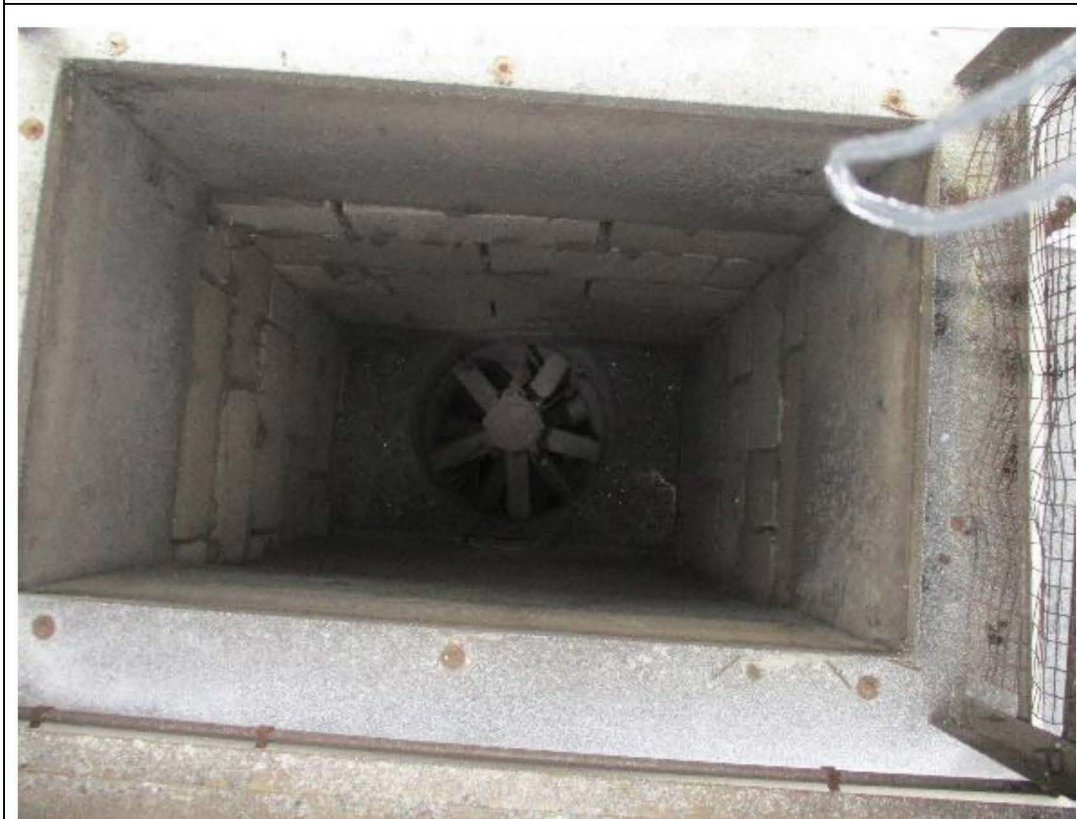
<p>North Lobby Smoke Extract Shaft looking down the shaft. Low quantities of light grey soot were observed.</p>

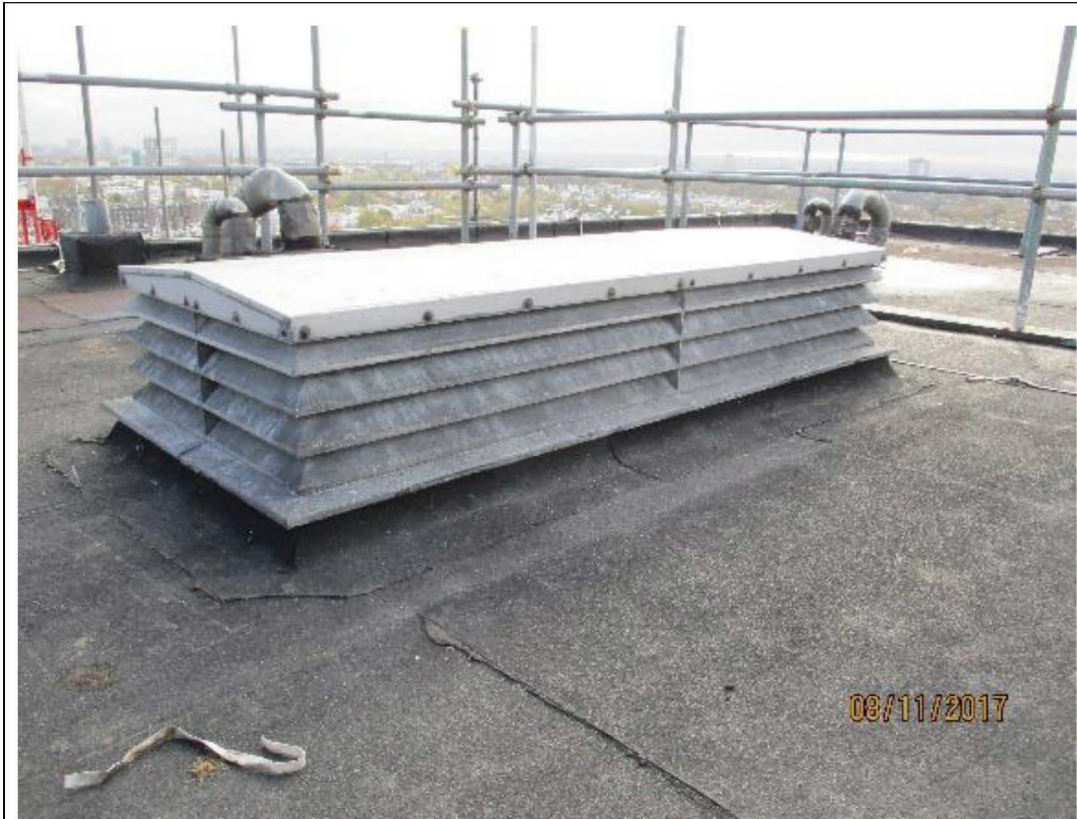
<p>08/11/2017</p>	<p>Roof top stairwell ventilator looking South East. Black particulate deposits and staining to louvres.</p>

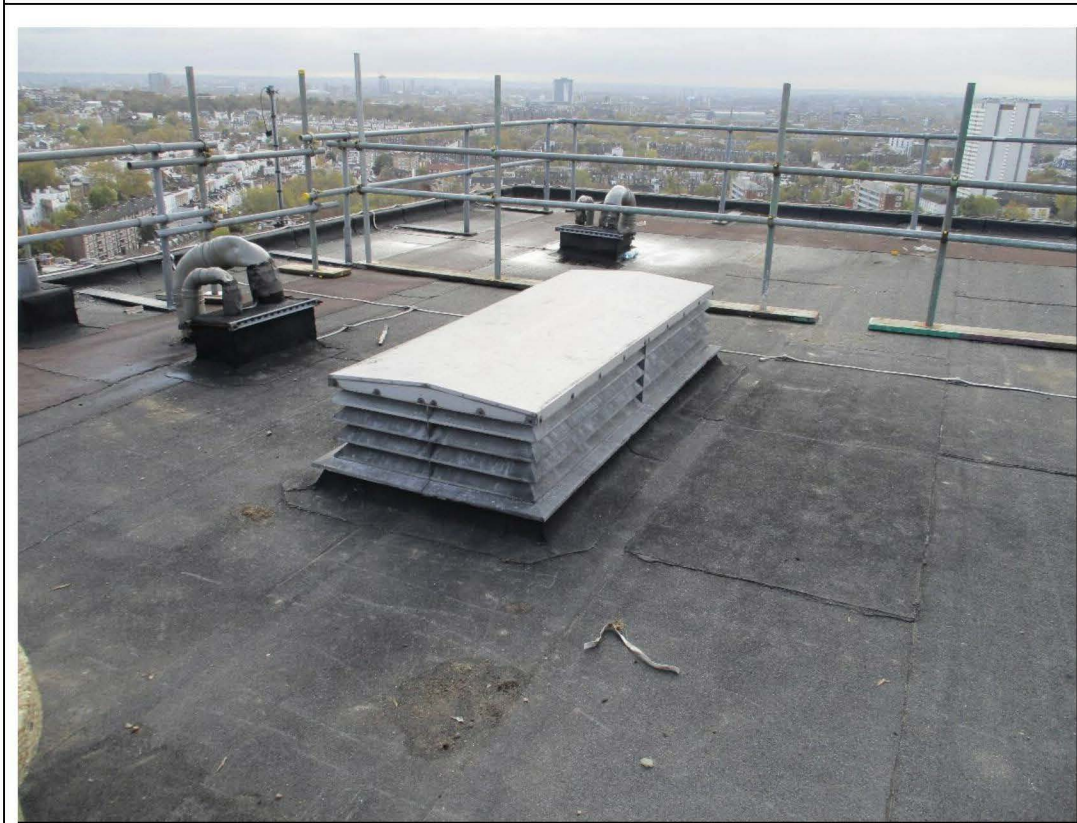
<p>Roof top stairwell ventilator looking East Black particulate deposits and staining to louvres.</p>

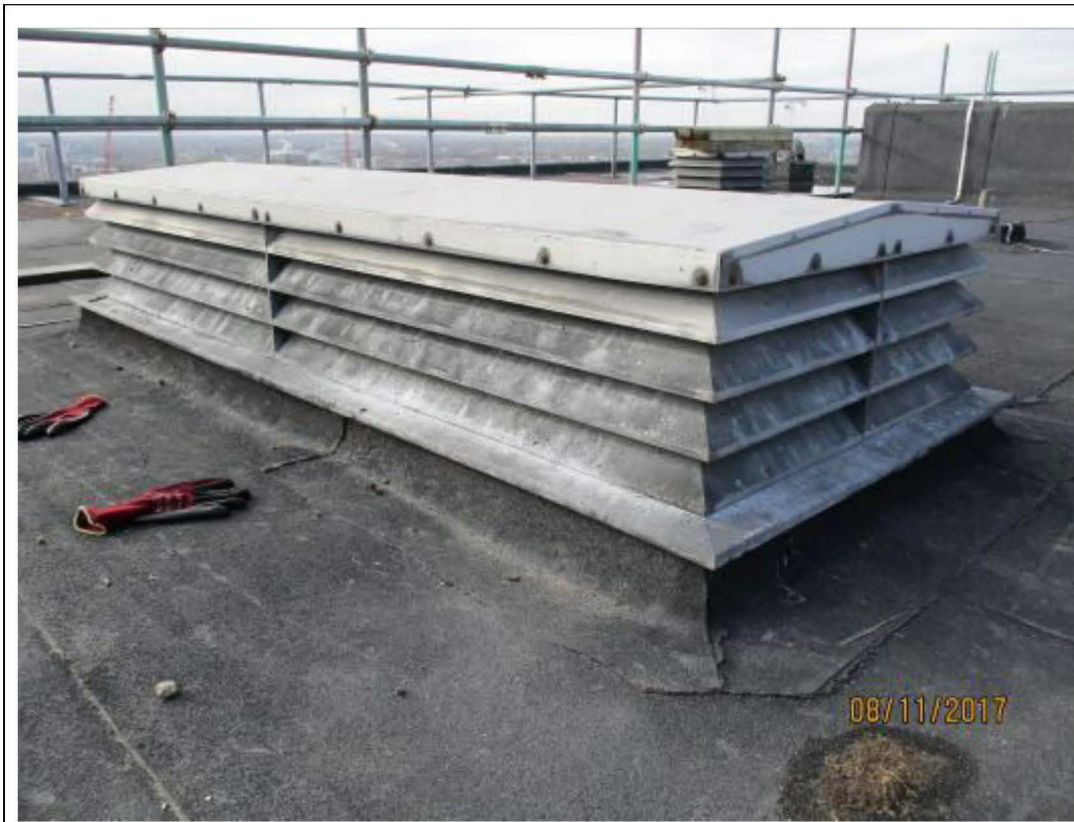
Roof top stairwell ventilator looking West
Black particulate deposits and staining to louvres.

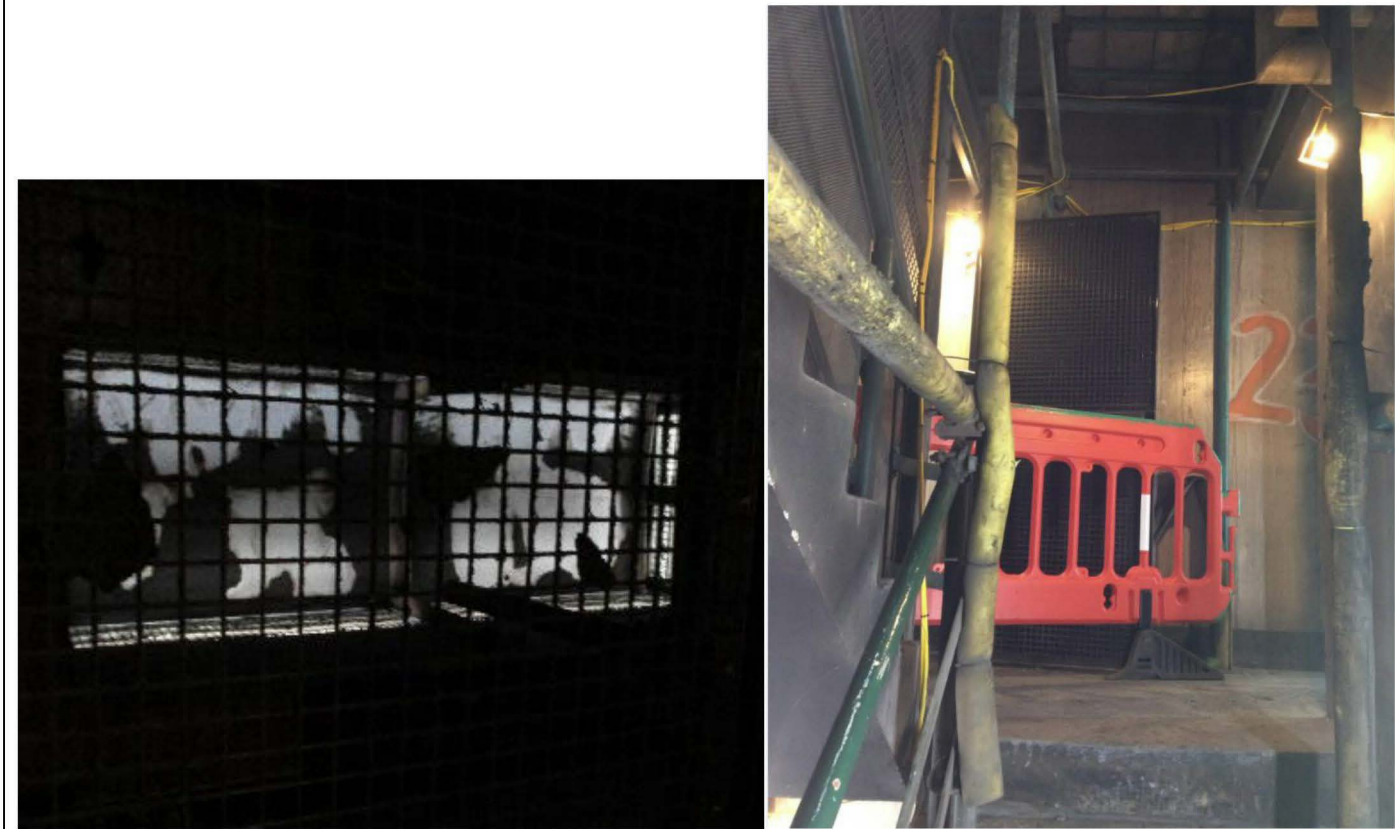
Left: Inside of stairway ventilator looking up from Level 23. This shows that the ventilator was open to the stair.
Right: The condition of the stair in Level 23 is shown below. Soot deposits on walls (light) and stair (heavy) indicate smoke was present just below the ventilator.

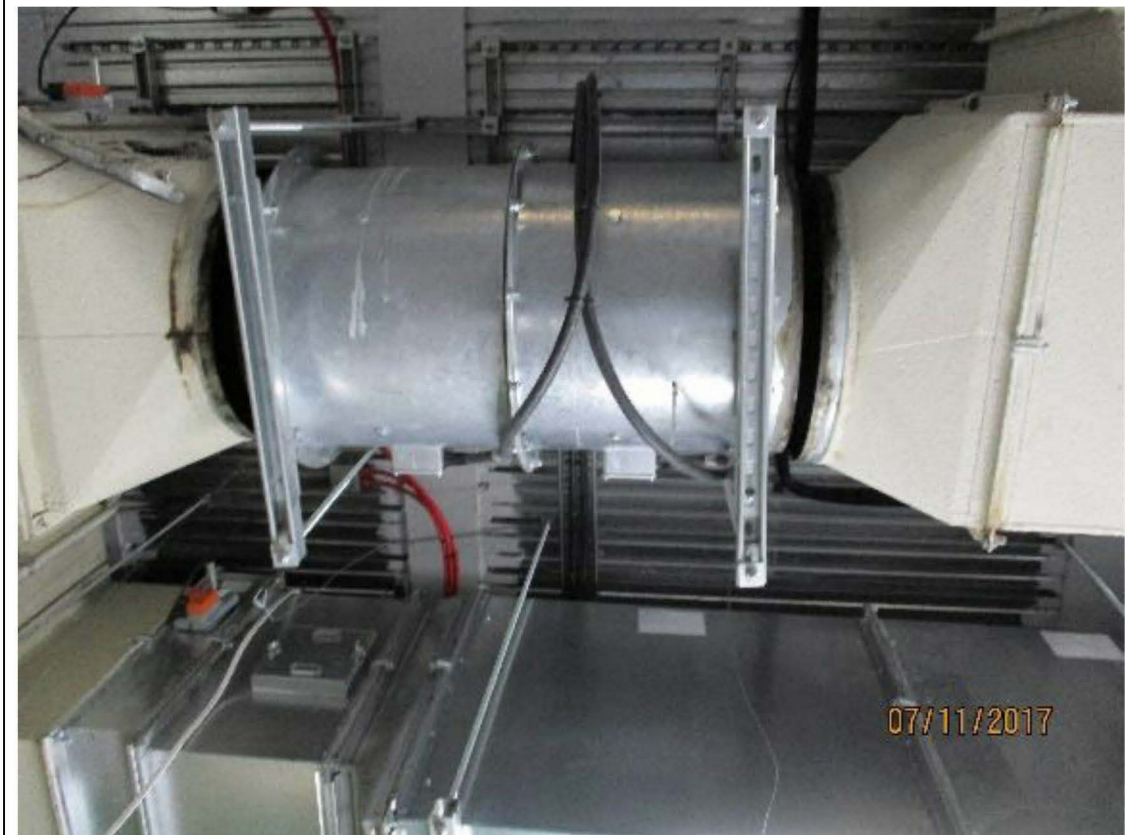
Smoke Extract fan with both flexible connections missing – removed by post fire forensic investigation teams.

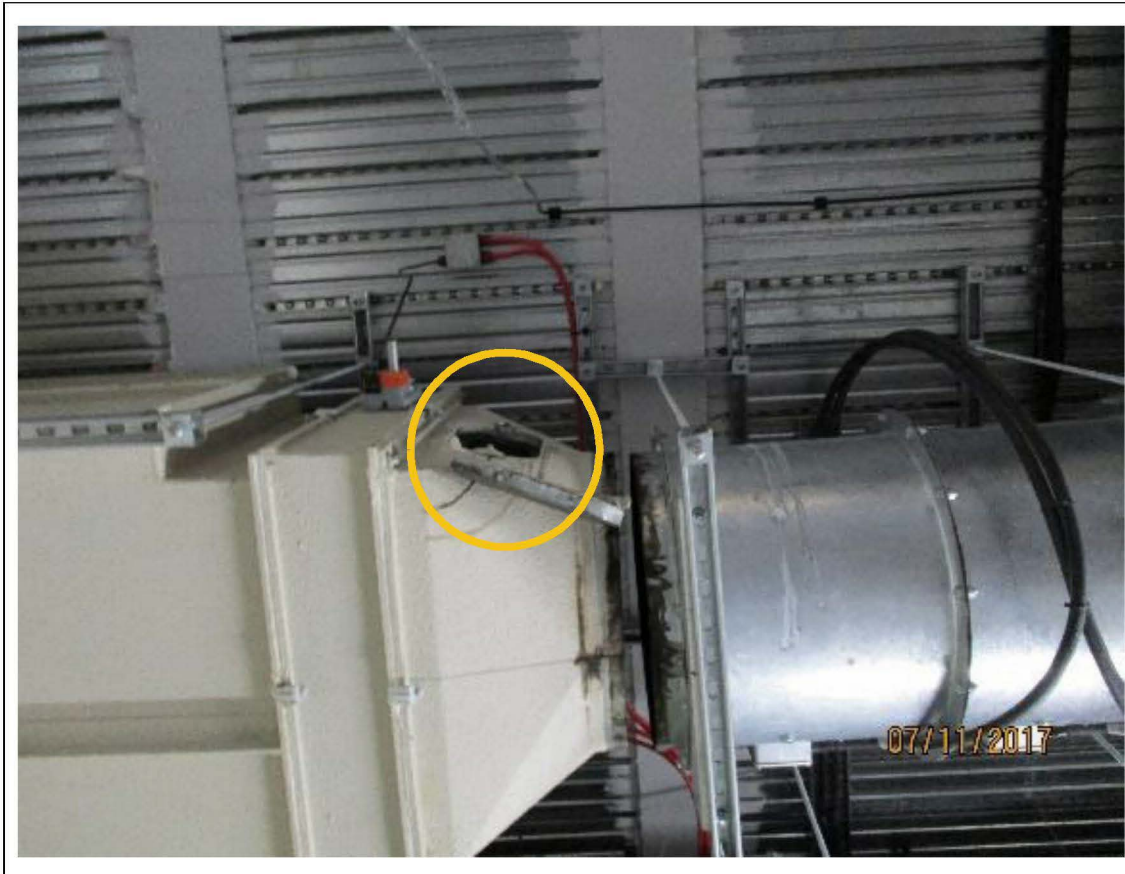
<p>Access door (circled) into smoke extract duct work open, unknown if this was closed at the time of the incident</p>

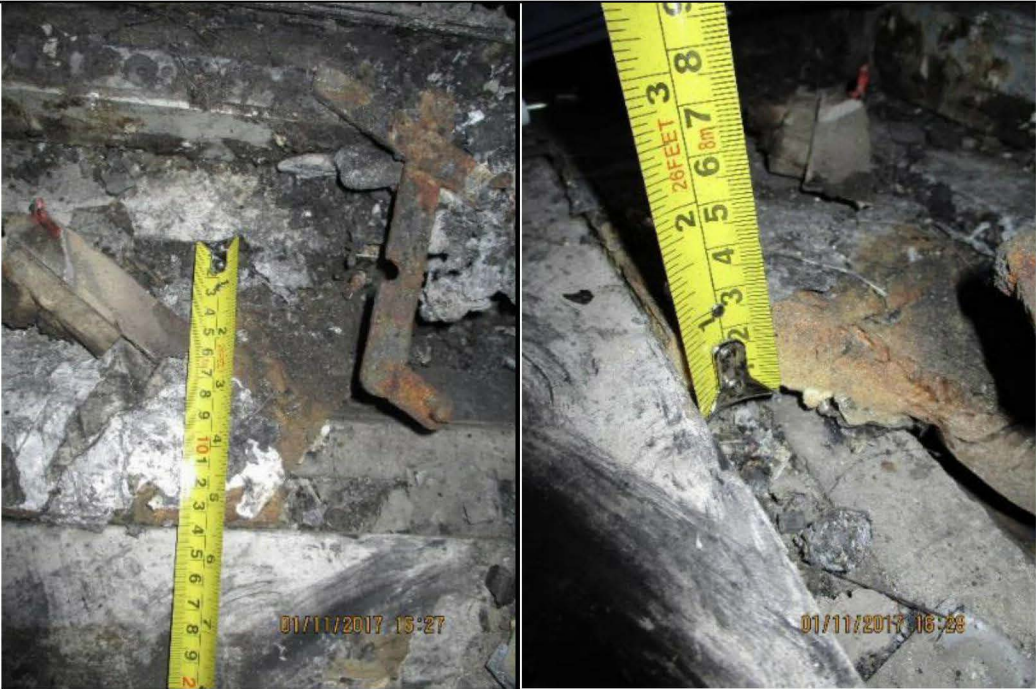
5	21	Yes. In place, though fire damage at Livingroom window reveals insulation around window.	Yes – Insulation visible behind charred uPVC
