Grenfell Tower – fire safety investigation:
The fire protection measures in place on the night of the fire, and conclusions as to:
the extent to which they failed to control the spread of fire and smoke;
the extent to which they contributed to the speed at which the fire spread.

Phase 1 Report – Appendix I

Flat entrance and stair fire doors – requirements and provisions

Dr Barbara Lane FREng FRSE CEng

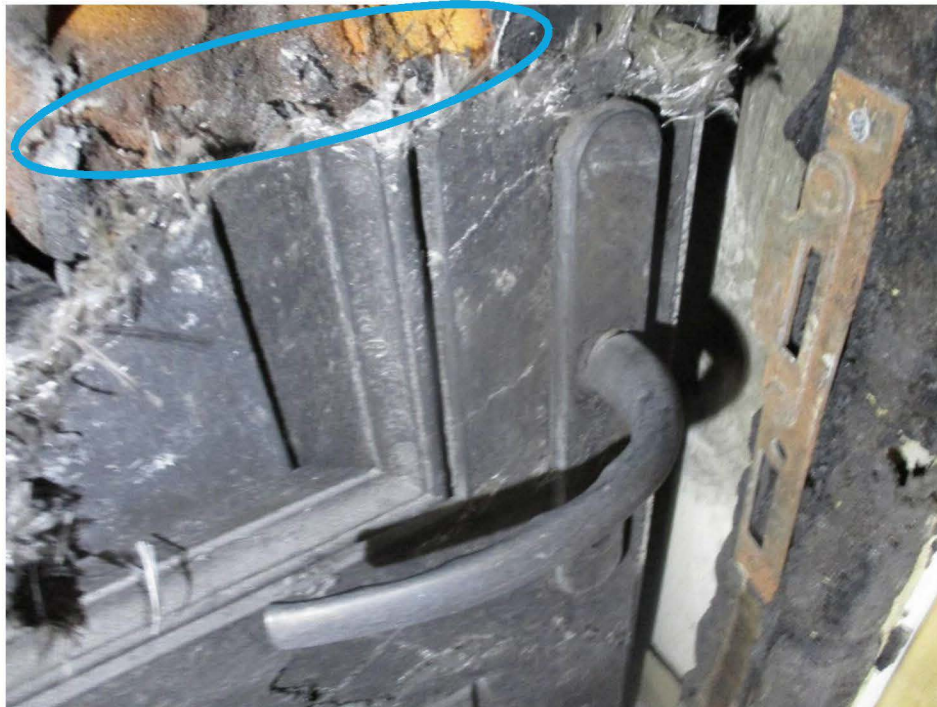
I4.5.37 The eight doors that I surveyed consisted of a polymeric foam type core which is similar to the test specimen in report BTC 14434F (MAS00000001). All 8 doors were all noted as 45mm thick which is in accordance with the FD30 test specimen in report BTC 14434F (MAS00000001).

Figure I.10: Polymeric based foam core of door circled in blue (photo from Flat 26)

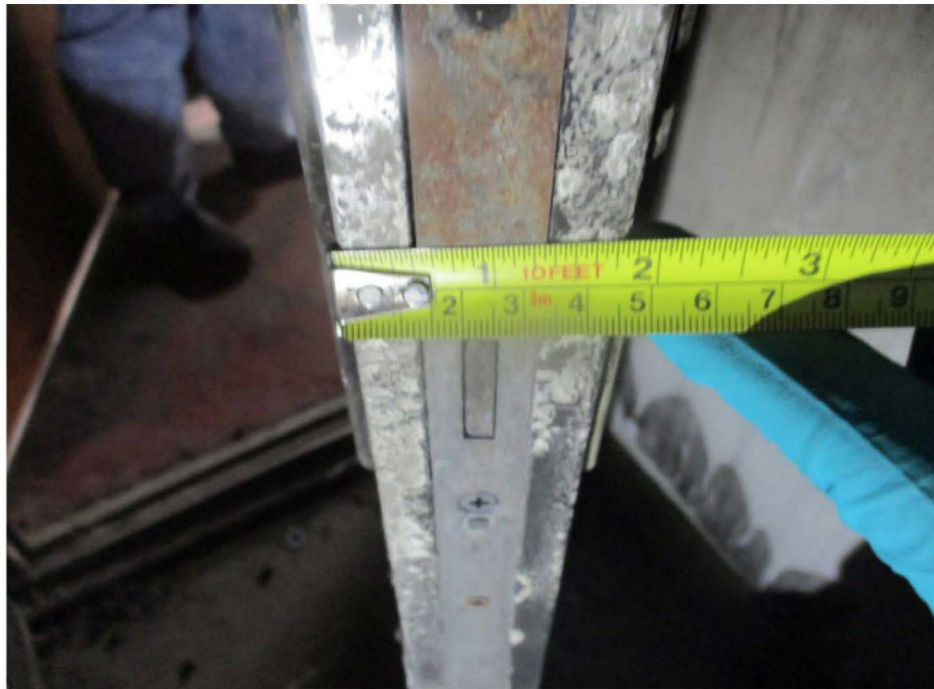
Figure I.11: 44mm door leaf (photo from Flat 26)

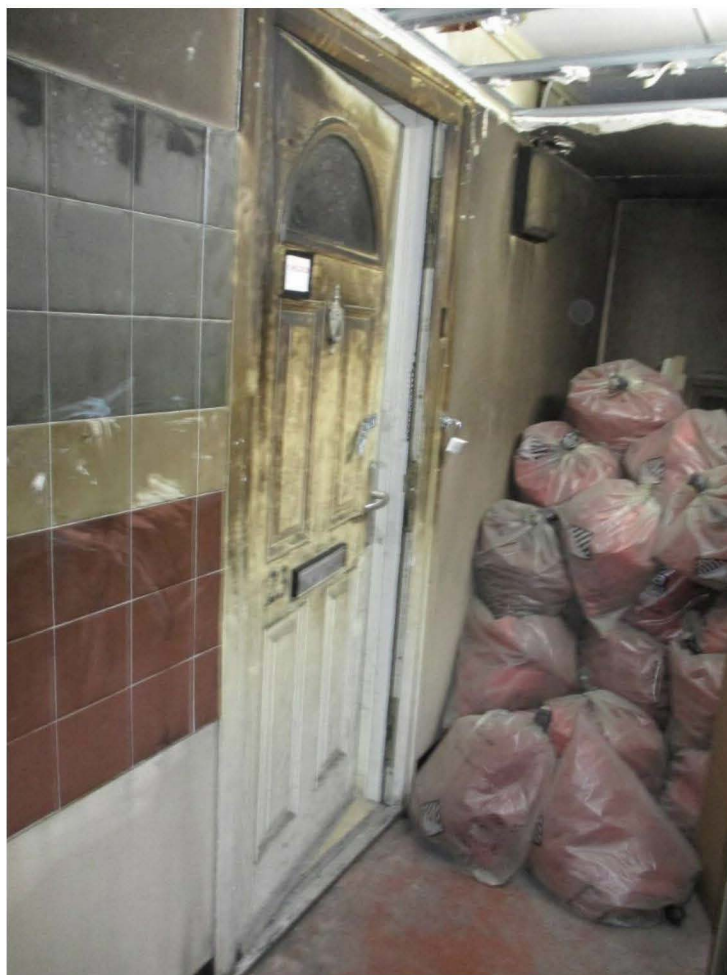
- I4.5.48** Of the 48 doors where glazing was installed, none were specified in accordance with the test evidence relied upon.
- I4.5.49** Note the main flat door to Flat 23 inspected by my team and I contained glazing (Refer to Figure I.12) however there was no marking on it to indicate what type.

Figure I.12: Flat 23 entrance door (Glazing in place)

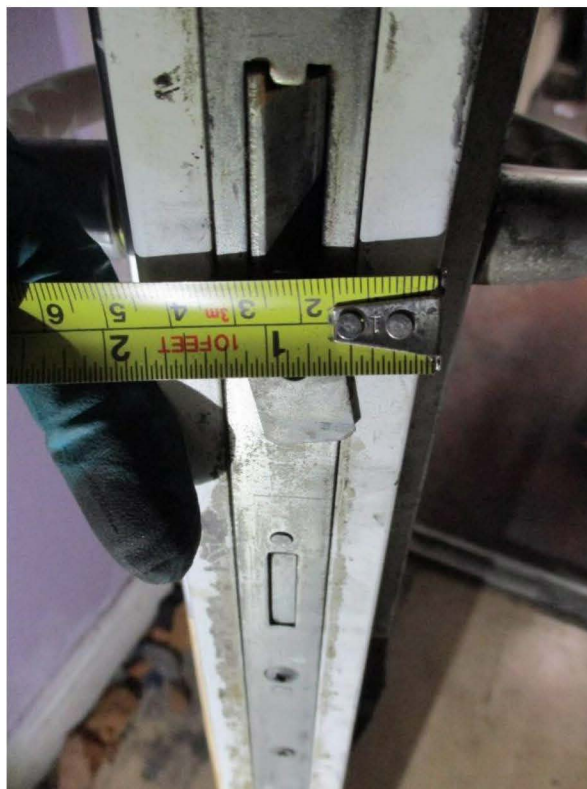
I4.5.55 Of the eight main flat doors surveyed by my team and I eight were fitted with three-point locks. The lock product installed could not be determined through visual inspection (refer to Figure I.13).

Figure I.13: Example lock (from Flat 24)

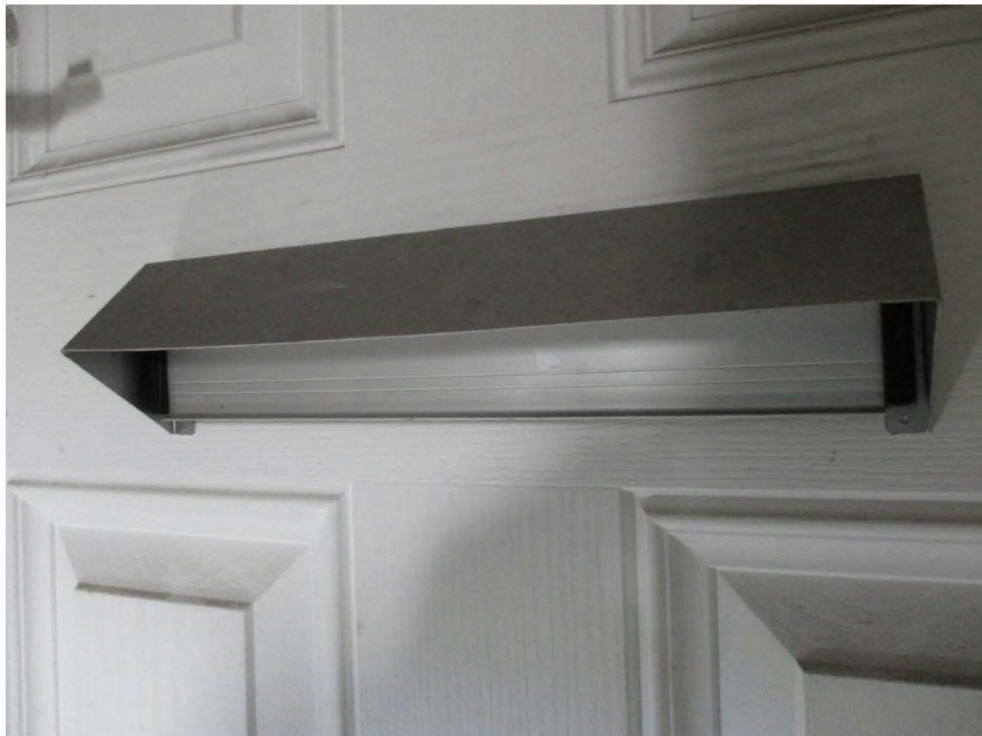
- I4.5.62** Of the eight main flat doors surveyed by my site inspection team and I, four had letter plates. The type of letter plate could not be confirmed through visual inspection only (refer to Figure I.14). It should be noted that the specification spread sheet (MAS000000003) states that all 106 doors installed in 2011 should have been fitted with letter boxes.

Figure I.14: Example letter box (Flat 23)

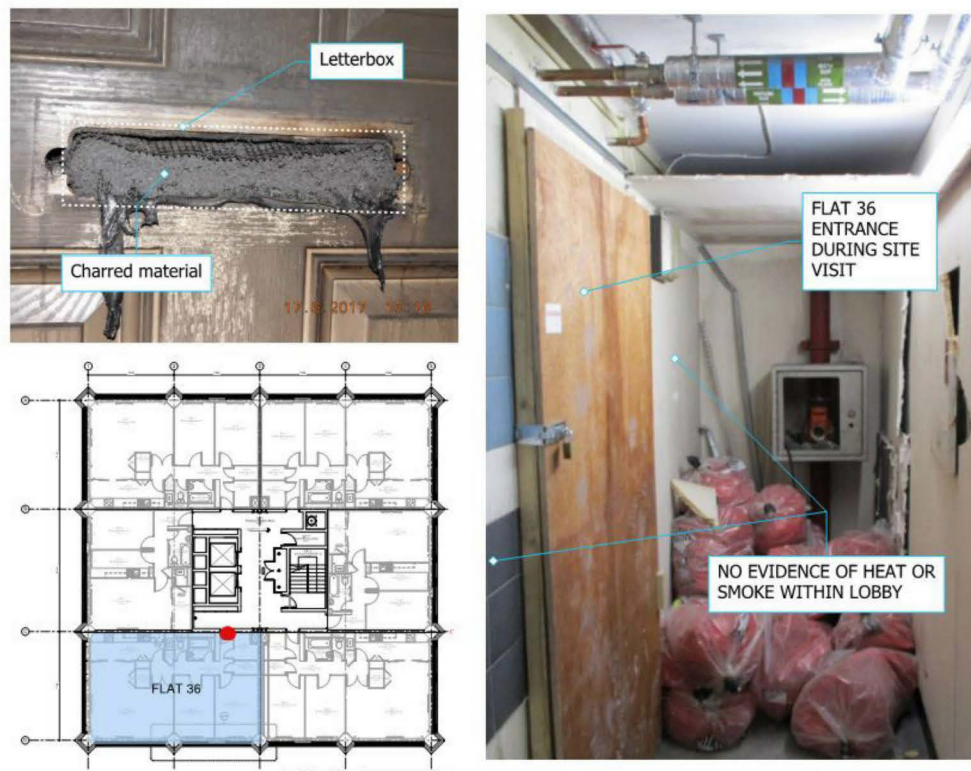
- I4.5.63** Photographs taken within Grenfell Tower after the fire on 17/06/2018 show evidence the letterbox (MET00018830) installed within the Masterdor Suredoor contained intumescent materials (i.e. materials that char and swell on

I4.5.64 I have included that photograph in Figure I.15 along with my own photograph of the Level 6 lobby directly outside Flat 36; there is no sign of heat or damage within the lobby therefore any intumescence would be a result of heat within the flat.

Figure I.15 Flat 36 Letterbox (MET00018830) and Level 6 lobby outside Flat 36 flat entrance door

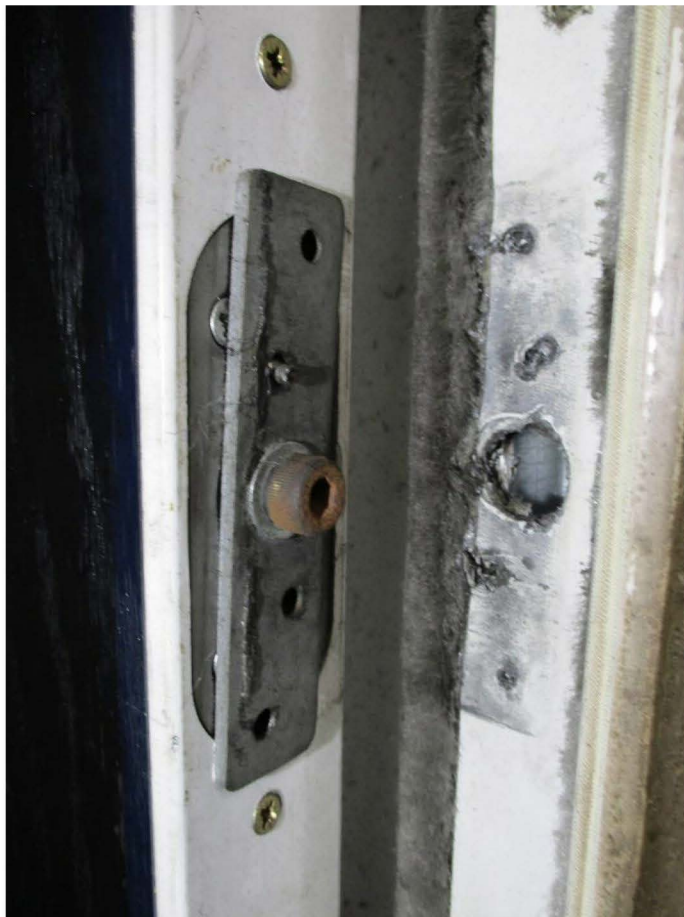
I4.5.71 Concealed door closers were noted on all eight of the flat main doors surveyed by my site inspection team and I. These were all disconnected at the time of survey therefore the action of the self-closers could not be verified.

Figure I.16: Example concealed door closer (photo from Flat 22)

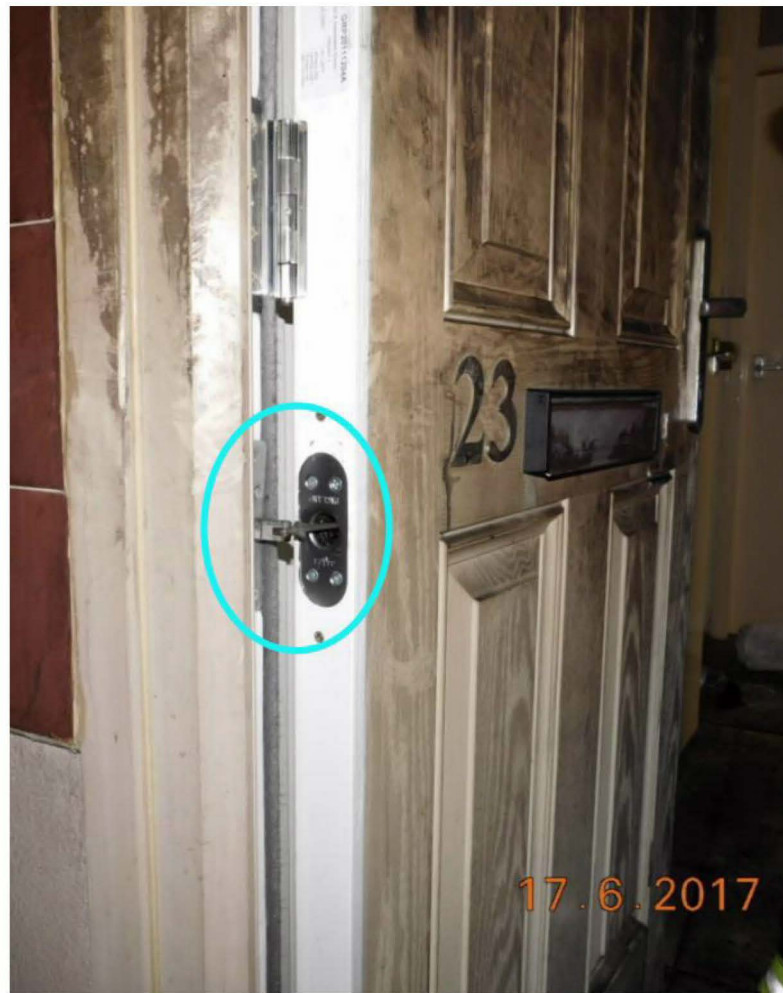
I4.5.73 The photographs disclosed by the MPS dated 17/06/2017 (three days after the fire) do show that the door closer on flat 23 was attached. This is shown in Figure I.17.

Figure I.17 Door closer on flat 23 (circled in blue) was attached (MET00018892)

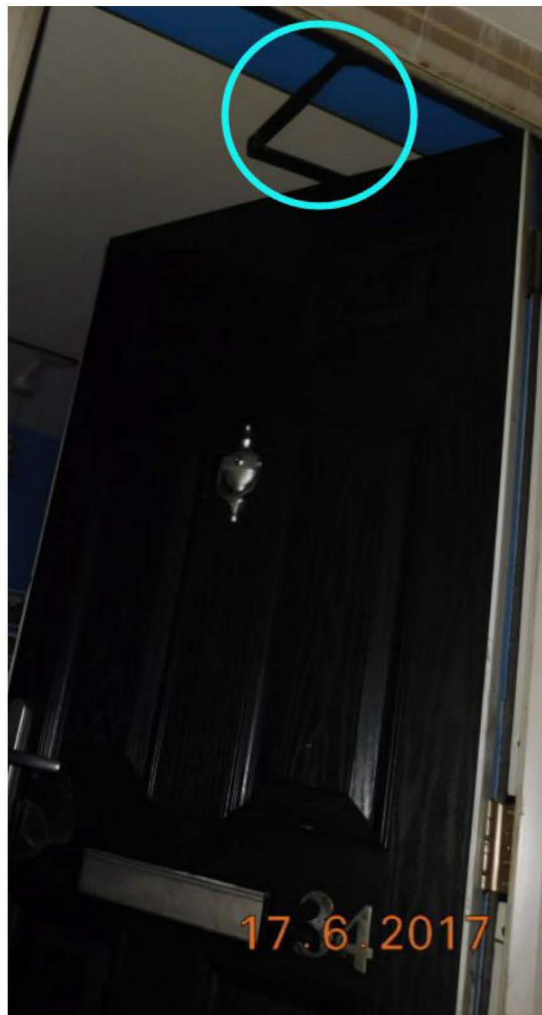
- I4.5.74** It should be noted that photos disclosed by the MPS show the front entrance door of Flat 34 was fitted with an overhead door closer instead of the specified *Astra 3003 Concealed Door Closer V1 PL3*. It is unclear if this was installed in 2011 or was added to the door later.

Figure I.18 Flat 34- Overhead door closer installed instead of the specified *Astra 3003 Concealed Door Closer VI PL3* (MET00018847)

- I4.5.75** The lack of effective door closers is non-compliant with ADB 2010 and the LGA guidance. Whether this was an original installation non-compliance or an ongoing maintenance issue shall be investigated fully in Phase 2.
- I4.5.76** At this stage I would however like to highlight several witness statements which seem to indicate the door closers were disconnected prior to the fire.
- I4.5.77** The Witness statement from Sener Macit of Flat 113, Floor 14 (IWS00000069) states:

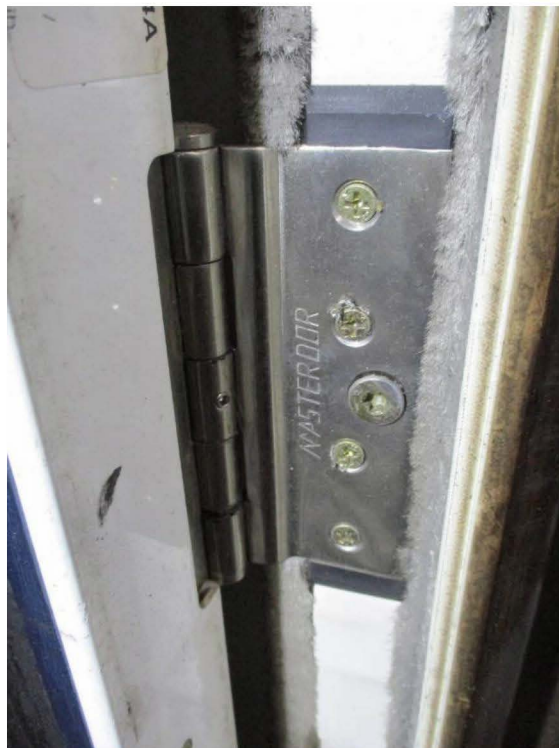
I4.5.96 Three hinges were noted for every door frame assembly of the eight flats surveyed by my site inspection team and I which is consistent with the test report BTC 14434F (MAS00000001) however the product type could not be ascertained in the visual site inspection.

Figure I.19: Example door hinge (Flat 24)

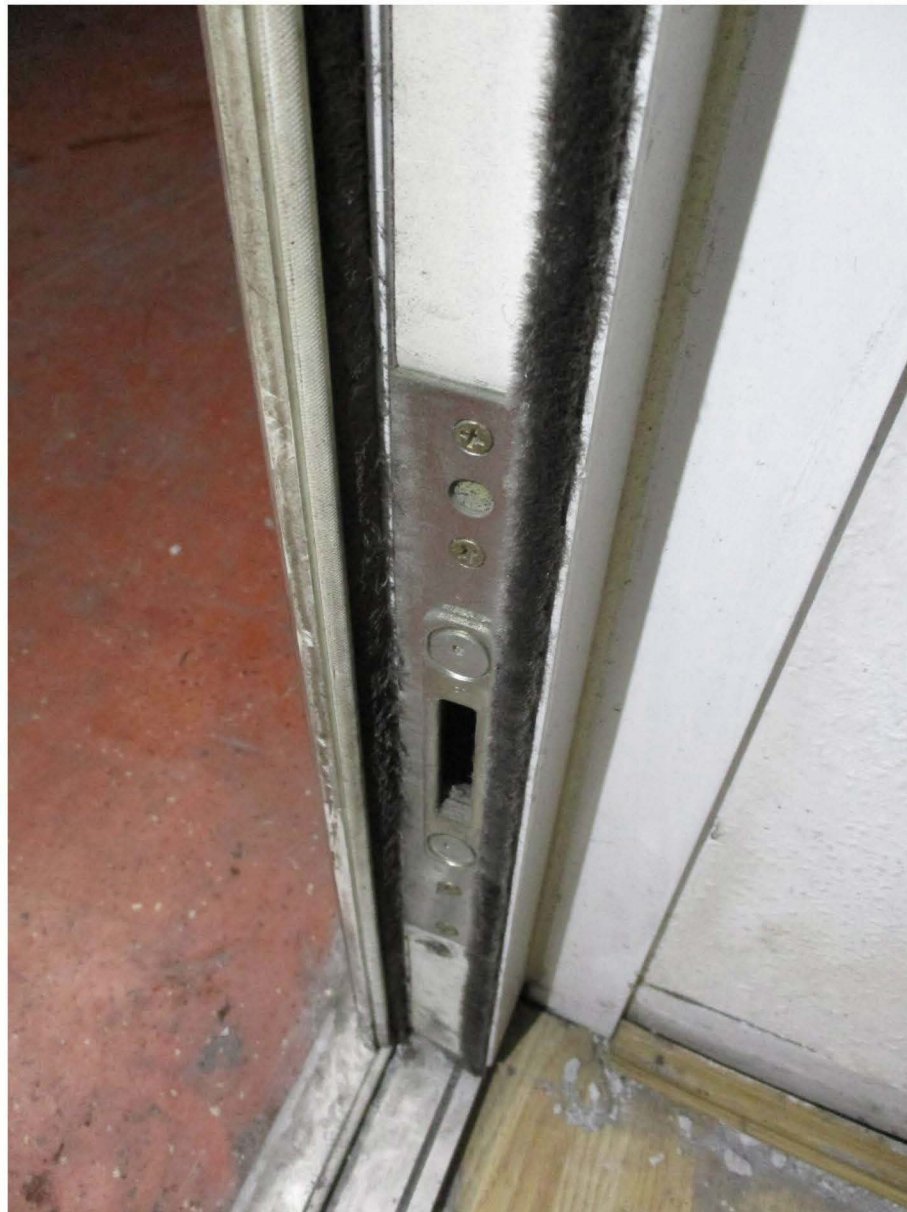
I4.5.101 The frame type on all eight of the flat fire doors inspected by my site inspection team and I were PVC/metal construction which is consistent with both the specification in the spreadsheet MAS00000003 and the test reports (report BTC 14434F (MAS00000001) and report Chilt/RF07024 (MAS00000002)).

Figure I.20: Example photo of door frame (from Flat 22)

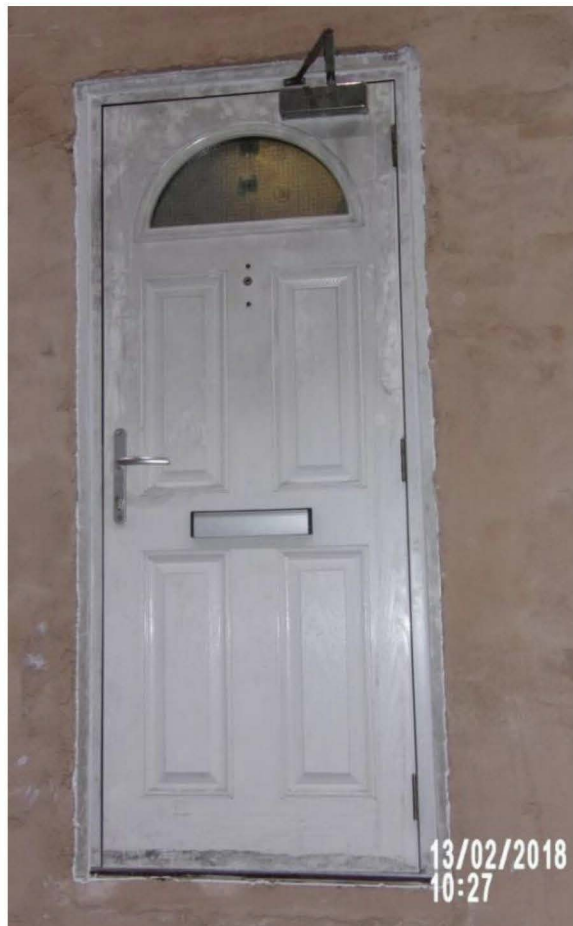
Figure I.I.21: Photograph of door assembly tested

- I4.6.8** The result of the fire test (MET00019996) show that the door achieved 15 minutes integrity. This is lower than the 30 minutes integrity required for compliance with ADB 2010.

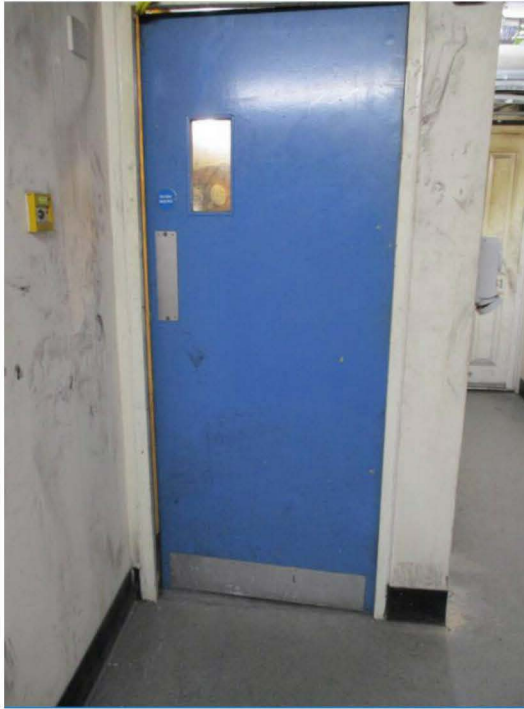
Figure I.25: Level 6 stair door

- I5.6.14** Figure I.25, Figure I.26, and Figure I.27 show photographs taken of the door to the protected stair enclosure on Level 6 during my site inspections.

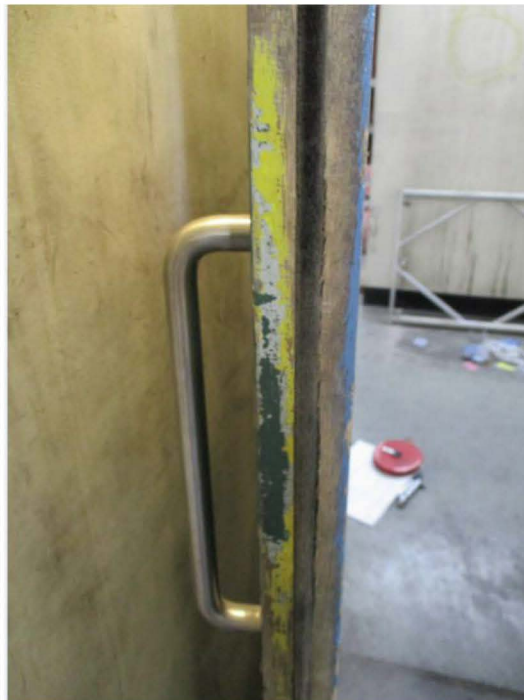
Figure I.26: Level 6 stair door (brush seal present, unknown if intumescent seal present below brush seal)

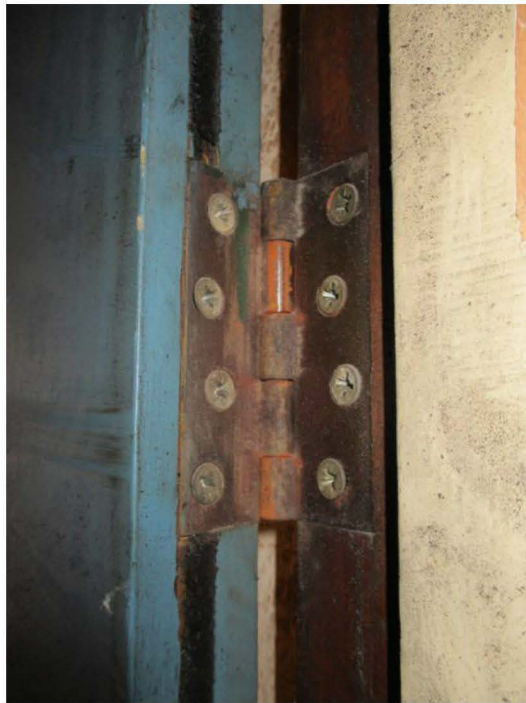
Figure I.27: Level 6 stair door (brush seal present, unknown if intumescent seal present below brush seal)

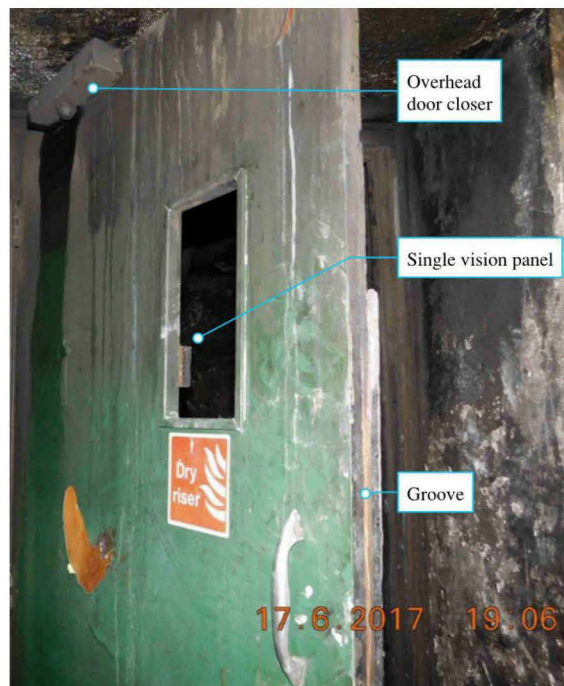
Figure I.28 Level 10 stair door (MET00018829)

I5.6.16 Figure I.28 shows the level 10 stair door. The photograph shows the closing edge of a stair door with what appears to be a groove routed into the wood. No seals can be observed in this photo in the closing edge of the door leaf. I have labelled these observations in Figure I.28.

- I5.6.19** It is unclear whether the level 10 and 19 stair doors were originally fitted with the smoke seals on the sides and top of the door leaf as I observed on the level 6 door, and heat from the fire melted them/removed them somehow, or if they were not installed at all, on the night of the fire.
- I5.6.20** The smoke leakage performance of the stair doors is not known as I am not aware of any tests of stair door samples to BS 476-31.1 “*Fire tests on building materials and structures, Section 31.1. Methods for measuring smoke penetration through doorsets and shutter assemblies, method of measurement under ambient temperature conditions*” being undertaken by BRE Global on behalf of MPS

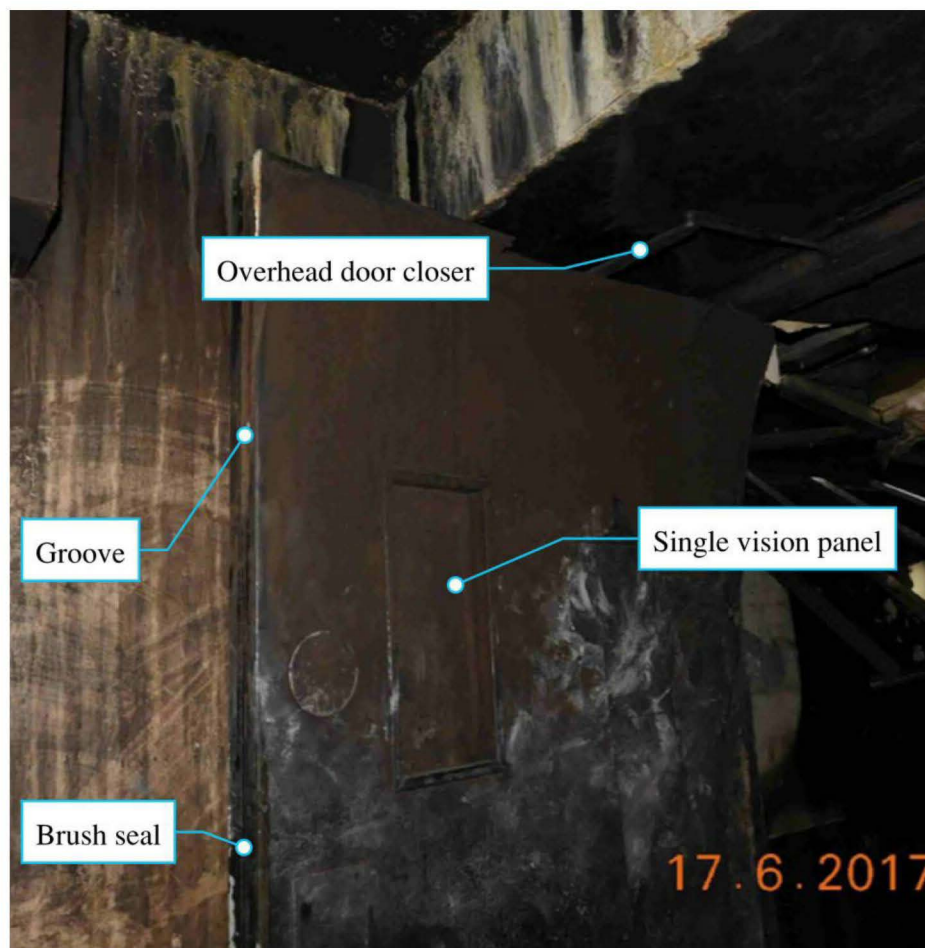
Figure I.29 Level 11 stair doors (MET00018873)

I5.6.17 Figure I.29 shows the level 11 stair door. The closing edge of level 11 stair doors contains what appears a discontinuous brush seal. I have labelled this in Figure I.29.

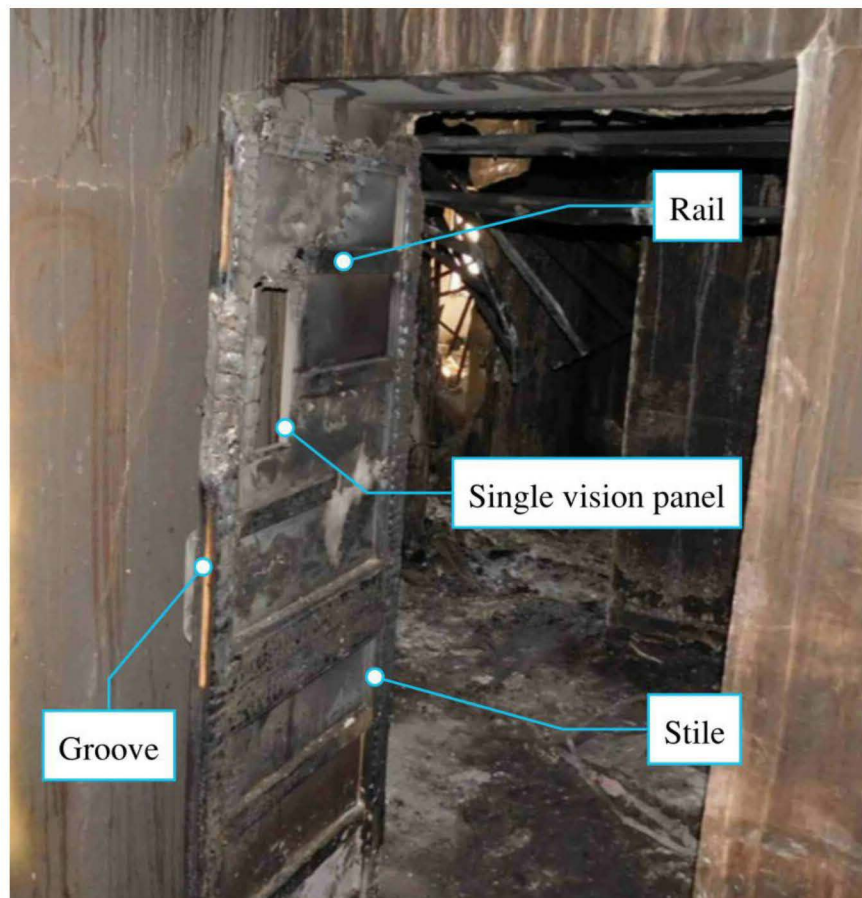
Figure I.30 Level 19 stair door(MET00018975)

I5.6.18 Figure I.30 shows the level 19 stair door. The closing edge of level 19 stair doors contains what appears to be a groove routed into the wood. No seals can be observed in this photo in the closing edge of the door leaf. The internal framing of the door is also noted as “*stile and rail plasterboard composite*” type consistent with a No. 3 Class A door from Table G of Schedule VI of the *London Building Constructional Amending Bylaws*. I have labelled these observations on the photo below Figure I.30.

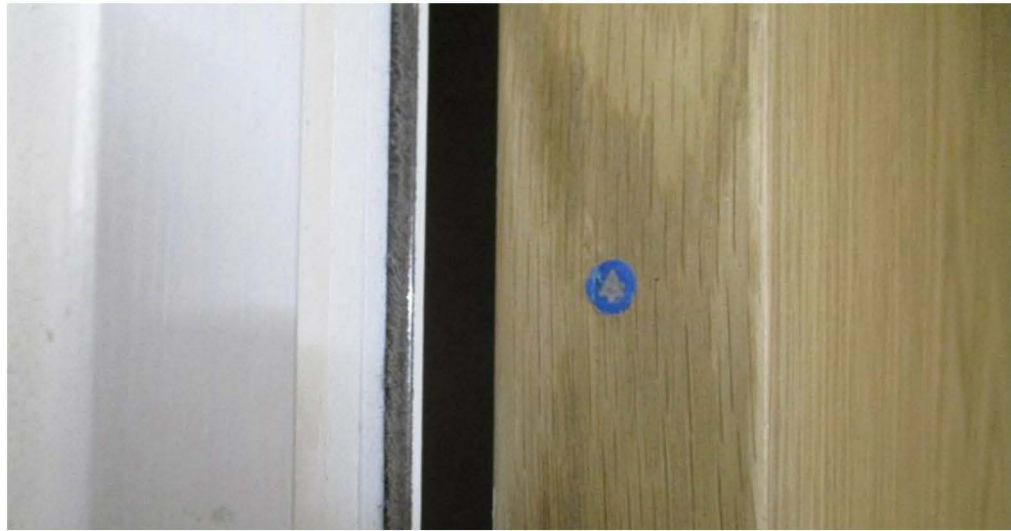
Figure I.35: fire door marking on entrance door to Flat 7 (Level 3)
