Grenfell Tower – fire safety investigation:
The fire protection measures in place on the night of the fire, and conclusions as to:
the extent to which they failed to control the spread of fire and smoke;
the extent to which they contributed to the speed at which the fire spread.

Phase 1 Report – Section 10

Routes for vertical and horizontal fire spread throughout the building envelope

Dr Barbara Lane FREng FRSE CEng

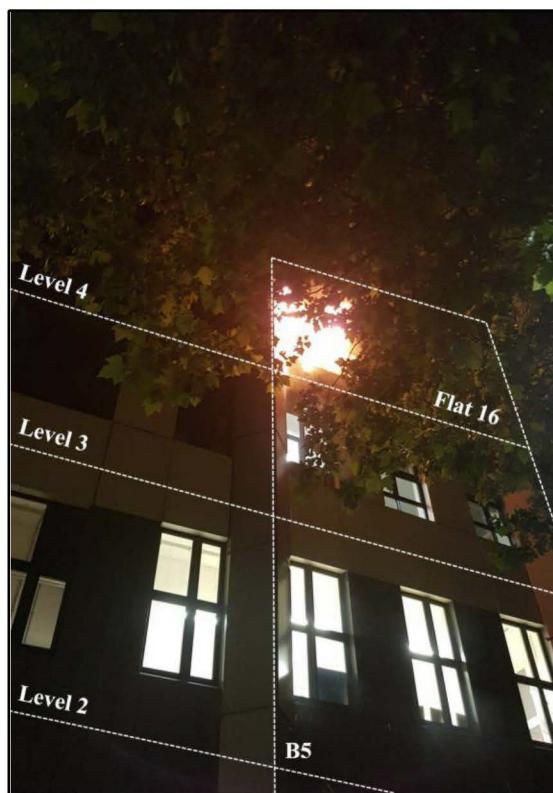
10.3.3 Figure 10.7 and Figure 10.8 show the origin and subsequent fire spread vertically up the column as a Pathway. This occurred on several other columns during the fire, and fire spread down the columns was also observed for example as shown in Figure 10.9.

Figure 10.7: Earliest image of external fire observed on Level 4, at 01:14 on 14 June 2017 (MET00006589)

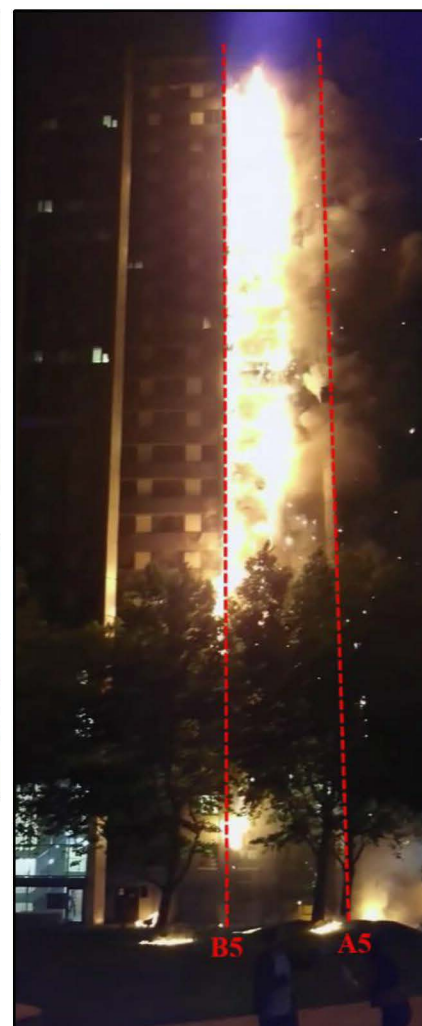
Figure 10.8: Fire on the full height East elevation of the building envelope on 14 June 2017, estimated time 01:26³

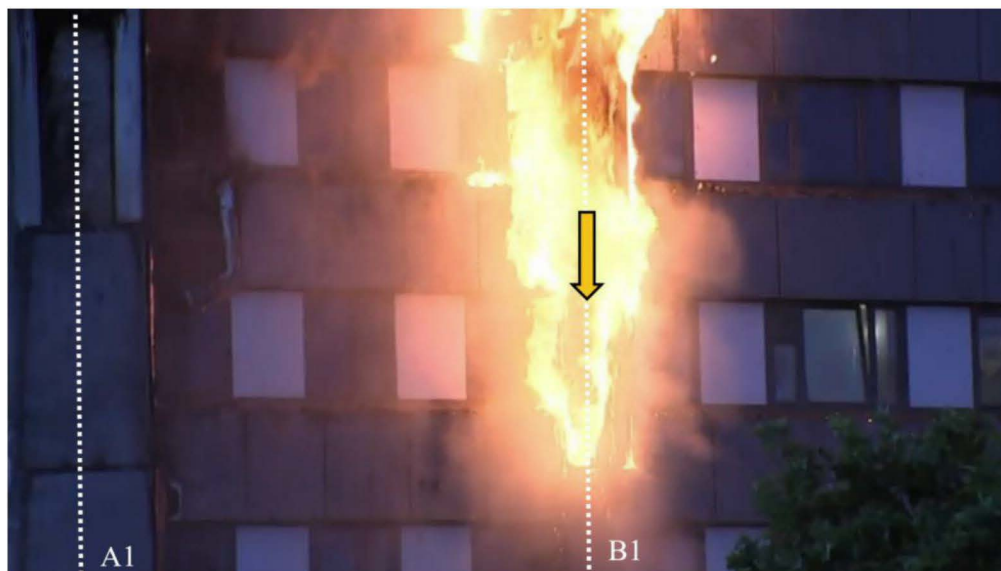
10.3.4 Figure 10.9 shows fire spread vertically down a column as a Pathway.

Figure 10.9: Downwards fire spread along column B1 on the West elevation⁴

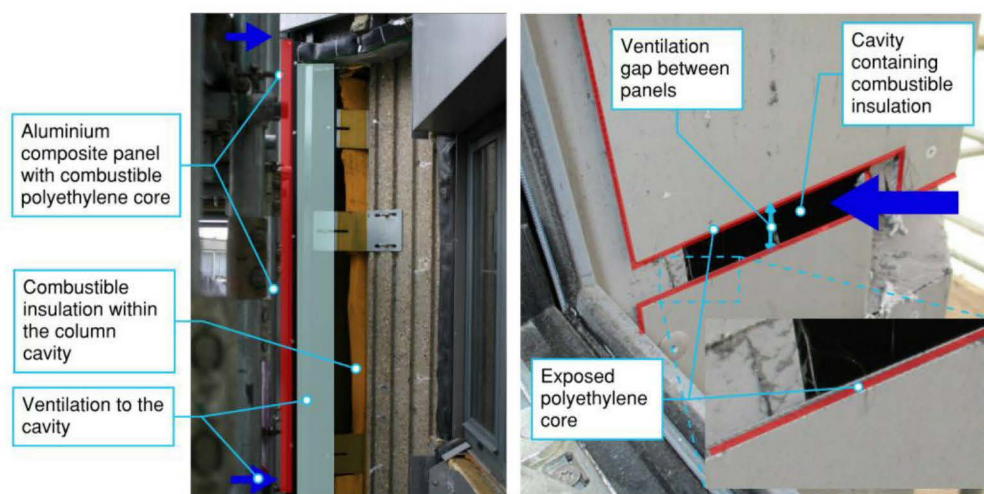
10.3.13 Figure 10.10 shows photographs taken of the column outside Flat 13 (left) and the column outside Flat 11 (right). In the left hand image, the rainscreen panels and insulation have been removed from the nearest half of the column, to show the layers on materials on the other half of the column. Figure 10.10 also identifies routes for air to pass into the cavity behind the Reynobond rainscreen cladding panels. The right hand image shows the construction of the panels featuring the exposed PE core material around all edges of each panel.

Figure 10.10: Images of available fuel and ventilation within column cavities from Grenfell Tower site inspection (left image – Flat 13, right image – Flat 11)

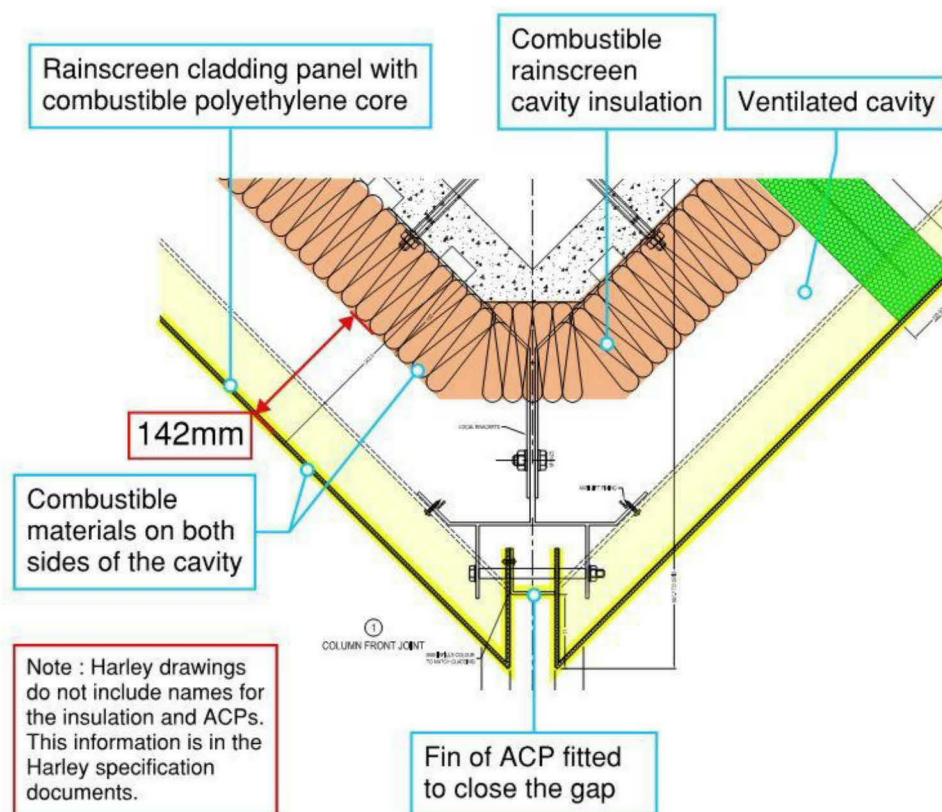
10.3.14 Figure 10.11 shows a marked up horizontal section drawing through a column identifying each of the components, and the resulting cavity between the face of the Celotex RS5000 insulation and the rear of the Reynobond 55 PE rainscreen cladding panel. This was approximately 140mm in depth. This image also shows the construction of the panels at the column nose, where the panels fold over and a separate fin of ACP is fitted to close the gap.

Figure 10.11: Harley design drawing showing column in plan view showing that both interior surfaces of the cavity contain combustible materials (Based on HAR00008902)

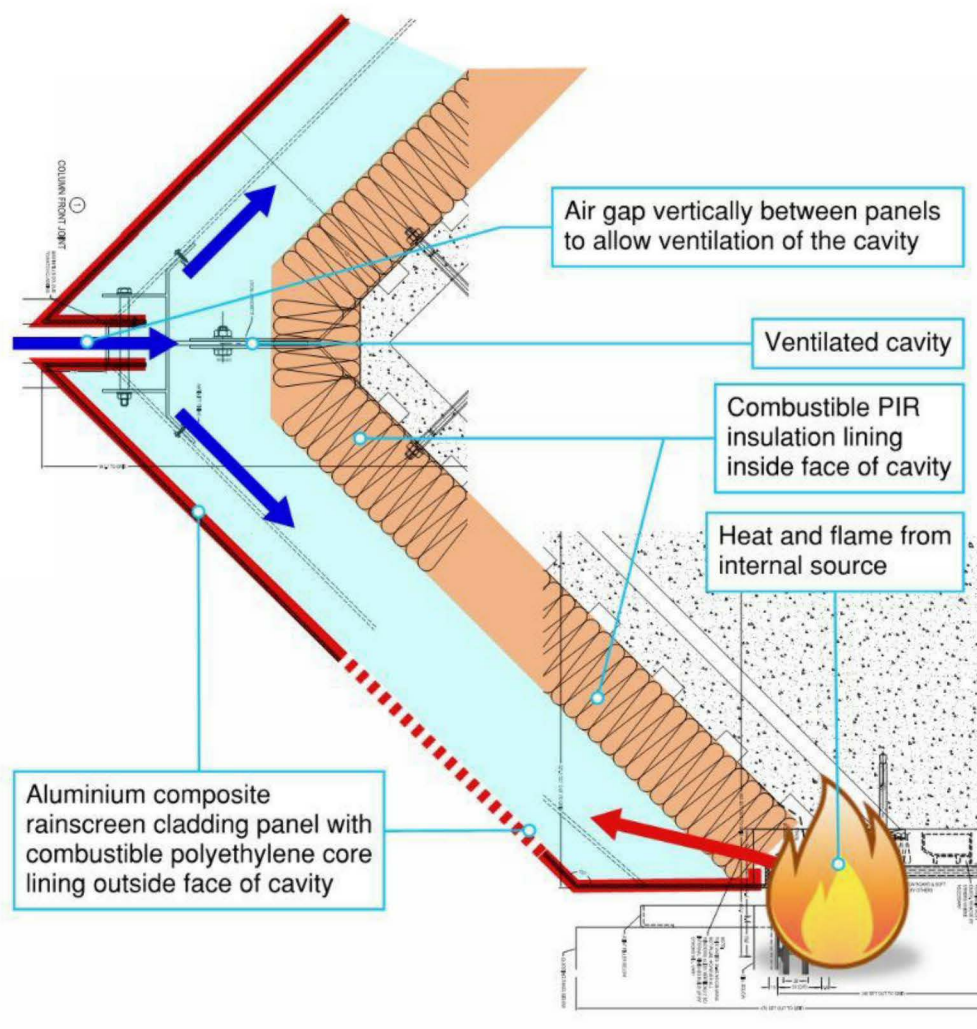
- 10.3.25** Cavity barrier/fire stops were fitted in the construction with the purpose of restricting the spread of smoke and flames through the rainscreen cavity. In the next section I describe how these barriers were ineffective [please also refer to Section 11 of my report].

Figure 10.12: The fuel, ventilation and heat available within the column cavity of Grenfell Tower adjacent to Flat 16 (based on Harley drawings HAR00008880 & HAR00008902) to support combustion (dotted line denotes continuation of panel between underlying drawings)

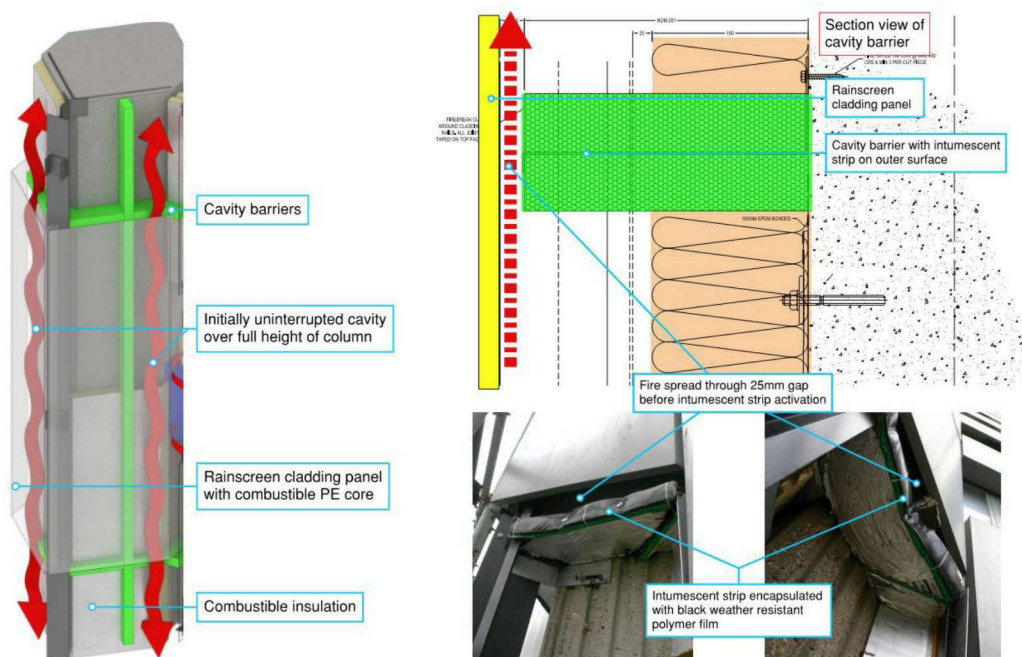
10.3.37 **Horizontal cavity barriers** - The initial condition of the cavity is that it is continuous up the full height of the column, prior to activation of the intumescent coating (Figure 10.17):

Figure 10.17: Continuity of the cavity within the column rainscreen over cladding system and evidence of 25mm gaps at locations of cavity barriers (Photos external of Flat 14). (HAR00008901)

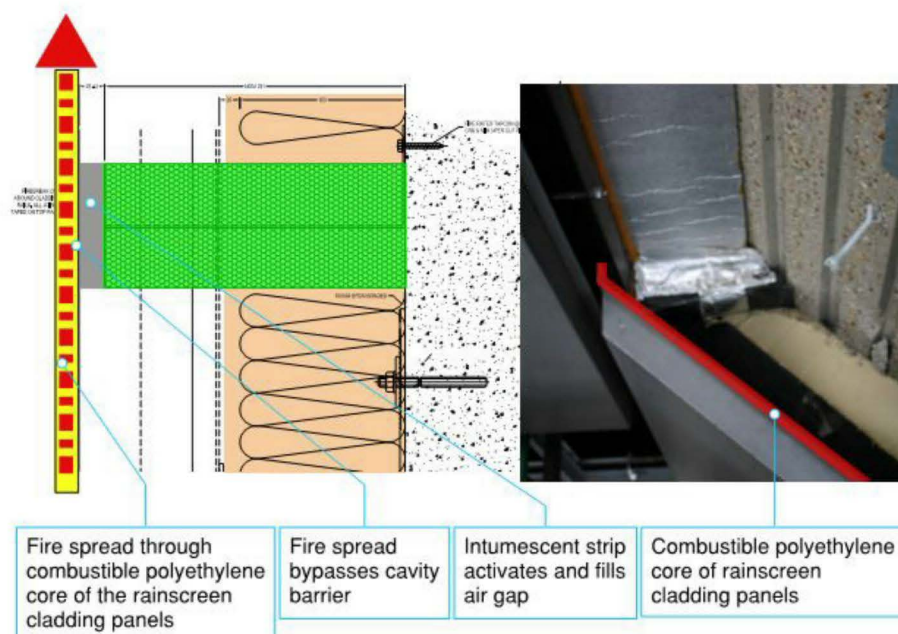
10.3.38 Horizontal & vertical barriers – The combustible polyethylene core of the rainscreen cladding panel itself provides a route of fire spread, bypassing the cavity barriers (Figure 10.18):

Figure 10.18: Fire spread through the combustible rainscreen cladding panel core (Photo external of Flat 14) (HAR00008901)

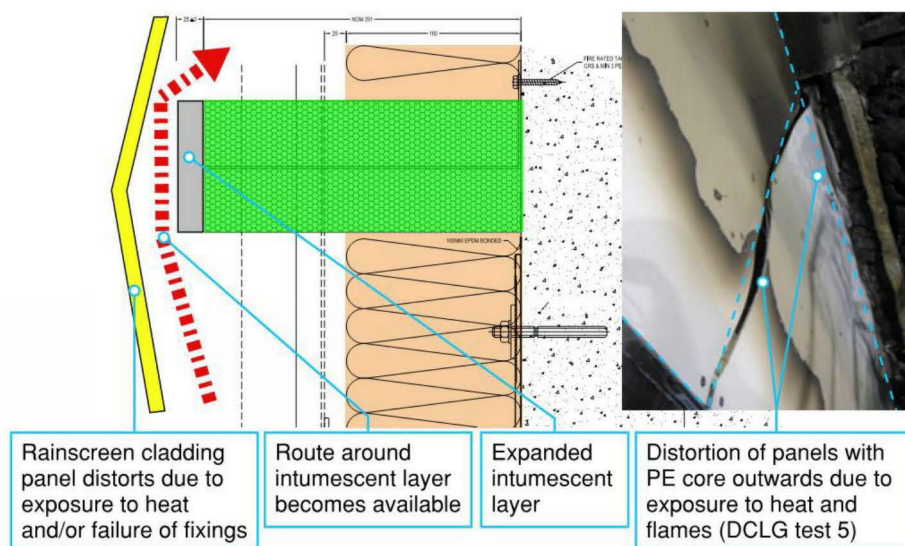
10.3.39 Horizontal & vertical barriers – Rainscreen cladding panels can distort when heated, either through heating of the panel itself or by failure of the supporting fixtures. This can allow further gaps between the cavity barriers and the rainscreen cladding panels to form (Figure 10.19):

Figure 10.19: Integrity failure of rainscreen cladding (HAR00008901) (photo: CLG00016837)

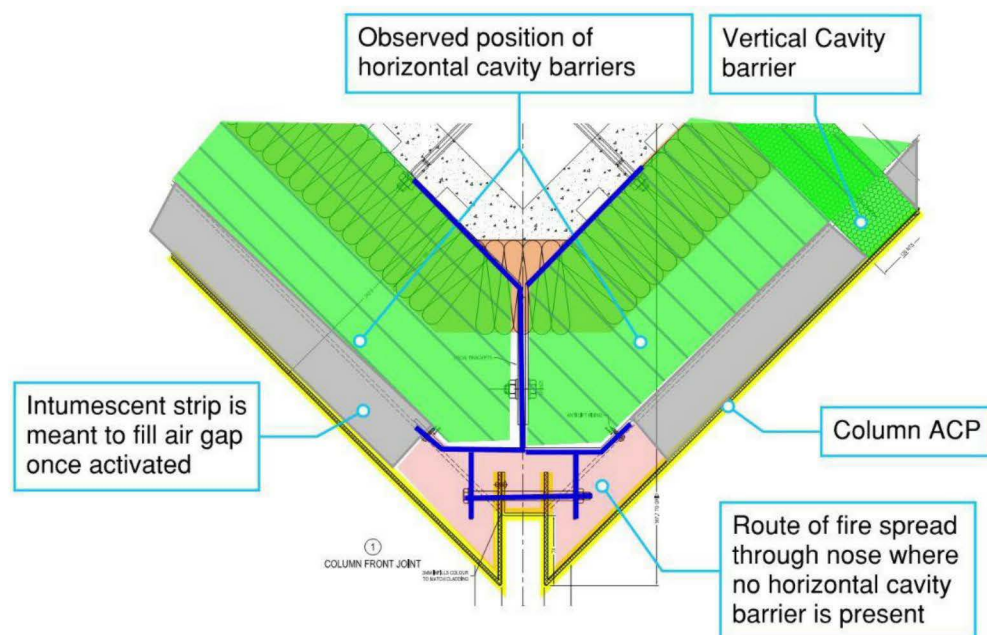
- 10.3.40** The performance of the cavity barriers in restricting the spread of fire was also compromised at the nose of the column, due to the specific geometry of the ACP and support bracket. As illustrated in Figure 10.20, a gap where the horizontal cavity barrier was not present existed at the nose, which provided another route of fire spread past the horizontal cavity barriers.

Figure 10.20: Harley design drawing showing column in plan view showing a gap where the horizontal cavity barrier was not present at the nose of the columns (Based on HAR00008902)

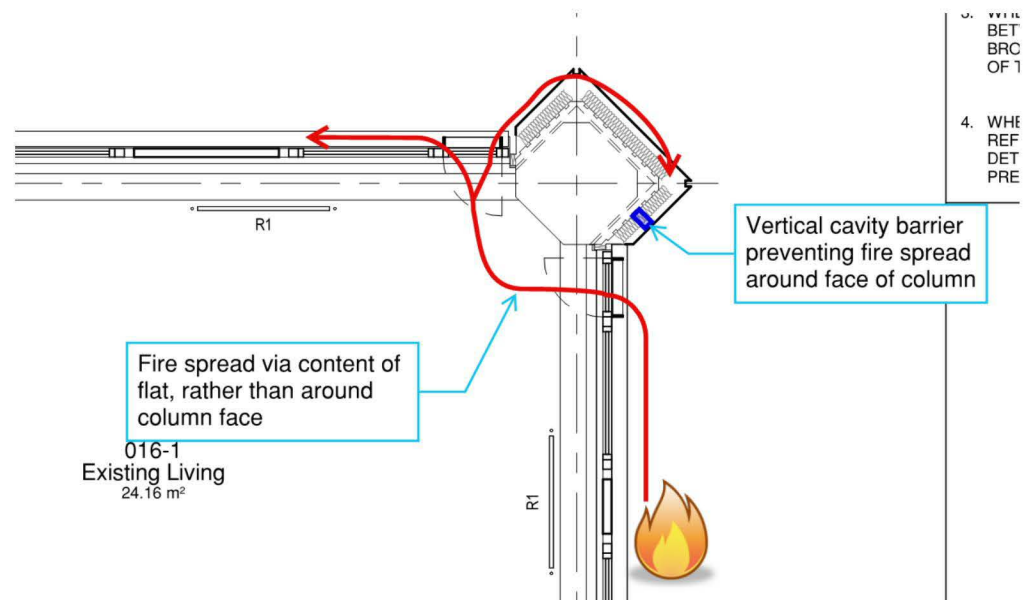
- 10.3.41 Columns with no vertical cavity barriers** – In this case the column contains no impediment to the horizontal spread of fire around the building envelope (For example Column A2, A4, D2 and D4).
- 10.3.42 Corner columns with vertical (and horizontal) barriers** – as described in Section 9, the materials and construction of the window installations also provide a Pathway for fire to spread rapidly between the flats and the rainscreen cavity (from inside to outside, and vice versa). This introduces a further avenue for bypassing the vertical cavity barriers situated on the corner columns (Figure 10.21):

Figure 10.21: Route for fire to bypass corner column cavity barrier (based on SEA00010474)

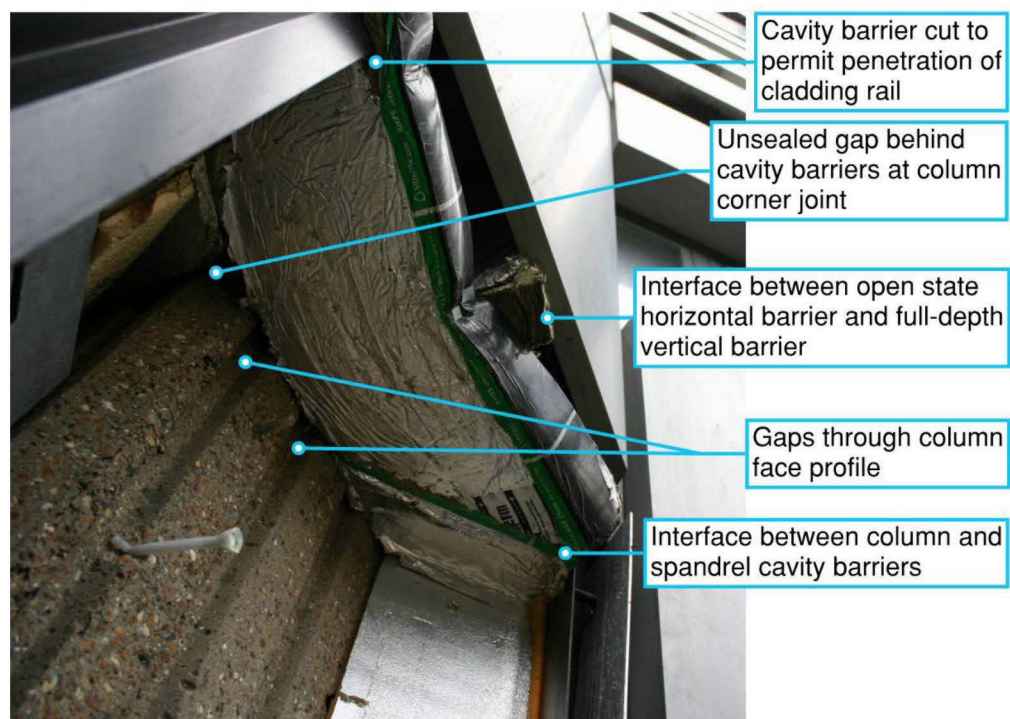
- The same product (Siderise RH25 with an intumescent strip) used for horizontal cavity barriers was used for the vertical cavity barriers, with the intumescent strip facing the concrete.

Figure 10.22: Horizontal column cavity barrier example - floor 4, external Flat 12.

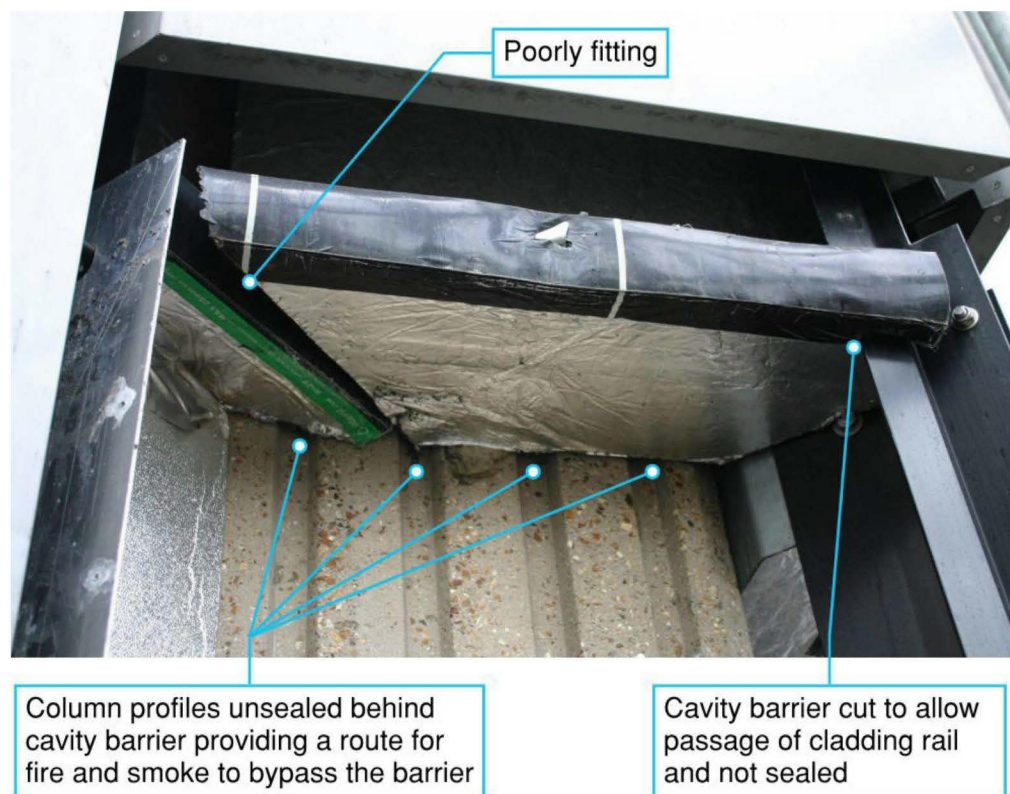
Figure 10.23: Horizontal cavity barrier in column cavity - floor 4, external Flat 12.

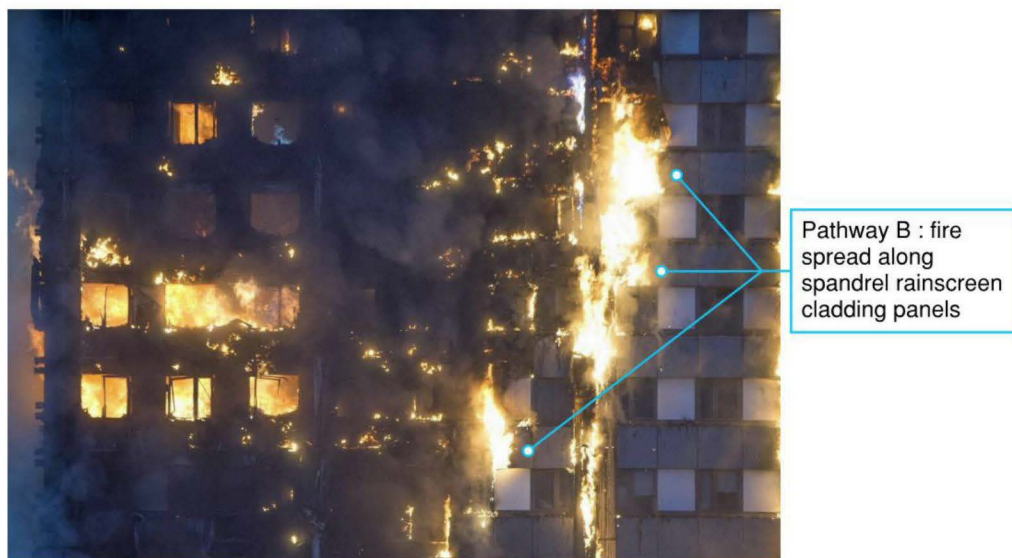
10.4.2 Specific evidence of fire spread via this Pathway is presented in Figure 10.24. Additionally, this Pathway is evident in Figure 10.30 and Figure 10.34.

Figure 10.24: Evidence of fire spread along Reynobond panels⁵

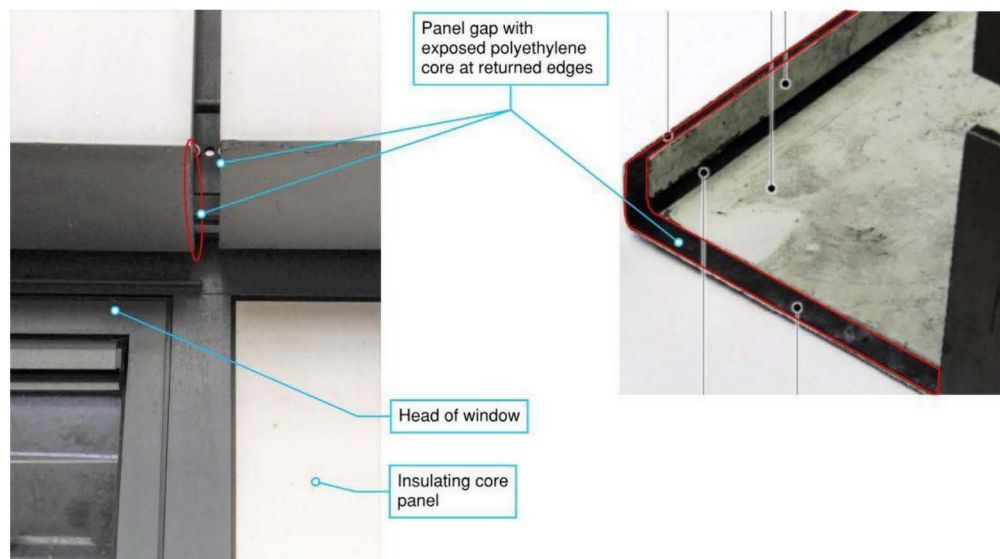
Figure 10.26: Photograph outside Flat 10 showing gaps (with combustible PE core exposed at panel edges) permitting air into the cavity (also refer to Figure 10.2) (Prof. Bisby's phase 1 report figure 20)

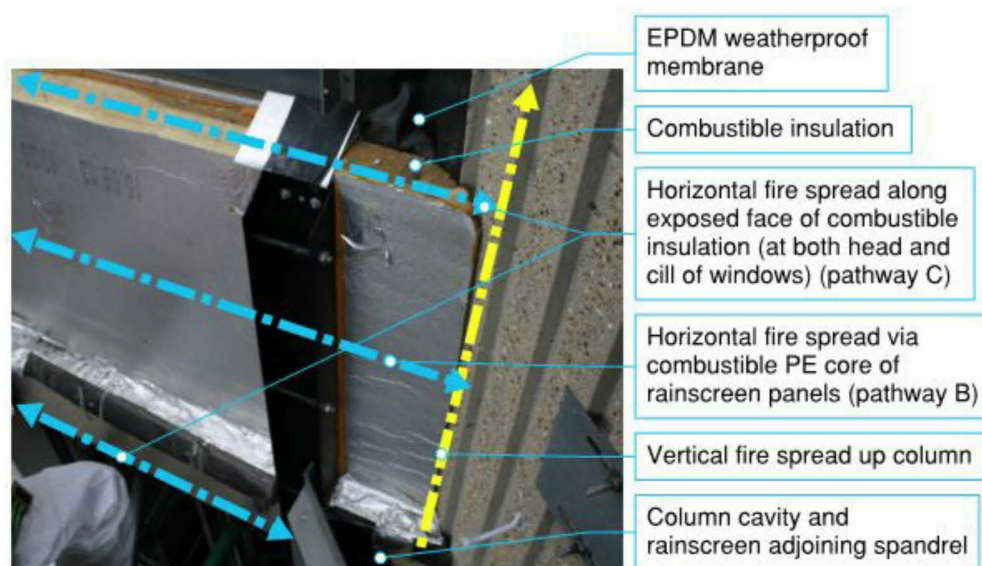
- 10.4.13** As identified in Figure 10.28, the exposed edges of the insulation support flame spread to a greater extent than if the edges had been covered in aluminium foil taping. PIR or PF insulation covered by aluminium foil has a higher resistance against flame spread compared to the uncovered material. This is because the aluminium foil covering acts to reflect radiant heat, and to prevent flames from reaching combustible gasses being released as the PIR heats up. However, this protection only lasts until the thin layer of aluminium is damaged or destroyed by the fire. So in the early stages of fire spread across the material, the cut edges will be more prone to support flame spread.

Figure 10.28: Exposed insulation in spandrel panel rainscreen cavity (External Flat 14)

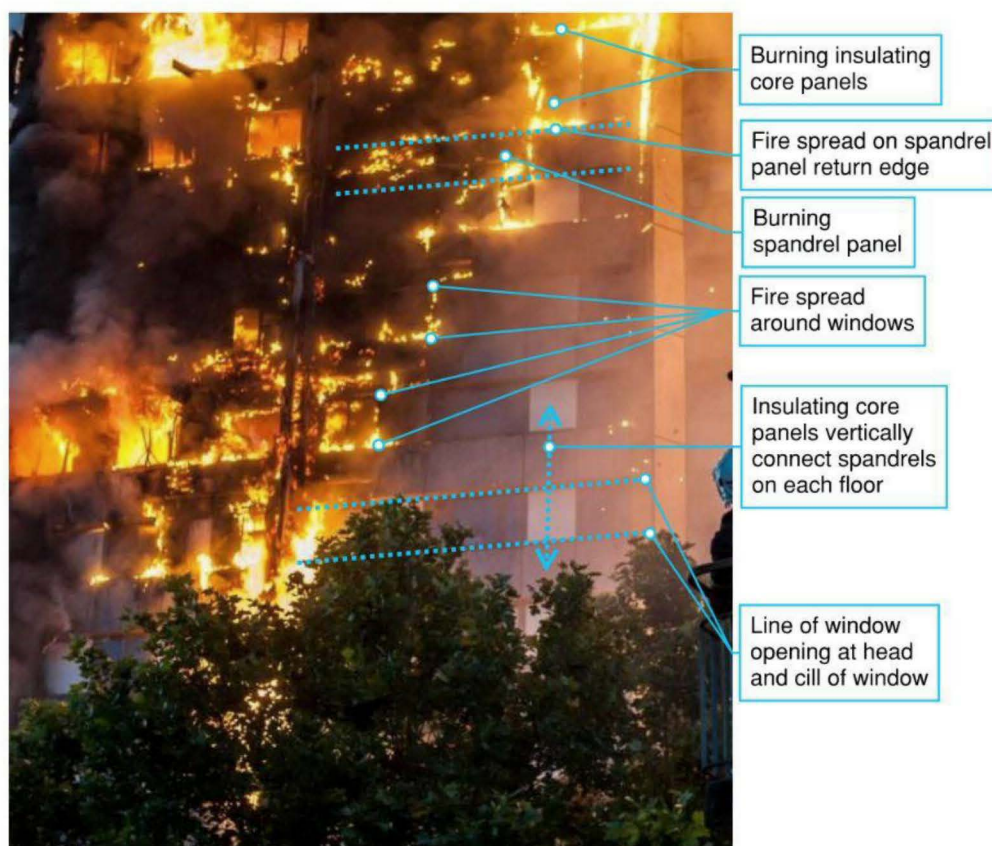
10.5.2 Fire spread was observed along the line of the window openings (all sides), as shown in Figure 10.30, and along the edges of the infill panel:

Figure 10.30: Photo evidence of fire spread observed along the line of window openings, at head and cill⁶

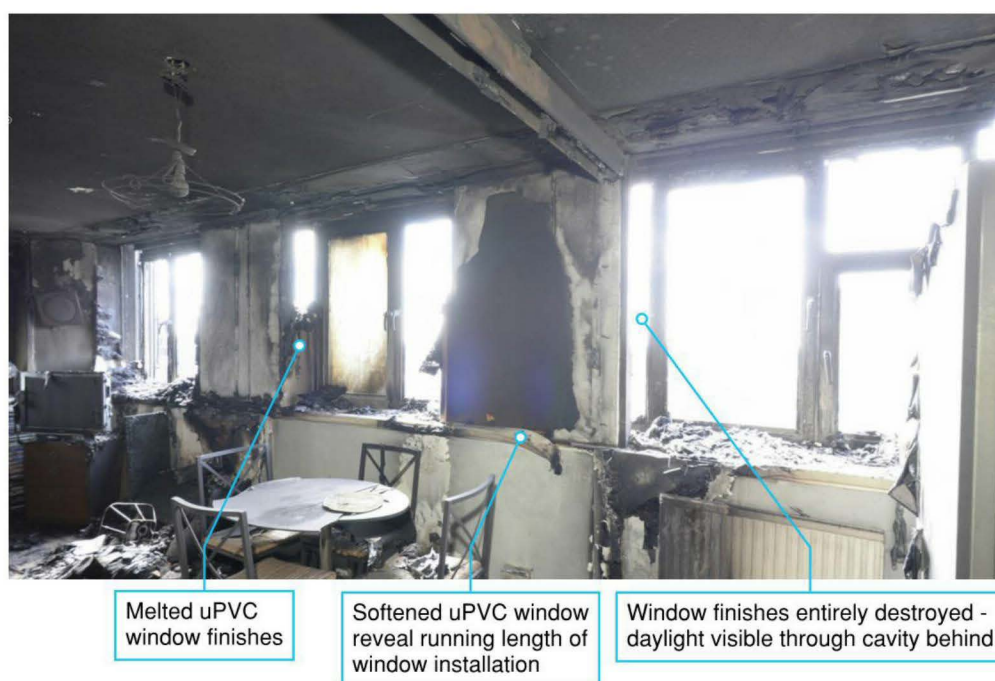
Figure 10.32: Internal example showing the uPVC cill reveal spanning the length of the window internally, passing by the inside of the original in-fill panel

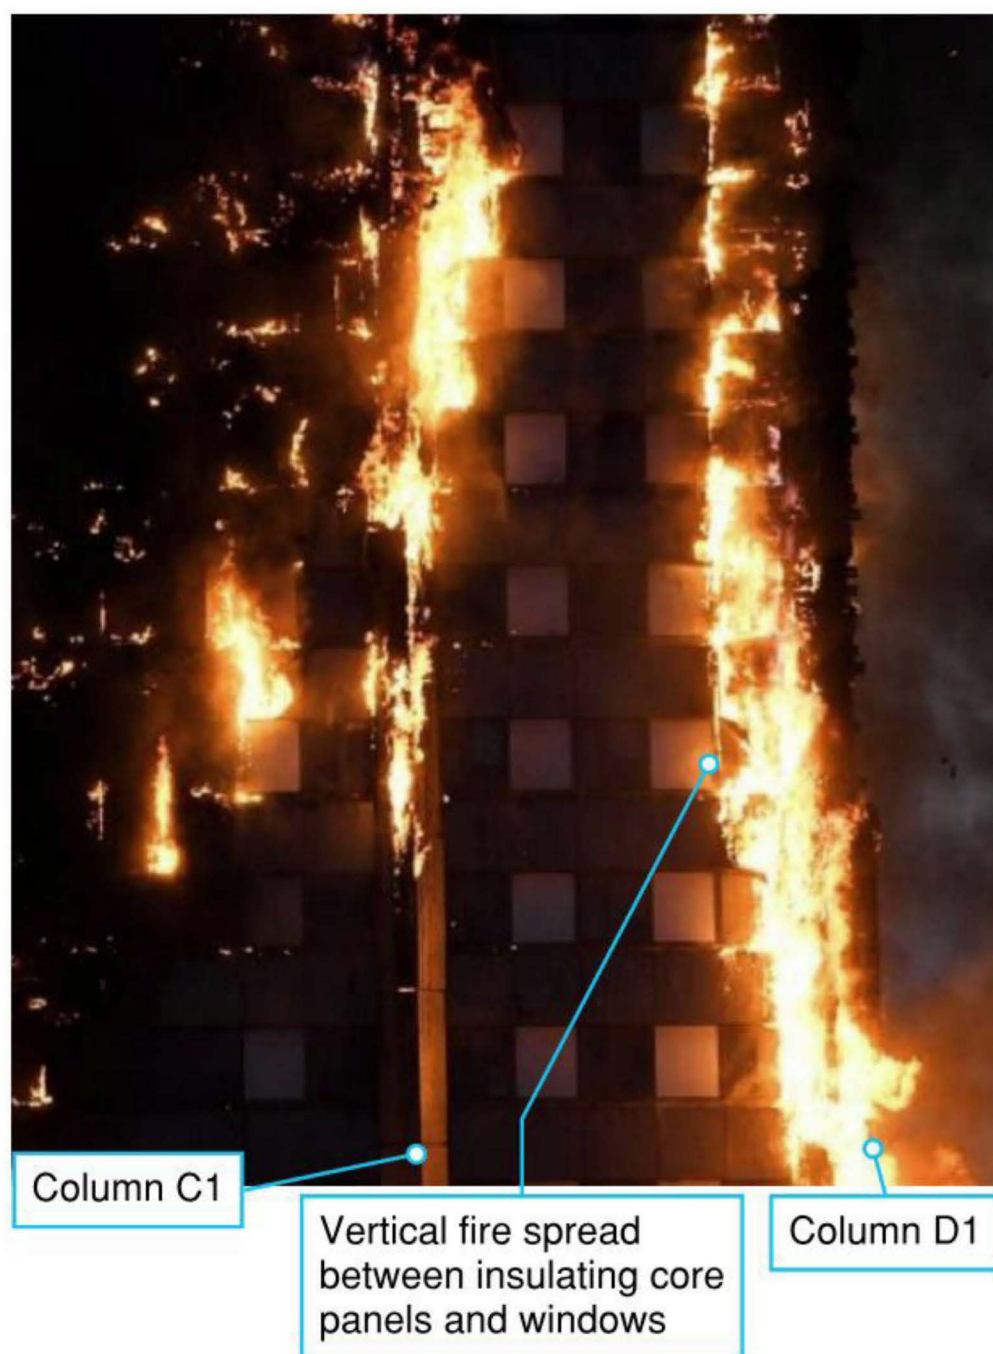
10.6.2 Figure 10.34 provides evidence that fire spread vertically along the edges of the window and the edges of the infill insulating core panel. Figure 10.34 shows external fire spread observed between columns C1 and D1, where Route 1 and 2 (Figure 10.1) met on the West elevation.

Figure 10.34: Photo evidence of vertical fire spread at the junction between the insulating core panels and windows⁷

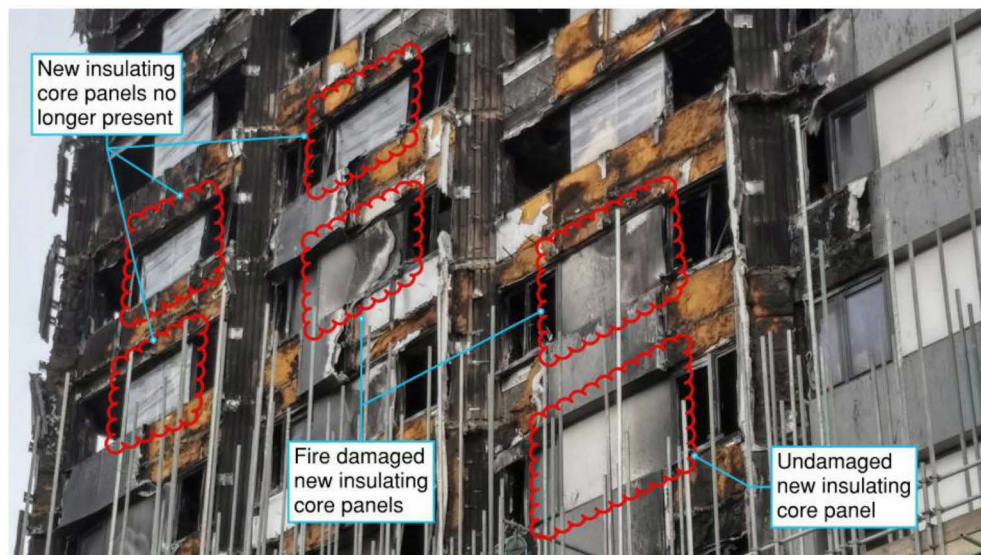
- 10.6.9** It can be seen in the case of the fire damaged panels that the aluminium skin has failed and revealed the 25mm Styrofoam XPS core, allowing oxygen in the air to access the fuel surface.

Figure 10.35: Evidence of fire damage to new insulating core panels

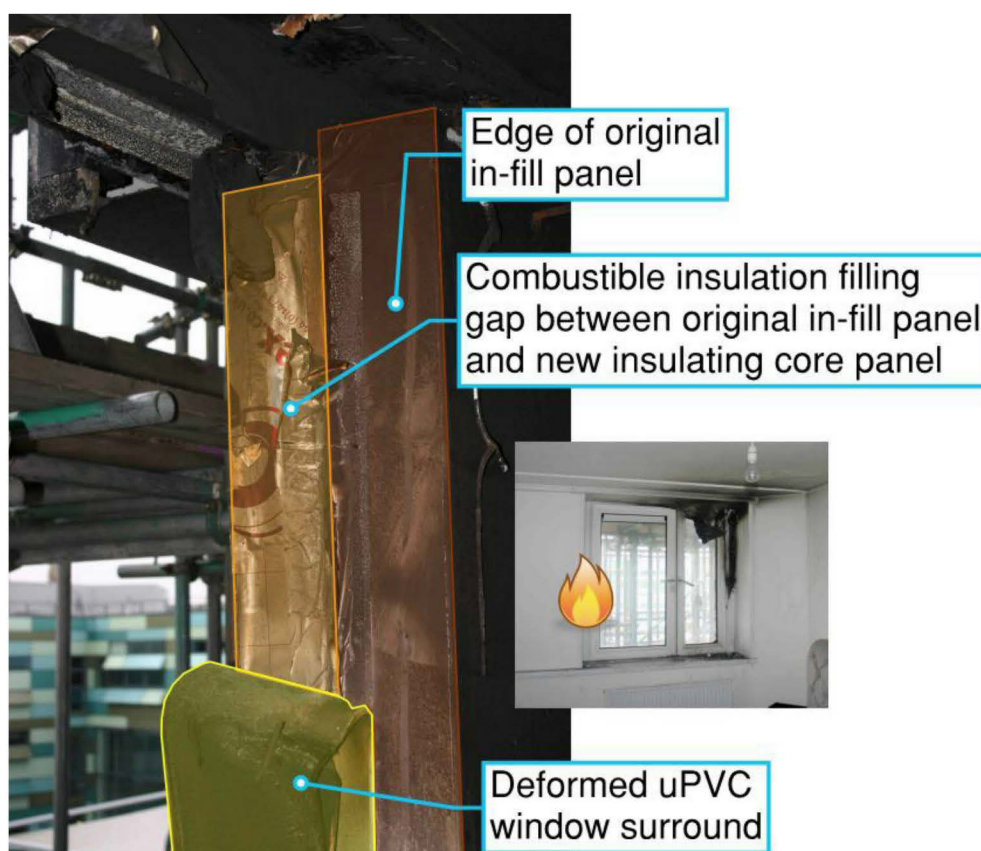
Figure 10.36: Effect of fire on the infill panel side of the window (Flat 16 living room window) with example location inset

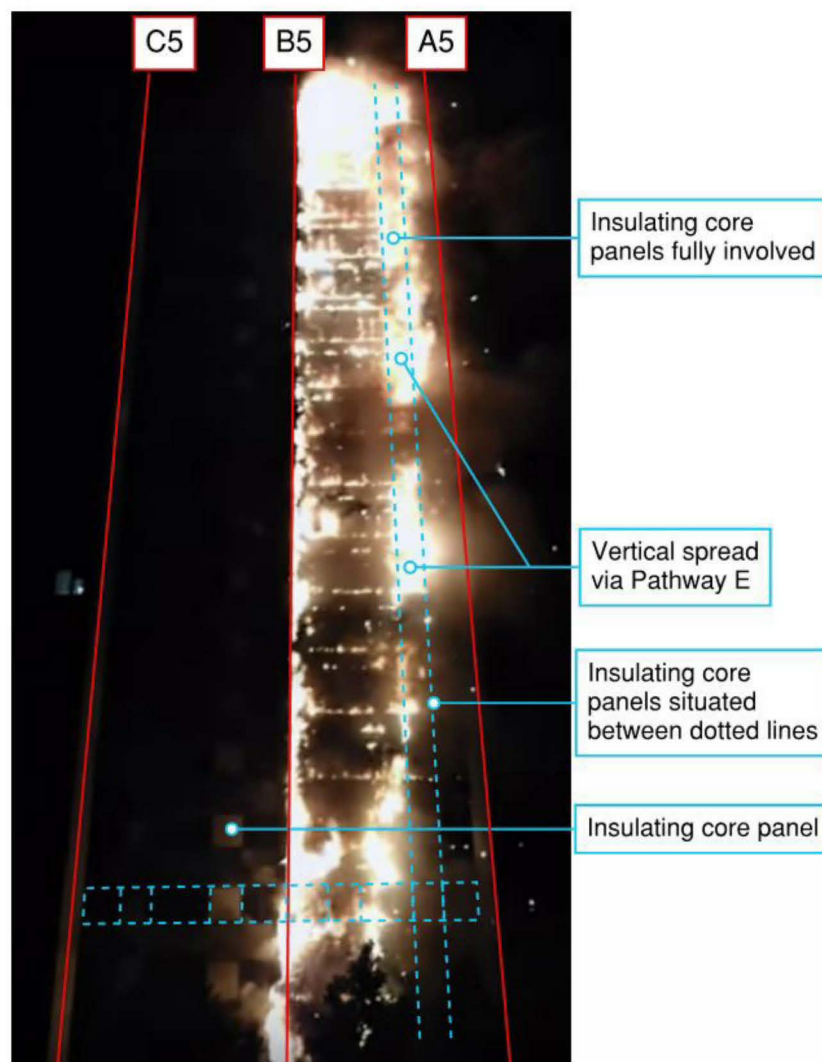
Figure 10.37: Photo evidence of vertical fire spread up insulating core panels, estimated time 01:26⁸

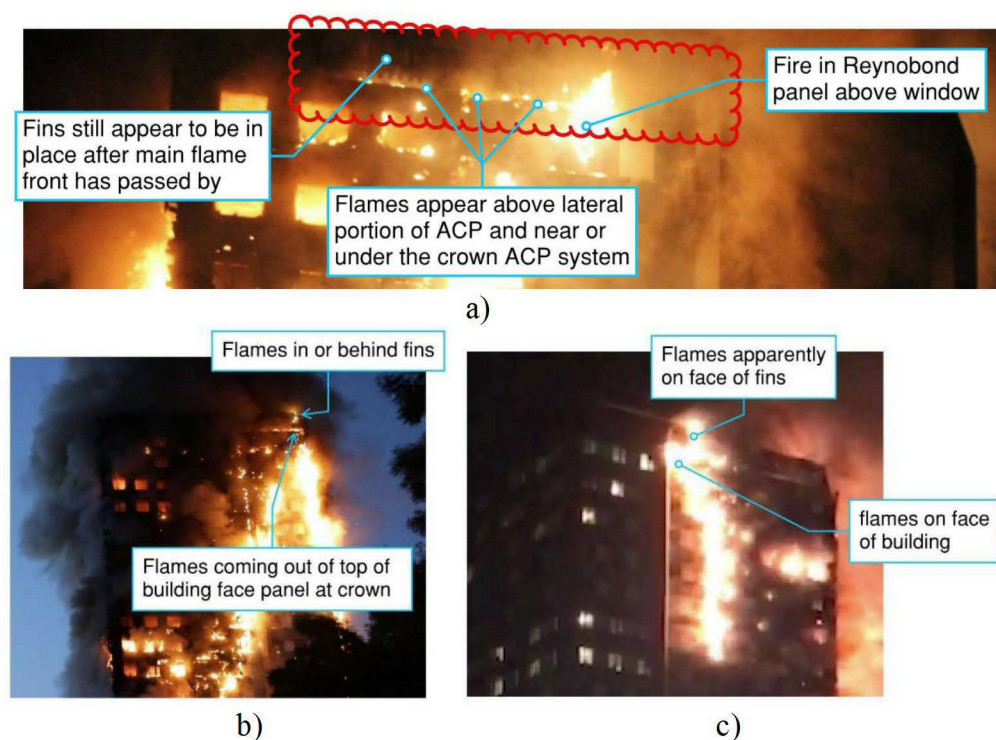
10.8.2 Fires were observed to be burning in and around the crown cladding construction, as shown in Figure 10.39.

Figure 10.39: Fire in the crown construction (see Video 5 accompanying Prof. Bisby's supplemental Phase 1 report)^{9, 10}

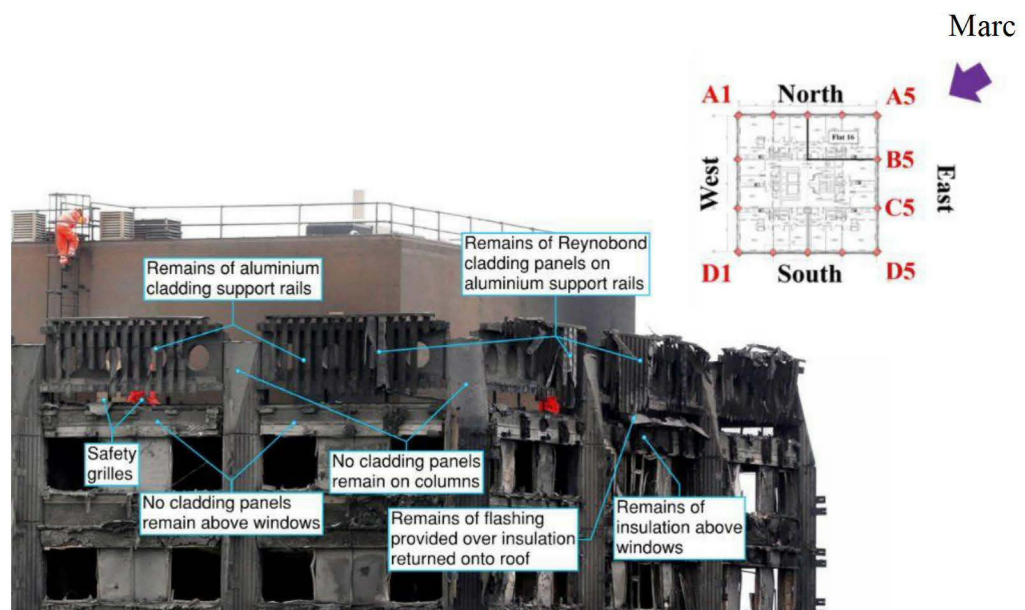
Figure 10.40: Post fire remains of crown cladding¹¹ (Plan drawing: SEA00010474)

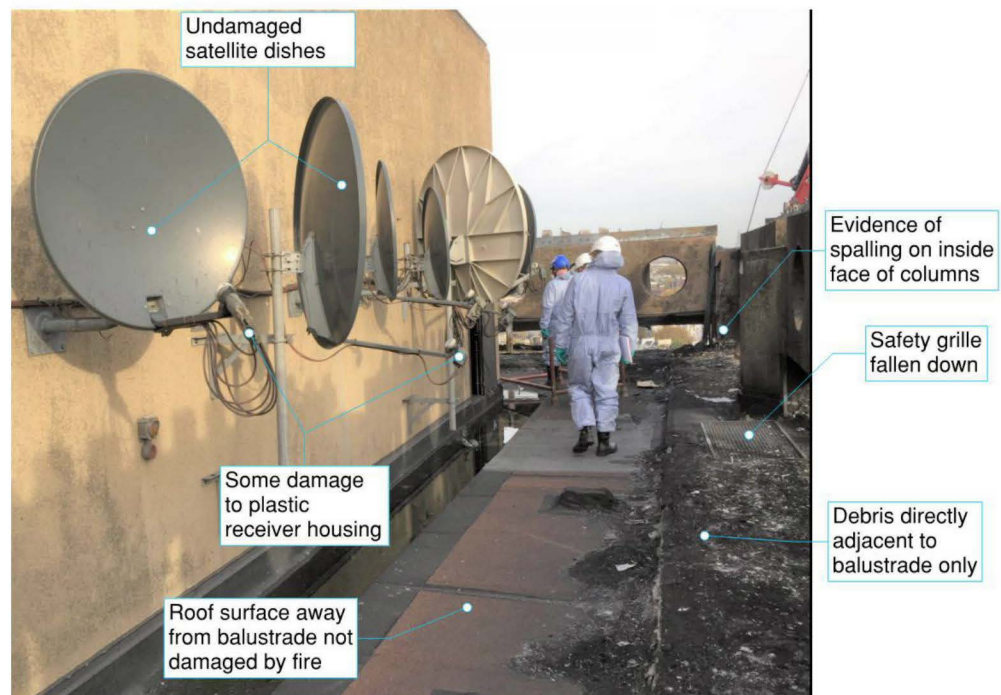
Figure 10.44: Evidence of post-fire condition along the South of the roof taken during my inspection [South]

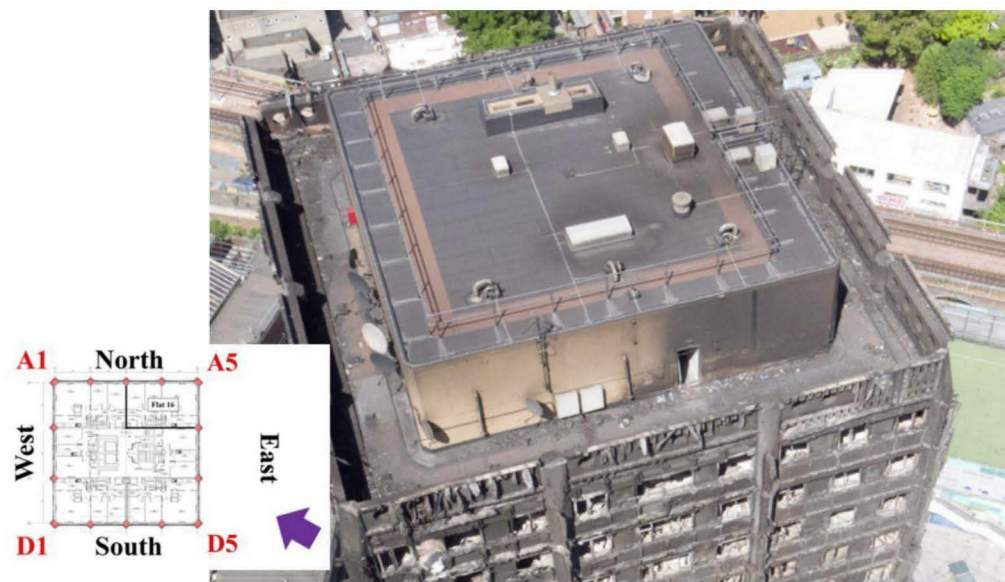
Figure 10.45: Aerial view of overall roof conditions post-fire [East] (MET00012593)

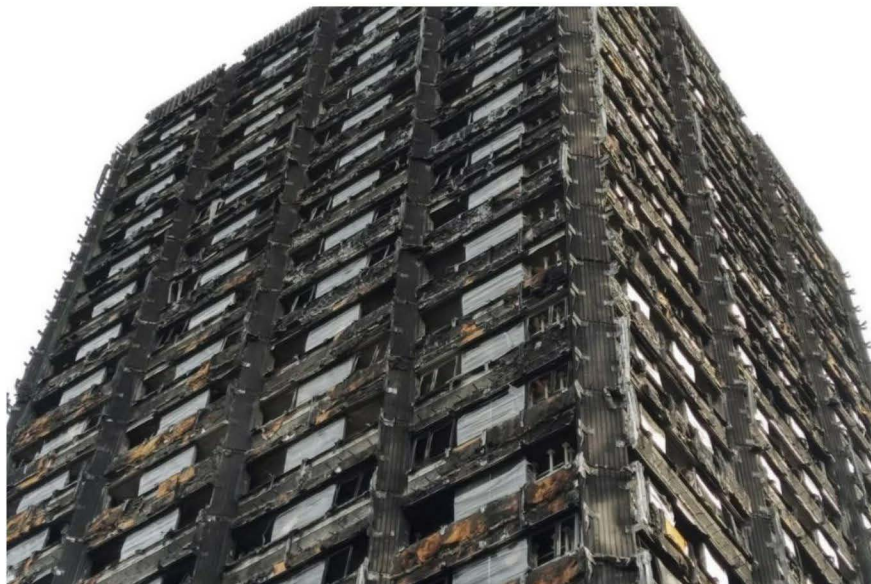
Figure 10.50: Reynobond 55 PE panels and Styrofoam XPS insulating core panels destroyed in all areas

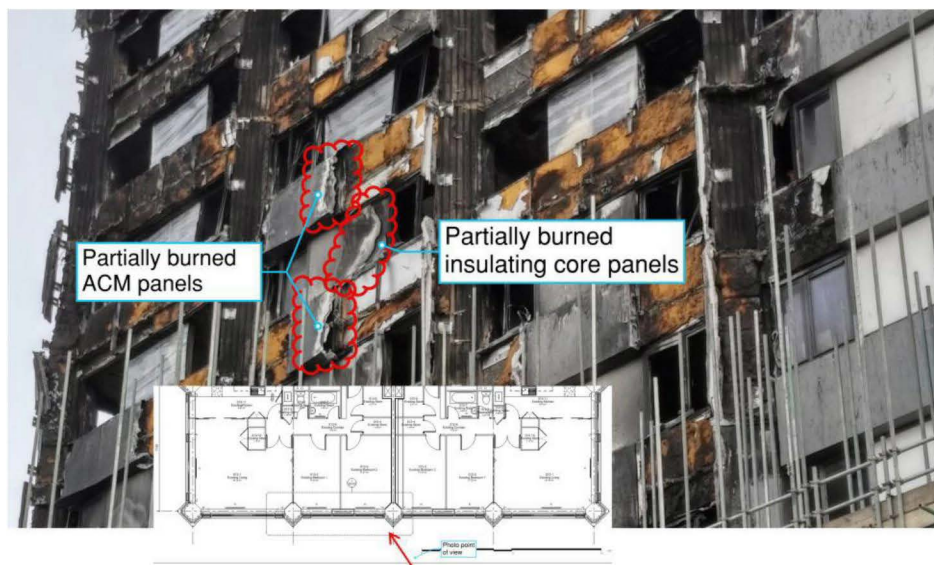
Figure 10.51: Partially burned Reynobond 55 PE panel and Styrofoam XPS insulating core panel on South façade on lower levels

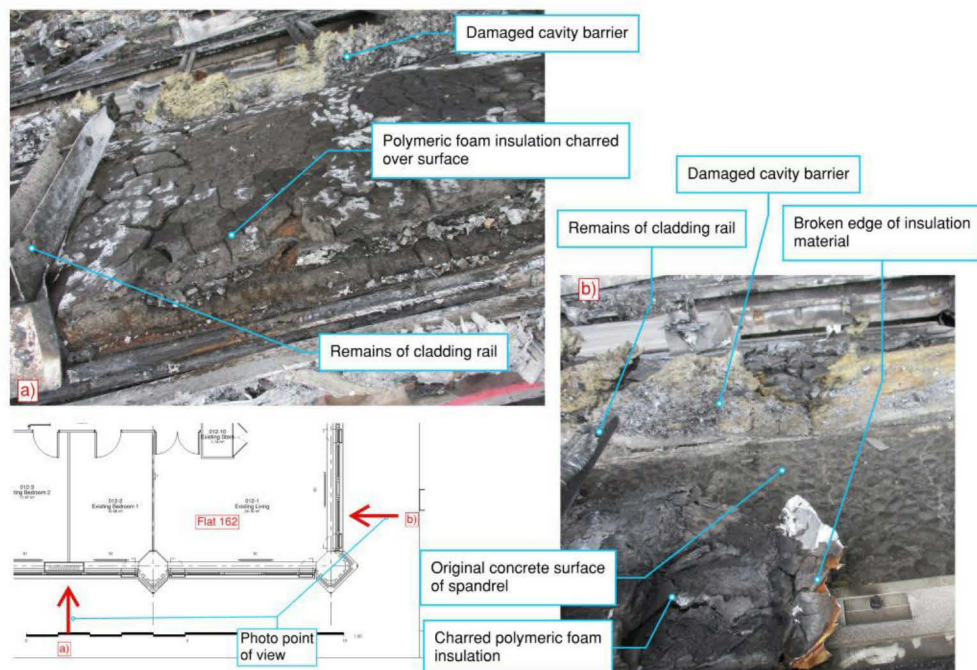
Figure 10.52: Charred polymeric foam insulation on the outside of Flat 162 (photos taken looking down out of window)

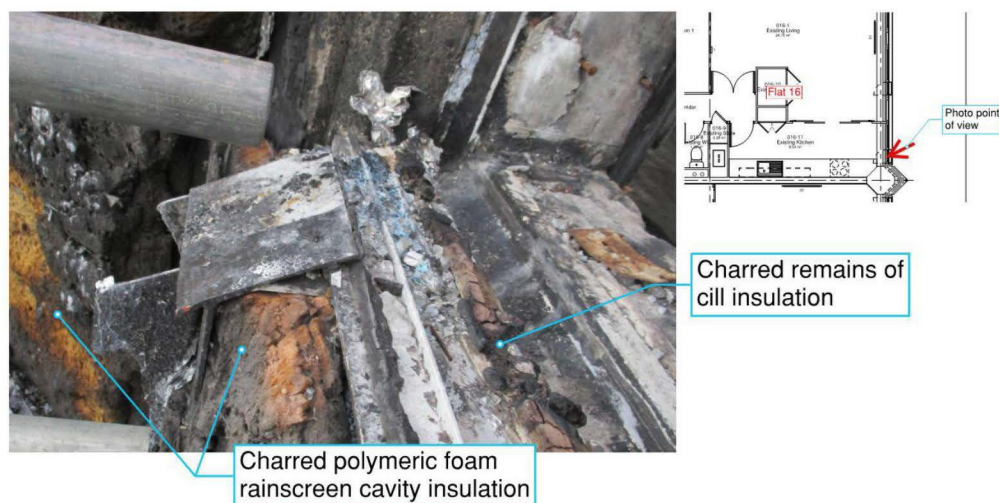
Figure 10.53: Charred polymeric foam insulation in cill cavity and in rainscreen cavity

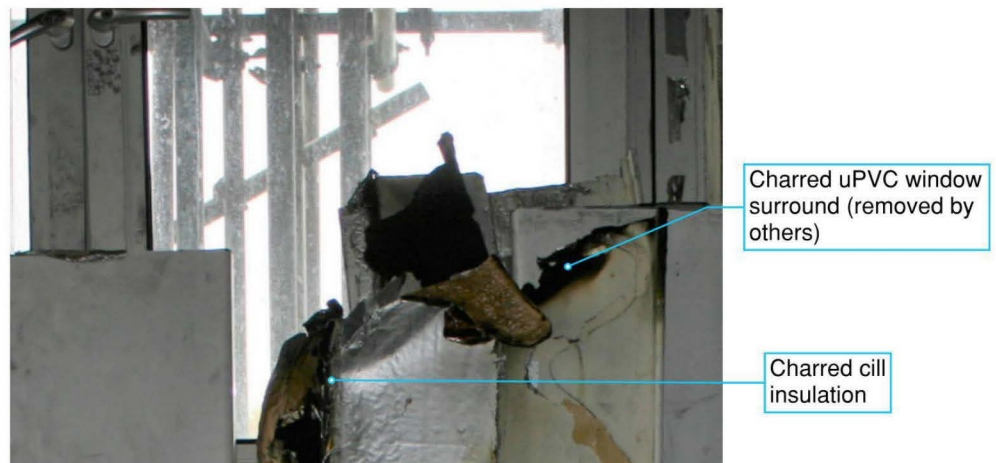
Figure 10.54: Evidence of burned uPVC and cill insulation in Flat 15
