Grenfell Tower – fire safety investigation:
The fire protection measures in place on the night of the fire, and conclusions as to:
the extent to which they failed to control the spread of fire and smoke;
the extent to which they contributed to the speed at which the fire spread.

Phase 1 Report – Section 10

Routes for vertical and horizontal fire spread throughout the building envelope

Dr Barbara Lane FREng FRSE CEng

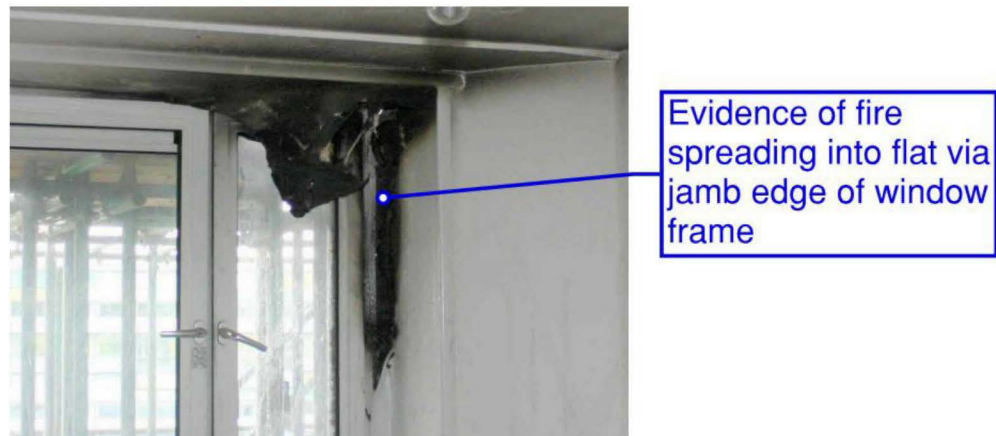
Figure 10.55: Burned uPVC frame in Flat 15

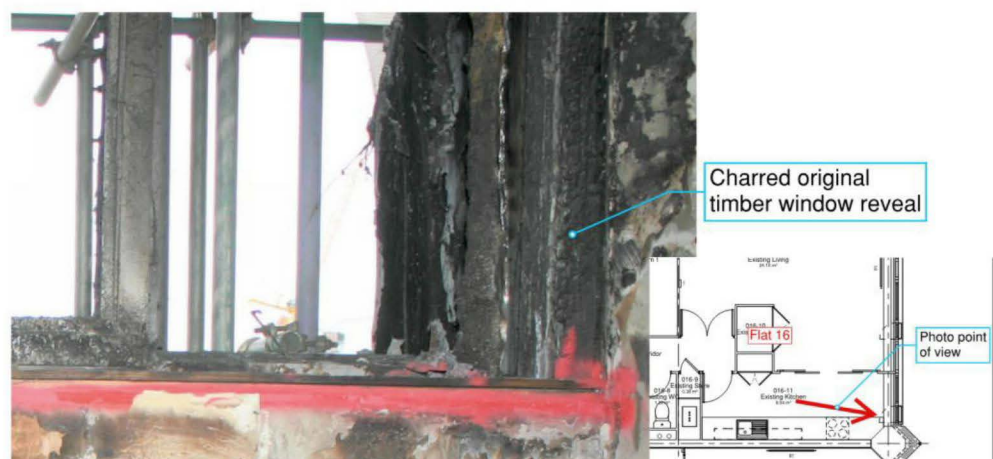
Figure 10.56: Charred timber reveal in Flat 16

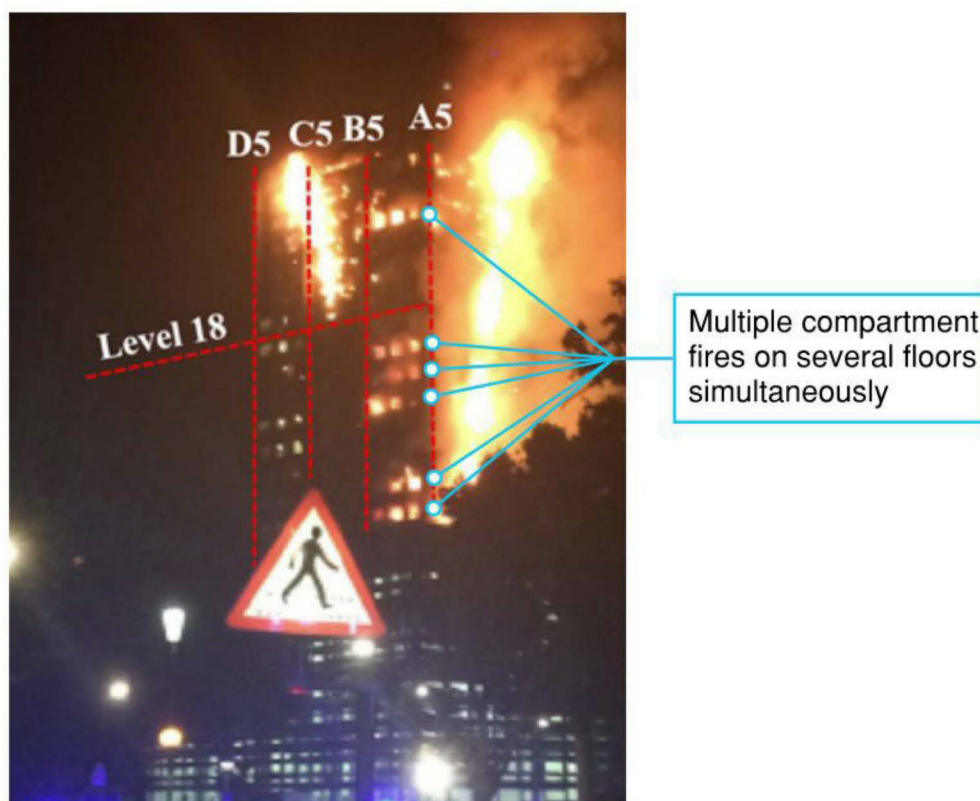
10.10.8 On this basis the scenario of multiple compartment fires developing on multiple floors, and soon after the initial fire spread, was made possible and in fact occurred. Multiple compartment fires on several floors burning simultaneously can be seen in Figure 10.60, which is a photograph of the East elevation of the building at 02:08.

Figure 10.60: Multiple simultaneous compartment fires (as external flaming from several windows observed on multiple floors) at 02:08 (MET00012593)

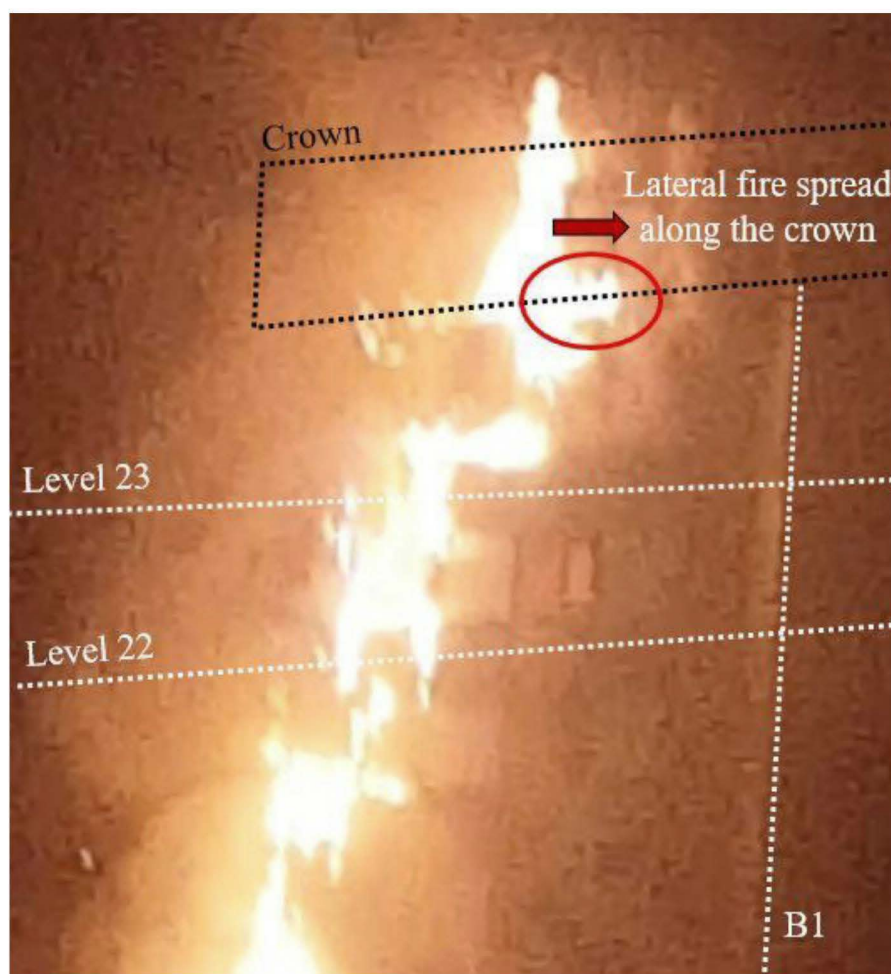
Figure 10.63: Lateral fire spread along the crown on the West elevation at 03:03 on 14th June 2017 (see Video 3 accompanying Prof. Bisby's supplemental Phase 1 report.)

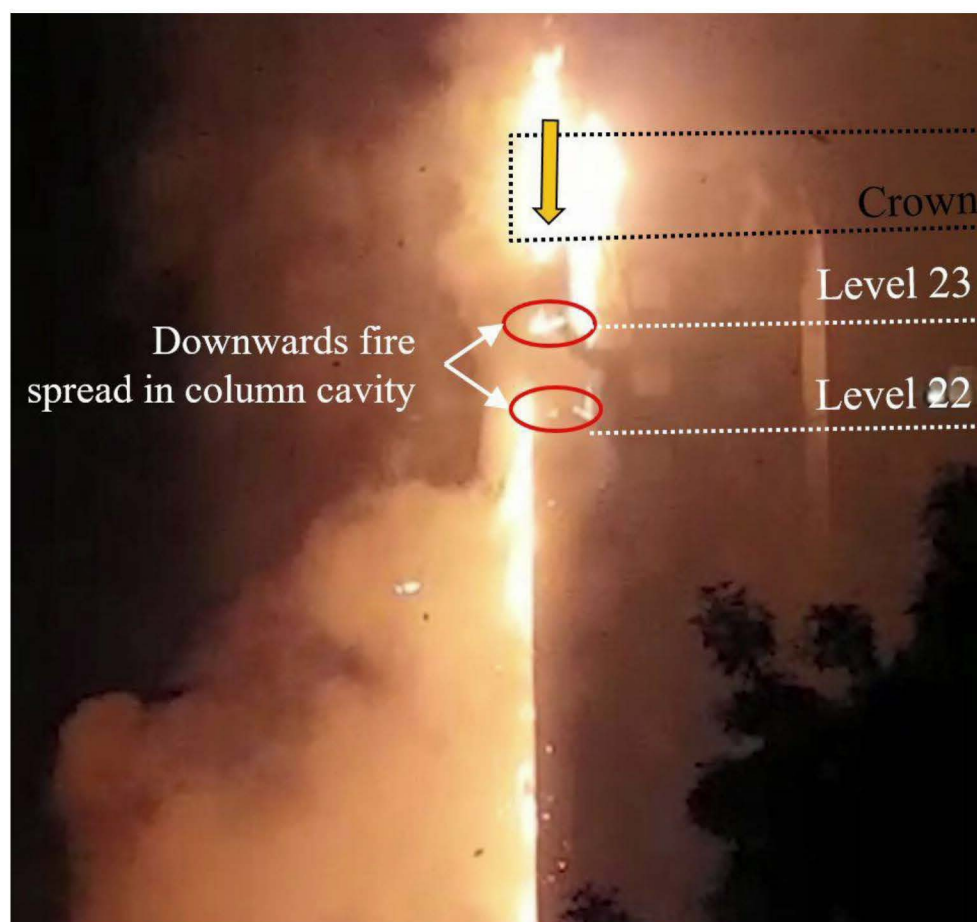
Figure 10.64: Fire spread down the Northwest column (A1) and within the column cavity at 02:51 on 14th June 2017 (see Video 3 accompanying Prof. Bisby's supplemental Phase 1 report)

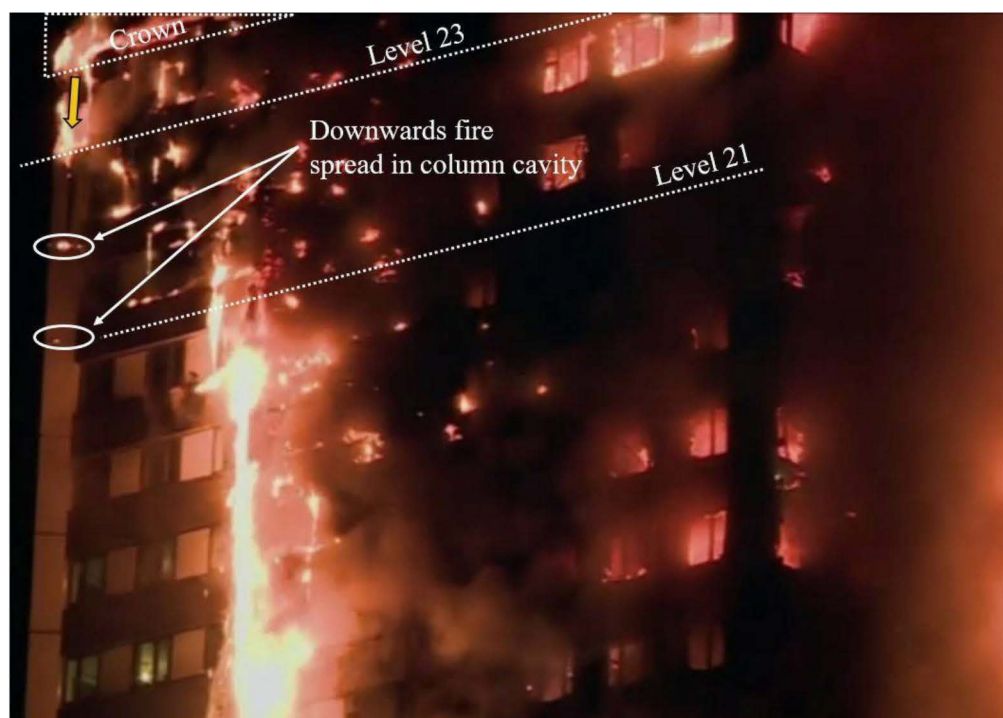
Figure 10.65: External fire spread along the exterior of the Southeast column (D5) and within the column cavity¹⁶

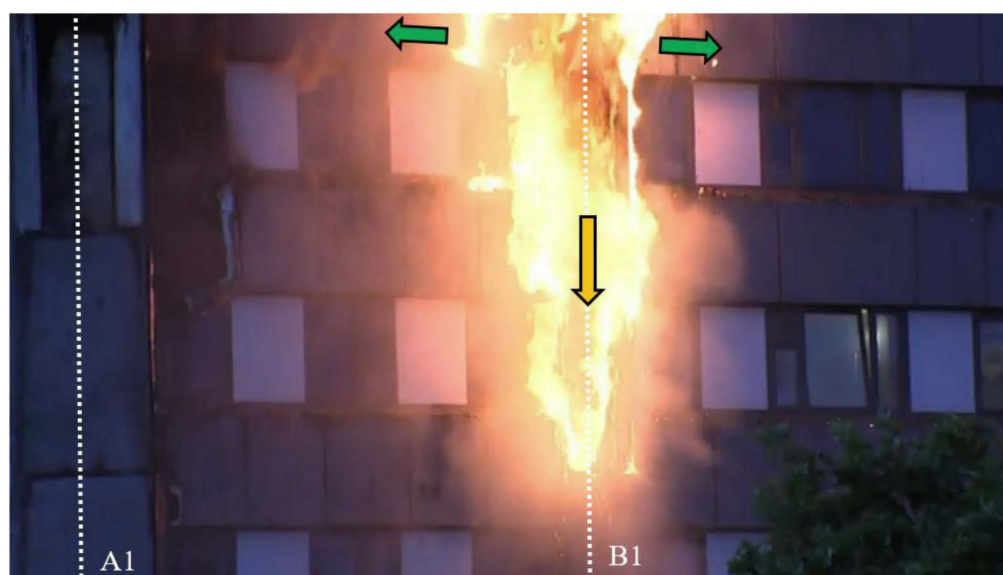
Figure 10.66: Downwards fire spread along column B1 and lateral fire spread in both directions from the column on the West elevation¹⁷

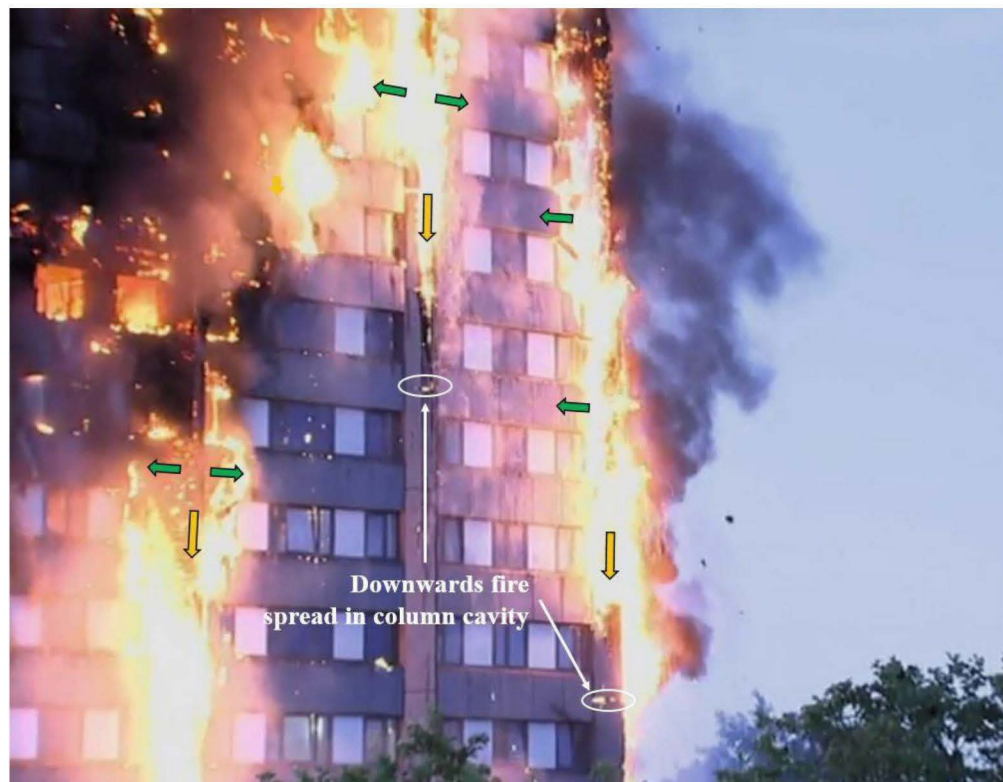
Figure 10.67: Downwards flame spread along columns on the West elevation.¹⁸

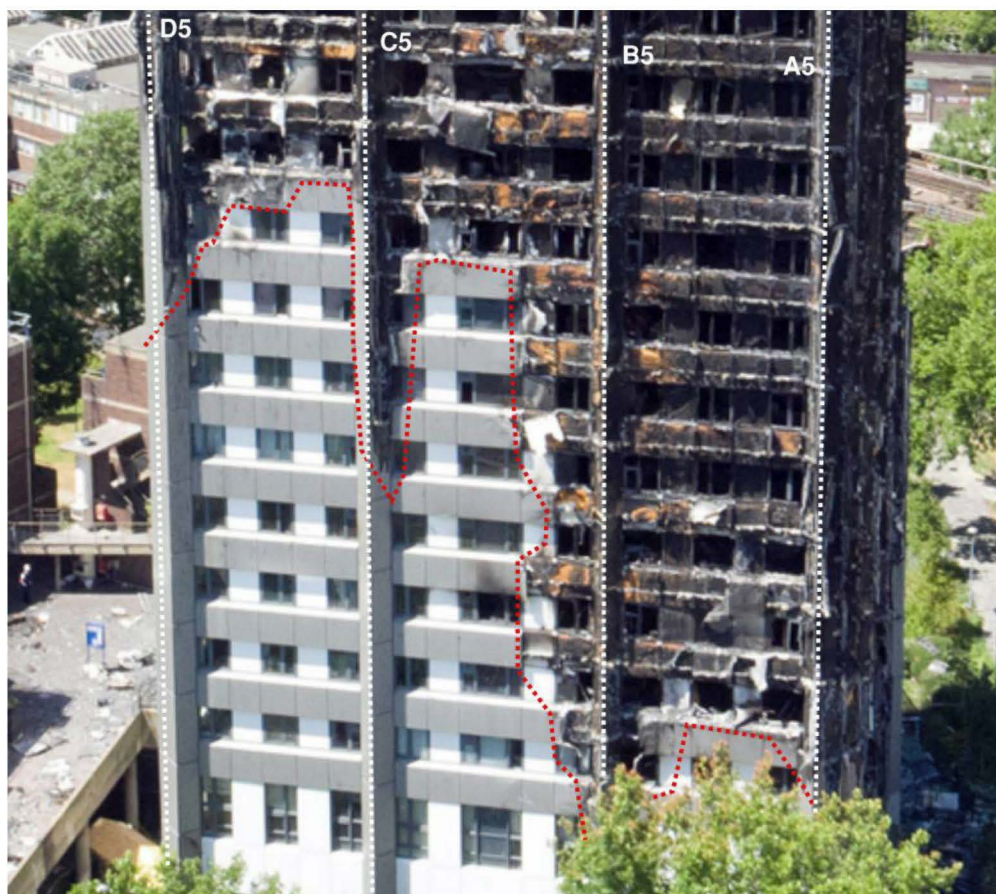
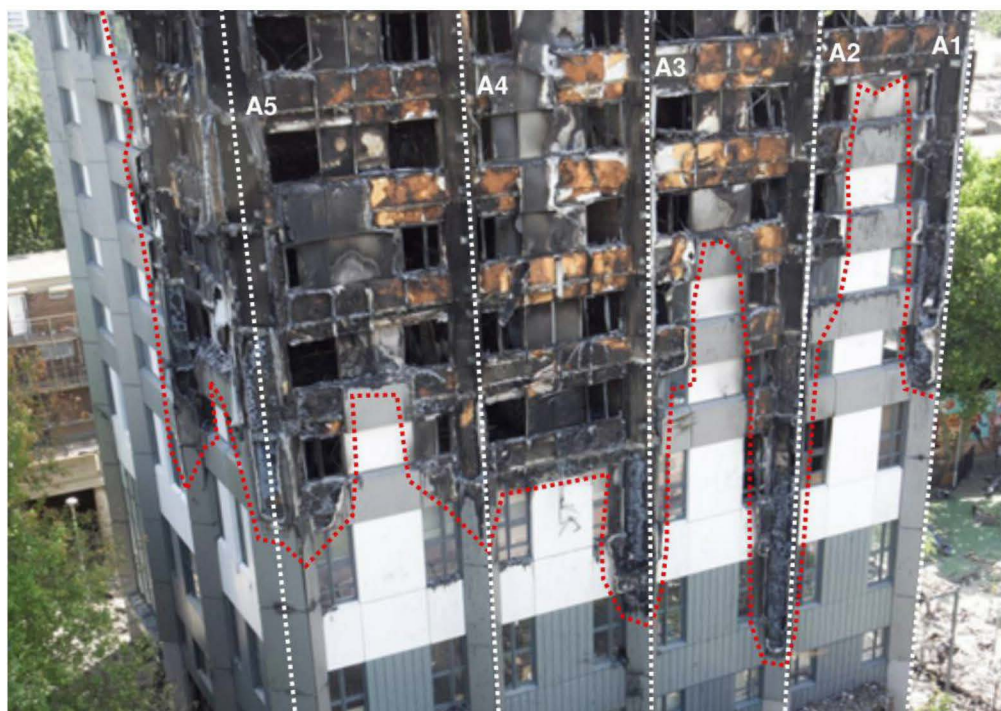
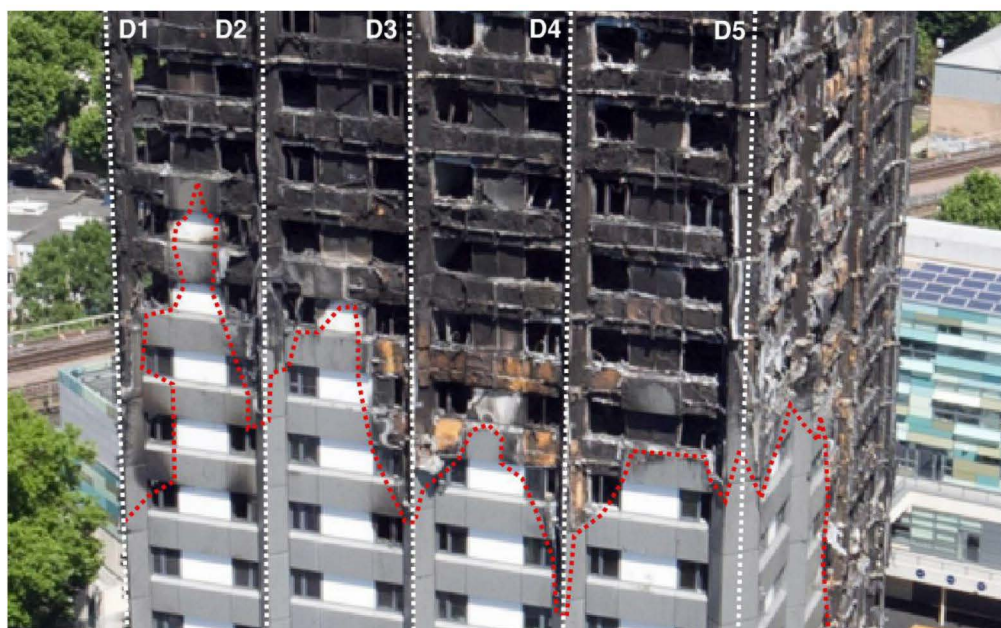
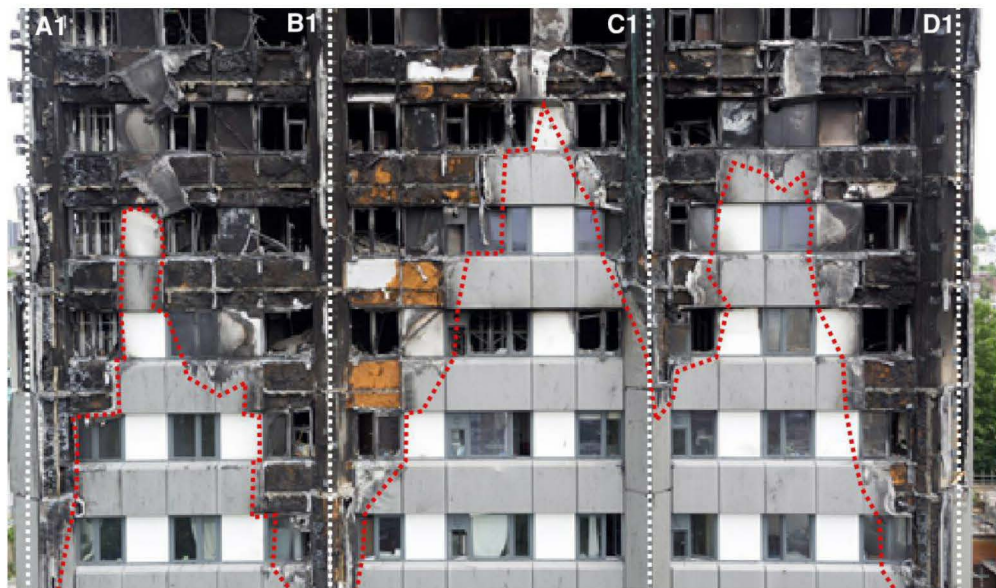
- 10.10.25** I observed a V-shaped pattern on the photographs of post-fire damage shown in Figure 10.68 through Figure 10.71. This V-shaped pattern is centred on each column on each elevation of Grenfell Tower, except for Column B5, which the column the fire spread up initially. These final damage patterns are further evidence that fire spread down the columns (step 2 described in Section 10.10.22) and then laterally away from the column in both directions (step 3 described in Section 10.10.22).

Figure 10.68: Post-fire damage on East elevation of Grenfell Tower (METS00020589)

Figure 10.69: Post-fire damage on North elevation of Grenfell Tower (METS00020592)

Figure 10.70: Post-fire damage on South elevation of Grenfell Tower (METS00020582)

Figure 10.71: Post-fire damage on West elevation of Grenfell Tower (METS00020661)

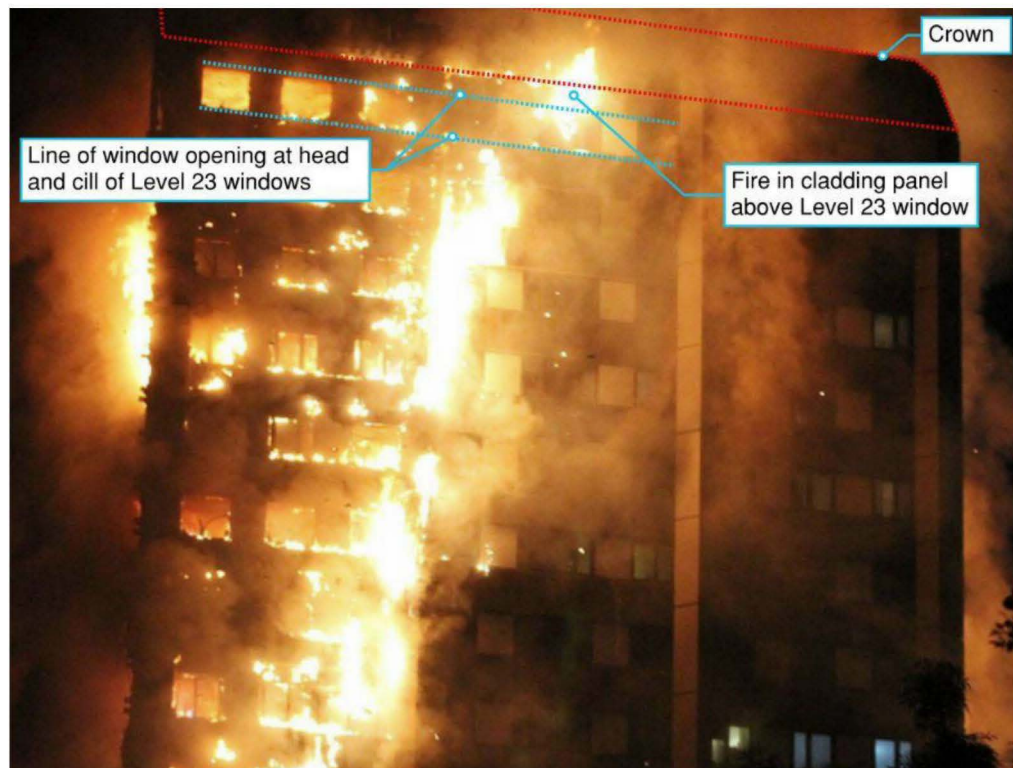
Figure 10.74: Fire in cladding panel above¹⁹

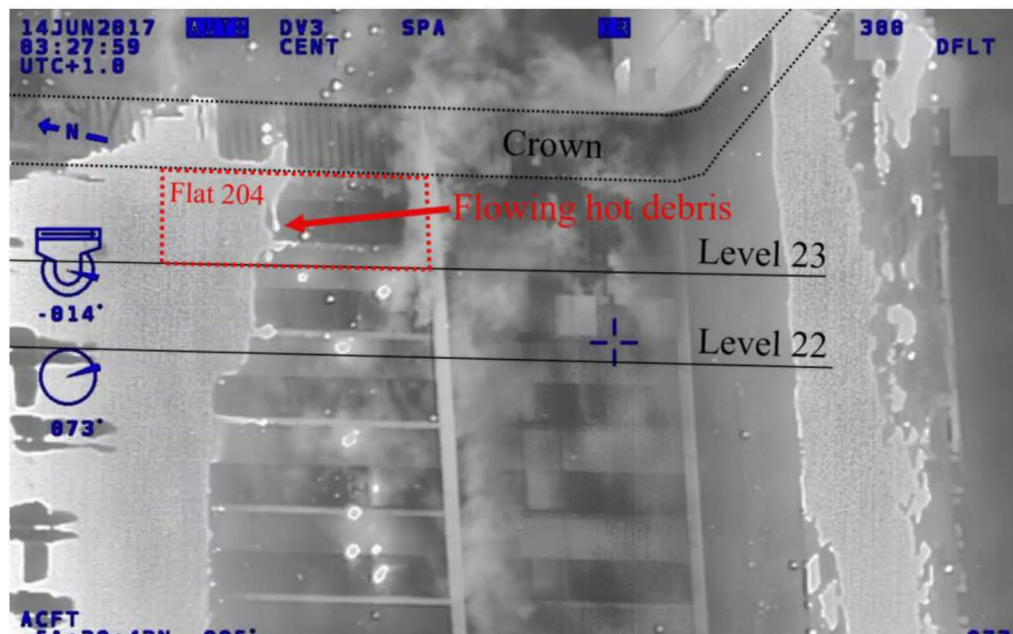
Figure 10.75: Thermal image showing flowing hot debris falling from panels above Level 23 windows on the West elevation of Grenfell Tower at 03:27 on 14th June 2017 (see Video 5 accompanying Prof. Bisby's supplemental Phase 1 report)
