**Grenfell Tower – fire safety investigation:  
The fire protection measures in place on the night of the fire, and conclusions as to:**

**Phase 1 Report – Section 14**

**The performance of the protected stair and lobbies**

**Dr Barbara Lane FREng FRSE CEng**

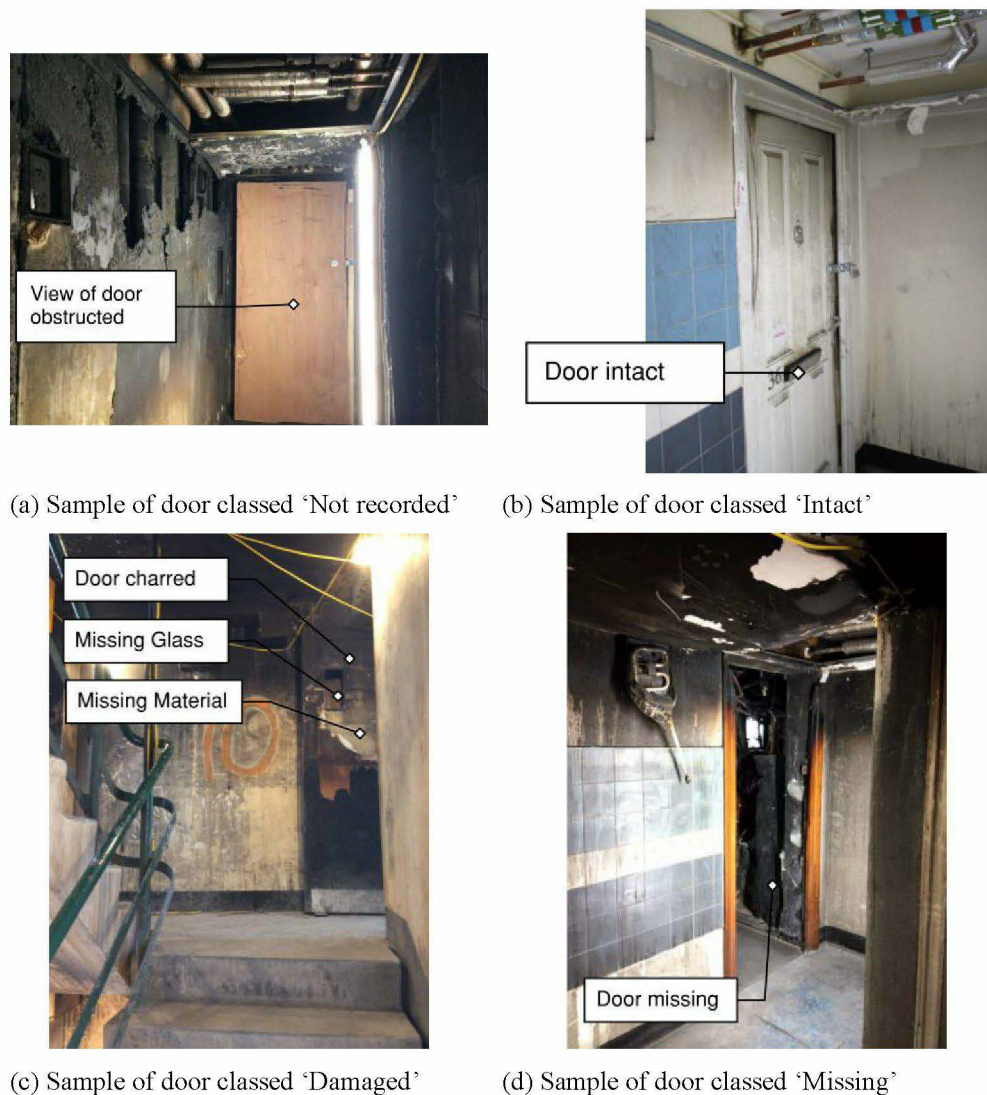
14.4.4 Table 14.2 describes the damage categories I have applied to doors and partitions. I have provided examples of the different categories for the doors in Figure 14.7.

Figure 14.7 (a) Level 9 (Flat 124) (b) Level 6 (Flat 96) (c) Level 10 stair door (d) Level 8 (Flat 116)

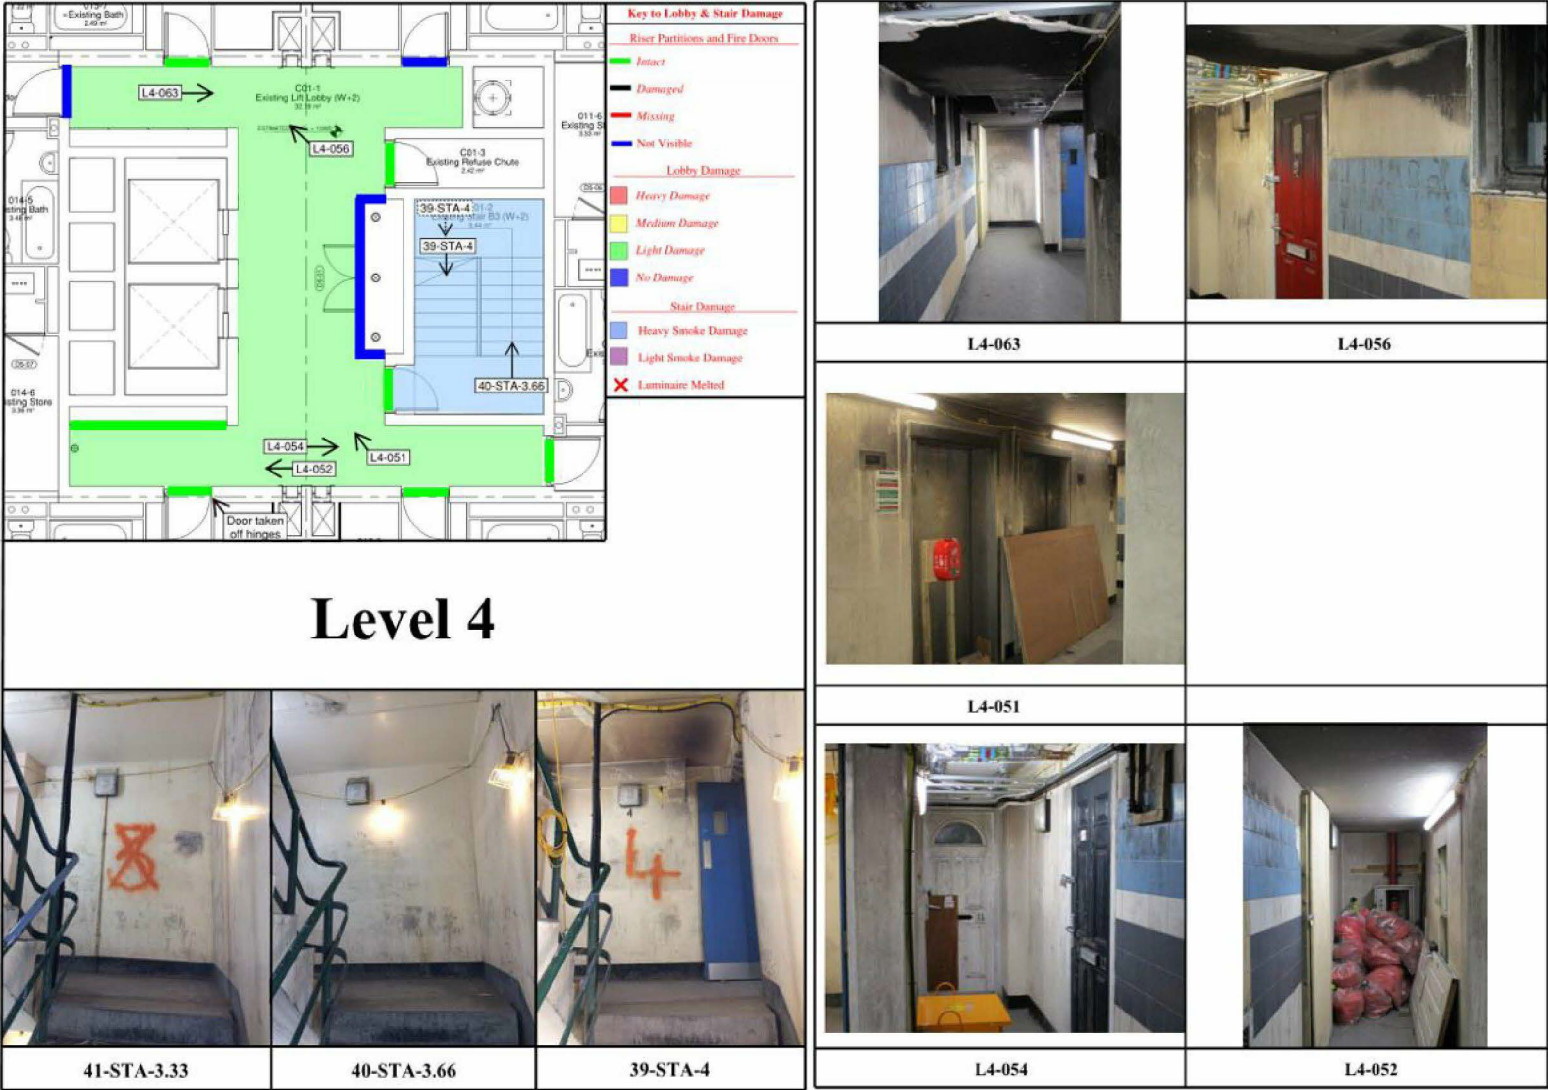
Figure 14.8: Record of stair and lobby damage from post fire site inspection – Level 04

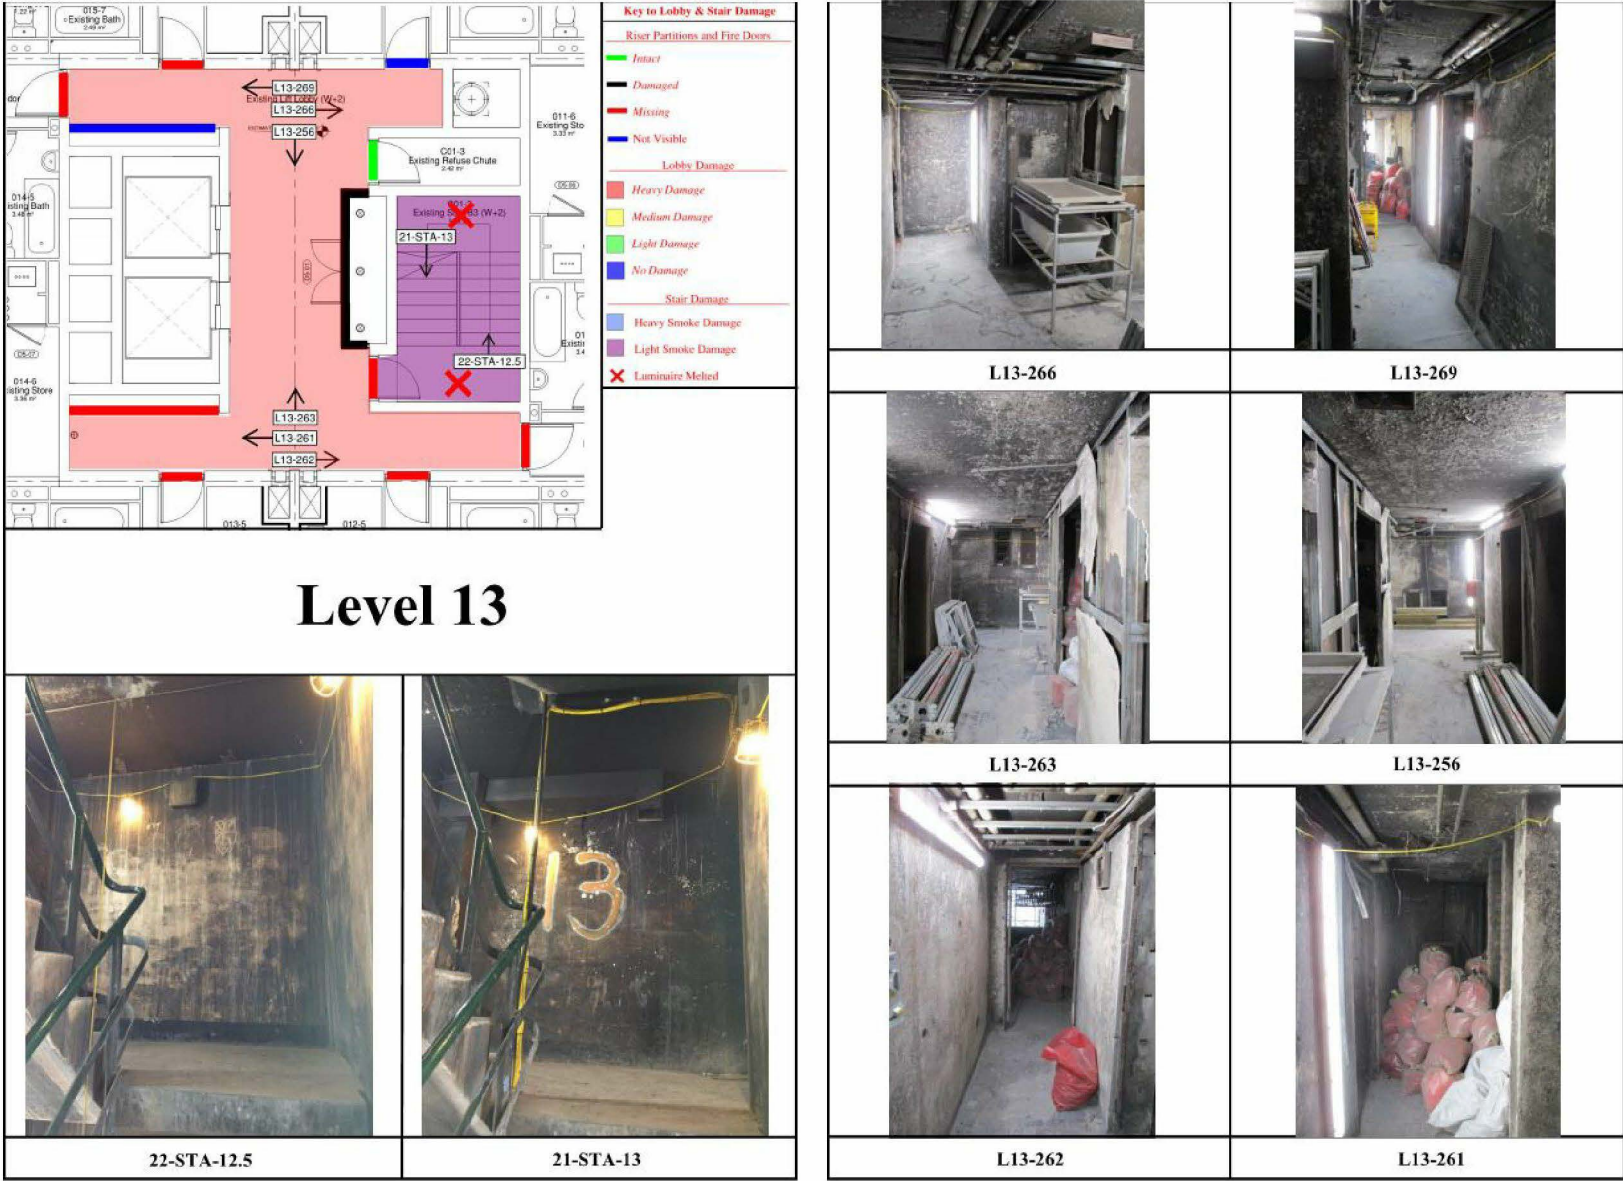
Figure 14.9: Record of stair and lobby damage from post fire site inspection – Level 13 (plan adapted from SEA00010474)

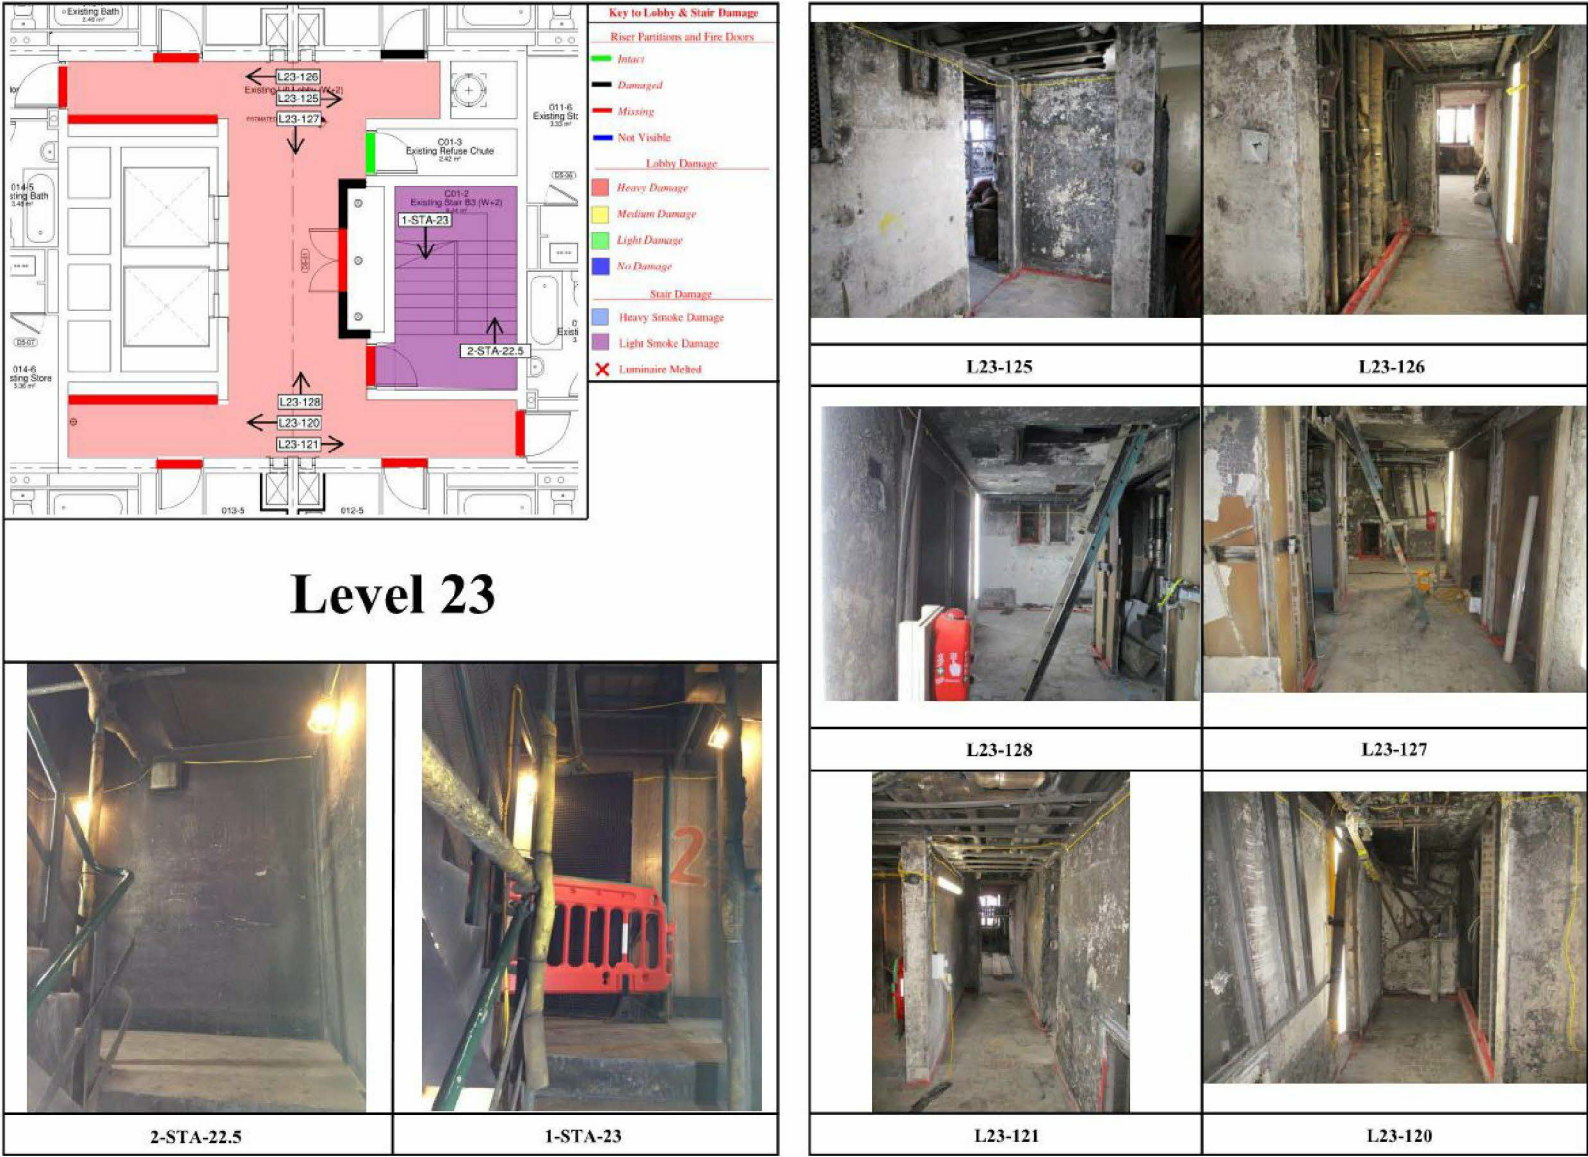
Figure 14.10: Record of stair and lobby damage from post fire site inspection – Level 23 (plan adapted from SEA00010474)

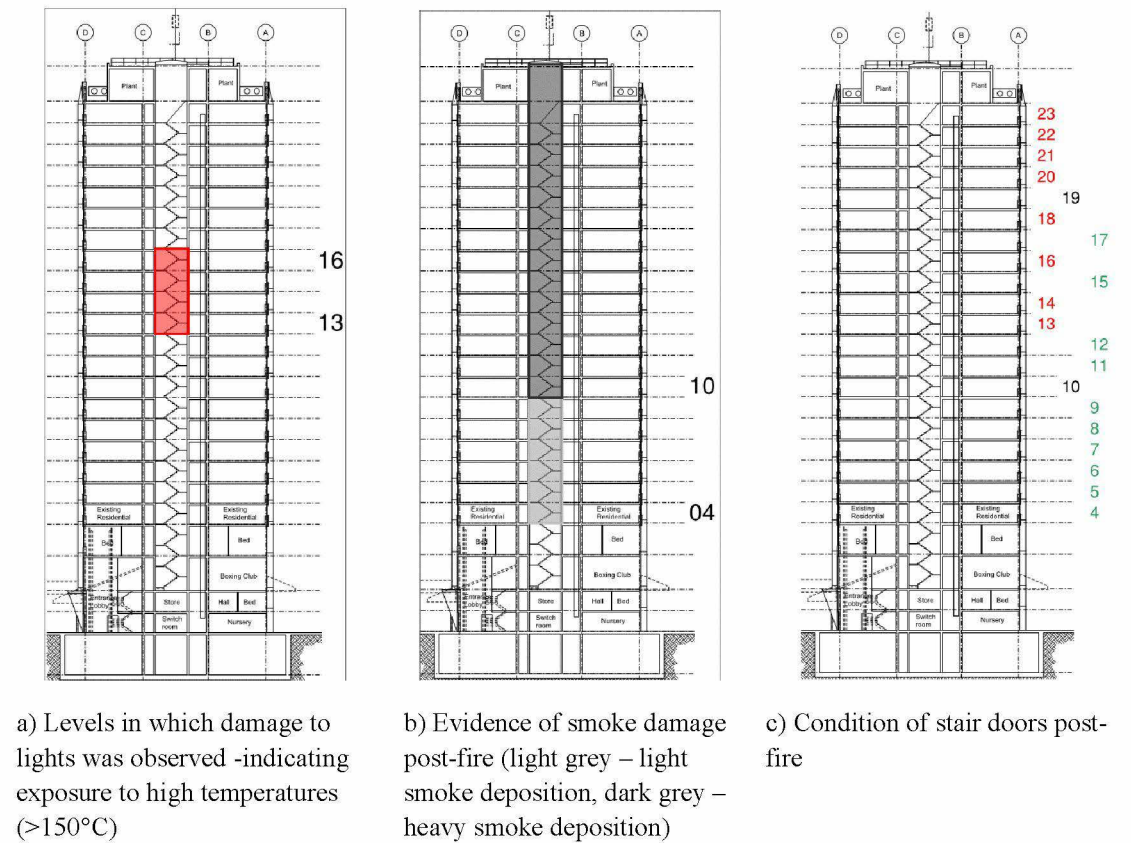
14.4.7      In Figure 14.11 I have summarised the damage I observed within the stair at all levels using the stair light fitting damage criteria (Figure 14.11 (a)), soot deposition criteria (Figure 14.11 (b)) and the stairwell door damage assessment (Figure 14.11 (c)).

14.4.8      Figure 14.11 (a) shows that stairs between Levels 13 and 16 were exposed to temperatures above 150°C. This assessment is based on the condition of light fittings in the stairs which show evidence of softening, flowing and melting.

Figure 14.11: Damage observed in stairs (SEA00009461)

- 14.4.10** Figure 14.11 (b) summarises the degree of smoke deposition observed in the stairs. Light smoke deposits were observed between Levels 04 and 09. From Level 10 to the top of the building, the stair was heavily stained with soot. Please refer to Appendix C for further photographic evidence of the stair condition from the post fire inspection.

- 14.4.11** Figure 14.11 (c) provides a summary of the damage observed to doors between the stair and the lobbies on each level of the building.
- 14.4.12** From my site inspections I observed stair doors were missing on Levels 13, 14, 16, 18, 20, 21, 22 and 23.

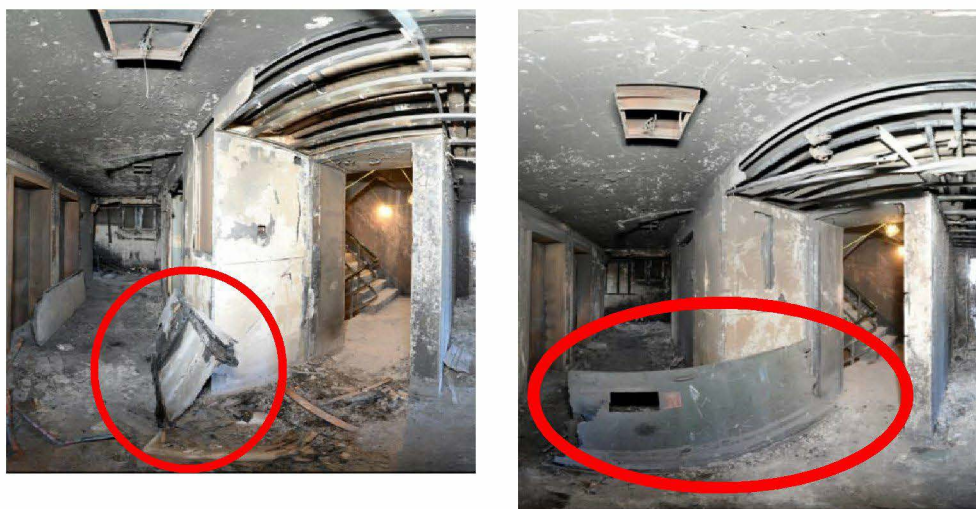
- 14.4.14** These photographs indicate the stair doors on levels 16, 18, 22 and 23 were present immediately after the fire though in each case the door was badly damaged and no longer on their hinges; I have provided a sample of these photos for Level 16 and 18 in Figure 14.12.

Figure 14.12 MPS photographs of the stair doors in the immediate aftermath of the fire (a) Level 16 and (b) Level 18 – remains of door circled in red in each

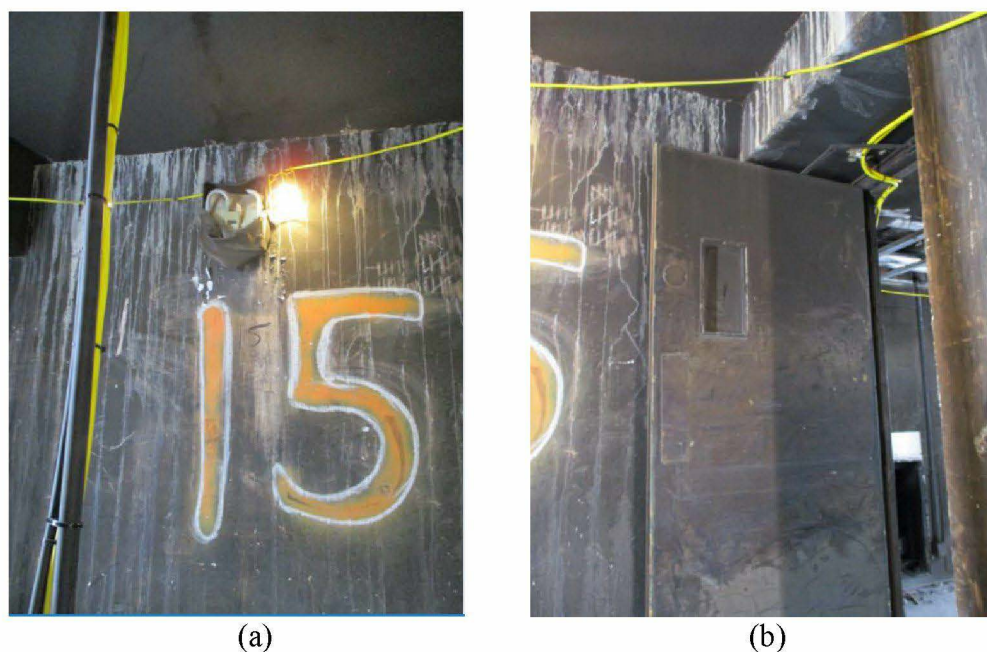
Figure 14.13: (a) Stair light fitting condition and (b) door condition on Level 15

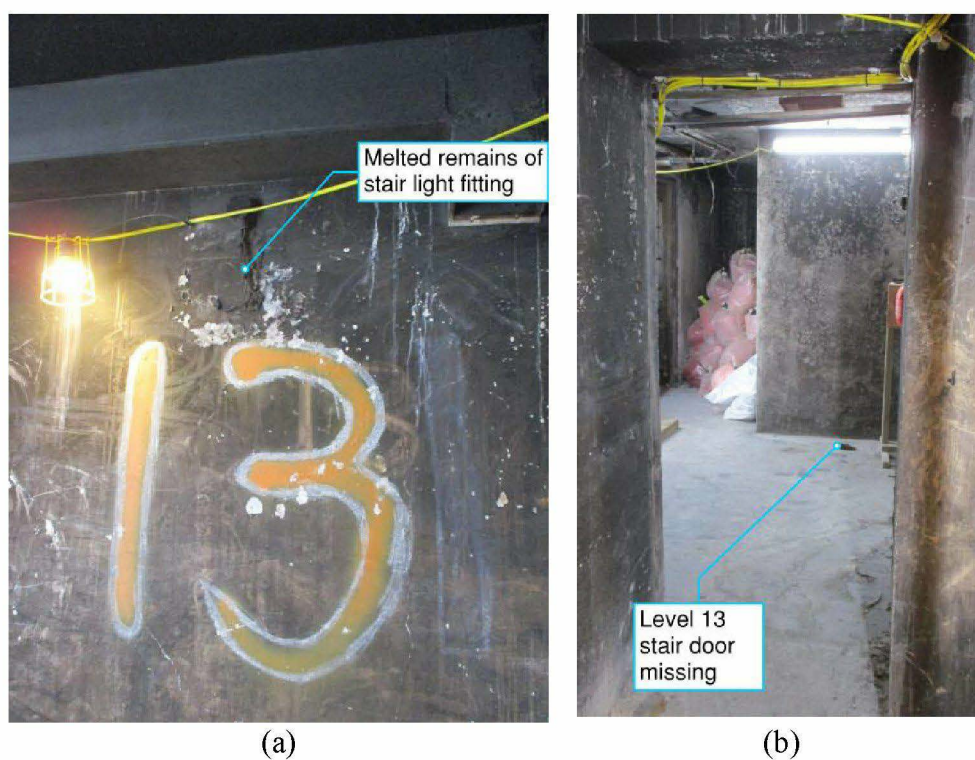
- 14.4.23** The half landing lights are also melted between Level 13 and 16, so it is most likely the door at Level 13 was held open for a time, causing a flow of hot smoke up the stairs sufficient to melt the light at the landing above level 16.

Figure 14.14: (a) Stair light fitting condition and (b) door condition on Level 13

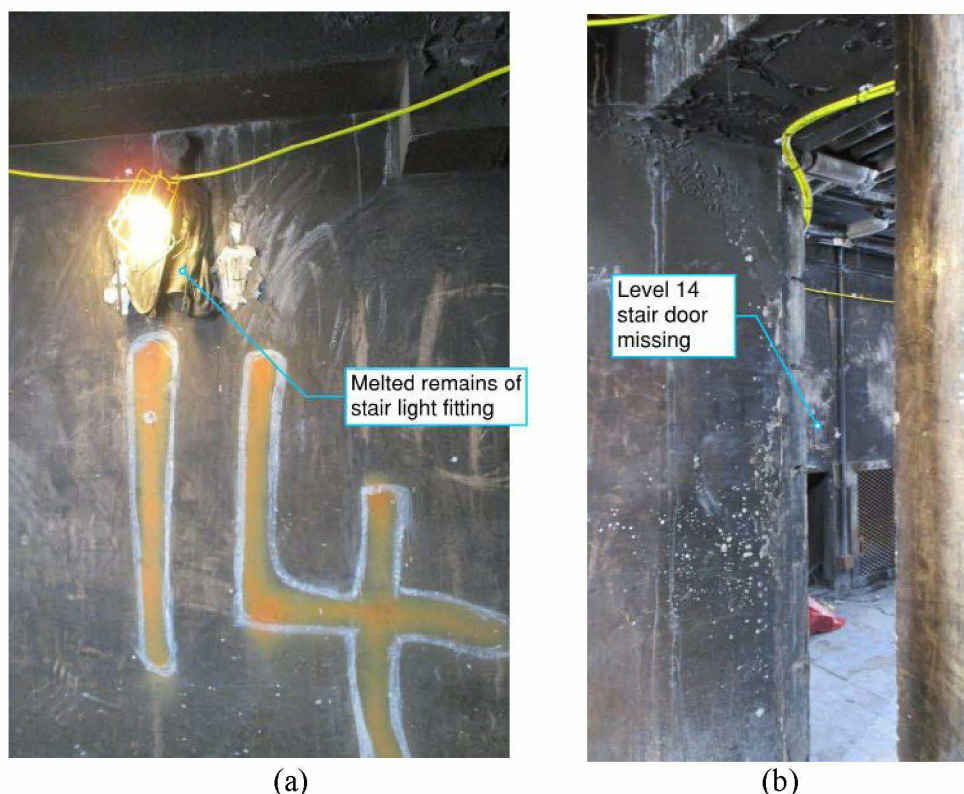
Figure 14.15: (a) Stair light fitting condition and (b) door condition on Level 14

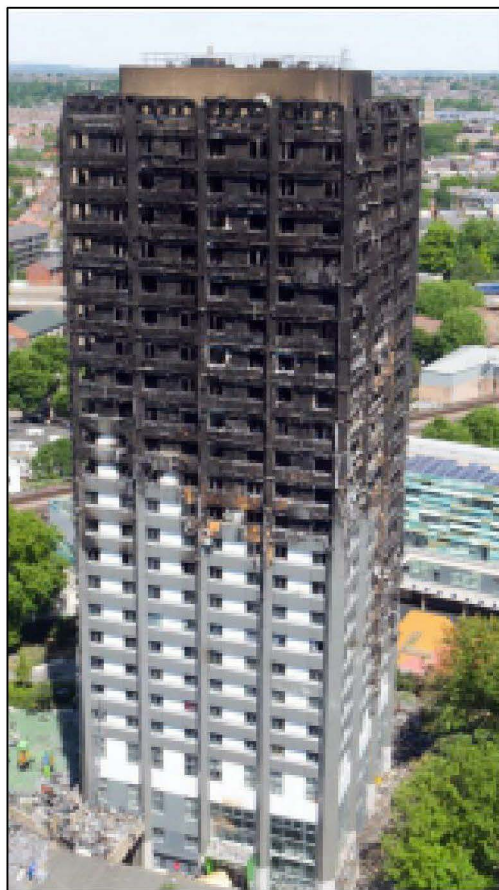
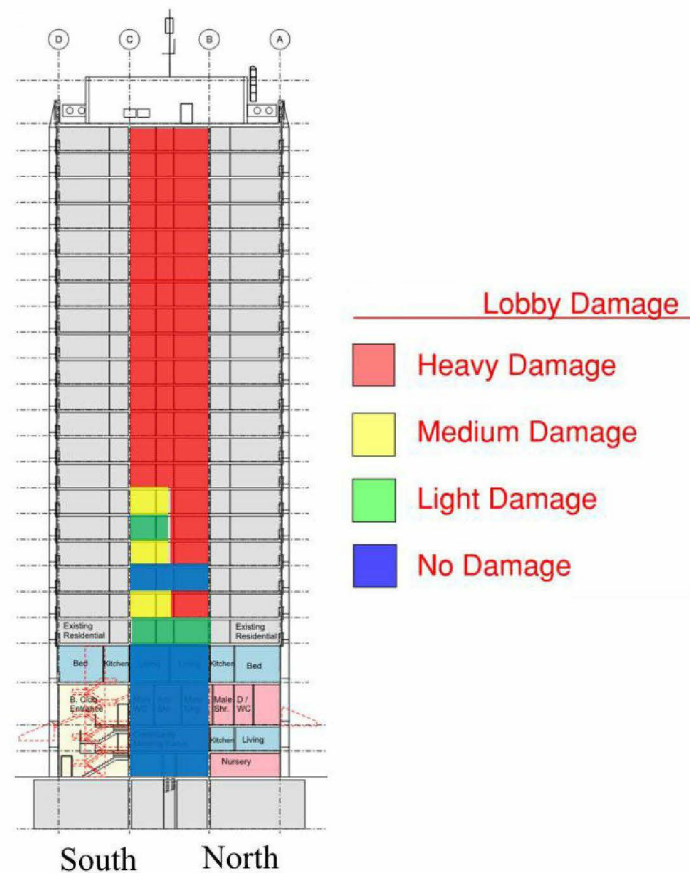
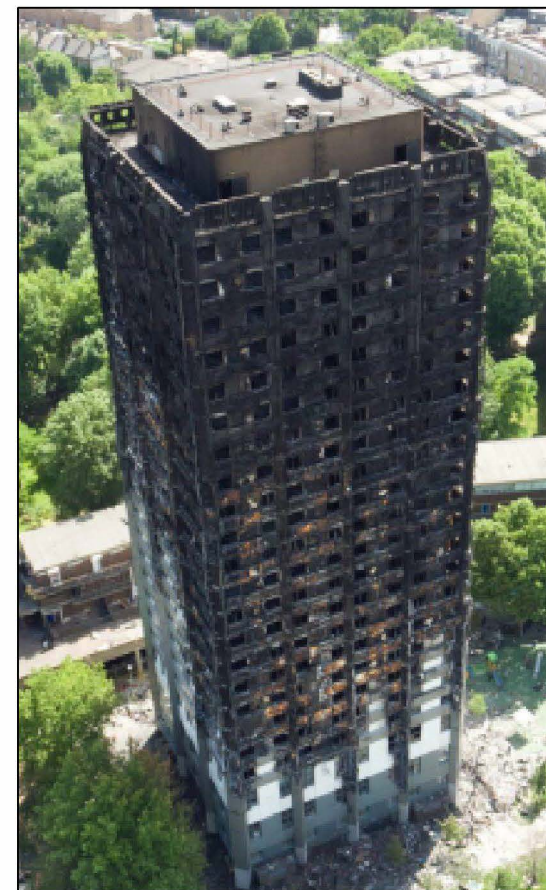
- 14.6.15** The plasterboard ceilings installed in the areas around the flat doors on the north and south ends of the lobbies are partially or completely collapsed on all floors from 10 to 23, except in Level 15 where the ceilings are damaged to a lesser extent than on the adjacent floors.

(b) North – South Lobby damage observations (SEA00009461)

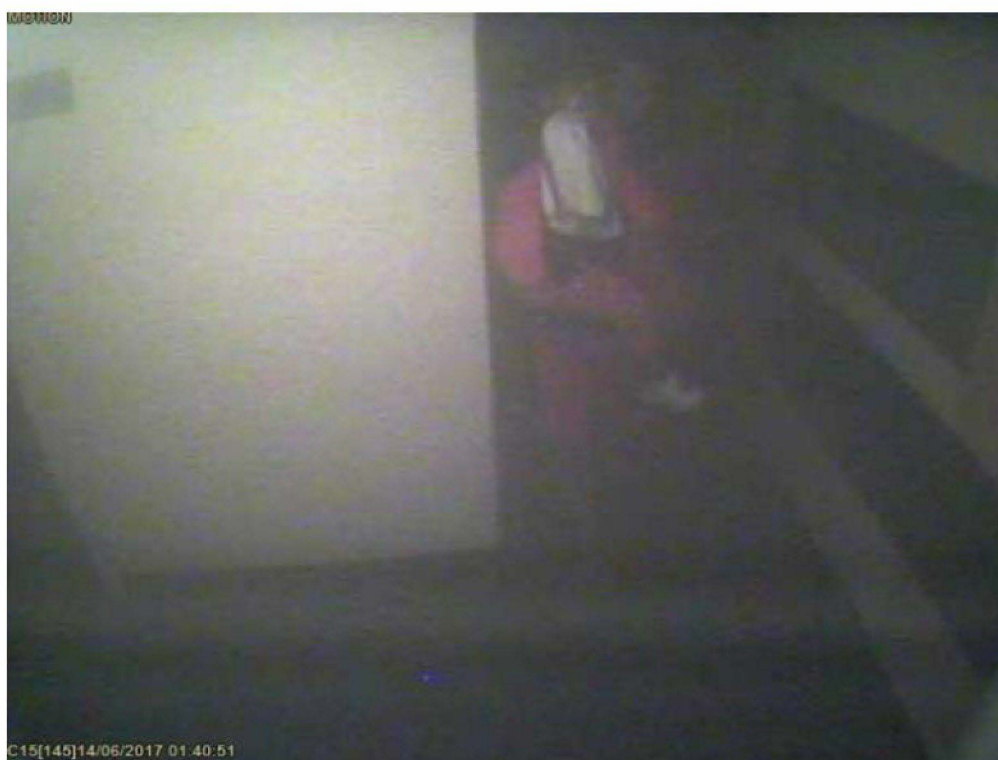
**14.6.54** Stills taken from CCTV footage (MET00012593), reproduced in Figure 14.39 to Figure 14.42, identify the changing conditions in the lobby of Level 7 at 01:40, 03:00 and 03:36. The conditions at 03:36 (Figure 14.42) indicate that the lighting has either failed, the CCTV camera has malfunctioned or complete obscuration of the light has occurred due to thick black smoke.

Figure 14.40: Level 7 lobby at 01:40 (MET00012593)

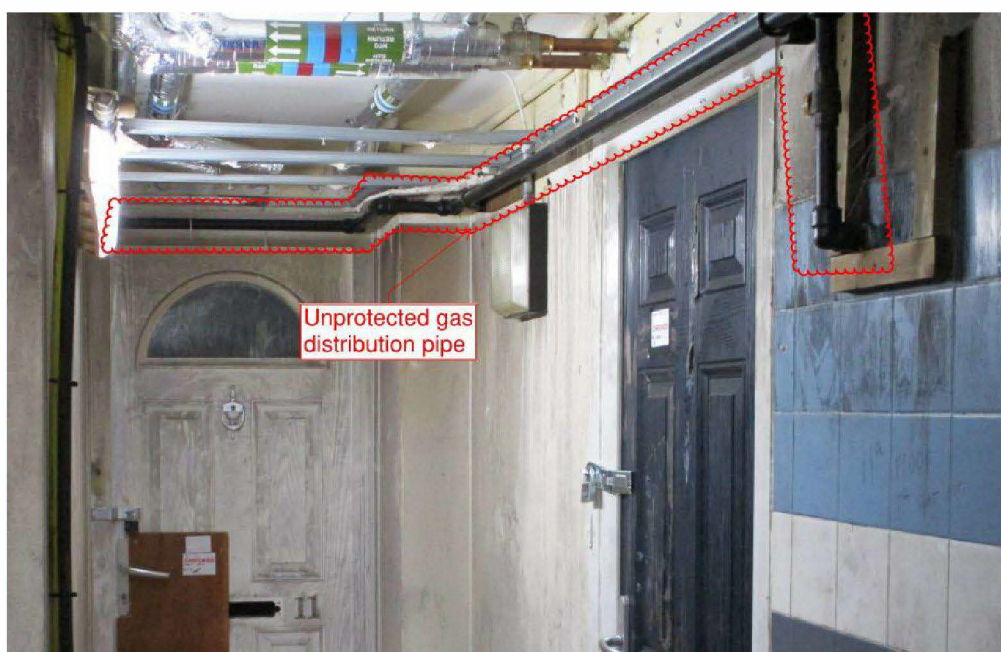
Figure 14.43: Unprotected gas distribution pipe in Level 4 lobby

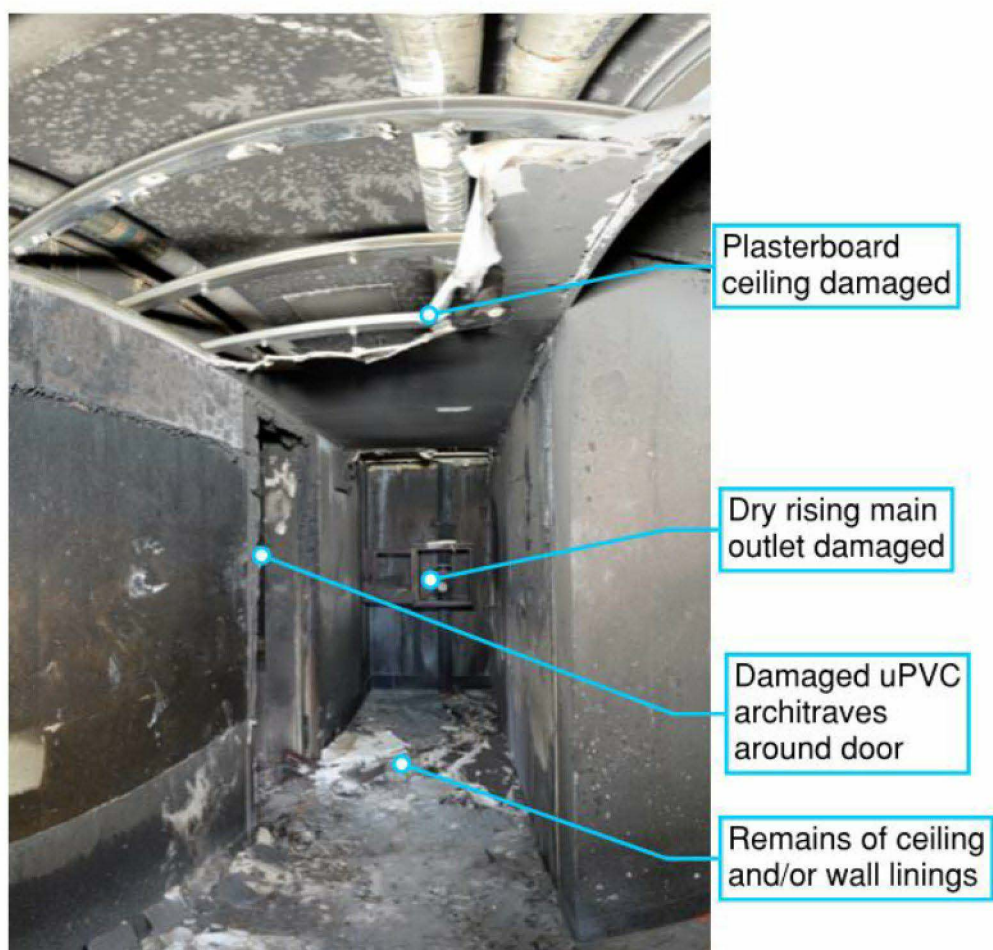
Figure 14.44: Level 12 common lobby (south), photograph taken towards flat 93 (METS00017072)

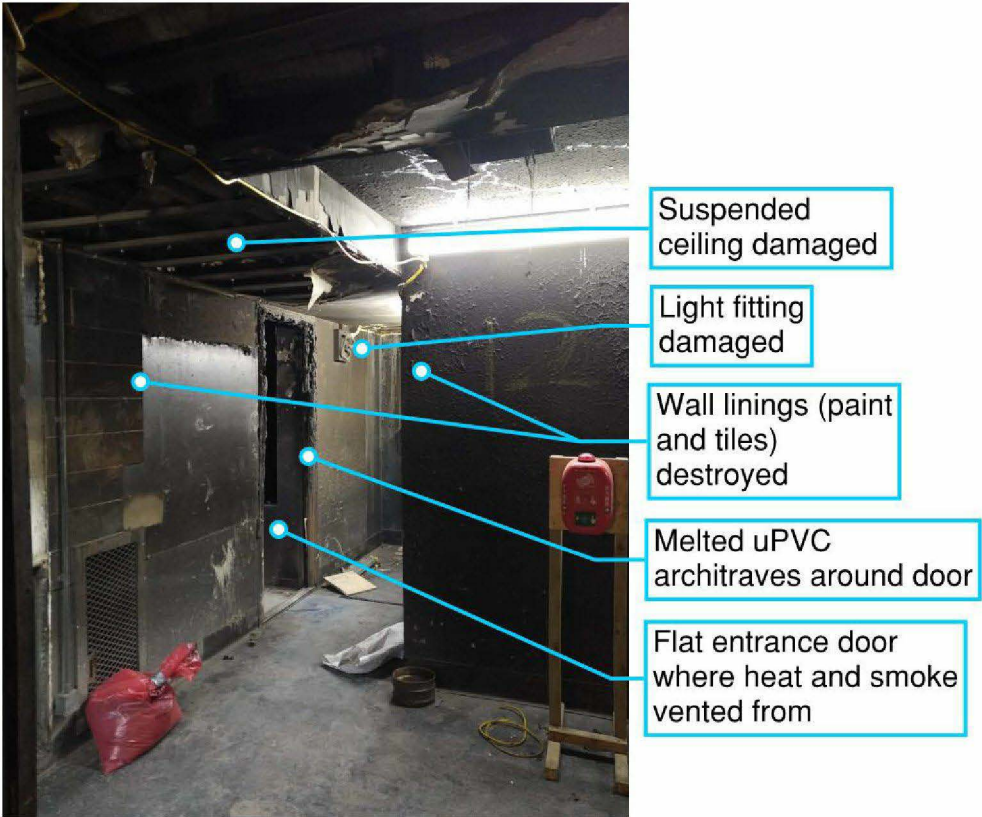
Figure 14.45: Level 12 lobby taken from central portion of lobby

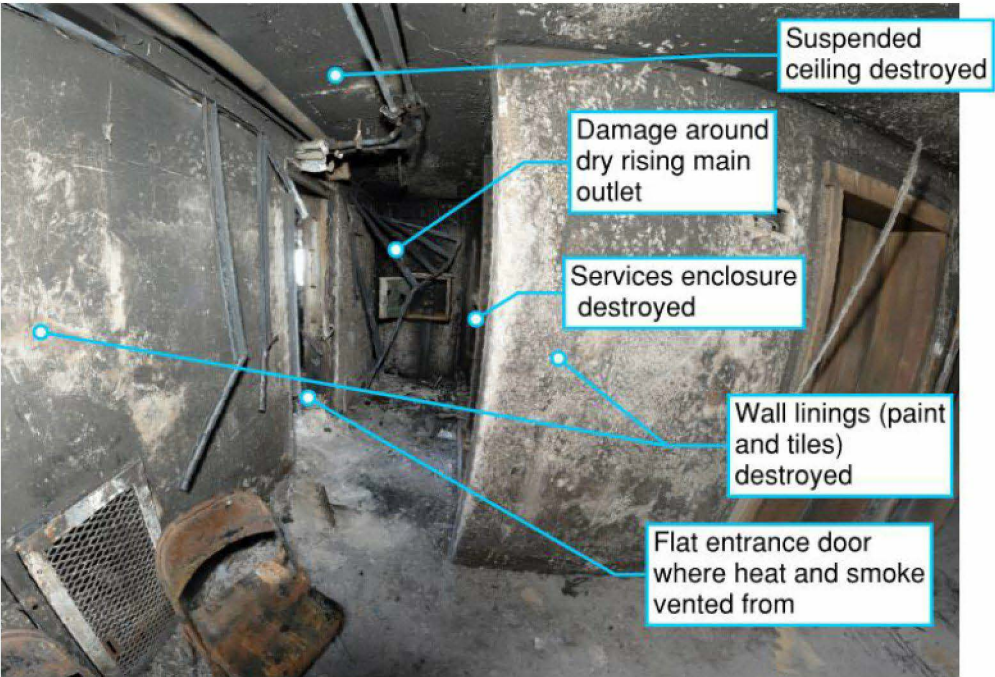
Figure 14.46: Example of how damage caused in lobby by smoke and heat venting from apartments through narrow corridor on Level 13 (South side) (METS00017081)

- 14.6.73** I observed severe damage in the narrow corridors leading to the flat entrance doors; I have provided examples for Levels 12, 13 and 16 in Figure 14.49, Figure 14.50 and Figure 14.46. Figure 14.51 shows the conditions in the central portion of the Level 12 lobby.
- 14.6.74** Figure 14.52 presents an example of damage inside the flat directly in front of the flat door observed in Flat 185 on Level 20 from my post fire inspection.

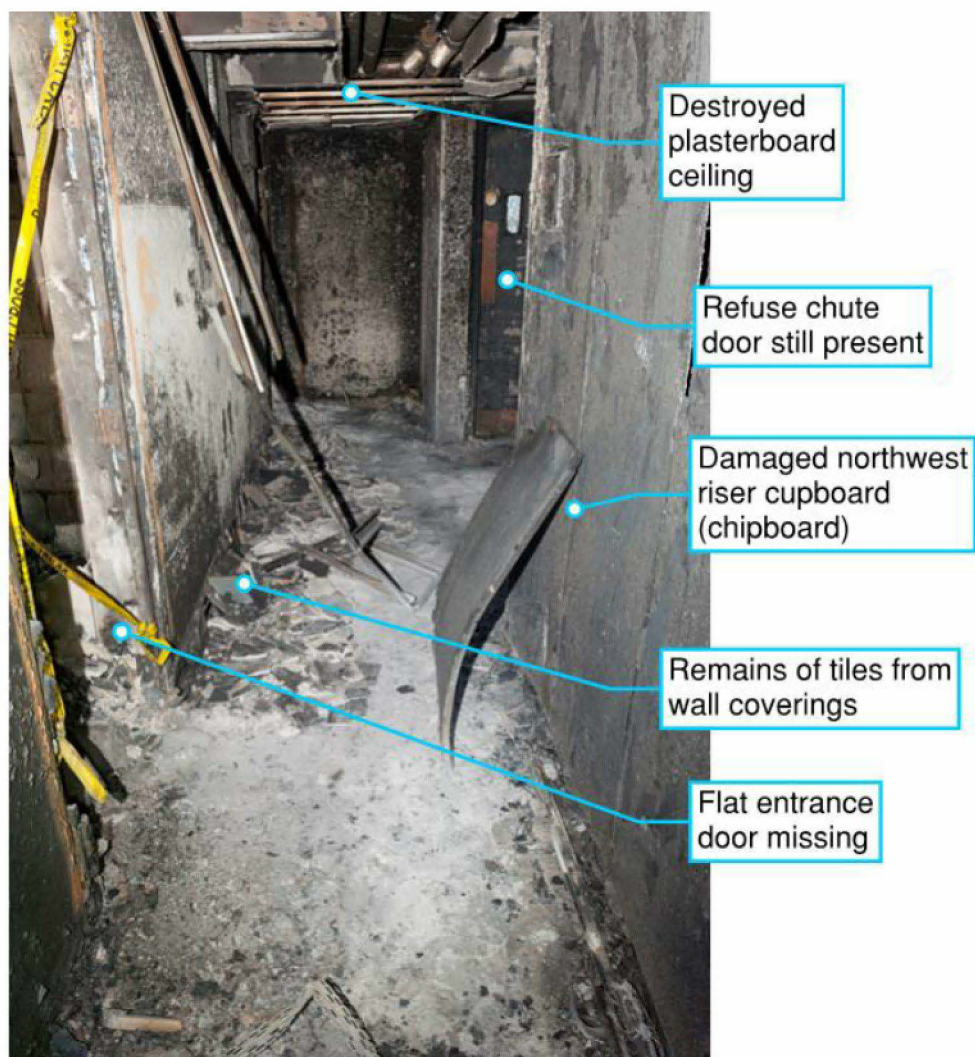
Figure 14.47: Level 13 common lobby (north), photograph taken towards flat 105 and 106 (METS00019286)

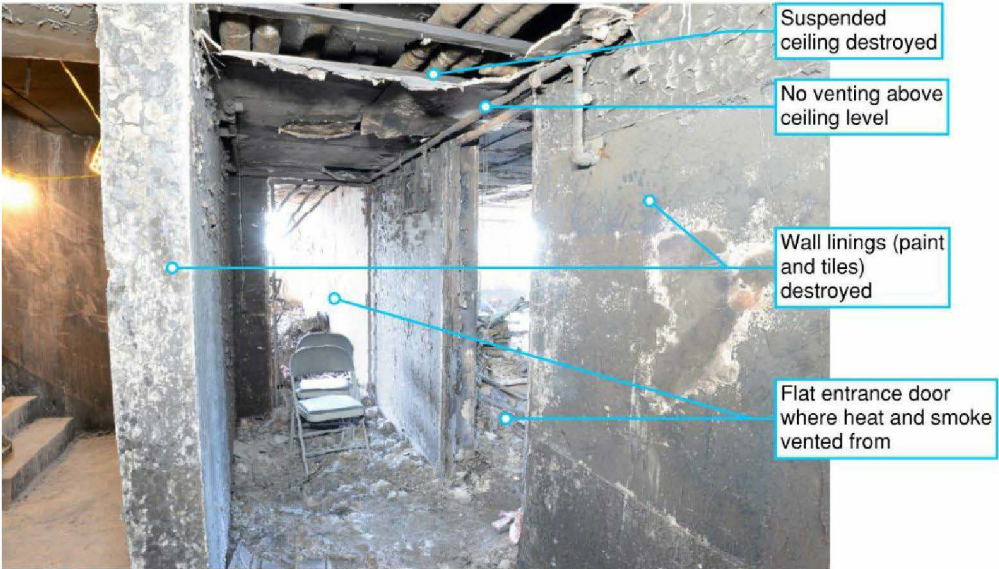
Figure 14.49: Example of how damage caused in lobby by smoke and heat venting from apartments through narrow corridor on Level 16 (South side) (METS00016987)

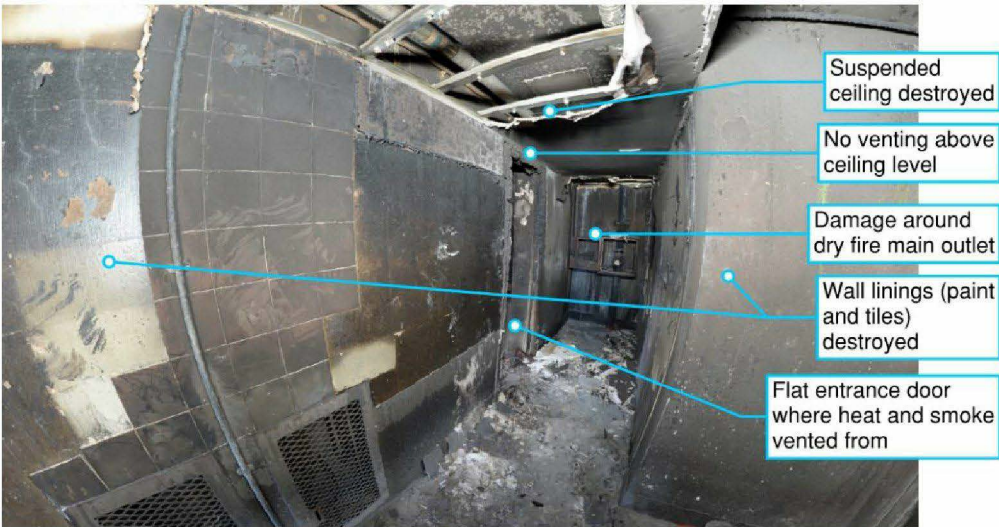
Figure 14.50: Example of how damage caused in lobby by smoke and heat venting from apartments through narrow corridor on Level 12 (South side) (METS00017072)

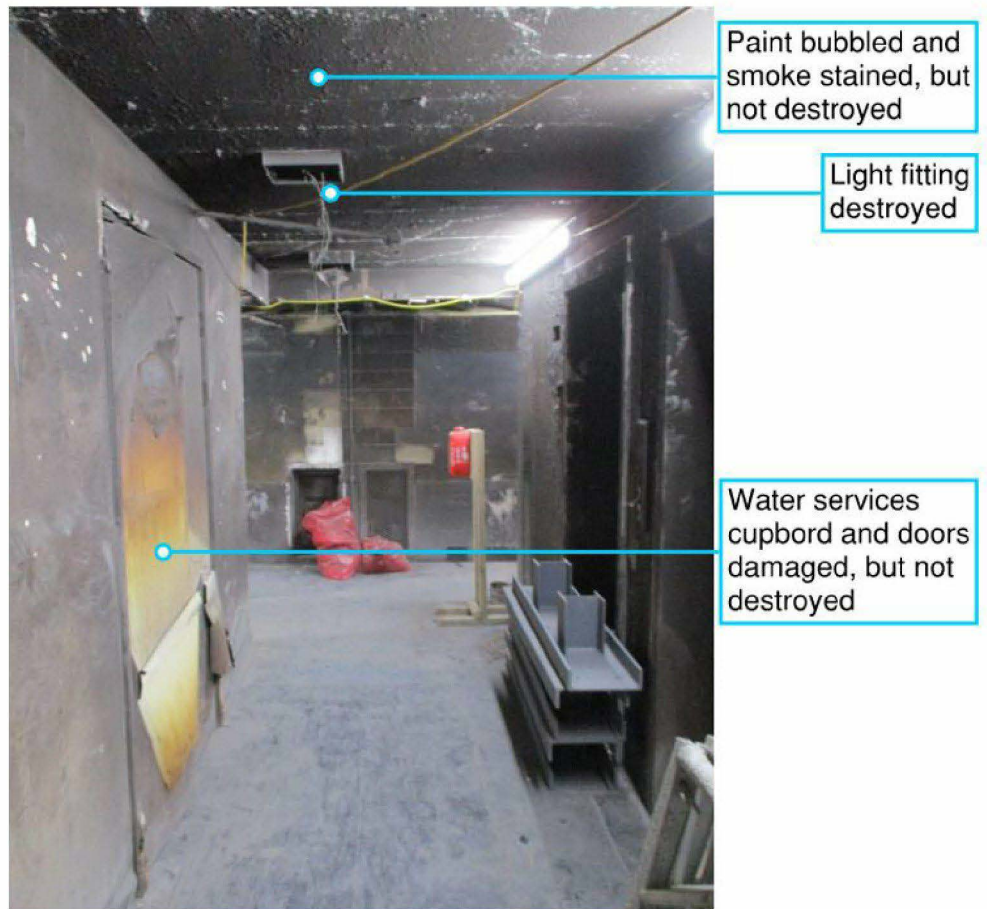
Figure 14.51: Example of post-fire conditions in Level 12 lobby (Central portion)

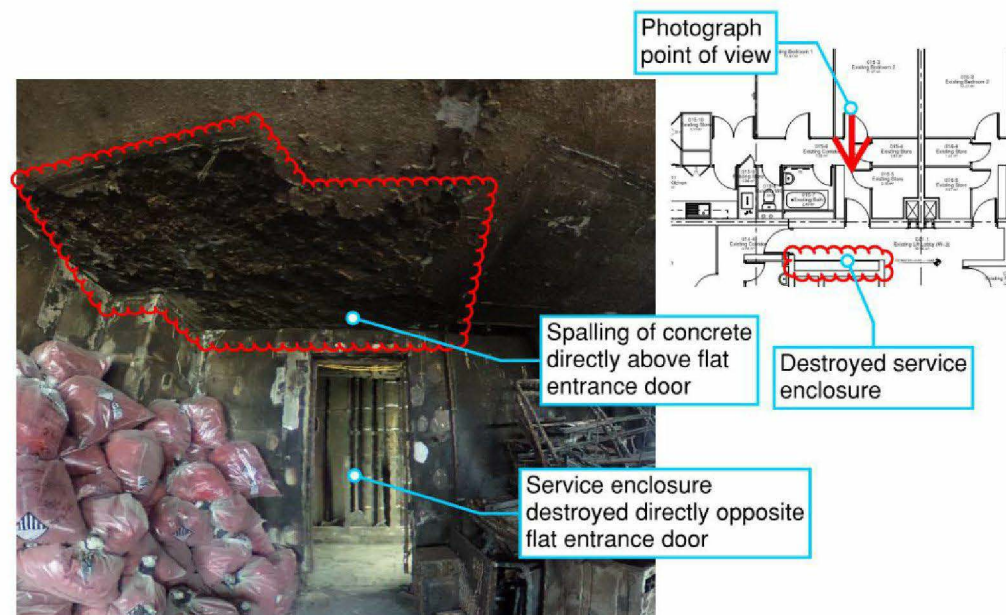
Figure 14.52: Example of damage around entrance door to Flat 175 on Level 20 (post-fire inspection, 08/11/17)

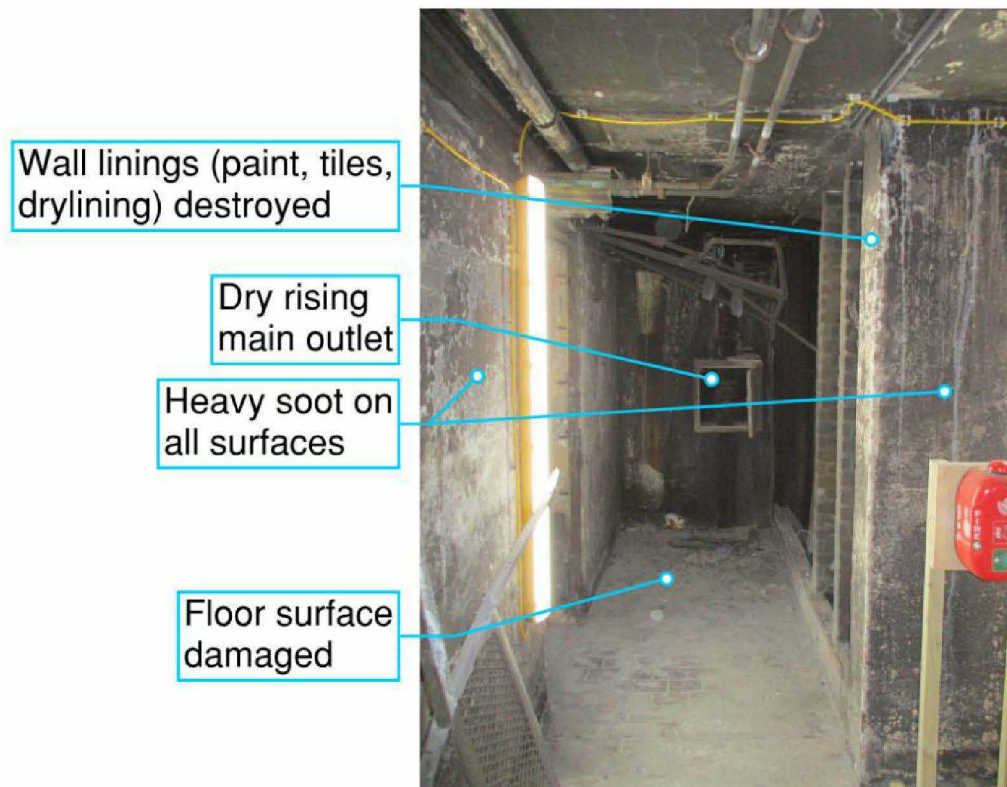
- 14.6.75** The fire main was also located within these narrow corridors; which sustained heavy damage. I have included in Figure 14.53 an example of the damage sustained surrounding the fire main that firefighters were attempting to access during the fire.
- 14.6.76** Figure 14.54 shows the dry rising main outlet on Level 14, taken during my post fire inspection. It indicates the damage around the outlet, and a fire hose attached indicating that firefighters attempted to use this outlet at some point during 14<sup>th</sup> June 2017.

Figure 14.53 Damage surrounding fire main located on Level 19

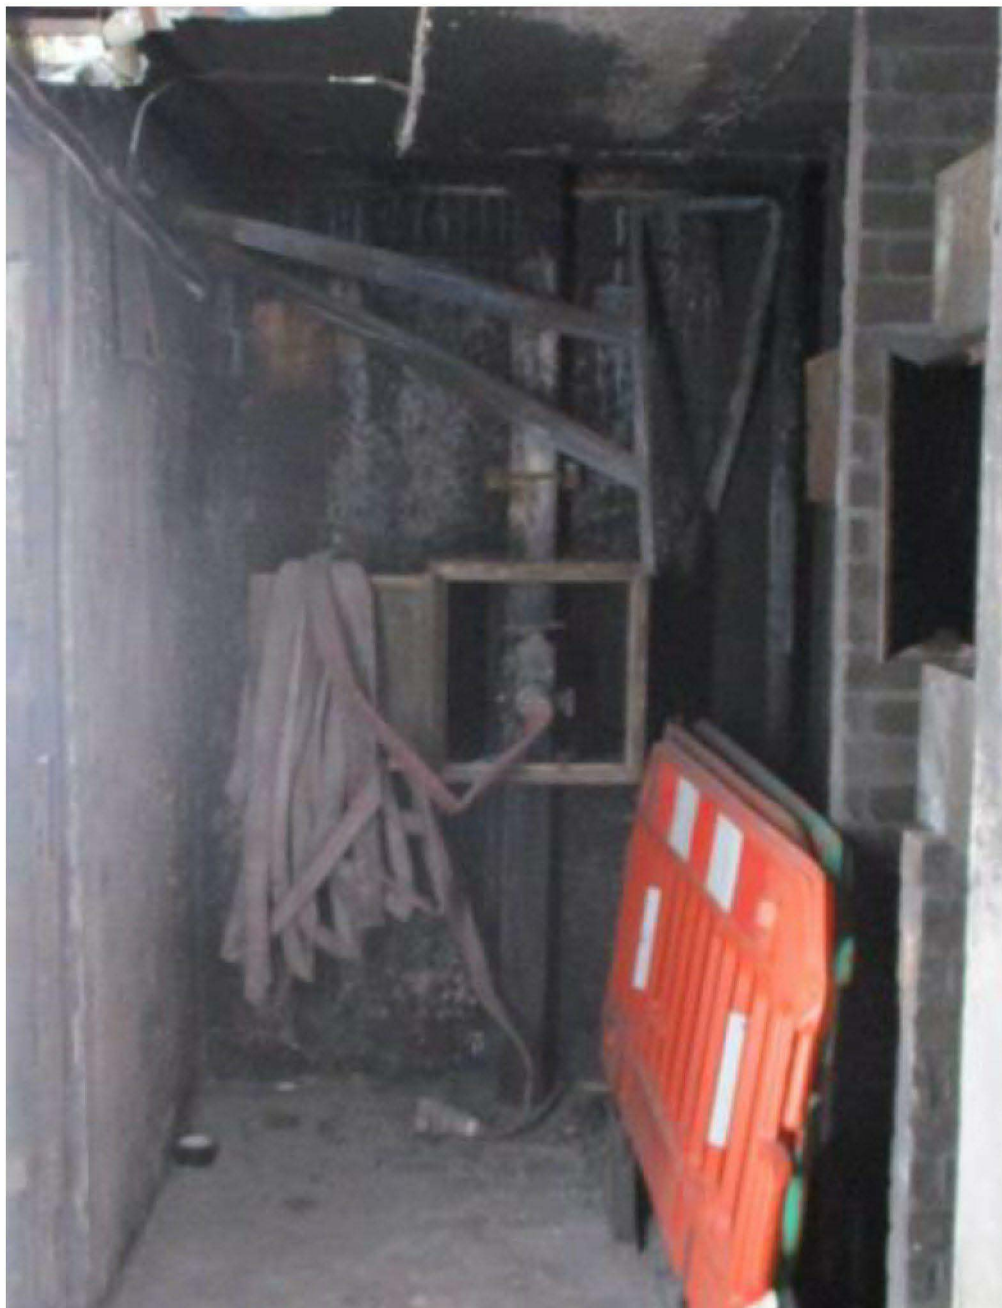
Figure 14.54: Damage around dry rising main outlet on Level 14, where a hose was attached
