**Grenfell Tower – fire safety investigation:  
The fire protection measures in place on the night of the fire, and conclusions as to:**

**Phase 1 Report – Section 14**

**The performance of the protected stair and lobbies**

**Dr Barbara Lane FREng FRSE CEng**

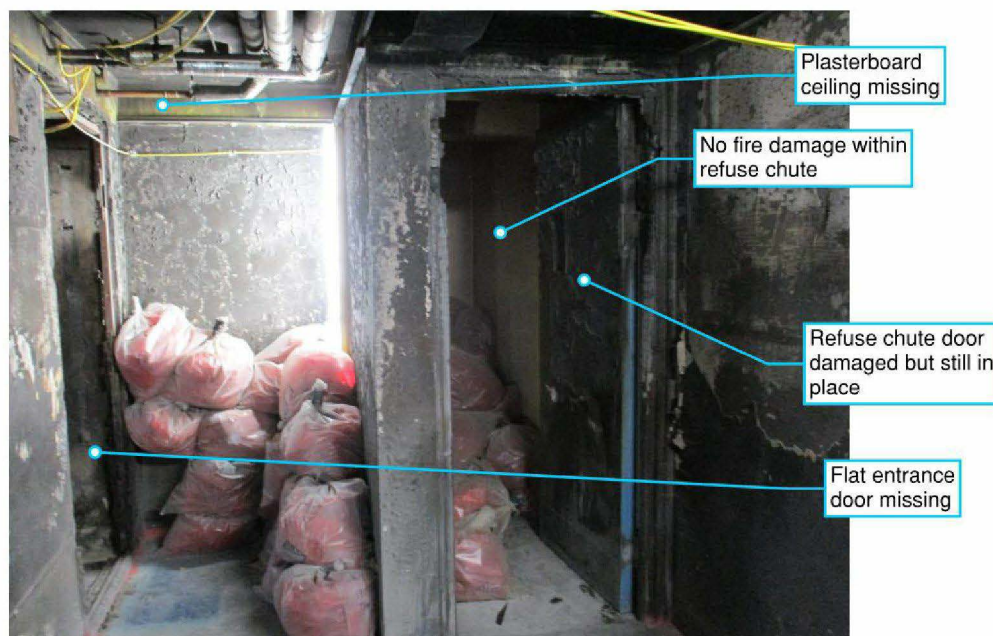
Figure 14.55 Level 10 refuse chute – showing no fire damage within the refuse chute.

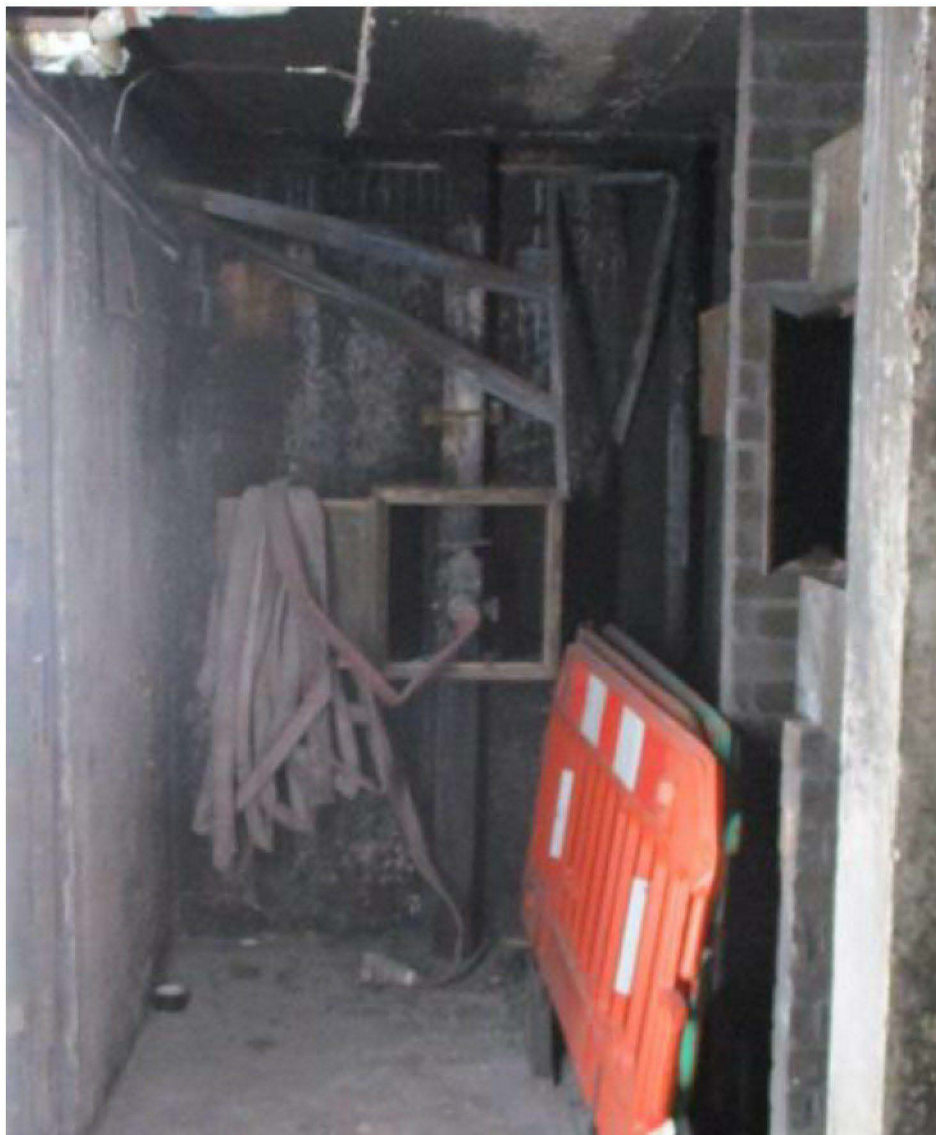
Figure 14.57 Hose connected to the fire main outlet on Level 14 of Grenfell Tower

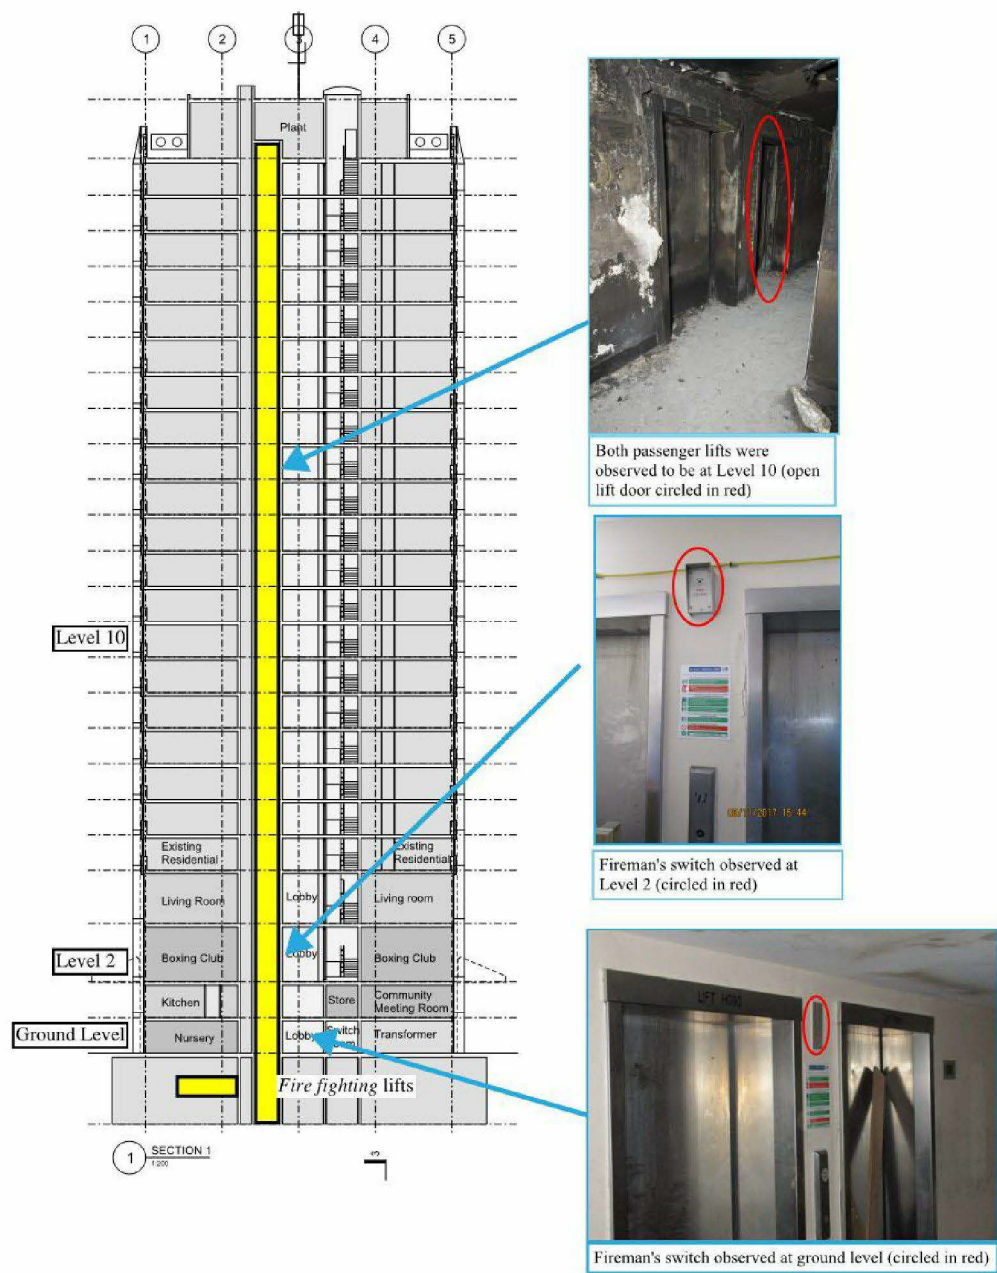
Figure 14.60 Site inspections findings with respect to the position of the lift cars in Grenfell Tower. (SEA00009461)
