Grenfell Tower – fire safety investigation: The fire protection measures in place on the night of the fire, and conclusions as to:

Phase 1 Report – Section 17

External access for the fire and rescue services – the provisions available at Grenfell Tower

24th October 2018

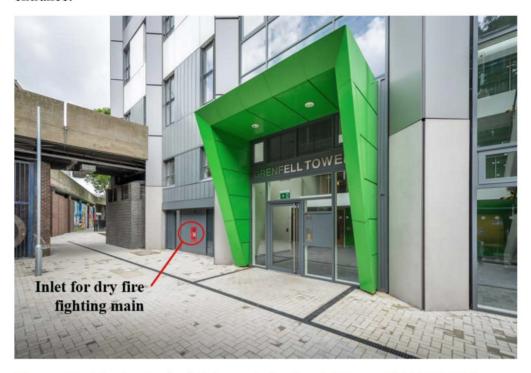
17.2.11 Refer to Figure 17.3 for a photograph of the inlet to the firefighting main, located on the South elevation of Grenfell Tower, adjacent to the main entrance.

Figure 17.3: Inlet for dry firefighting main for Grenfell Tower (SEA00000394)

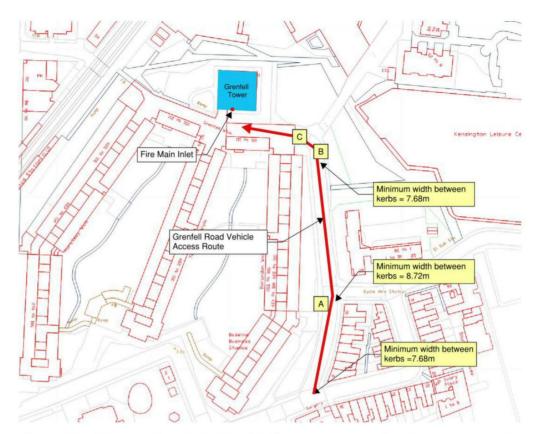
- 17.2.12 In Figure 17.4, I have marked up the ordnance survey map of the area surrounding Grenfell Tower to identify the vehicle access route which leads to the fire main inlet which is located on the South elevation only.
- On this Figure 17.4 I have marked the key widths that my team measured during the post fire inspection. Labels A C indicate the locations of photographic records I have included in Figure 17.5.

Figure 17.4: Fire vehicle route to Grenfell Tower, summary of onsite measurements of 7^{th} November 2017

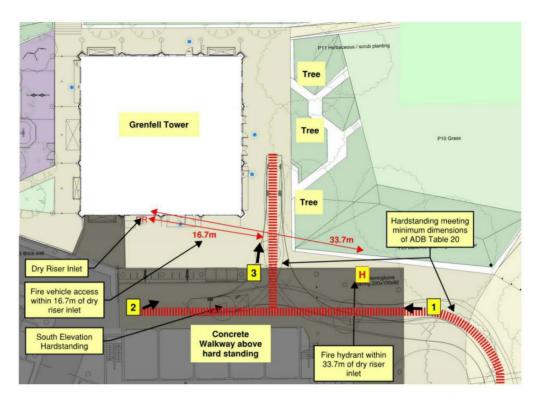
- 17.2.18 Underneath the concrete walkway, Grenfell Road runs parallel to the South elevation of Grenfell Tower. In Figure 17.6, I have over marked the distance of the vehicle access to the fire main inlet on the South Elevation of Grenfell Tower and the location of an external hydrant I observed in this location too.
- 17.2.19 I measured the minimum distance of the access route to the fire main inlet as 16.7m, which is less than the maximum 18m permitted by ADB 2013 Section 16.6. The proximity of Grenfell Road to the Grenfell Tower fire main inlet is therefore compliant for a fire appliance access road.

Figure 17.6: Grenfell Road where it reaches at Grenfell Tower. Please refer to Figure 17.7 for photographic views of Locations 'A', 'B' and 'C'; over marked on Studio E Fire Access Plan drawing (SEA00003480)

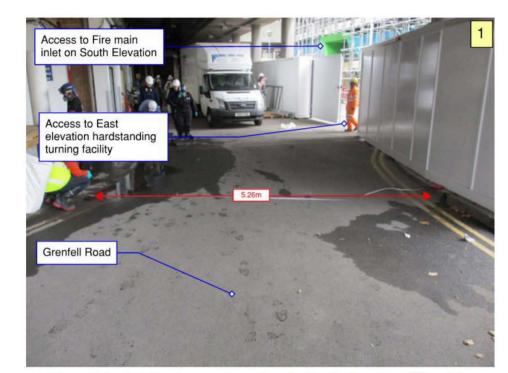
(a) View of Grenfell Road where it reaches the South elevation of Grenfell Tower - Location 'A' -Figure 17.6. Figure 17.6. Measurements were taken by my site inspection team

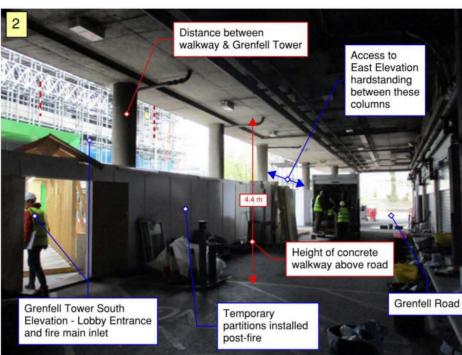
(b) View of Grenfell Tower on South Elevation of Grenfell Tower – Location 'B' Figure 17.6. Measurements were taken by my site inspection team

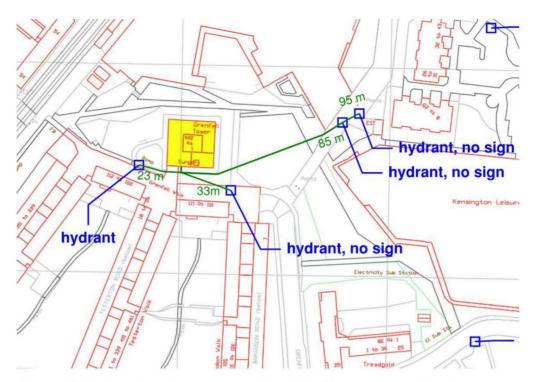
- 17.2.30 In the Ordnance Survey map marked in Figure 17.8 I have marked up the location of all the hydrants I observed on site on 7th November 2017. I also indicate where the observed hydrants were not provided with a sign. I observed 4 hydrants in close proximity to Grenfell Tower. I measured the distances of these hydrants using an ordnance survey map. Three of these hydrants were less than 90m from the fire main inlet and one of these hydrants had appropriate signage. The fourth was 95m from the dry fire main inlet.

- 17.2.31 Therefore, Grenfell Tower was compliant with the hydrant provisions of Section 15 in ADB 2013.

Figure 17.8 Hydrant location summary of onsite findings and approximate measurements from ordinance survey maps

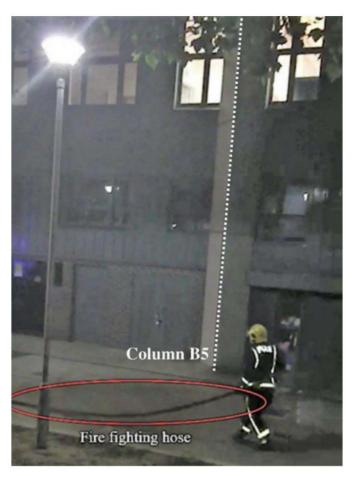
- 17.3.15 Resident video footage shows a fire fighter positioning a fire fighting hose along the East elevation of Grenfell Tower at 01:11 (IWS00000054); refer to Figure 17.9. This is the only firefighting hose I observed in this video, which indicates that the hose in Figure 17.9 was the first firefighting hose positioned directly below Flat 16 on the East elevation.

- 17.3.16 I did not observe any water on the ground by Column B5 at this time in this video (IWS00000054), as shown in Figure 17.9, indicating that water had not been applied to the East elevation of Grenfell Tower before 01:11.

Figure 17.9: Fire fighter positioning a fire fighting hose along the East elevation of Grenfell Tower at 01:11. (IWS0000054)

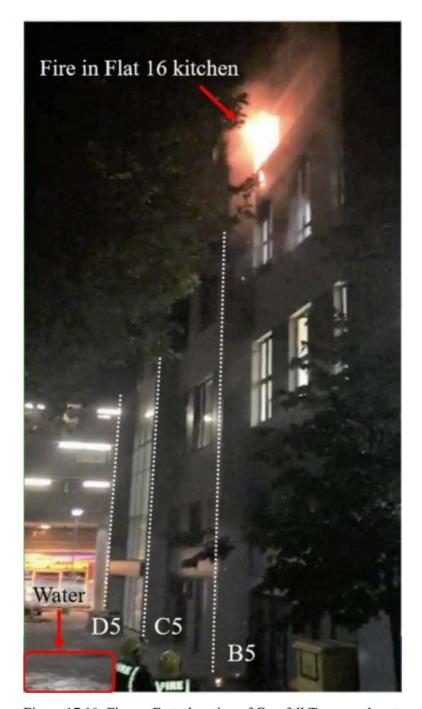
17.3.17 In the same resident video footage (IWS00000054), approximately 55 seconds after Figure 17.9, I observed water on the ground adjacent to the East elevation of Grenfell Tower, shown in Figure 17.10. I do not have photographic or video evidence showing where this water came from.

Figure 17.10: Fire on East elevation of Grenfell Tower and water on ground at 01:11.

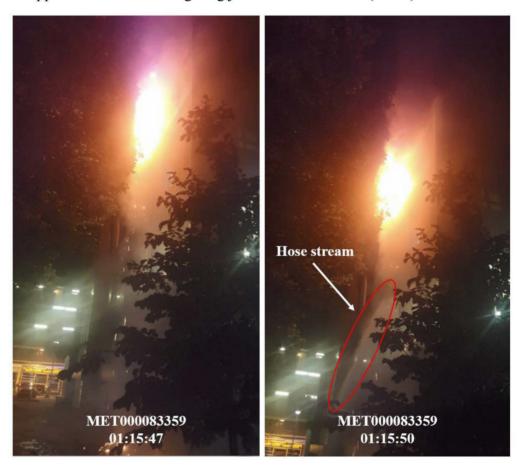
Figure 17.11: First observed firefighting hose stream on East elevation of building envelope at 01:15 on 14 June 2017 (MET000083359)

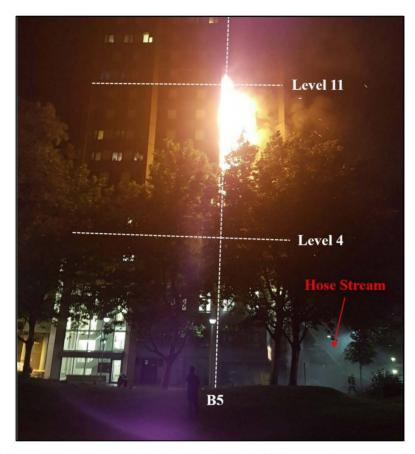
- I have observed through photographic and video evidence that a water jet was intermittently applied to the East elevation of Grenfell Tower, and to burning debris at ground level, between 01:15 and 01:25 with a handheld hose. (MET000083359, MET00006576, MET00006834, MET00006577, MET00006833, MET000083360, MET000083361, MET000083362).
- 17.3.29 Refer to Figure 17.12 for a photograph of a firefighter applying a water jet to the East elevation of the building at 01:21.

Figure 17.12: Fire on East elevation of the building envelope at 01:21 on 14 June 2017; Firefighter applying a hose stream to the East elevation (MET00006591)

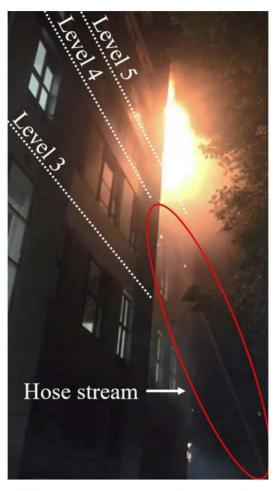
- As I will explain in Section 17.4, at a later stage in the night, the water from a handheld hose from ground level appeared to reach Level 7 on the West elevation of Grenfell Tower. However, I have been unable to find positive evidence of water being applied at or above the level of the Flat 16 kitchen window in my review of photographs and videos between 01:15:50 and 01:25.
- 17.3.31 I have only been able to find evidence of water being applied below Level 4; refer to Figure 17.13.

Figure 17.13: External firefighting from ground level (MET00006577)

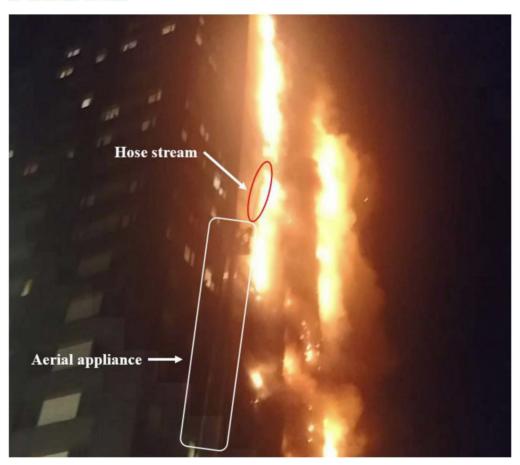
Figure 17.16: Aerial appliance with hose stream applied to the East elevation of the building envelope at 01:47 on 14 June 2017 (extract from Bisby Video 2 accompanying Luke Bisby's supplemental phase 1 Report).

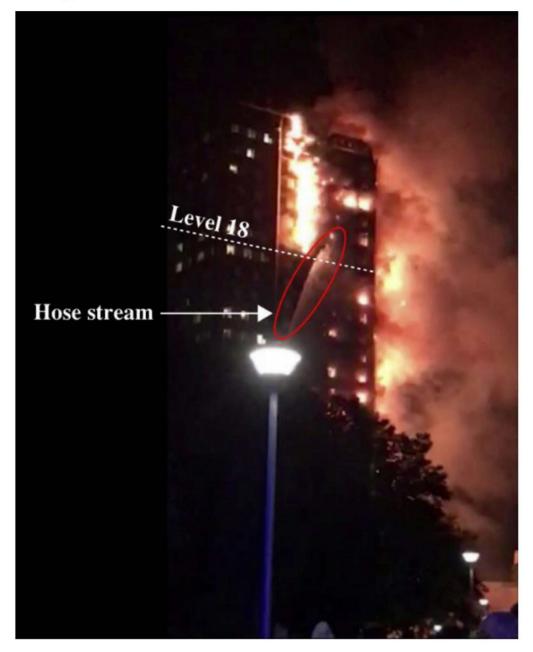
17.3.59 However, the projection of the hose stream from the aerial appliance in Figure 17.17 appears to reach Level 18.

Figure 17.17: Aerial appliance with hose stream applied to the East elevation of the building envelope up to Level 18 at an unknown time between 01:43 and 01:57 (extract from Bisby Video 2, accompanying Luke Bisby's Supplemental Phase 1 Report).

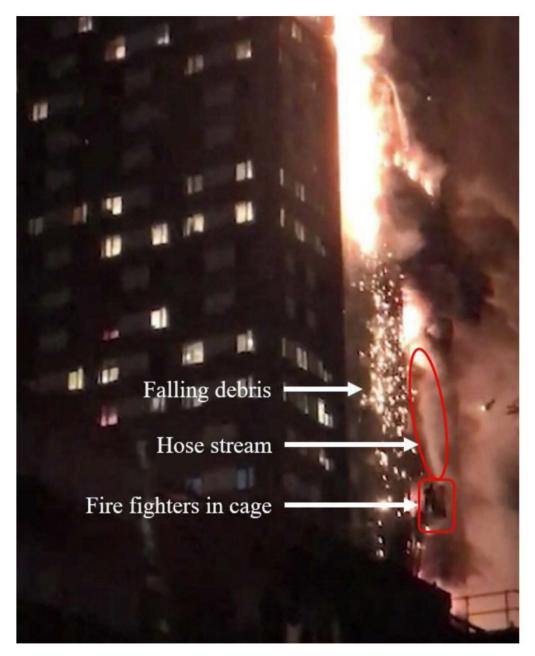
danger due to falling debris; refer to Figure 17.18 and Section 5 for photographic evidence of falling, burning debris (Keane, MET00007782):

Figure 17.18: Aerial appliance with hose stream applied to the East elevation of the building envelope at 02:00 on 14 June 2017 (extract from Bisby Video 2, accompanying Luke Bisby's Supplemental Phase 1 Report)

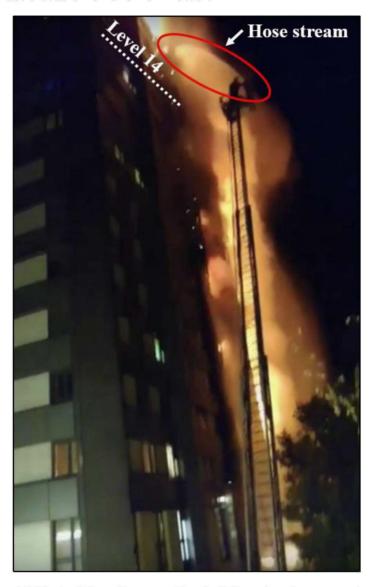
Figure 17.19 shows a hose stream from aerial appliance, Alpha 213, being applied to the East elevation of Grenfell Tower at 02:05. This is the latest visual evidence I have seen of a hose stream from Alpha 213 being applied to the East elevation of Grenfell Tower.

Figure 17.19: Aerial appliance on East building elevation approximately 02:05 (https://www.youtube.com/watch?v=z8wIbhf7NL4)

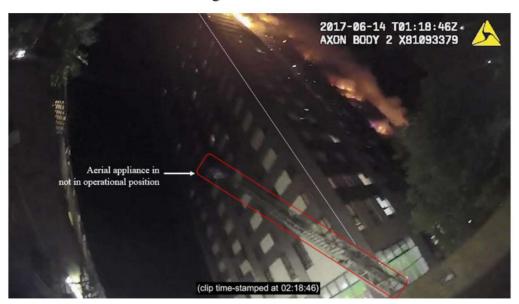
17.3.63 As shown in Figure 17.20, the aerial appliance was no longer in position on the East elevation of the building at 02:18.

Figure 17.20: No aerial appliance observed at 02:18 on 14 June 2017 (extract from Bisby Video 2, accompanying Luke Bisby's Supplemental Phase 1 Report)

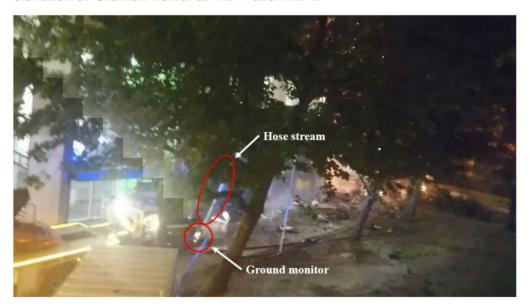
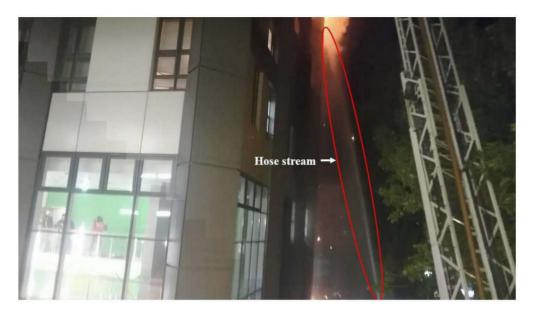
I have also observed a ground monitor set at the base of the East elevation, adjacent to the aerial appliance, as shown in Figure 17.21 and Figure 17.22. I do not know the exact time that this ground monitor was used, however, I have observed, through video evidence, that water was applied to the East elevation of Grenfell Tower at 01:47 and 01:54.

Figure 17.21: Ground monitor on East elevation at unknown time between 01:43 and 01:57 (extract from Bisby Video 2, accompanying Luke Bisby's Supplemental Phase 1 Report)

Figure 17.22: Ground monitor on East elevation at 01:47 (extract from Bisby Video 2, accompanying Luke Bisby's Supplemental Phase 1 Report)

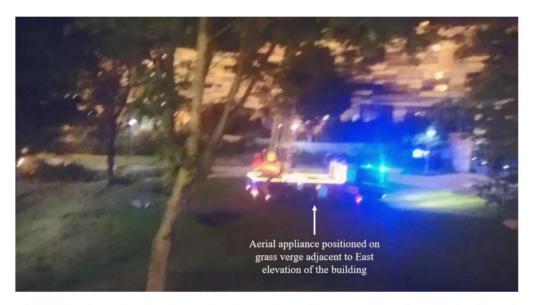
Figure 17.24: Appliance observed to be positioned on grass verge between 01:43 and 01:57 (extract from Bisby Video 2, accompanying Luke Bisby's Supplemental Phase 1 Report)

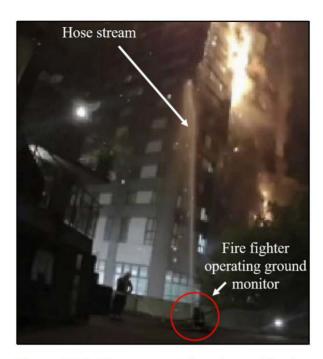
- 17.3.82 Hose Stream 4 on the South elevation of the building was supplied by a ground monitor located on the Lancaster Estate raised walkway (referred to as "car port" in fire fighter witness statements) (Keane, MET00007782 and Collins, MET00010086), as shown in Figure 17.30. Through photographic and video evidence, I observed water being applied to the South elevation of Grenfell Tower intermittently between 02:41 and 03:59. (MET00012593)

Figure 17.30: Hose stream 4; hose jet position located on the Lancaster Estate raised walkway on the South building elevation at 02:48 (MET00012593)

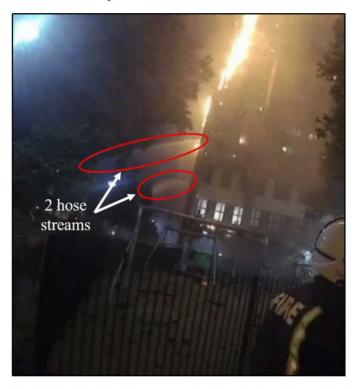
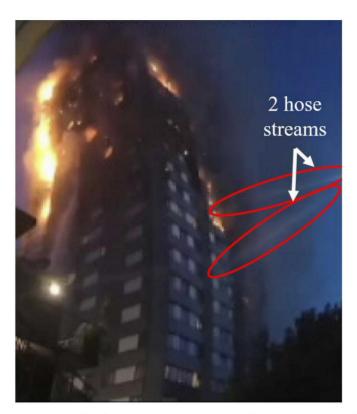
have observed other jets on the building. For example, Figure 17.31 shows that two hose streams were applied to the North elevation of the building at 03:25 and Figure 17.32 shows two hose streams were applied to the East elevation of the building at 03:59. These additional hose streams could have been the 5th and/or 6th jets.

Figure 17.31: Two firefighting jets on the North elevation of the building at 03:25 (MET00012593)

Figure 17.32: Two firefighting jets on the East elevation of the building at 03:59 (MET00012593)

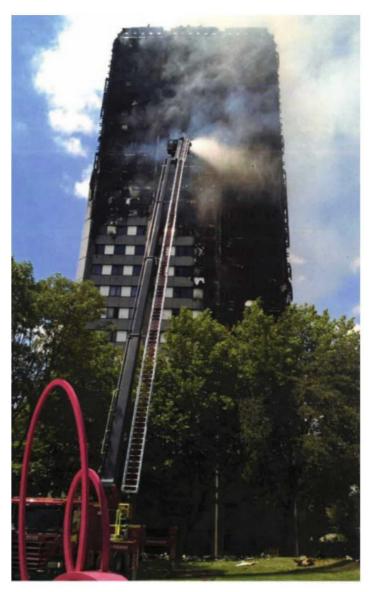
- 17.3.90 According to the LFB Short Incident Log, a 42m ALP aerial appliance (N245) arrived at the incident at 08:19 (MET00013830 at p.37p).
- According to the Record of Actions report of Chris Payton (MET00015742), Surrey's ALP (N245) replaced Soho's ALP (A245) on the grass verge adjacent to the East elevation of Grenfell Tower at approximately 10:45 and began spraying water onto the building at approximately 11:15; refer to Figure 17.33.

Figure 17.33: Surrey's ALP (N245) on the grass verge adjacent to the East elevation of Grenfell Tower (MET00015739)

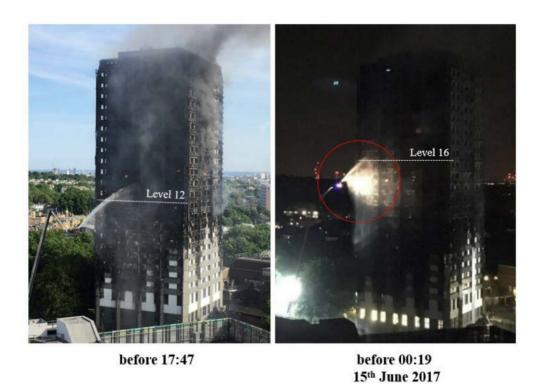
17.3.92 I have also observed through photographic evidence that an aerial appliance provided a firefighting jet on the North elevation of the building before 17:47 and again before 00:19 on 15th June 2017, as shown in Figure 17.34. These timings are based on the time the images were posted to Twitter only. Based on the operating height of the appliance in these photographs, this is likely the Surrey aerial appliance.

Figure 17.34: ALP providing firefighting jet on North elevation of building on 14th June 2017 (exact times unknown; https://twitter.com/Natalie_Oxford/media?lang=en)

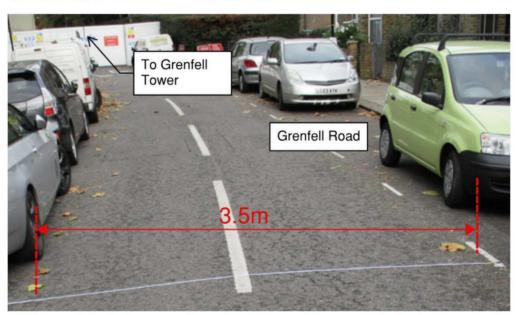
Figure 17.37: Reduction in available roadway due to parked vehicles
