Grenfell Tower – fire safety investigation:
The fire protection measures in place on the night of the fire, and conclusions as to:
the extent to which they failed to control the spread of fire and smoke;
the extent to which they contributed to the speed at which the fire spread.

Phase 1 Report – Section 19

How the protected stairs and lobbies failed for the residents and firefighters

24th October 2018

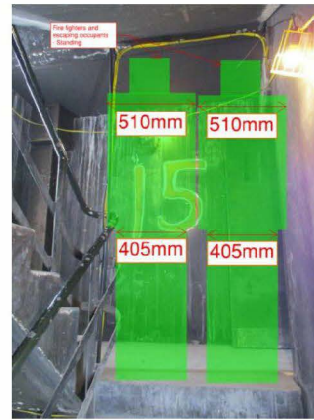
(b) Illustration of the capacity of 2 people side by side in the stair of Grenfell Tower on the stair

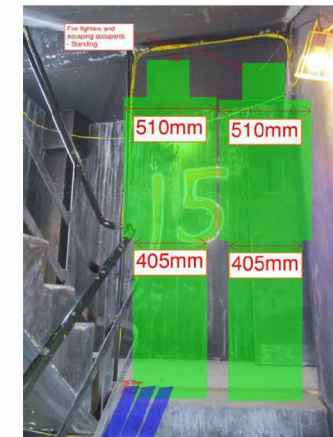
19.6.81 Despite the Grenfell Tower stair being perceived to be narrow I have so far seen no evidence that the stairs actually became blocked at any stage or that its width in and of itself significantly impacted on escape by the residents or access by fire fighters.

(f) Impact of hoses on usable stair width of Grenfell Tower
