Grenfell Tower – fire safety investigation:
The fire protection measures in place on the night of the fire, and conclusions as to:
the extent to which they failed to control the spread of fire and smoke;
the extent to which they contributed to the speed at which the fire spread.

Phase 1 Report – Section 4

**Overview of building works at Grenfell Tower,
including recent refurbishment 2012-2016**

Dr Barbara Lane FREng FRSE CEng

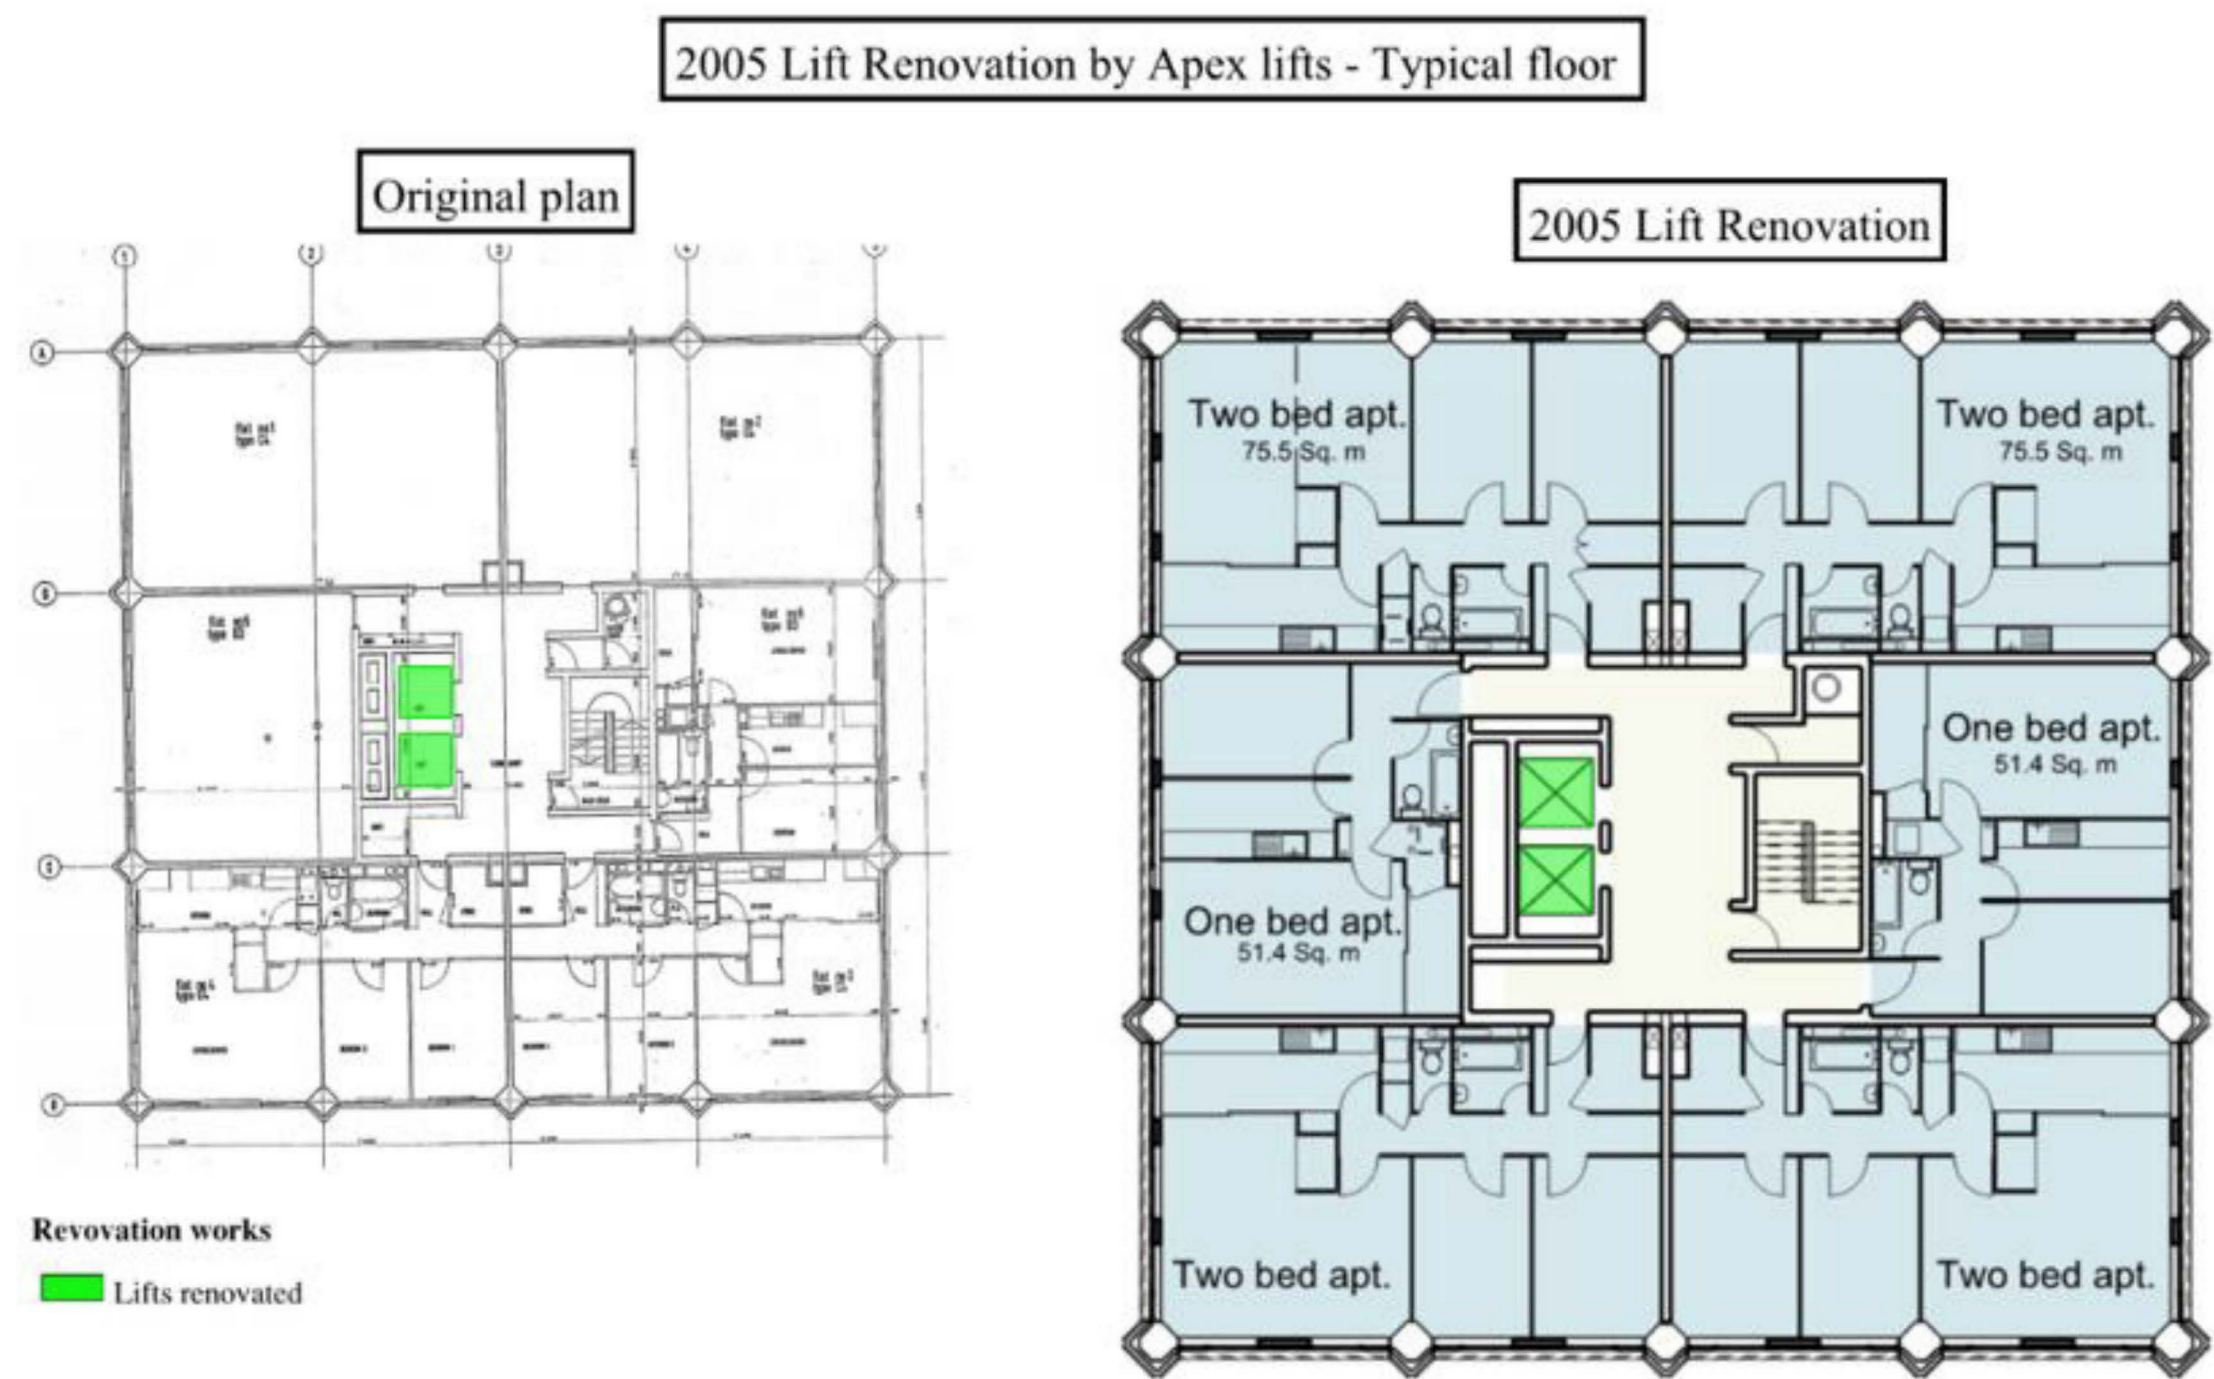
4.5.4 I have reviewed the Health and Safety file (CST00000384) which includes the specification for the lifts. The lift replacement was undertaken as a “like for like” replacement. The lifts were not installed as full firefighting lifts in accordance with the relevant guidance in 2005, i.e. they were not provided with alternative power supplies and with water protection to their control systems. Please refer to Appendix L for additional details.

4.5.5 I have highlighted the 2005 lift replacement works in Figure 4.17 and Figure 4.18, with a side by side comparison of the original plan and existing plan (2012) of the typical residential levels (4 – 23) and the plant room (no original drawing available at this time).

Figure 4.17: 2005 lift replacement on typical residential levels 4– 23. (RBK00018837, CCL00000028)

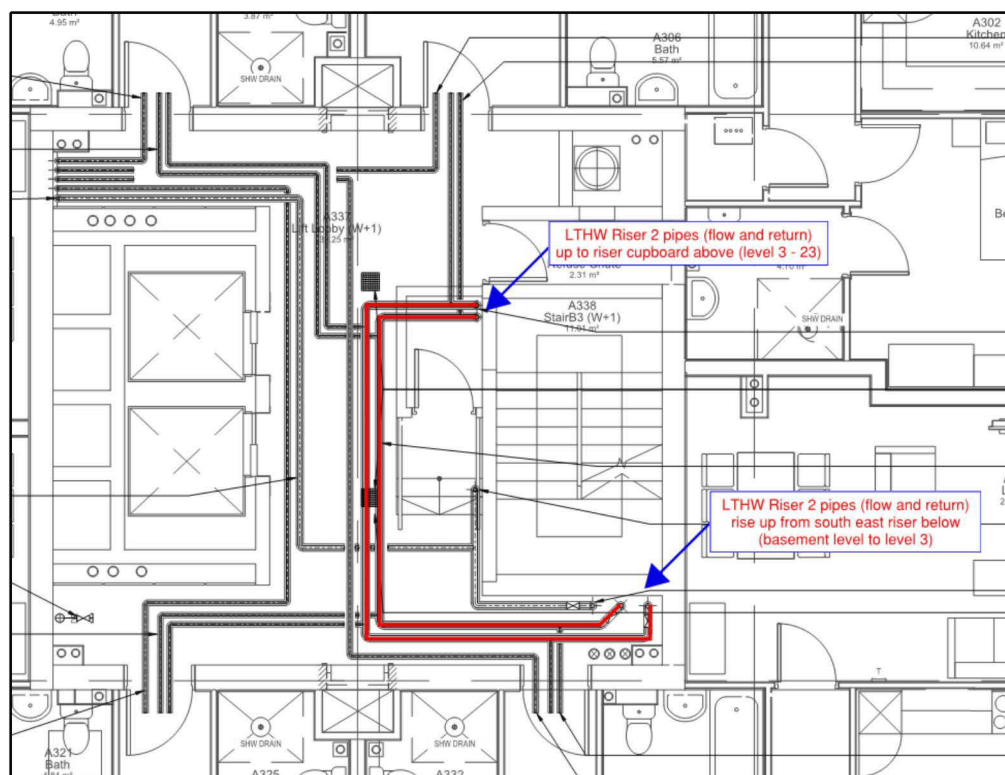
- 4.7.52** As indicated in Figure 4.28, the pipes serving Levels 3 to 23 enter the existing Southeast riser in the core on the basement level. On Level 3, the LTHW flow and return pipes leave the Southeast riser (south of protected stairway), run laterally through the common lobby, and enter the protected stairway, as shown in Figure 4.29. These pipes rise to level 4, where a new service cupboard was created as part of the refurbishment works. A new service cupboard was created in the same place in the lobbies on each level from level 4 – 23 as part of the 2012 – 2016 refurbishment works. The LTHW pipes rise through these cupboards to level 23. (RYD00000577)

Figure 4.29: Lateral LTHW lateral piping through level 3 common lobby (RYD00000577)

- 4.7.53** The pipes appear to have been fire stopped at each floor level. The service riser does not appear to form a protected shaft. The new riser cupboard is not shown on the fire strategy drawings by Studio E (SEA00003112). The new cupboards are not described in the Exova fire strategy report (EXO00000582).

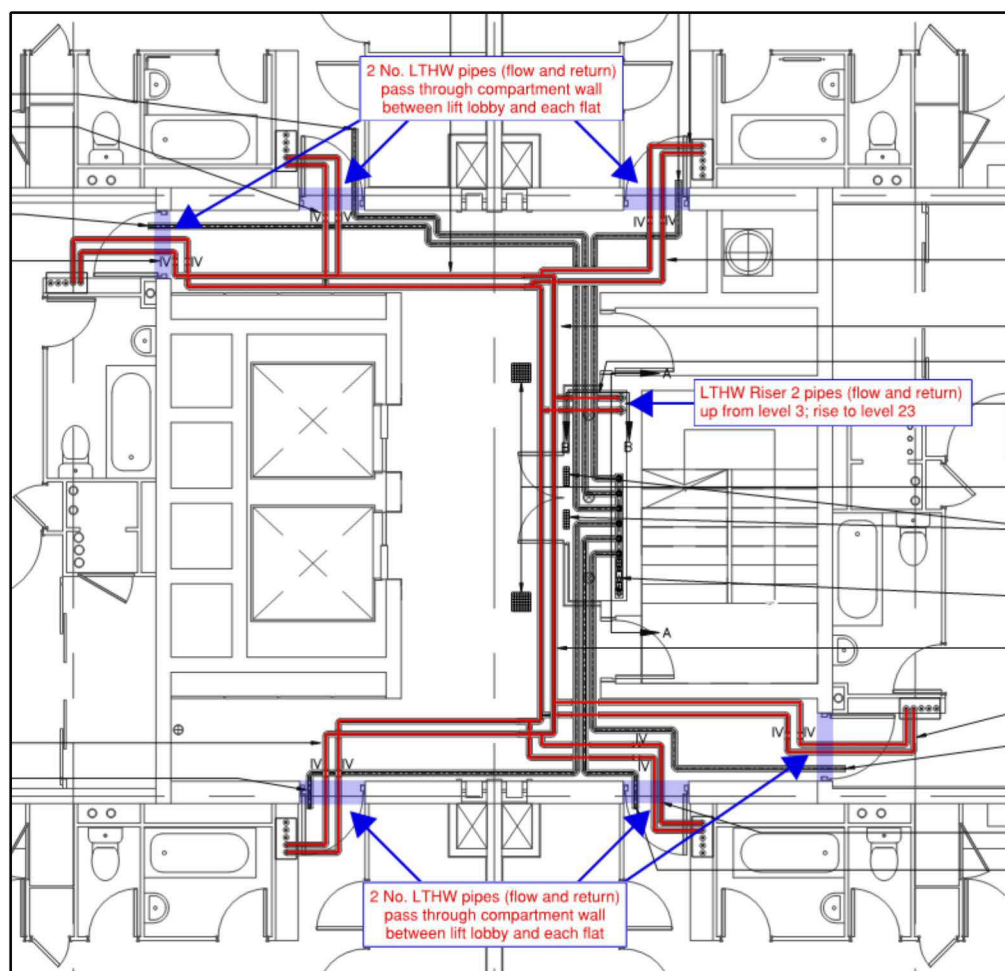
- 4.7.55** On each level from level 4 – 23, the LTHW pipes leave the riser cupboard and distribute laterally through the common lobby to each flat. As shown in Figure 4.30, a flow and return pipe enters each flat above the flat entrance door (RYD00000577).

Figure 4.30: LTHW lateral distribution piping through typical residential level common lobby (RYD00000577)

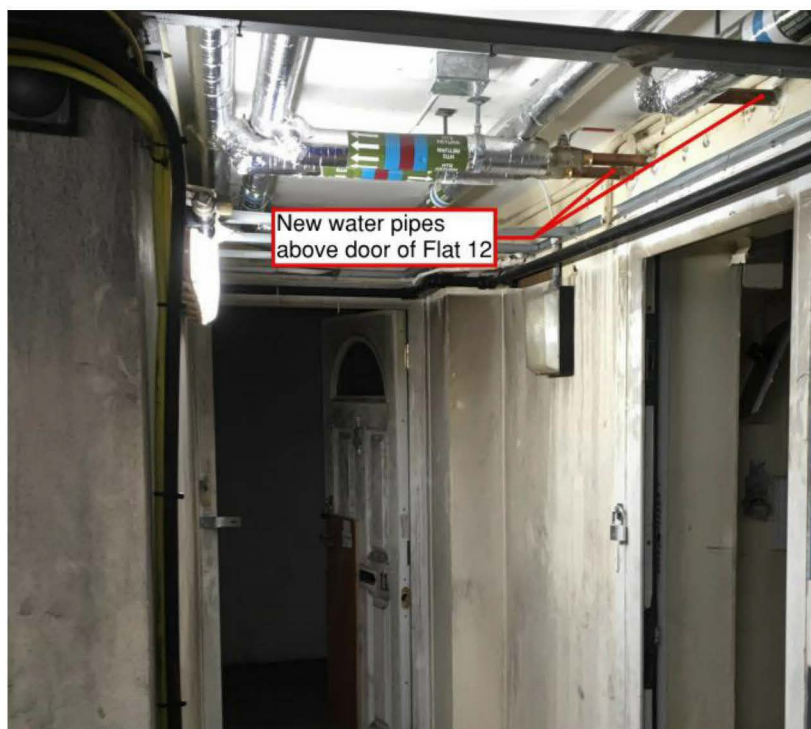
- 4.7.56** These changes are reflected in the Studio E As-Built drawings as indicated in this section.
- 4.7.57** The pipe distribution works in the lobby were then concealed above a new suspended plasterboard ceiling, described in Section 4.7.98.
- 4.7.58** Based on the Studio E Grenfell Tower Regeneration Project Room Data Sheets, Employer Requirements, dated 20-11-2013, holes were core drilled through the concrete wall above each flat front door for new water and heating pipes to each flat on every level (SEA00002540). This means that 18 holes were drilled on each floor, and 360 holes over all levels. Please see Figure 4.31 for an example of this distribution taken during my post fire inspection of the building.

Figure 4.31: New pipework fitted in ceiling of Level 4 common lobby

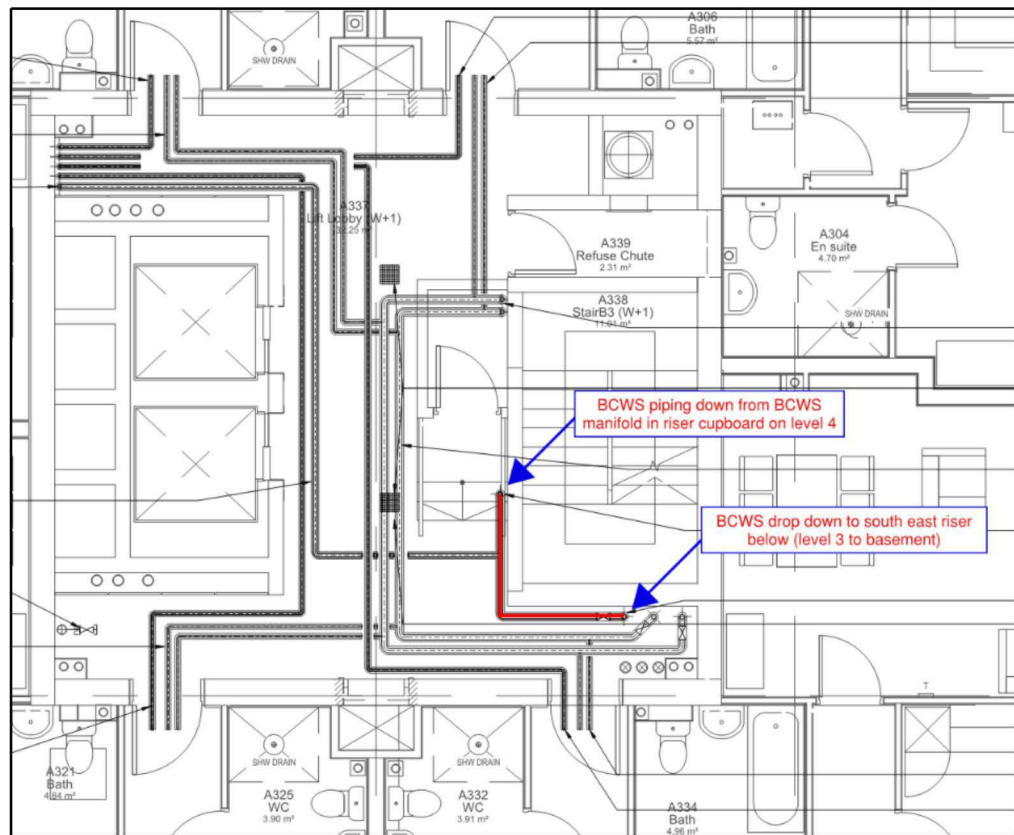
- 4.7.72** The BCWS pipe leaves the riser cupboard on level 4 and enters the protected stairway on level 3, as shown in Figure 4.36. The BCWS then leaves the protected stairway and distributes laterally to the Southeast corner of the level 3 common lobby.
- 4.7.73** The BCWS pipe then drops into the Southeast riser from level 2 to the basement level; it serves the boxing gym on level 2. At the basement level, the piping is distributed to 5 no. other risers, as shown in Figure 4.37. These 5 no. other risers supply the nursery, community room, and flats on level 2 and 3.

Figure 4.36: BCWS lateral distribution piping through level 3 common lobby (RYD00000577)

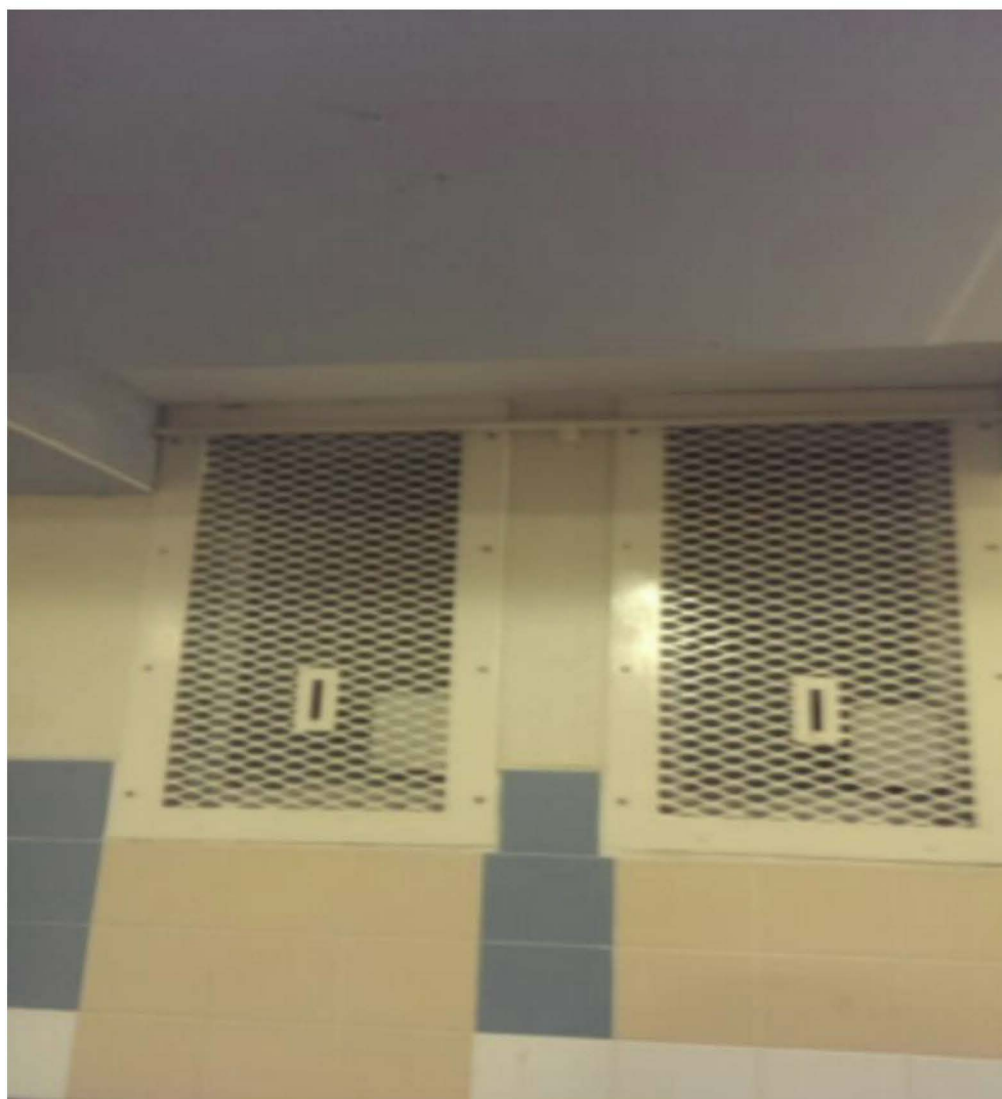
- 4.7.101** Pre-fire photographs of the Level 14 new ceiling installations are shown in Figure 4.44 and Figure 4.45.
- 4.7.102** Carl Stokes’ correspondence indicates that he believed that the ceiling and new cupboards were of fire resisting construction. There is no evidence in the refurbishment design information reviewed to date to support this.
- 4.7.103** During my site inspections I did observe the new ceiling cupboard enclosure. The ceiling construction was mounted on metal stud framing and not timber as stated by Mr Stokes. Please refer to Appendix C and Section 14.

Figure 4.44: New ceiling around vents on Level 14 (CST00000170)

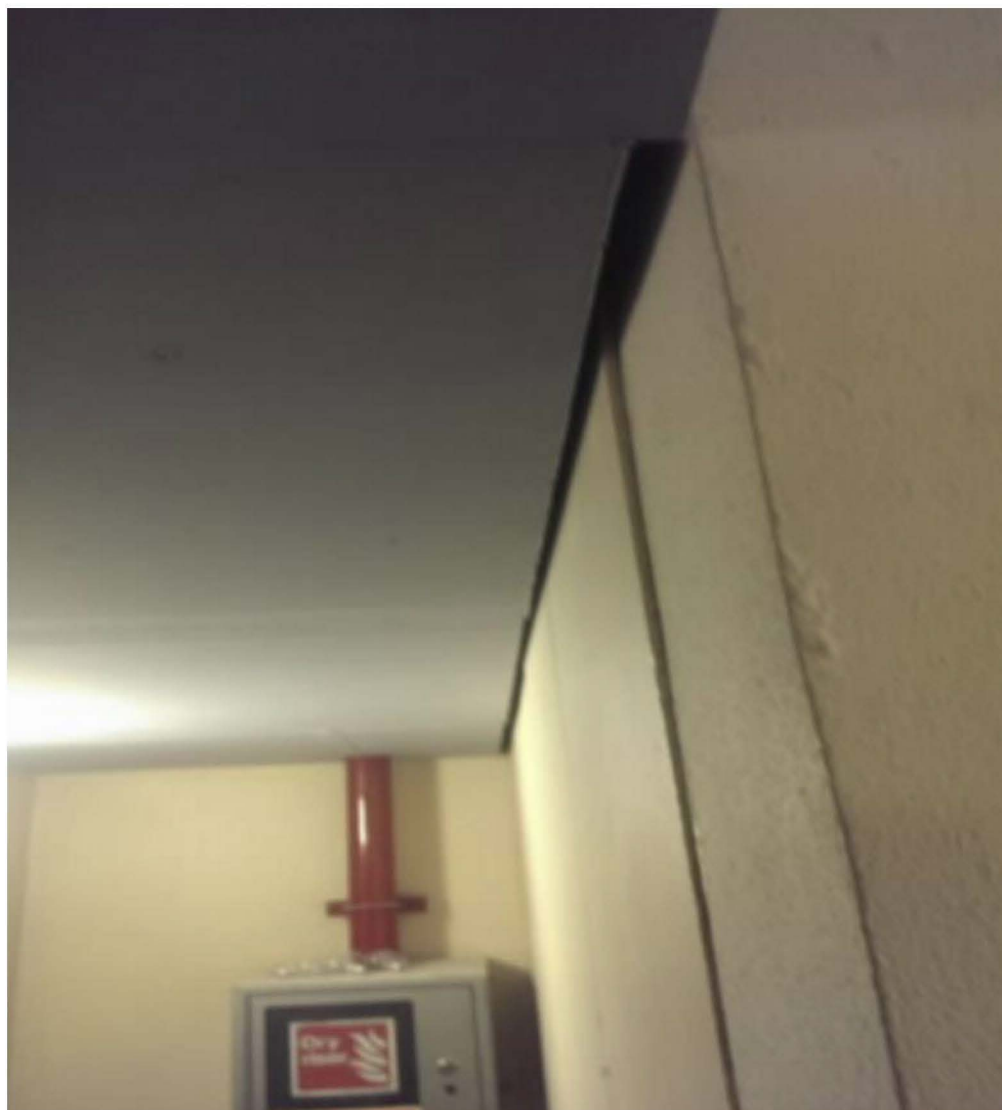
Figure 4.45: Wall access panels to be cut at new ceiling height so access to the electrical cable risers can be maintained (CST00000170)
