Grenfell Tower – fire safety investigation: The fire protection measures in place on the night of the fire, and conclusions as to:

Phase 1 Report - Section 5

The observed events of 14th June 2017

Dr Barbara Lane FREng FRSE CEng

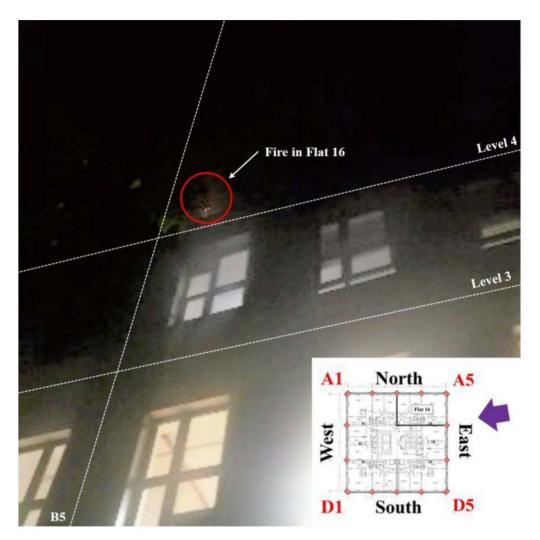
5.3.7	Figure 5.3 is a photograph of the fire in the Flat 16 kitchen window before 01:02. It is the earliest photograph of the fire that I have seen. (MET000083344)

Figure 5.3: Fire in Flat 16 on Level 4 at unknown time before 01:02 on 14 June 2017 (MET000083344) (SEA00010474)

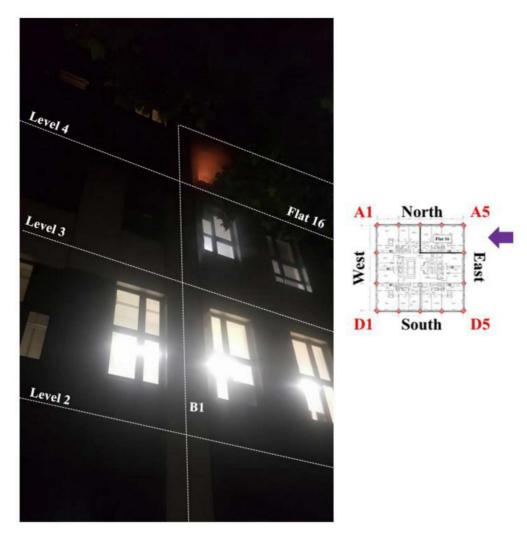
5.3.8 Figure 5.4 is a photograph of the fire in the Flat 16 kitchen window at 01:02. (MET00012593)

Figure 5.4: Fire in Flat 16 on Level 4 at 01:02 on 14 June 2017 (MET00012593) (SEA00010474)

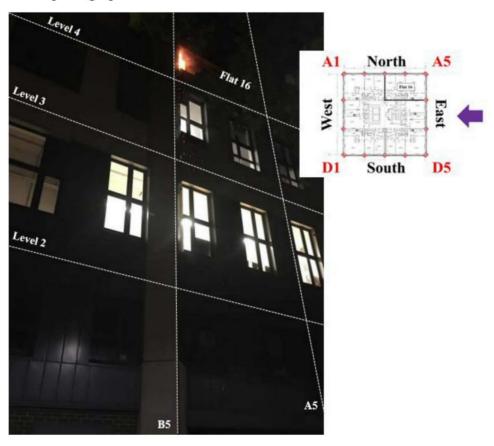
5.4.1 Figure 5.5 shows external flaming outside the window of the kitchen in Flat 16 at 01:08. This is the earliest evidence I have seen of external flaming based on the photographs and videos I have reviewed to date.

Figure 5.5: Fire on East elevation of the building envelope at 01:08 on 14 June 2017 (IWS00000051) (SEA00010474)

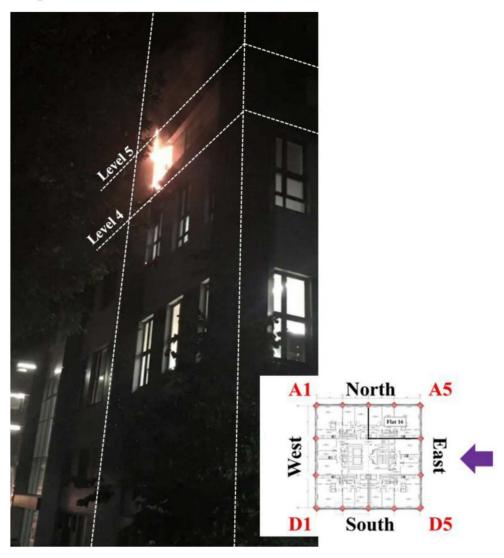
5.4.2 Figure 5.6 is a screenshot from new video evidence that shows fire spread above the compartment floor line at Level 5 by 01:13 (IWS00000050). Previously, the earliest evidence I had of fire spread above the Level 5 floor compartment line was at 01:15.

Figure 5.6: Fire on East elevation of building envelope spread to Level 5 at 01:13 (IWS00000050) (SEA00010474)

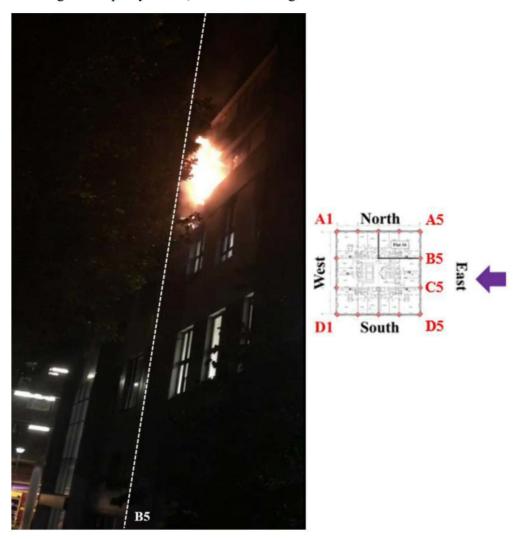
5.4.3 Flames then spread at Level 4 to column B5 on the East elevation of the building envelope by 01:14, as shown in Figure 5.6.

Figure 5.7: Fire on East elevation of building envelope spread to Level 5 at 01:14 (IWS00000050) (SEA00010474)

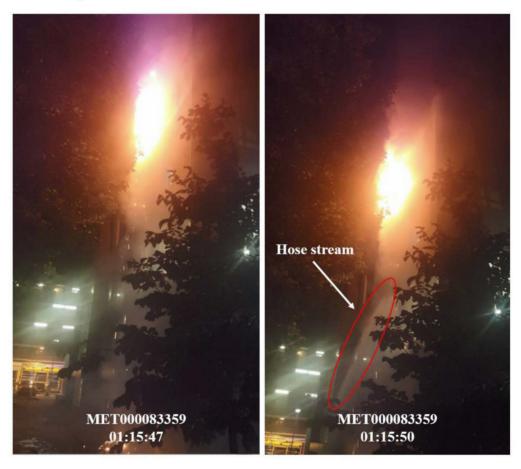
Figure 5.8 shows the East elevation of the building envelope at 01:15:47, which shows no firefighting water being applied to the building. In comparison, the East elevation of the building envelope at 01:15:50 is shown with external firefighting water being applied to the building. This is the first confirmed time of external firefighting I am aware of, based on the photographs and videos I have reviewed to date. Some firefighter witness statements suggest that water was applied to the building before 01:15:50, but I have not been able to confirm this through photographic and video evidence. Refer to Section 17 of my report for my analysis of the external firefighting achieved by LFB on 14th June 2017.

Figure 5.8: First observed fighting hose stream on East elevation of building envelope at 01:15 on 14 June 2017 (MET000083359)

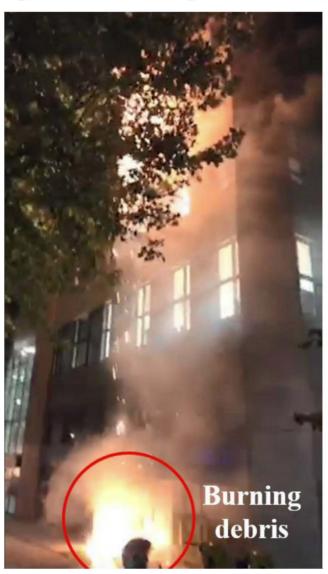
5.4.6 Figure 5.9 shows that burning debris started to fall off the building by 01:15.

Figure 5.9: Burning debris observed on East elevation of building envelope at 01:15 on 14 June 2017 (MET00006834)

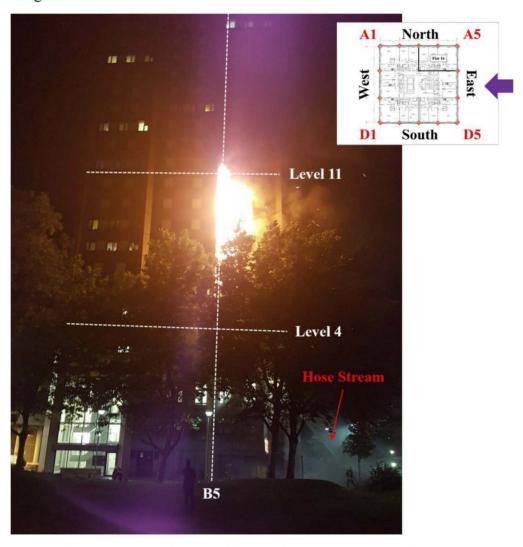
- 5.4.7 LFB then made the call for "Make pumps eight" at 01:19 (LFB00000003).
- 5.4.8 The fire had spread vertically along the line of column B5, reaching approximately Level 11 (32m above Ground level) by 01:21, as shown in Figure 5.10. LFB continued to actively fight the building envelope fire from the ground at this time.

Figure 5.10: Fire on East elevation of the building envelope at 01:21 on 14 June 2017 (MET00006591) (SEA00010474)

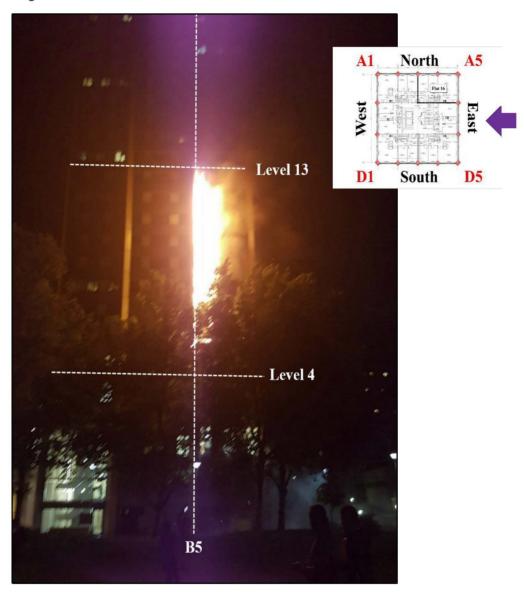
5.4.9 The fire spread vertically along the line of column B5, reaching approximately Level 13 (37m above Ground level) by 01:22, as shown in Figure 5.11.

Figure 5.11: Fire on East elevation of the building envelope at 01:22 on 14 June 2017 (MET00012593) (SEA00010474)

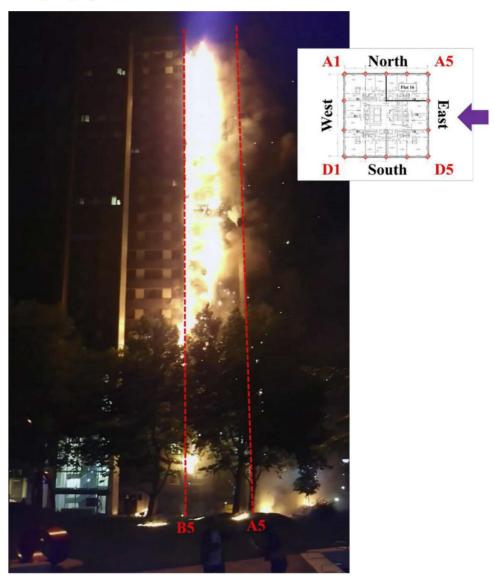
- 5.4.10 LFB then made the call to "Make pumps ten" at 01:24 (LFB00000003).
- 5.4.11 The fire spread from Level 4 to Level 23 along column B5, spanning a height of over 50 m by 01:26, as shown in Figure 5.12. In approximately 12 minutes, the fire spread up 19 storeys on the outside of the building.
- 5.4.12 Significant burning debris continued to fall off the building. Falling debris was a significant hazard for those occupants who decided to evacuate the building, and not stay put; and also for emergency responders (LFB, Ambulance, and MPS) throughout the fire. Please refer to Section 5.5 for additional photographs of falling debris and the impact debris had on emergency operations.

Figure 5.12: Fire on East elevation of the building envelope on 14 June 2017, estimated time 01:26 (SEA00010474)¹

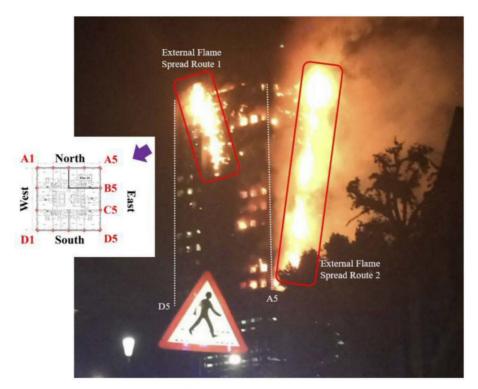
- 5.4.23 In most of the photographic and video evidence of external fire spread after 02:08 that I have reviewed, I observed a consistent diagonal pattern of fire spread along both External Flame Spread Route 1 and 2, as shown in Figure 5.16. I observed this diagonal pattern of fire spread on all elevations of Grenfell Tower for photographic evidence refer to Figure 5.21 (North elevation), Figure 5.28 (East elevation), Figure 5.35 (South elevation) and Figure 5.38 (West elevation). In Section 10 of my report I describe this diagonal pattern of flame spread with regards to the routes for external vertical and horizontal fire spread on the building envelope.

Figure 5.16: Diagonal pattern for External Flame Spread Routes 1 and 2 at 02:08 on $14^{\rm th}$ June 2017 (MET0001253) (SEA00010474)

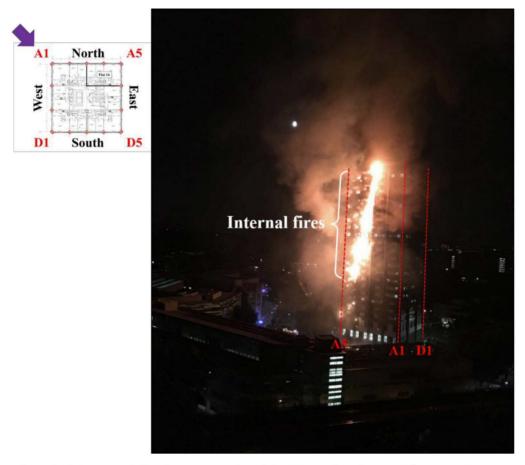
- 5.4.28 LFB then "Make pumps 40" at 02:04 (LFB00000003).
- 5.4.29 At 02:06, the LFB declared the fire a "major incident" (LFB00000003).
- 5.4.30 The fire continued to spread laterally on the North elevation of the building envelope, from column A5 (northeast corner of the building) towards column A1 (northwest corner of the building), along the lines of the windows, as shown in Figure 5.20, which is at 02:10.
- 5.4.31 At this time, both the East and North building envelopes of the building were involved in external fire, and multiple internal fires can be observed.

Figure 5.20: Internal fires burning on North building elevation and fire spread on North elevation of building envelope at 02:10 on 14 June 2017 (MET00012593) (SEA00010474)

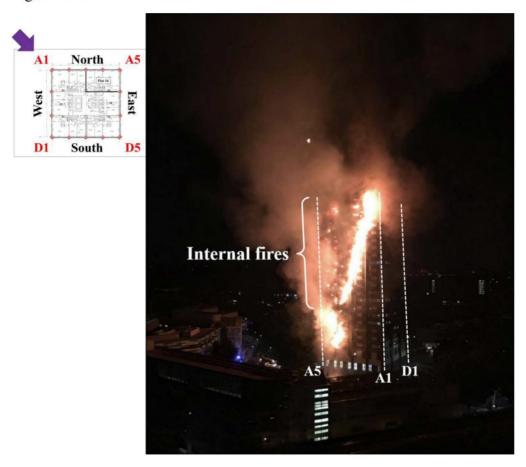
- 5.4.32 At 02:30, it was reported that the East elevation of the building envelope was fully involved in fire (MET00012593).
- 5.4.33 Multiple internal fires were burning simultaneously at 02:34, as shown in Figure 5.21.

Figure 5.21: Internal fires burning on North elevation and fire spread on the North elevation of the building envelope at 02:34 on 14 June 2017 (MET00012593) (SEA00010474)

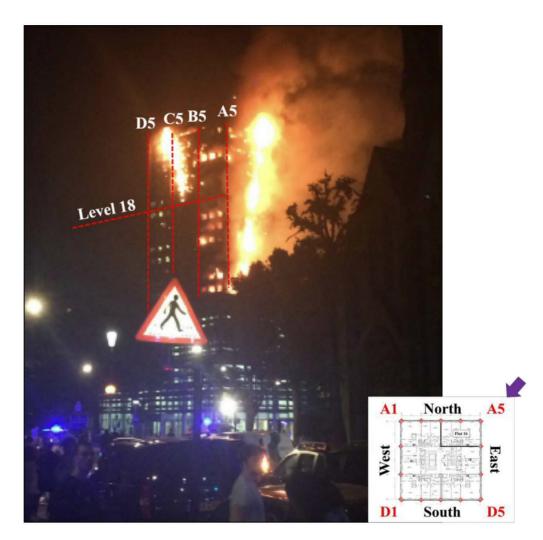
- 5.4.47 As noted in Section 5.4.29, the LFB declared the fire a "major incident" at 02:06 (LFB00000003).
- 5.4.48 At this time, both the East and North elevations of the building envelope were involved in external fire (MET00012593)
- 5.4.49 The fire continued to spread laterally from column C5 to D5 on Levels 18 to 23, as shown in Figure 5.27. Multiple internal fires can be seen in the building in this photograph.

Figure 5.27: Fire spread on East elevation of the building envelope at 02:08 on 14 June 2017 (MET00012593) (SEA00010474)

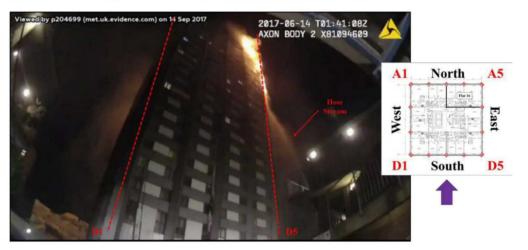
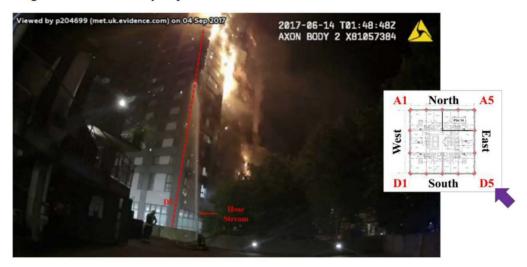
Figure 5.32: Fire spread on South elevation of the building envelope at 02:41 on 14 June 2017 (MET00012593) (SEA00010474)

- As noted in 5.4.34, LFB changed the stay put guidance at 02:35 (Jo Smith) and 02:47 (AC Roe) (MET00005404). At this time, the East, North, and South elevations of the building envelope were involved in fire and multiple internal fires were burning simultaneously, as shown in Figure 5.21.
- 5.4.56 The fire continued to spread laterally on the upper levels of the South elevation of the building envelope from the Southeast corner of the building (column D5) towards the Southwest corner of the building (column D1), as shown in Figure 5.32 and Figure 5.33.

Figure 5.33: Fire spread on South elevation of the building envelope at 02:48 on 14 June 2017 (MET00012593) (SEA00010474)

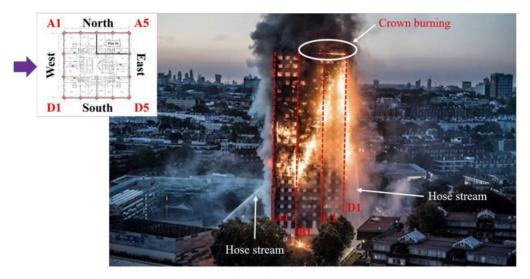
- 5.4.69 The two flame fronts spread laterally towards each other between columns C1 and D1, fully enveloping the building's perimeter, as shown in Figure 5.39, Figure 5.40, Figure 5.41, and Figure 5.42.
- 5.4.70 On 14 June 2017, civil twilight was from 03:55 and sunrise was at 04:42. I have estimated the timings for some of the following images based on this daylight information and my visual observations of fire development, benchmarked to images with known times.
- **5.4.71** Figure 5.39 shows fire burning in and around the crown cladding construction.

Figure 5.39: Fire on West elevation of the building envelope on 14 June 2017 (exact time between 04:03 and 04:42 unknown) (SEA00010474)⁵

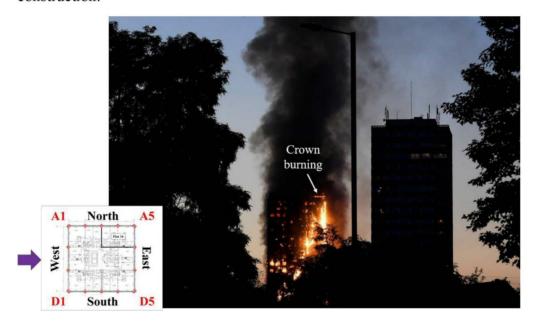
- 5.4.72 Figure 5.43, Figure 5.44, and Figure 5.45 show several internal fires burning while the building envelope on the West elevation continues to burn. These photographs are estimated to be between 04:03 and 04:42.
- 5.4.73 Figure 5.43 shows fire burning in and around the crown cladding construction.

Figure 5.43: External fire West elevation of building envelope on 14 June 2017 (exact time between 04:03 and 04:42 unknown) (SEA00010474)⁷

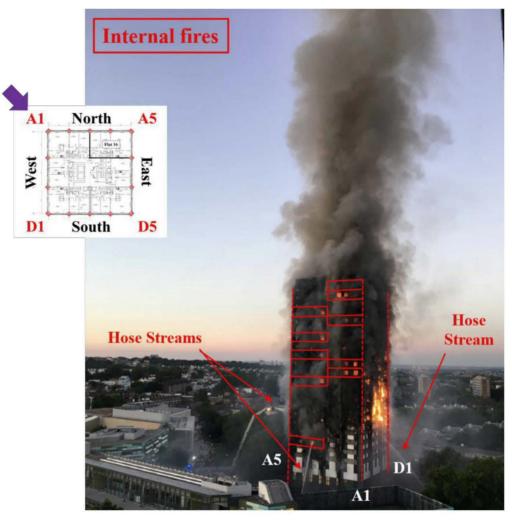
5.4.76 While the fire continued to spread on the West elevation of the building envelope, internal fires burned as well. Figure 5.48 shows internal fires burning on the North and West elevations while the West elevation of the building envelope continues to burn at 4:43. I observed three (3) fire fighter jets being applied in this photograph – one on each of the East, North, and West elevations.

Figure 5.48 Internal fires burning on North and West elevations and fire spread on West elevation of the building envelope at 04:43 on 14 June 2017 (MET00012593) (SEA00010474)

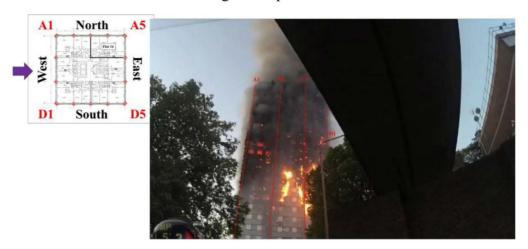
5.4.77 Figure 5.49 shows internal fires burning on the West building envelope while the West elevation of the building envelope continues to burn at 4:44.

Figure 5.49: Fire spread on West elevation of building envelope at 04:44 on 14 June 2017 (MET00012593) (SEA00010474)

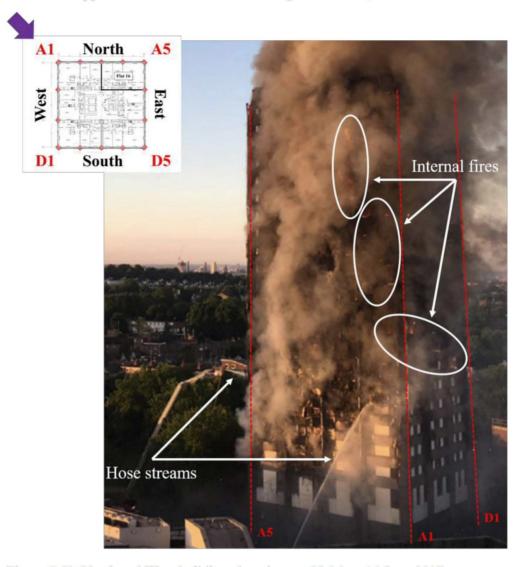
5.4.80 Figure 5.52 indicates there were at least two (2) fire fighter jets being applied to the building at 05:16 – one on the East elevation and one on the North elevation. Although it is not easily visible in Figure 5.52 and Figure 5.53, there does appear to be internal fires burning at this time, as indicated.

Figure 5.52: North and West building elevations at 05:16 on 14 June 2017 (MET00012593) (SEA00010474)

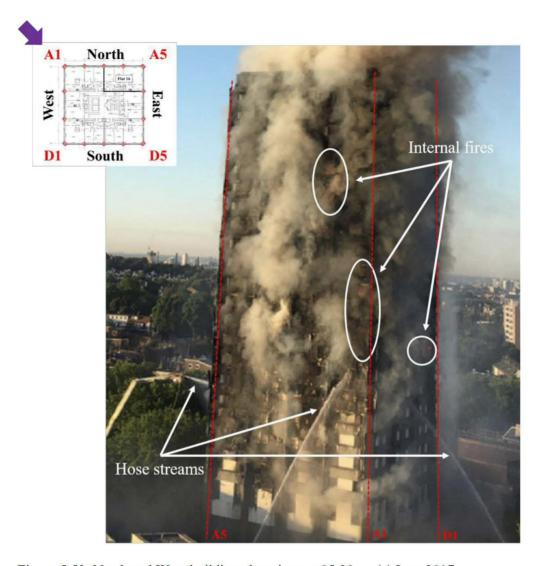
5.4.81 Figure 5.53 indicates there were at least three (3) fire fighter jets being applied to the building at 05:39 – one on each the East, North and West elevations. Although it is not easily visible in these images, there does appear to be internal fires burning at this time, as indicated in Figure 5.53.

Figure 5.53: North and West building elevations at 05:39 on 14 June 2017 (MET00012593) (SEA00010474)

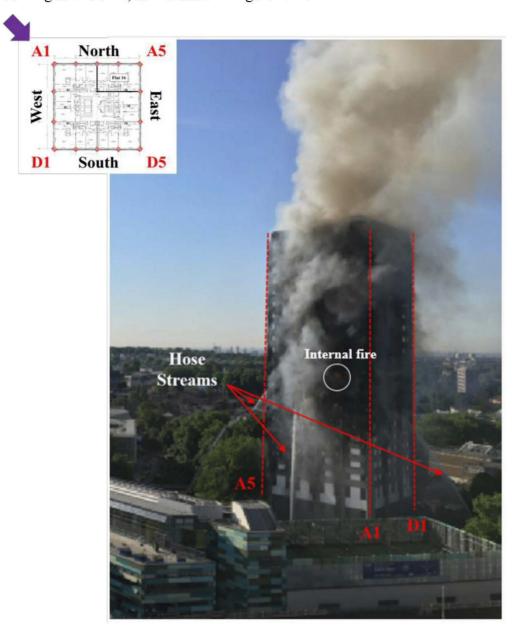
5.4.83 Based on Figure 5.55, at least two (2) fire fighter jets were being applied at 07:55 – one on the North and one on the West elevation. Although it is not easily visible in these images, there does appear to be at least one internal fire burning at this time, as indicated in Figure 5.55.

Figure 5.55: North and West building elevations at 07:55 on 14 June 2017 (MET00012593) (SEA00010474)

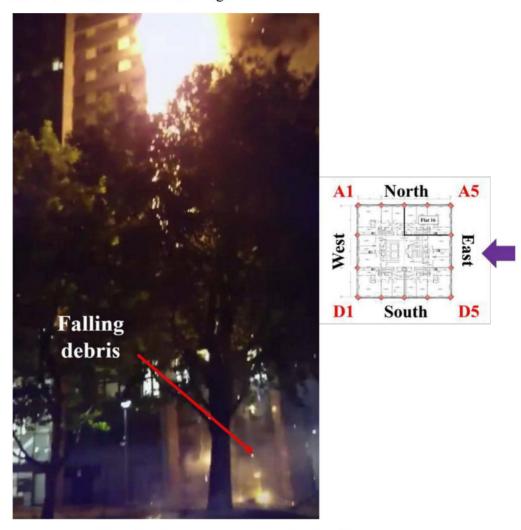
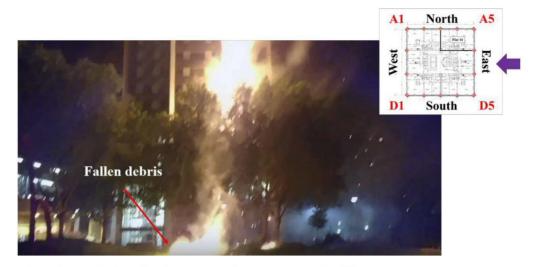
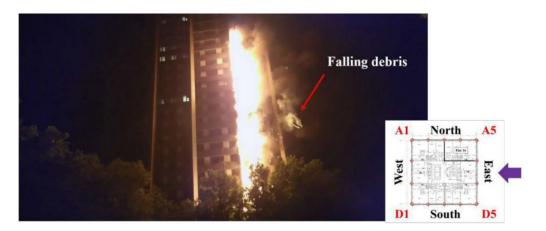
- I observed burning debris falling off the East elevation of Grenfell Tower as early as 01:15; refer to Figure 5.9.
- 5.5.3 Figure 5.62, Figure 5.63, and Figure 5.64 also show burning debris falling off the East elevation of the building.

Figure 5.62: Falling debris on East elevation of the building envelope on 14 June 2017, estimated time 01:24 (SEA00010474)¹⁶

Figure 5.63: Falling debris on East elevation of the building envelope on 14 June 2017, estimated time 01:26 (SEA00010474)¹⁷

Figure 5.64: Falling debris on East elevation of the building envelope on 14 June 2017, estimated time 01:26 (SEA00010474)¹⁸

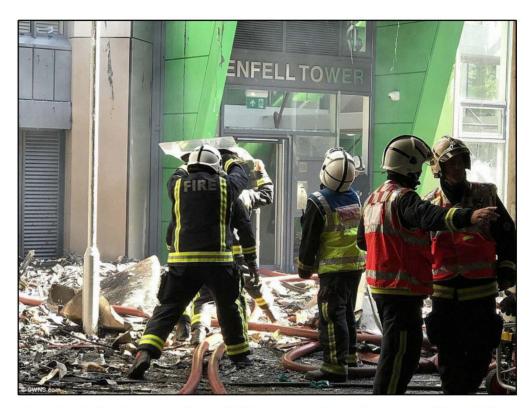
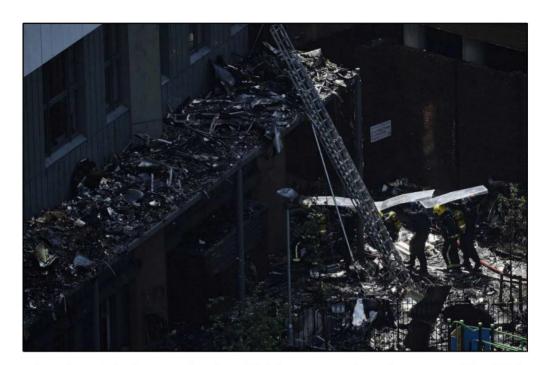
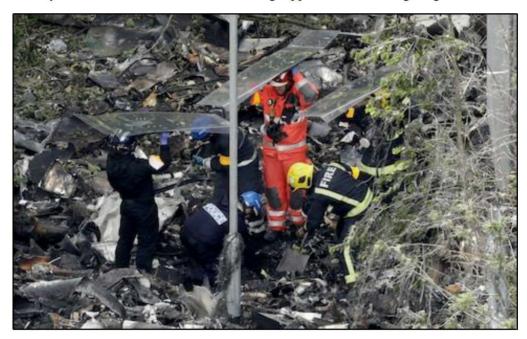
- LFB requested long shields for escort duties at 03:05 (MET00012593). The long shields were used by firefighters to protect themselves and others (primarily evacuating residents) from falling debris. Figure 5.65, Figure 5.66, and Figure 5.67 show emergency personnel using the long shields while navigating the site and entering Grenfell Tower. Figure 5.66 shows fire fighters wearing breathing apparatus and carrying fire hoses into the building while other emergency personnel hold long shields over head to protect the firefighters.

Figure 5.65: Firefighters use long shields to protect themselves from falling debris as they enter Grenfell Tower 19

Figure 5.66: Firefighters using long shields to protect themselves from falling debris as they enter Grenfell Tower with Breathing Apparatus and fire fighting hose ²⁰

Figure 5.67: Firefighters using long shields to protect themselves from falling debris while working at fire scene at Grenfell Tower ²¹

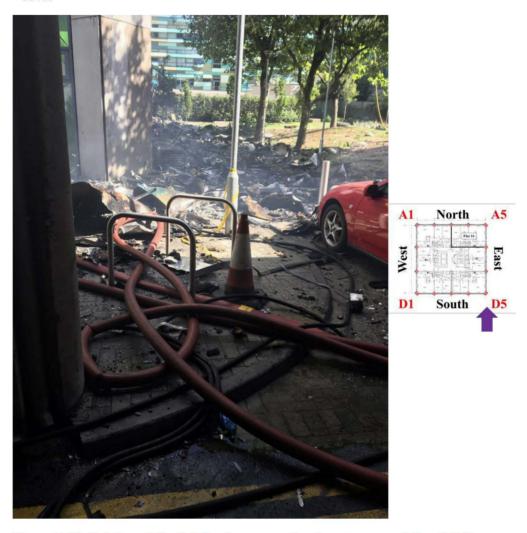
5.5.7 Figure 5.68 shows debris littered by the Southeast corner of Grenfell Tower, near the location of the building's main exit and the fire access road. This debris was an obstruction on the ground level and a damage hazard to the fire-fighting hoses.

Figure 5.68: Debris and firefighting hoses near Southeast corner of Grenfell Tower blocking access to building (MET00006773) (SEA00010474)

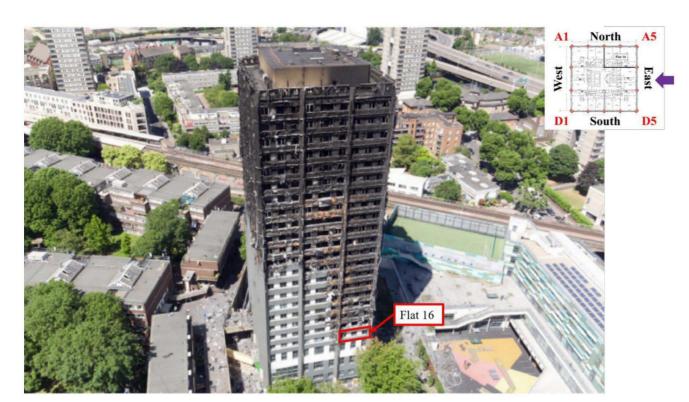
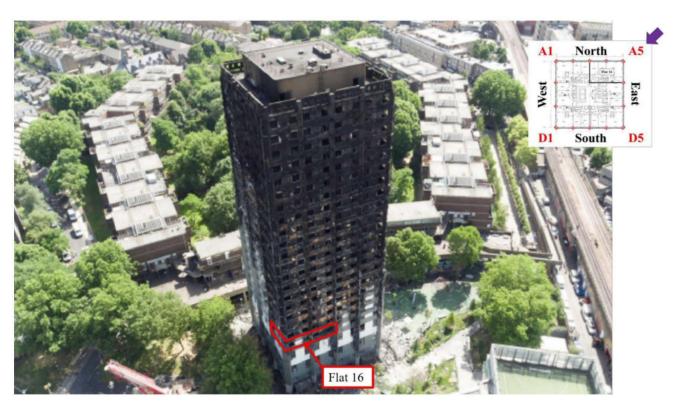
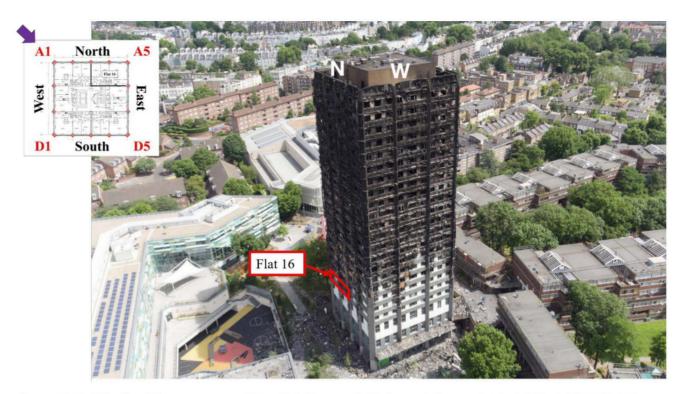
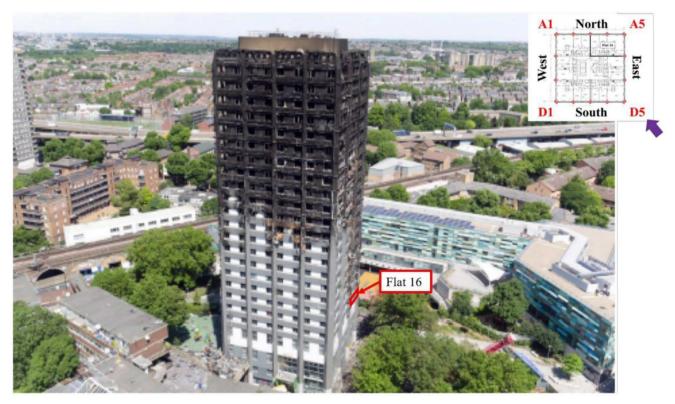
- 5.6.2 The cumulative fire damage to the external façade of Grenfell Tower from the events that unfolded on 14 June 2017 can be observed in Figure 5.69, Figure 5.70, Figure 5.71, and Figure 5.72.
