**Grenfell Tower – fire safety investigation:**  
**The fire protection measures in place on the night of the fire, and conclusions as to:**  
**the extent to which they failed to control the spread of fire and smoke;**  
**the extent to which they contributed to the speed at which the fire spread.**

**Phase 1 Report – Section 7**

**How and where the fire started**

**Dr Barbara Lane FREng FRSE CEng**

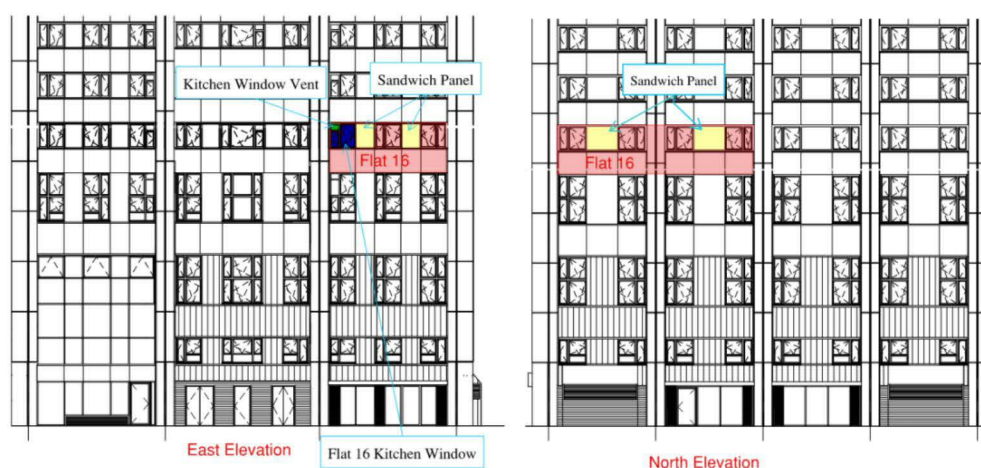
Figure 7.1: Location of Flat 16 (annotated on SEA00003082 & SEA00002981)

- 7.1.1 How the fire started, and its exact source in Flat 16, is a specific expert area and is dealt with in full by Professor Niamh NicDaeid.
- 7.1.2 During all my site visits I spent time observing the damage in Flat 16 and trying to ascertain how the fire moved from being an internal compartment fire, to the major external fire event observed on the night.
- 7.1.3 I also wanted to independently establish for myself the original fire was located in Flat 16.
- 7.1.4 Flat 16 is on the fourth floor of Grenfell Tower, at the corner of the East and North elevations. (See Figure 7.1)

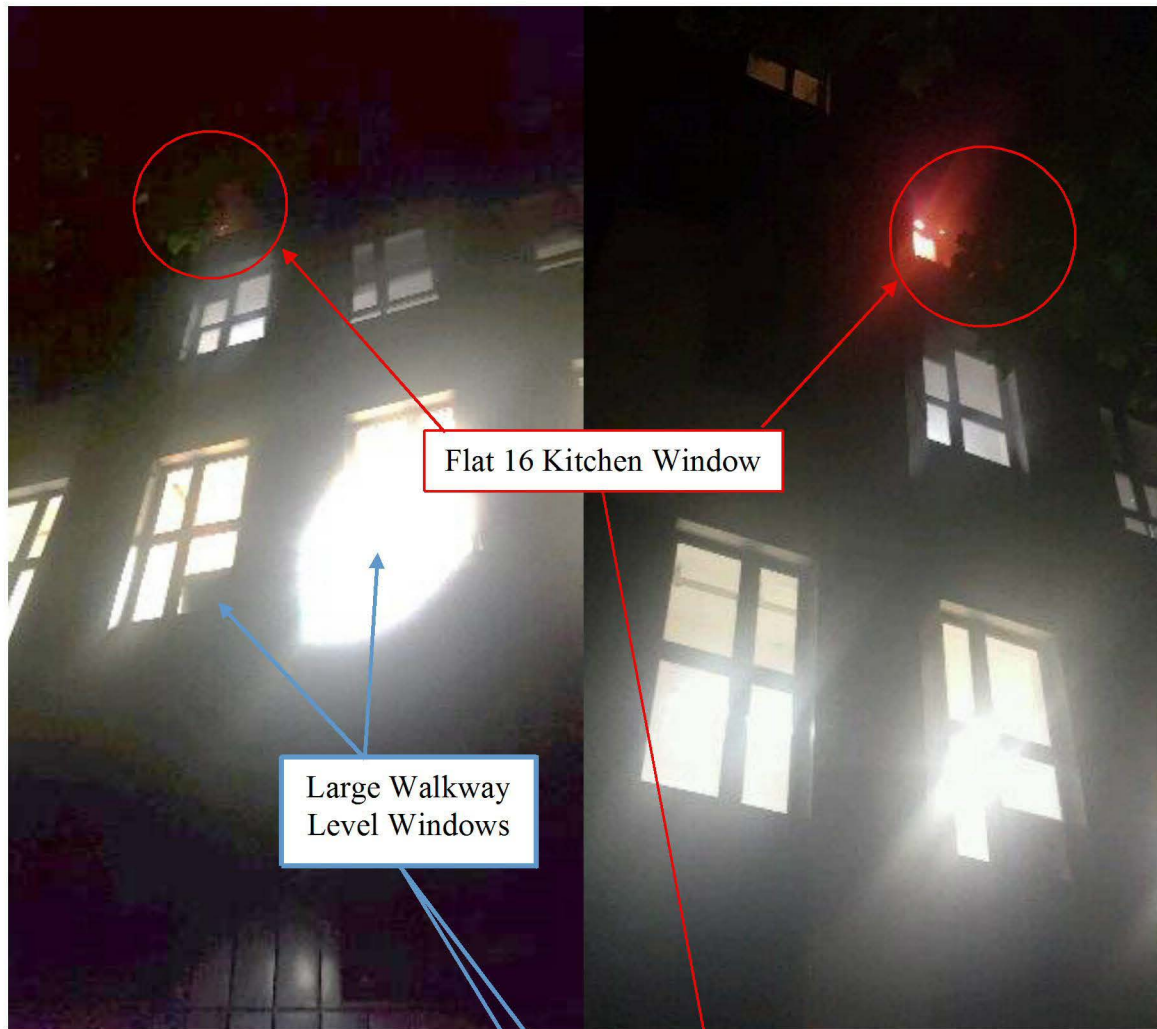
Figure 7.2: a) MET000083344

- 7.1.5 Flat 16 was a two-bedroom flat configuration with the bedrooms located on the North elevation and the kitchen located on the East elevation (See Figure 7.1).
- 7.1.6 One of the earliest photos of the fire in Flat 16 is provided in Figure 7.2 a) (MET000083344).
- 7.1.7 I can orientate and check the location of the very small flame visible - see red circle in Figure 7.2 a - by comparing the large windows located at levels 2 and 3 with the large windows visible in the Figure 7.3 East Elevation. I have marked them in Figure 7.2 and Figure 7.3.
- 7.1.8 Note, the fire is further developed in Figure 7.2 b) (MET000083343).

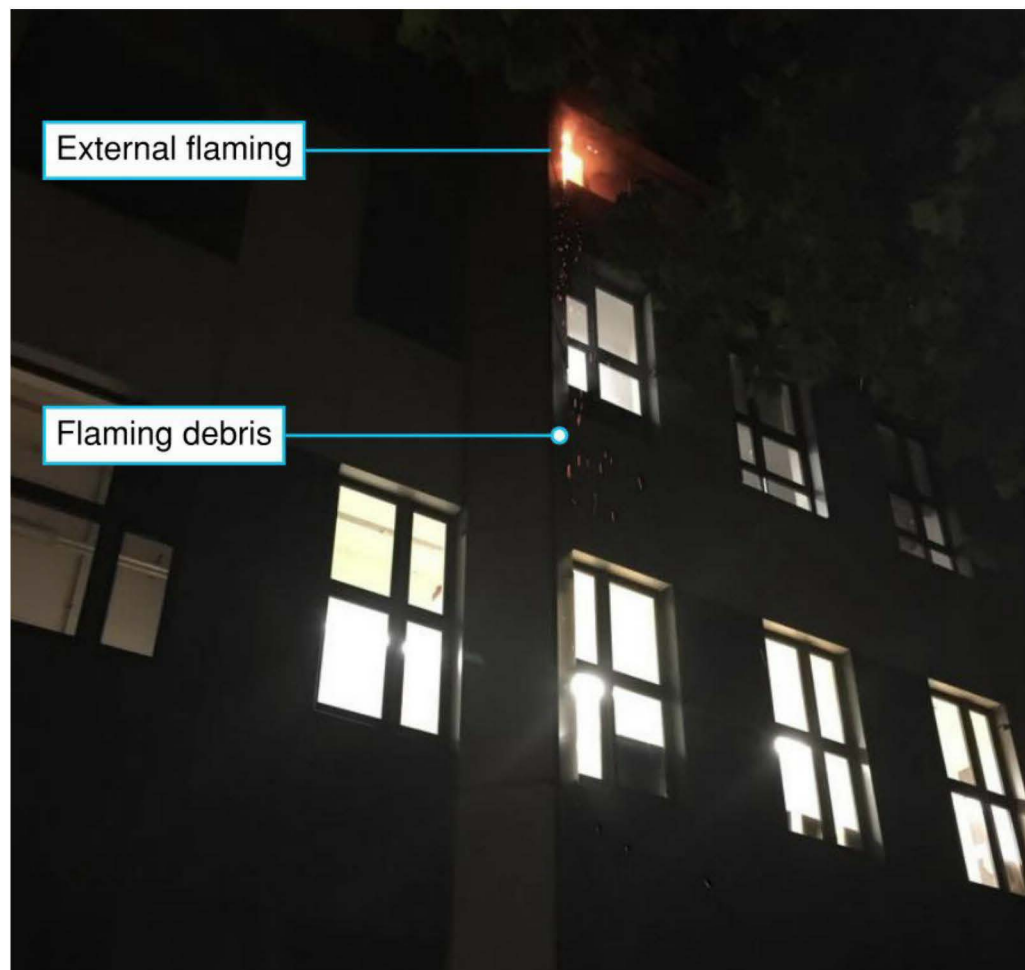
- 7.1.9** Flames from the fire are first observed on the exterior of the building in Figure 7.4 below, which is timed at 01:08.

Figure 7.4: First external flaming observed at 01:08 (IWS00000051)

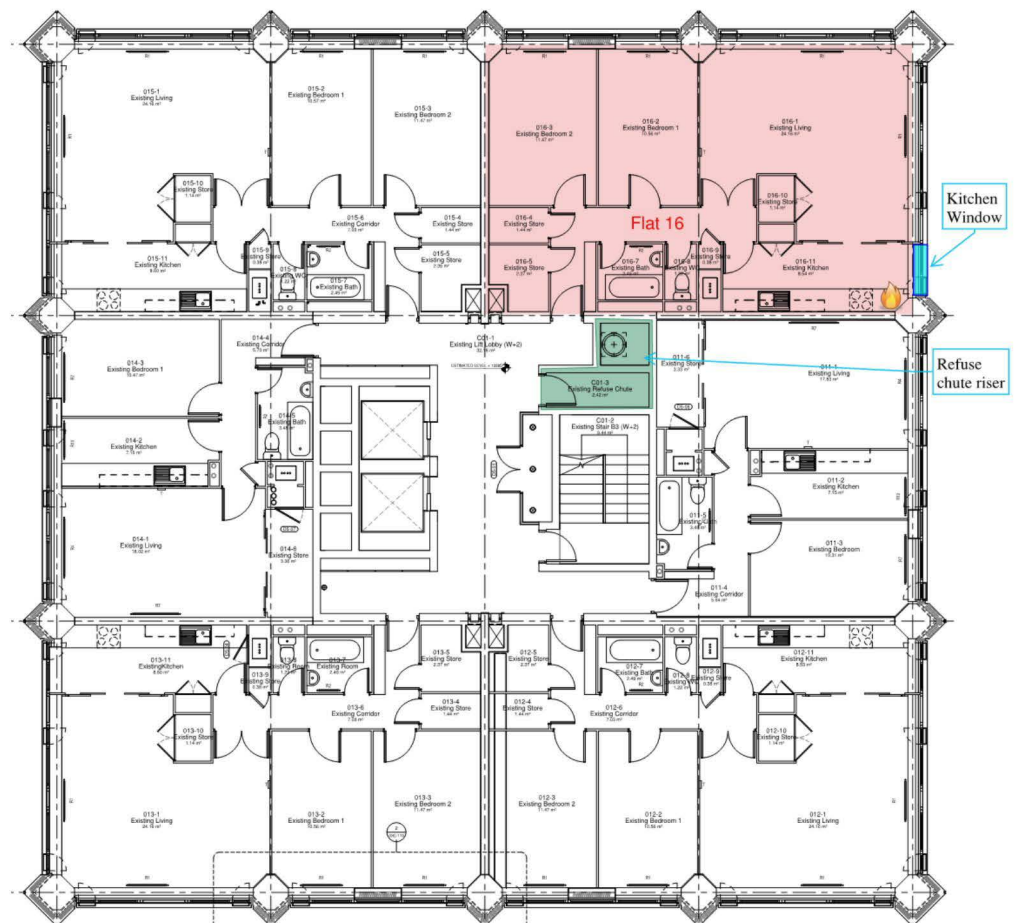
Figure 7.5: Architectural floor plan - Flat 16 location [SEA00010474]

- 7.1.10** I have marked on Figure 7.5 (the architectural floor plan), the location of the window on the East elevation through which flame was observed, with respect to its location within Flat 16.

- 7.1.11** Internally, the flat entrance door opened out on to the small “dogleg” portion adjacent to the refuse chute of the protected lobby to the single escape stair. See Figure 7.5.
- 7.1.12** In the photograph in Figure 7.6 (MET000083343) both the North and East elevations are very clear. With visible flame now protruding from the Flat 16 window in the kitchen.
