**Grenfell Tower – fire safety investigation:**  
**The fire protection measures in place on the night of the fire, and conclusions as to:**

**Phase 1 Report – Section 8**

**The external wall – materials and construction**

**Dr Barbara Lane FREng FRSE CEng**

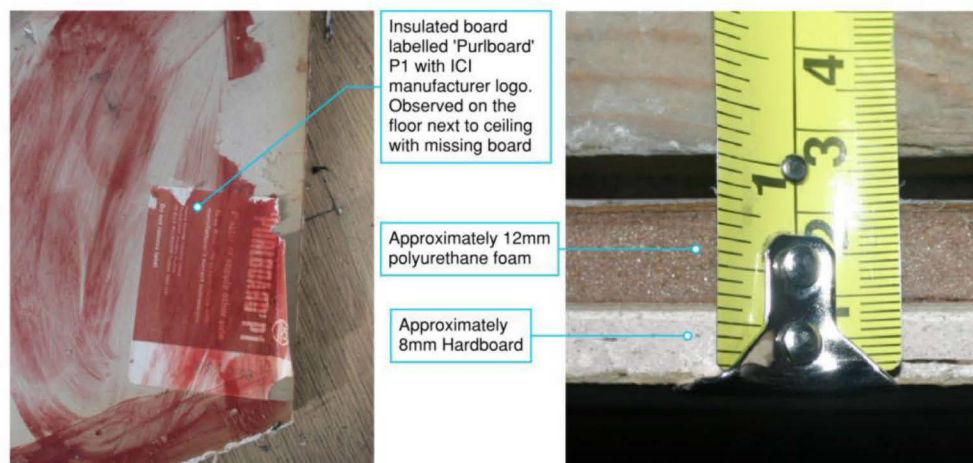
- 8.4.9** A protruding strip of material adjacent to the head of the window was observed during my site inspections to be labelled ICI Purlboard, an approximately 20mm thick product, comprising an 8mm thickness plasterboard layer with 12mm of combustible polyurethane foam insulation bonded to the rear - as shown in Figure 8.5.

Figure 8.5: Insulation board details (Left: product name and manufacturer visible on section of board observed on the floor of Flat 23, Level 5. Right: Thickness of layers in insulated board affixed to external wall as my team observed in Flat 13, Level 4)

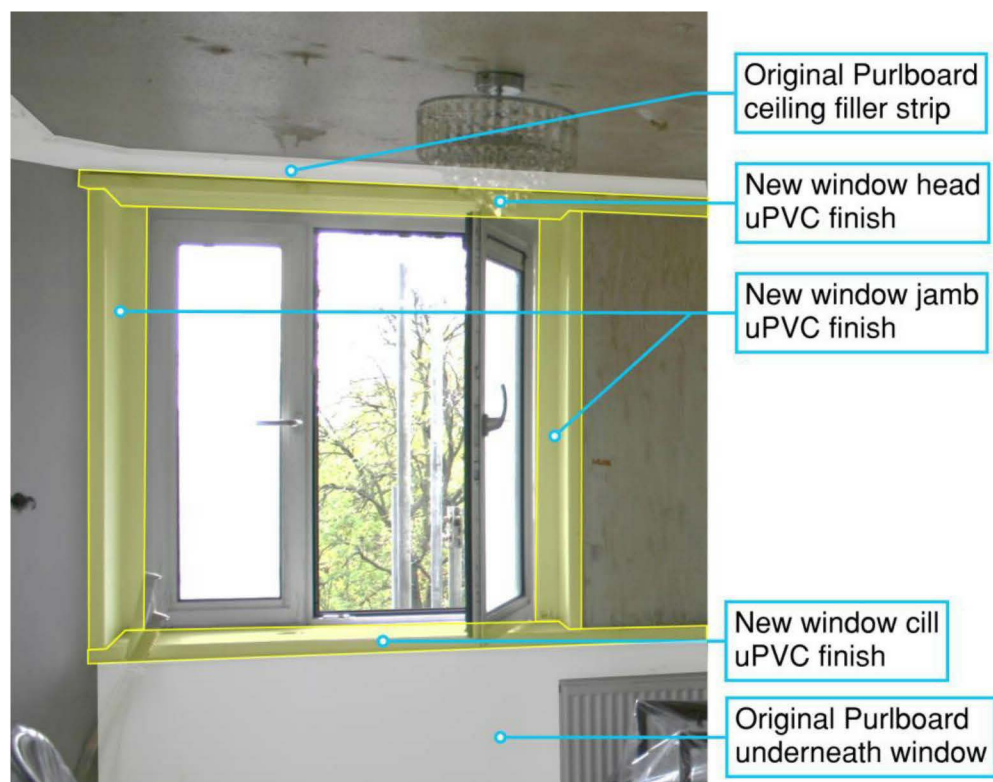
Figure 8.14: Internal linings as seen on my site inspection within Flat 22 living room.

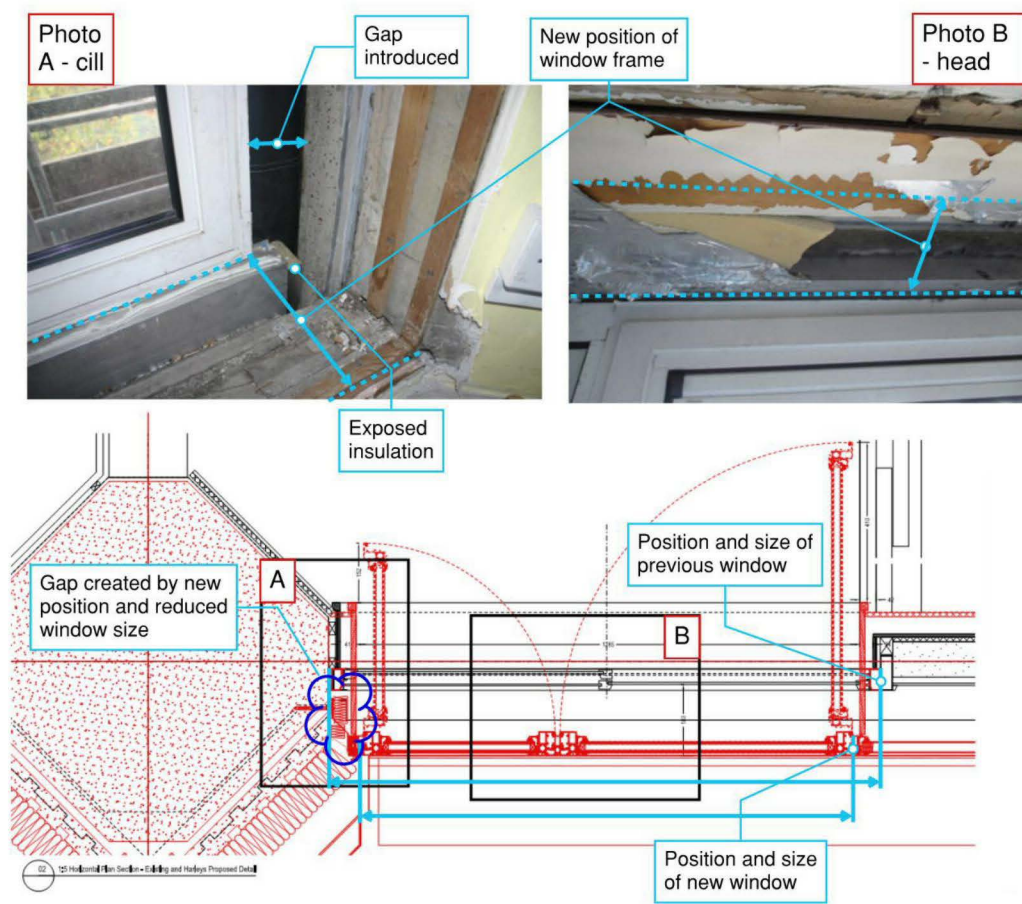
Figure 8.15: Evidence of repositioning and reduction of size of new windows (HAR00003765). Photos from Flat 13 Kitchen

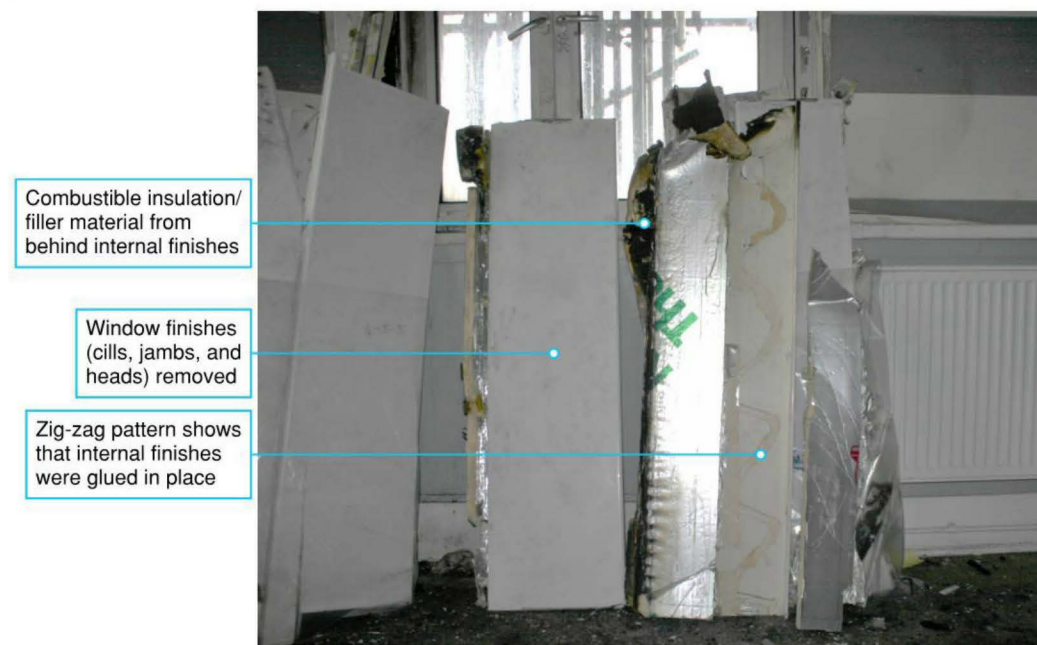
Figure 8.16: Combustible insulation materials (identified in section 8.7.12) from underside of internal finishes. Flat 15 living room.

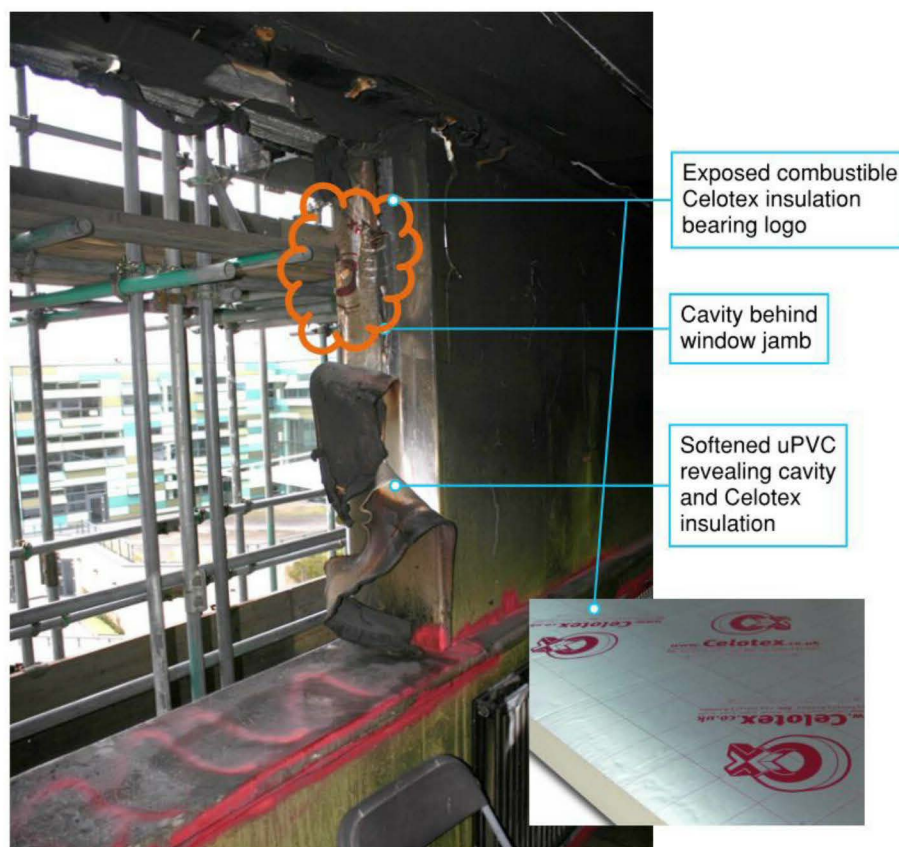
Figure 8.18: Softened uPVC finish revealing cavity and combustible insulation board within. Flat 16 Living room.

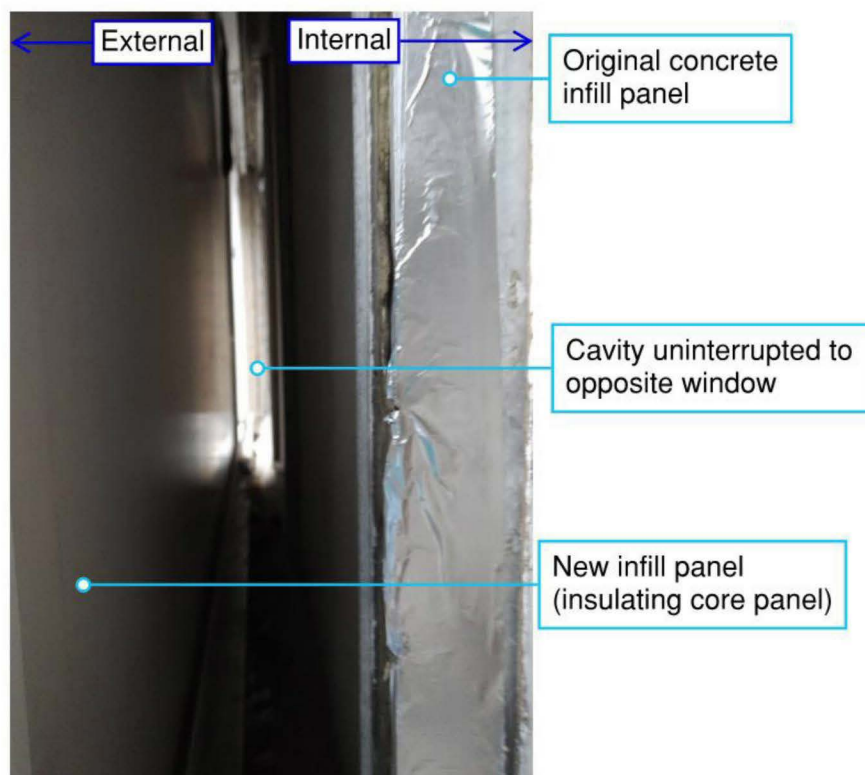
Figure 8.19: Cavity formed between original concrete infill panel and new insulating core panel (Aluglaze). These cavities were located between window sets. This image is from Flat 13.

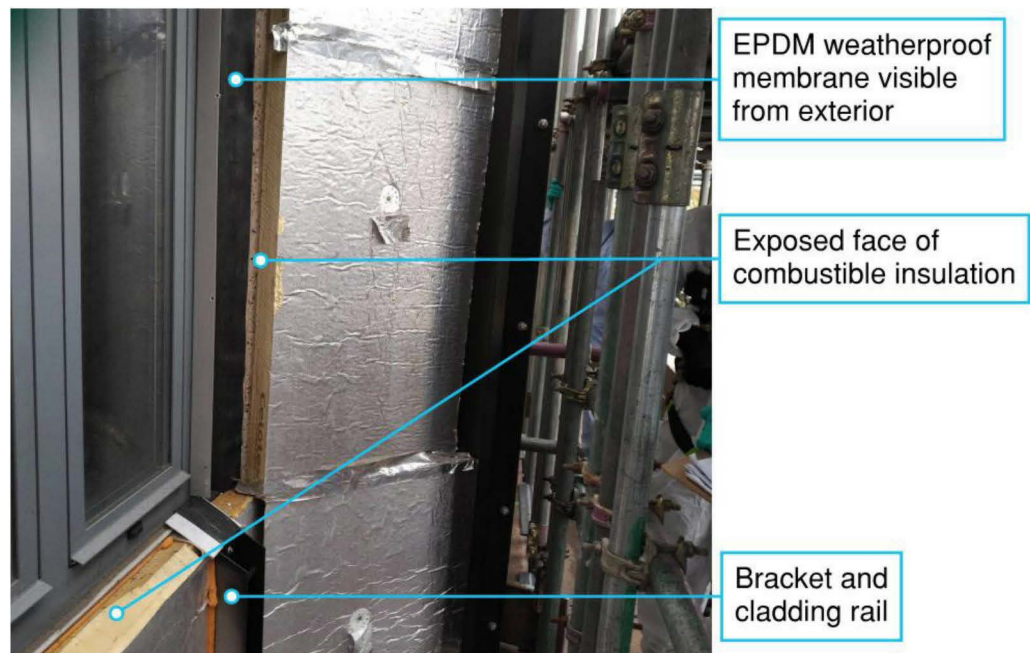
**8.8.5** The EPDM was bonded to the window frame and the face of the concrete column on site - onsite photographs are presented in Figure 8.22 & Figure 8.23.

Figure 8.22: Exterior view of window/column junction with exposed EPDM weatherproof membrane

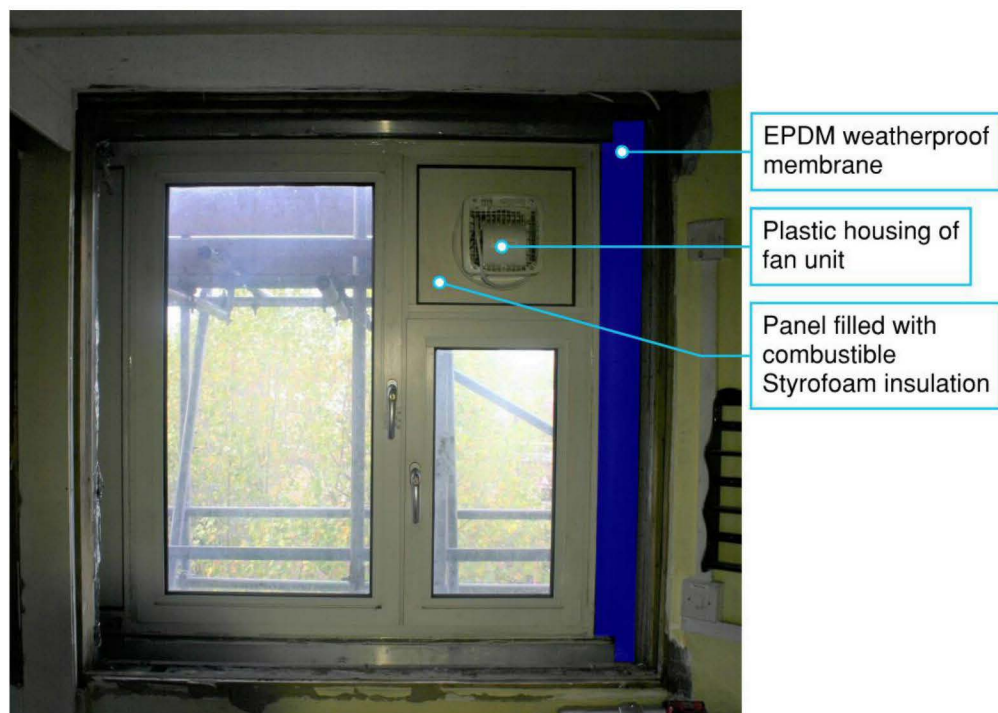
Figure 8.23: Interior view of window/column junction with exposed EPDM weatherproof membrane. Flat 13 Kitchen (see section 8.9 for further details of window insert panel)

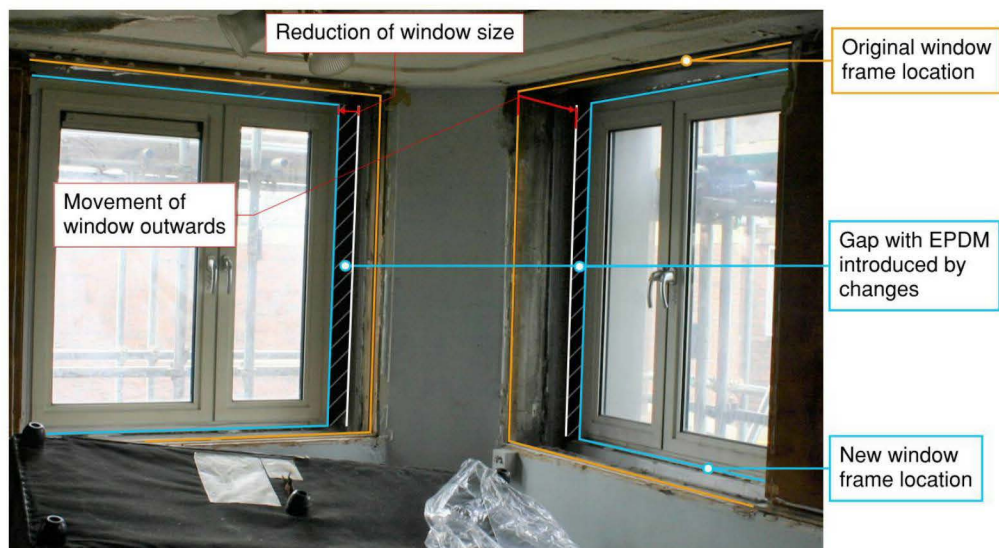
Figure 8.24: Photograph showing changes and how they introduced gaps around the window frames (Flat 13)

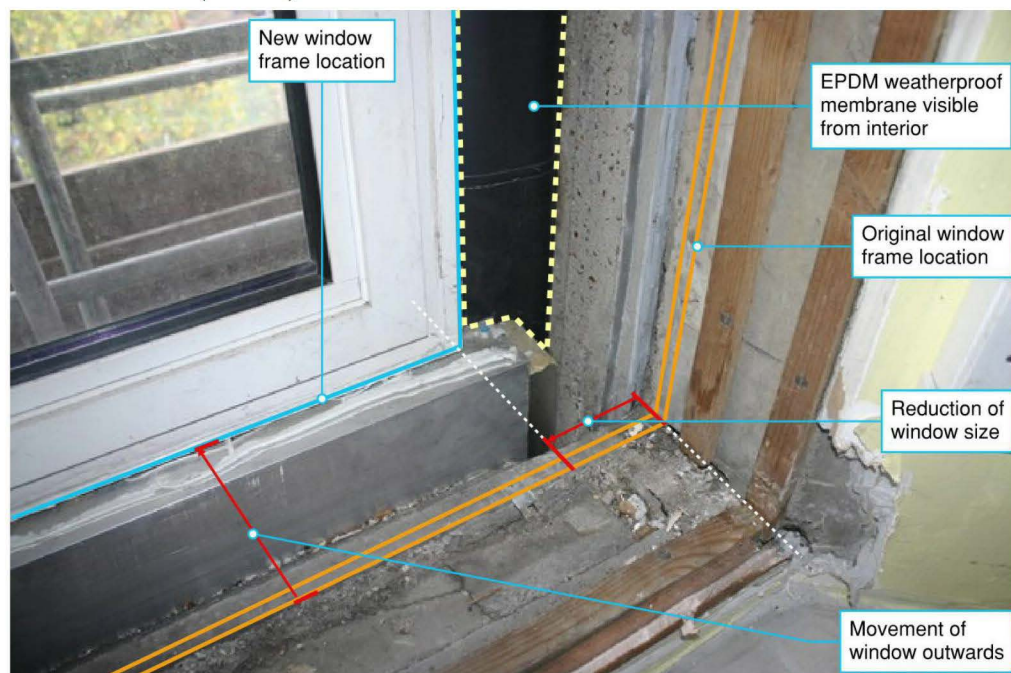
Figure 8.25: Detailed view of flat 13 window frame

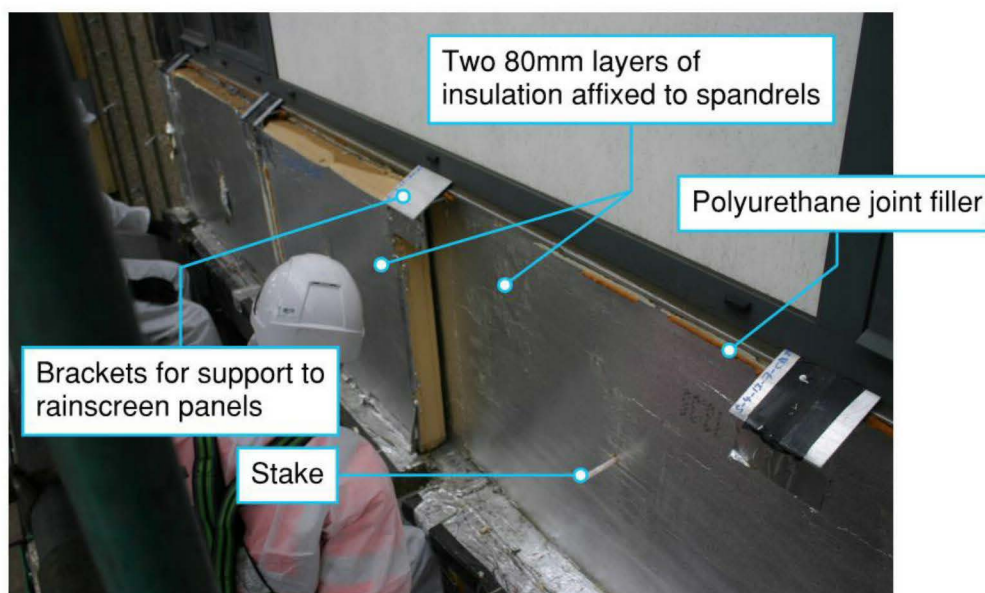
Figure 8.29: Two layers of insulation with exposed edges visible on spandrel, along with stakes for fixing (outside Flat 12).

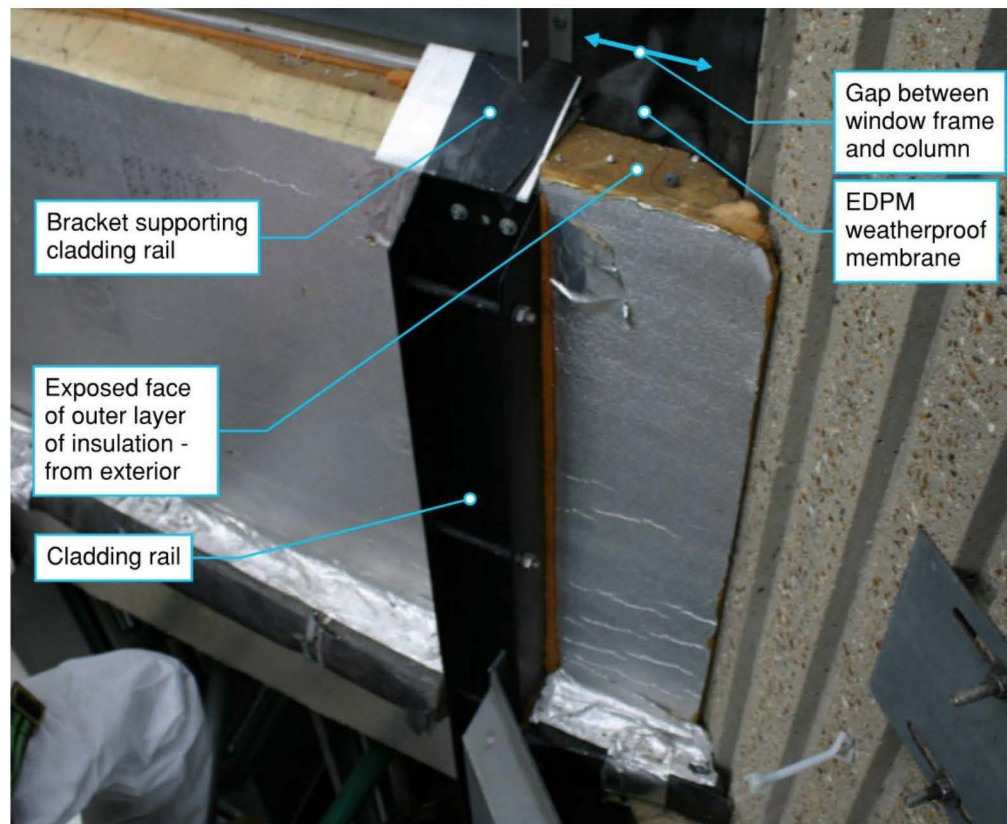
Figure 8.30: Cladding rail that supports panel cassettes shown attached to bracket. Exposed face of the insulation in close proximity to gap and EPDM weatherproof membrane (Outside Flat 12)

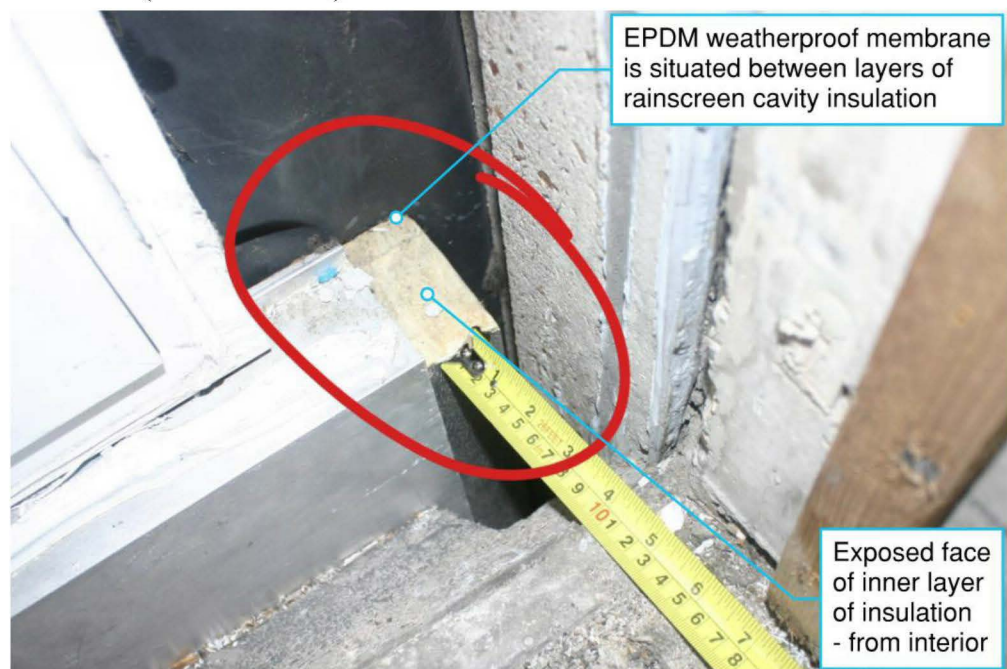
- 8.9.7** Figure 8.31 identifies a condition observed on site where the rainscreen cavity insulation was exposed on the “room side” in front of the EPDM weatherproof membrane. In this case, the EPDM weatherproof membrane has been sealed between the interface of the two layers of the rainscreen cavity insulation. The inner layer is fully exposed on the inside of the room (noting window and frame removed in this photo).
- 8.9.8** In Figure 8.32 I present one of my photos showing sun light through a post-fire damaged window reveal – to emphasise how little a barrier this posed to the detailing shown in Figure 8.31.

Figure 8.31: Rainscreen cavity insulation visible from interior due to EPDM weatherproof membrane bonded between insulation layers, in close proximity to gap and EPDM weatherproof membrane (Flat 13)

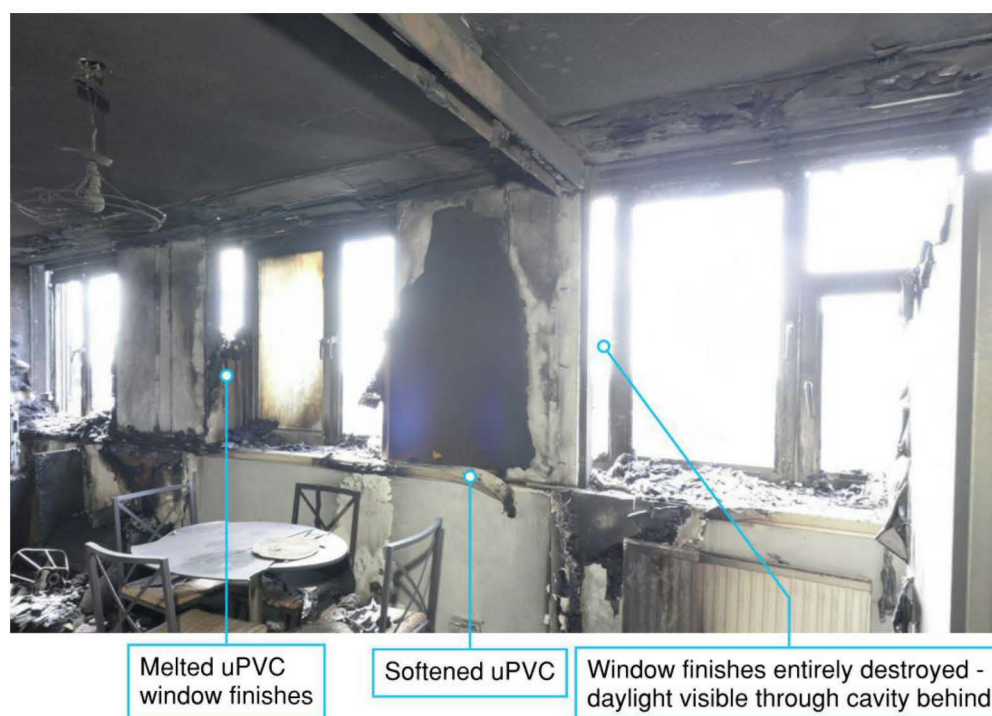
Figure 8.32: Post-fire condition of window finishes in fire damaged flat (METS00017068) (Flat 93, Level 12)

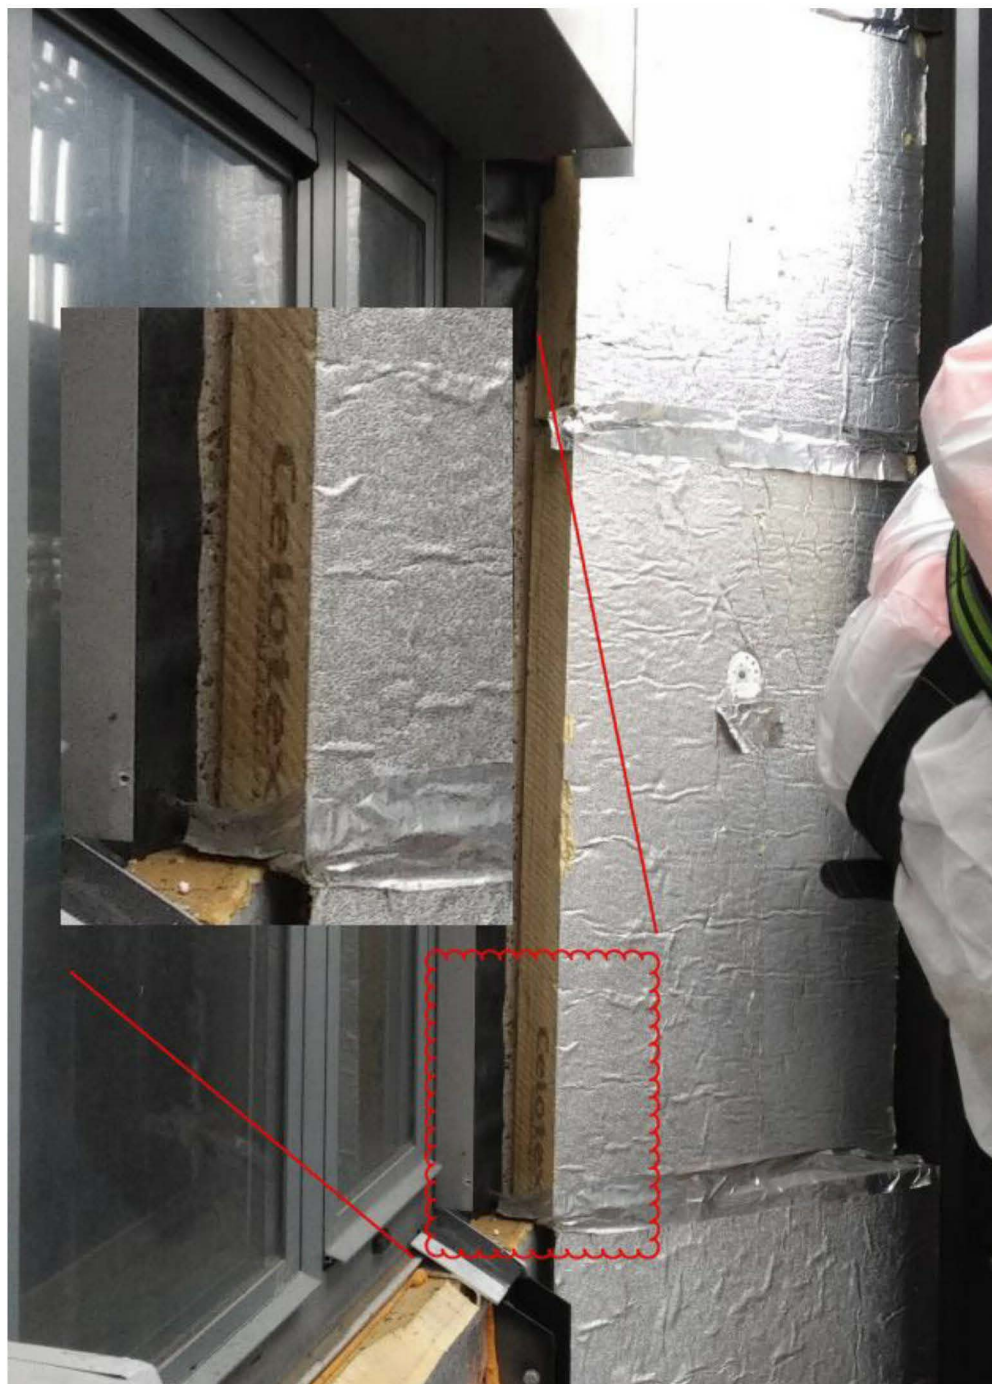
- 8.9.24** The edges of these insulation boards were observed to be exposed, i.e. neither foil nor foil tape was affixed to the edges of the insulation. In Figure 8.37, it can be seen that these exposed edges were visible in close proximity to the new window frames and the gap introduced by the window alterations. The Rainscreen Cladding Specification Guide does not expressly advise the edges of insulation boards to be taped.

Figure 8.37: Evidence of Celotex in place as part of the external wall

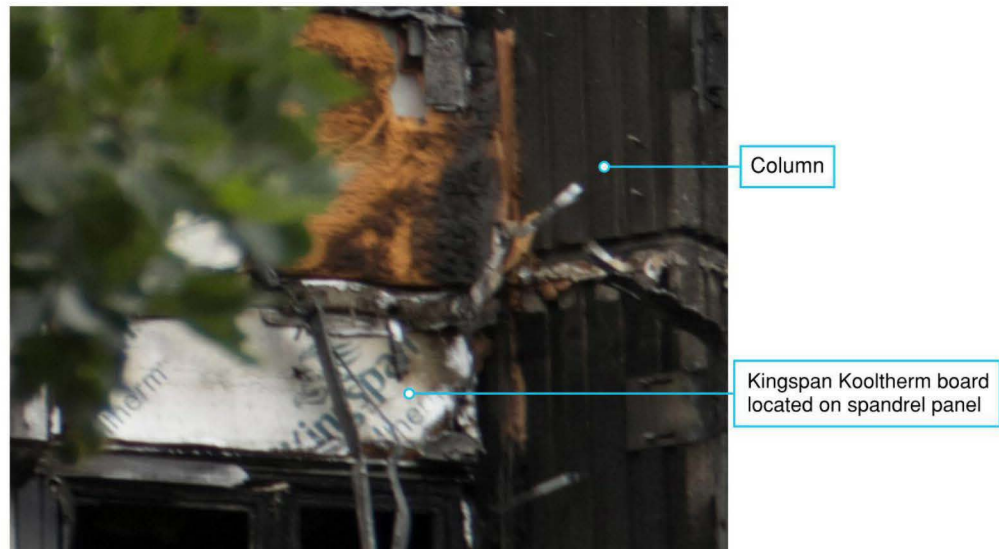
Figure 8.38: Photograph showing Kingspan Kooltherm board on spandrel panel (KIN00000015)

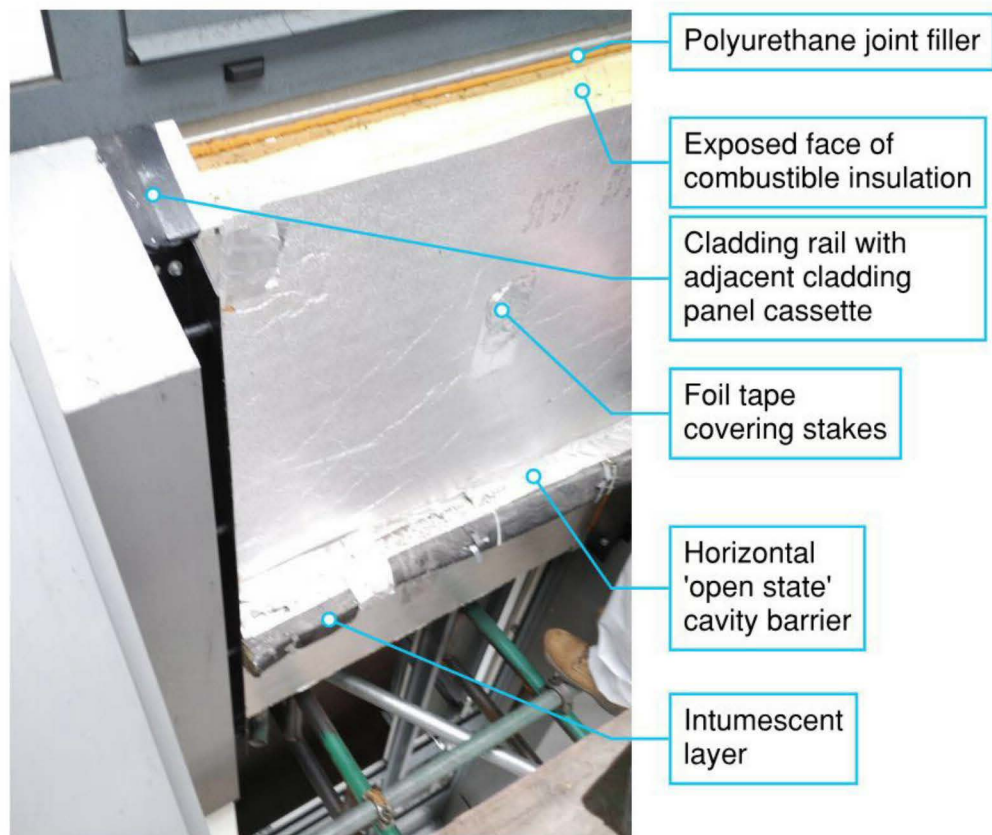
During my site inspections, I observed that the product installed was the SIDERISE RH ‘Open State’ Horizontal Cavity Barrier. Figure 8.40 presents a typical installation detail as observed on site. I observed this installed in the horizontal direction and vertical direction. (Figure 8.52).

Figure 8.40: Horizontal cavity barriers on spandrel as observed on site

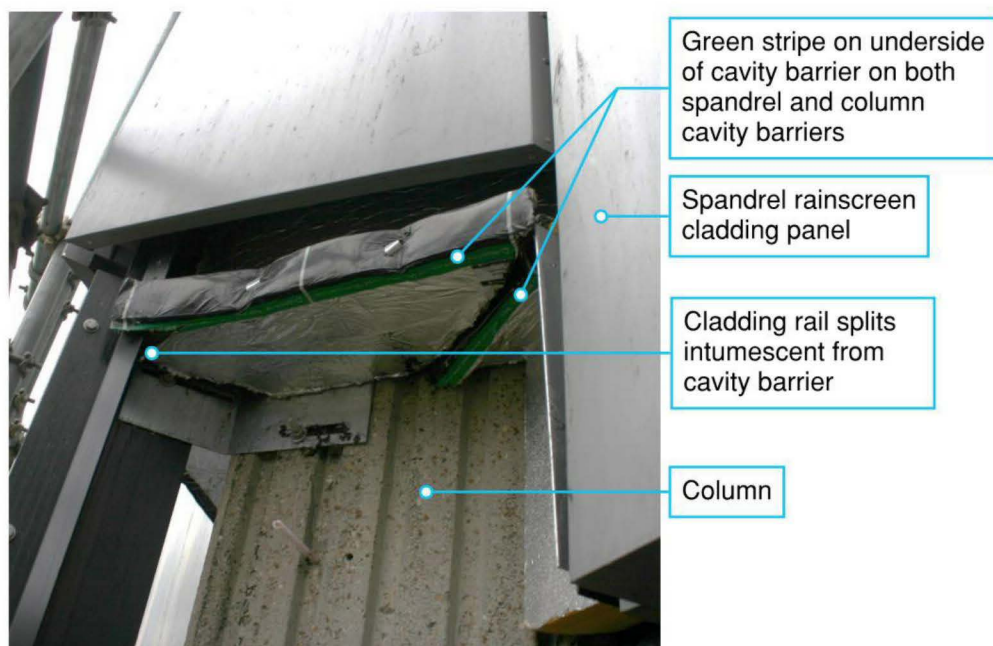
- 8.9.47** I noted on site at Grenfell Tower that the orientation of the product RH25G-120/60, which is 120mm deep, was installed such that the manufacturer's logo and data on the green tape was facing downwards in certain locations, as can be seen in Figure 8.47 & Figure 8.48. I have no test evidence available to me which shows that this orientation has been tested. As the intumescent strip behind the black polymeric seal is smaller than the depth of the cavity barrier (i.e. the strip is 75mm compared to the depth of the barrier at 120mm), evidence that this orientation provides the necessary protection is required

Figure 8.47: Cavity barriers installed onsite with green stripe on the bottom face of the cavity barrier, as well damage leading to the intumescent strip separating from the cavity barrier. External of Flat 12.

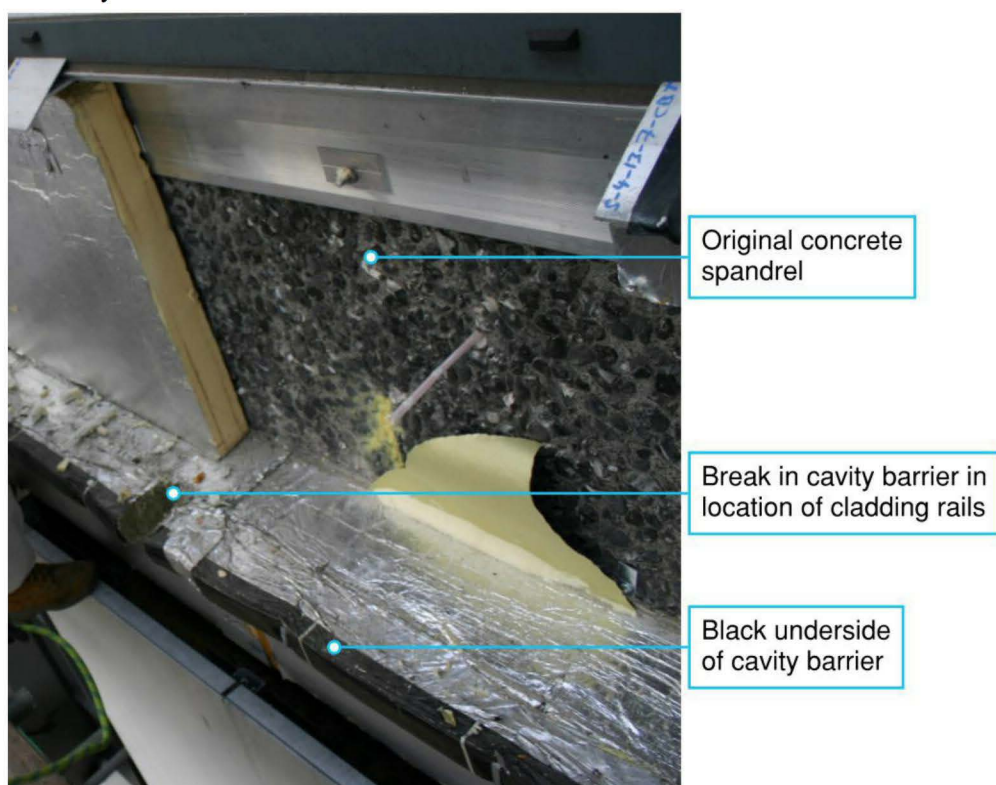
Figure 8.48: Horizontal cavity barrier without green strip visible on top of product. External of Flat 12.

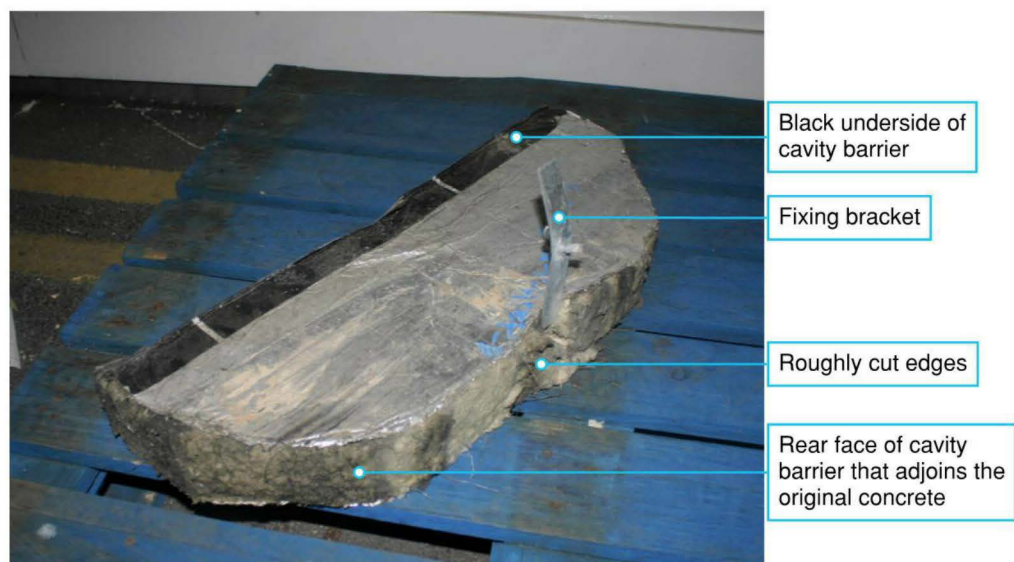
**8.9.49** Furthermore, it was noted onsite that the cut edges of the cavity barriers were of poor quality leading to a imperfect fit with the column or spandrel (Figure 8.49), as well as a poor fit where adjoining other cavity barriers.

Figure 8.49: Horizontal column cavity barrier showing roughly cut rear faces

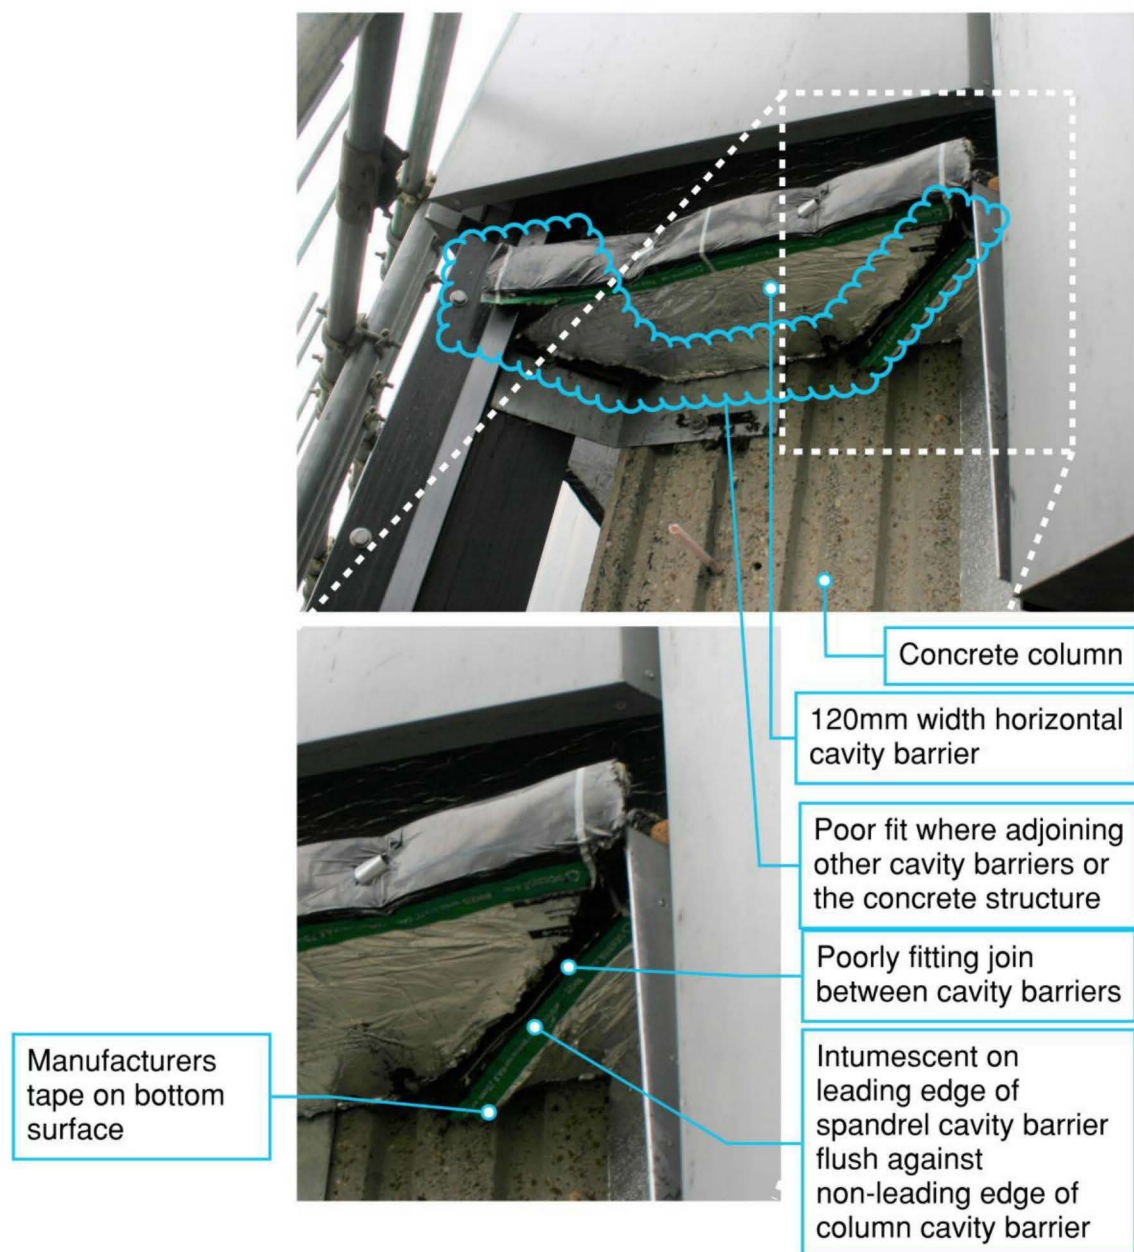
Figure 8.50: Poorly fitting horizontal cavity barrier. (Flat 12).

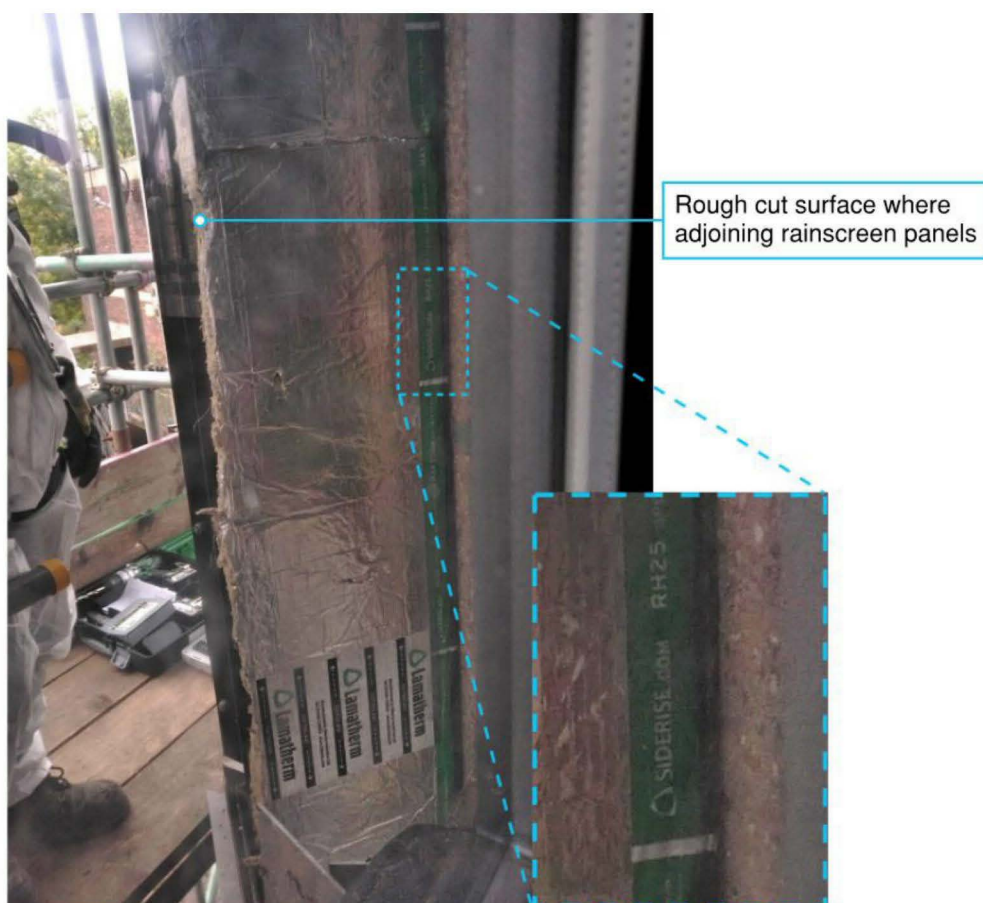
Figure 8.52: Siderise RH25 installed in vertical orientation. External of Flat 13, column D1.

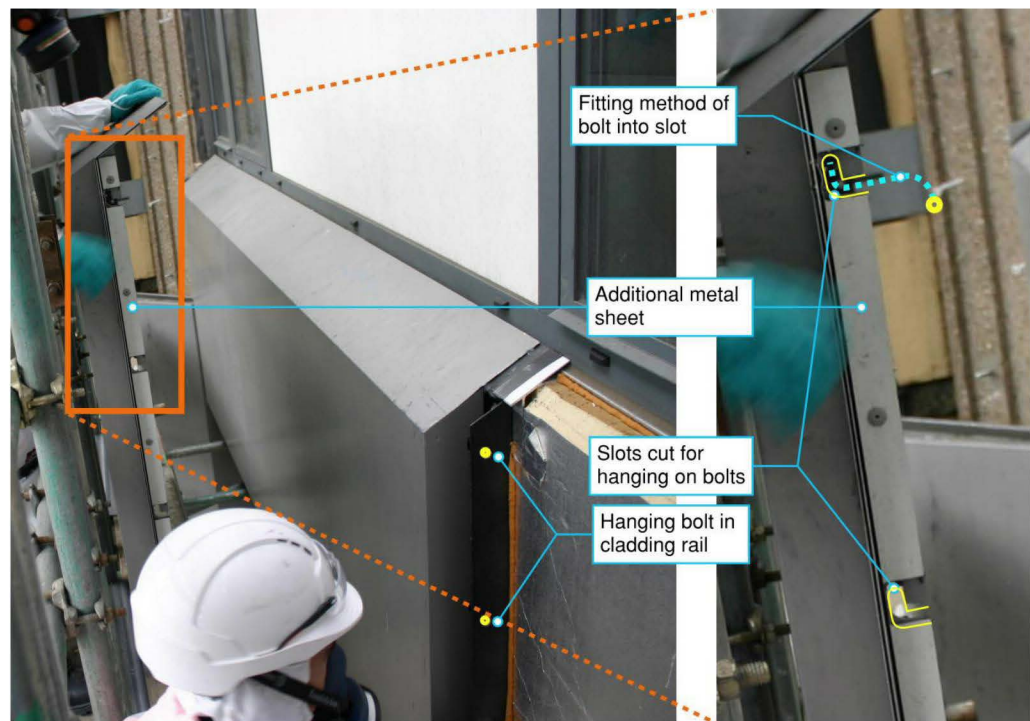
Figure 8.63: Additional metal sheet observed onsite attached to ACP panel on Grenfell Tower that was not shown on standard Arconic Drawings [photo taken on level 4 outside flat 13]

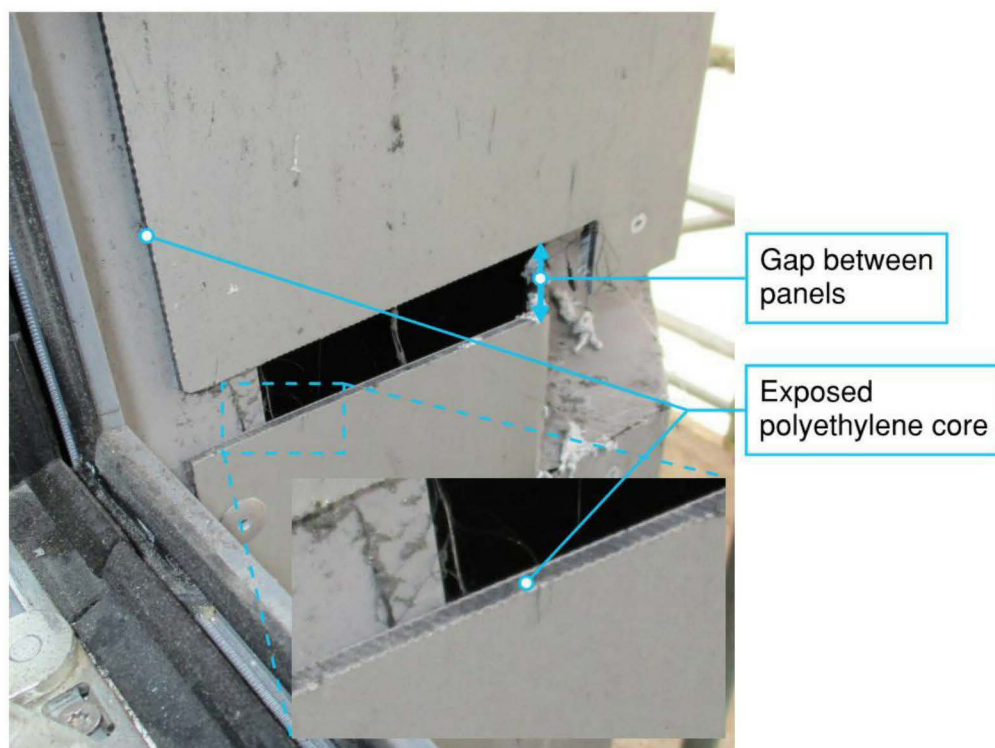
- 8.10.30** The rainscreen panel system incorporates gaps between each of the panel junctions for ventilation and rainwater drainage. On site in the areas I inspected, I noted that the panel gaps ranged between 15mm and 30mm.

Figure 8.65: Column rainscreen panel gaps and exposed PE core. Flat 10.

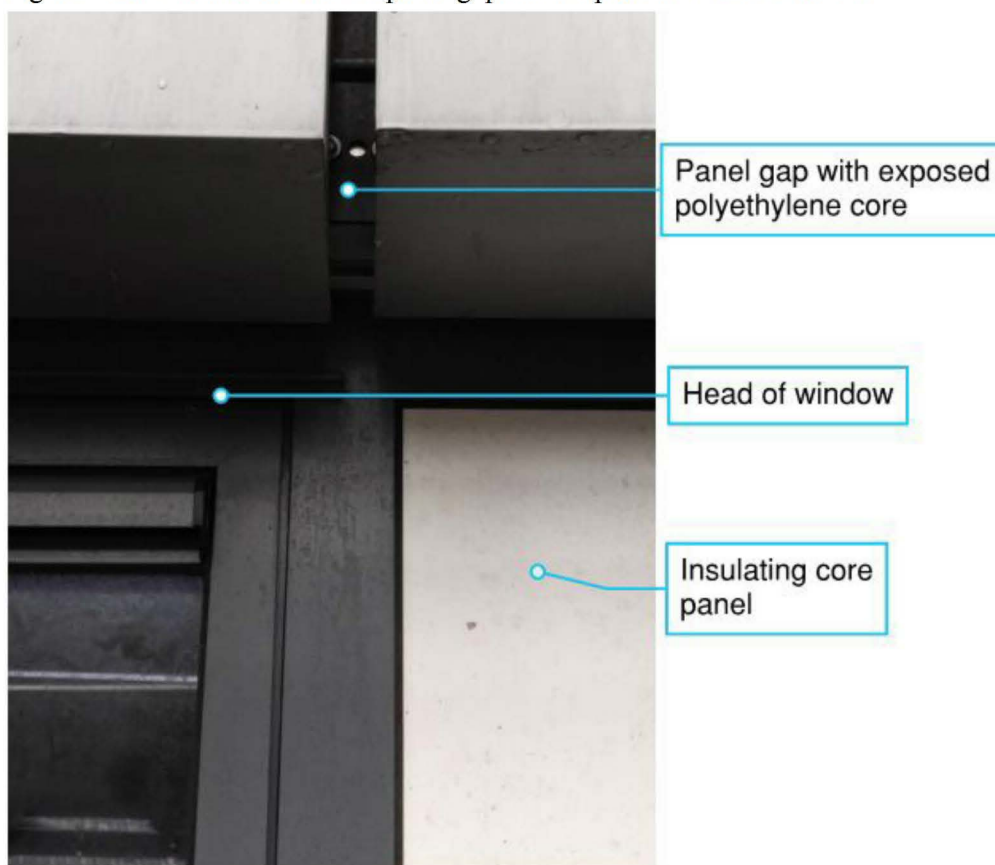
Figure 8.66: Panel gap in spandrel rainscreen cladding panels at head of window. Flat 10.

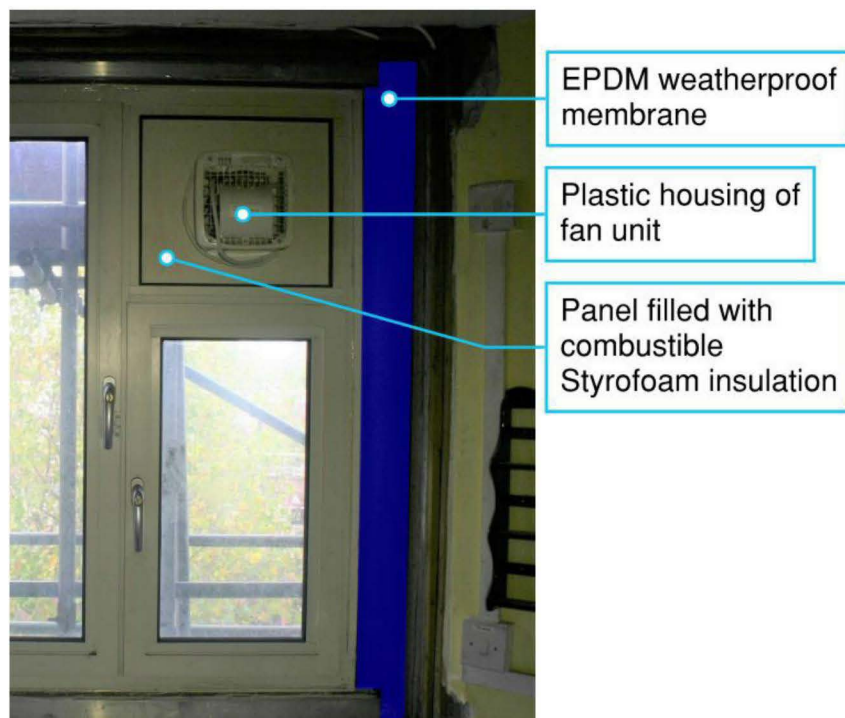
Figure 8.72: Window insert insulating core panel in place showing plastic housing for fan

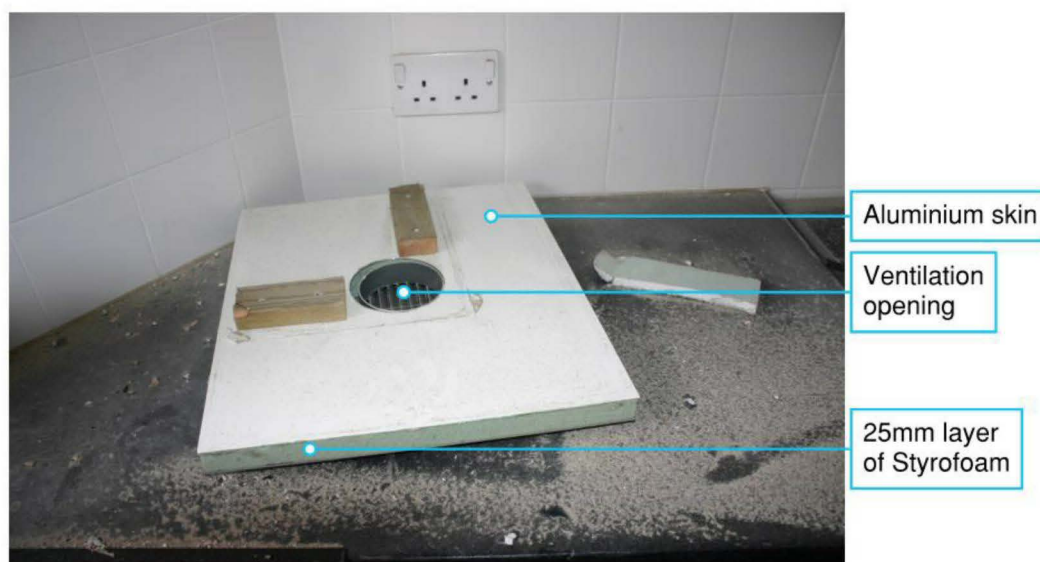
Figure 8.73: Window insert insulating core panel removed from glazing system. Flat 10 Kitchen (however this window insert was present for every flat as per the Harley specification (HAR00008991)).
