Grenfell Tower – fire safety investigation:
The fire protection measures in place on the night of the fire, and conclusions as to:

Phase 1 Report – Section 9

Routes for fire spread out through the window openings

24th October 2018

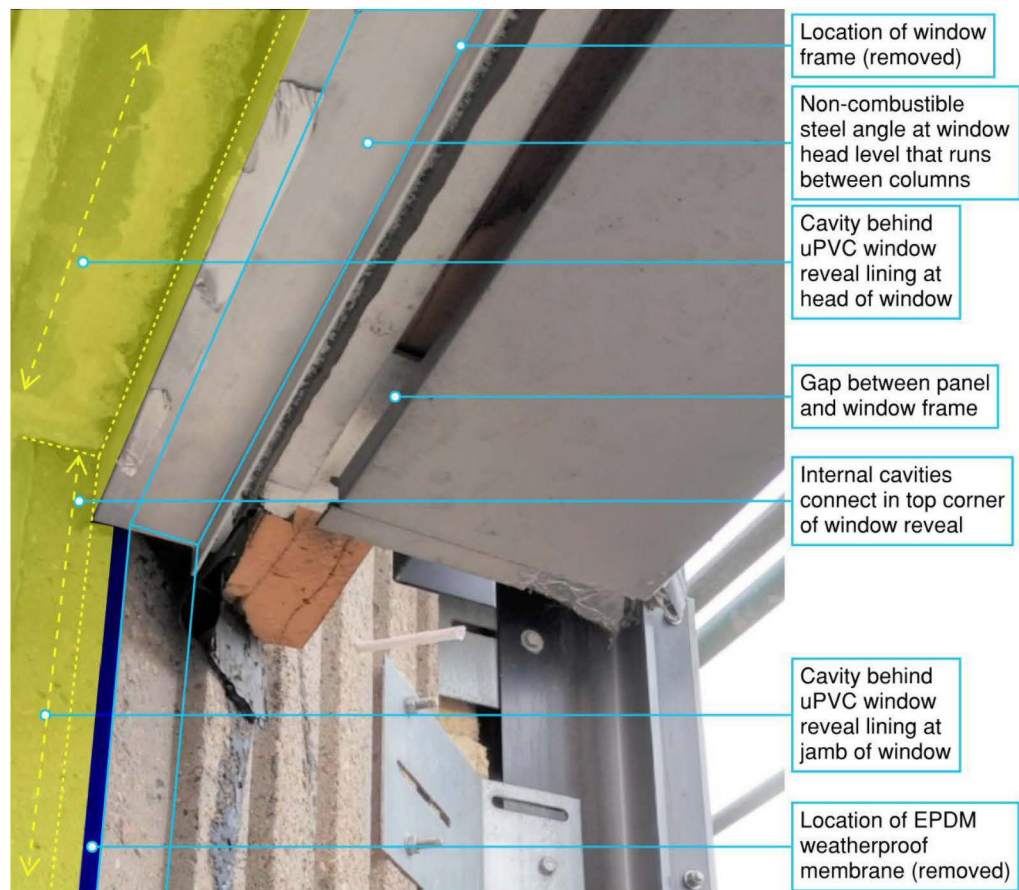
9.2.3 Vertical cavity between window jamb and concrete columns, underneath the uPVC reveal lining (Figure 9.1);

Figure 9.1: Cavities underneath window reveal linings at head and jamb of window and that they are connected.

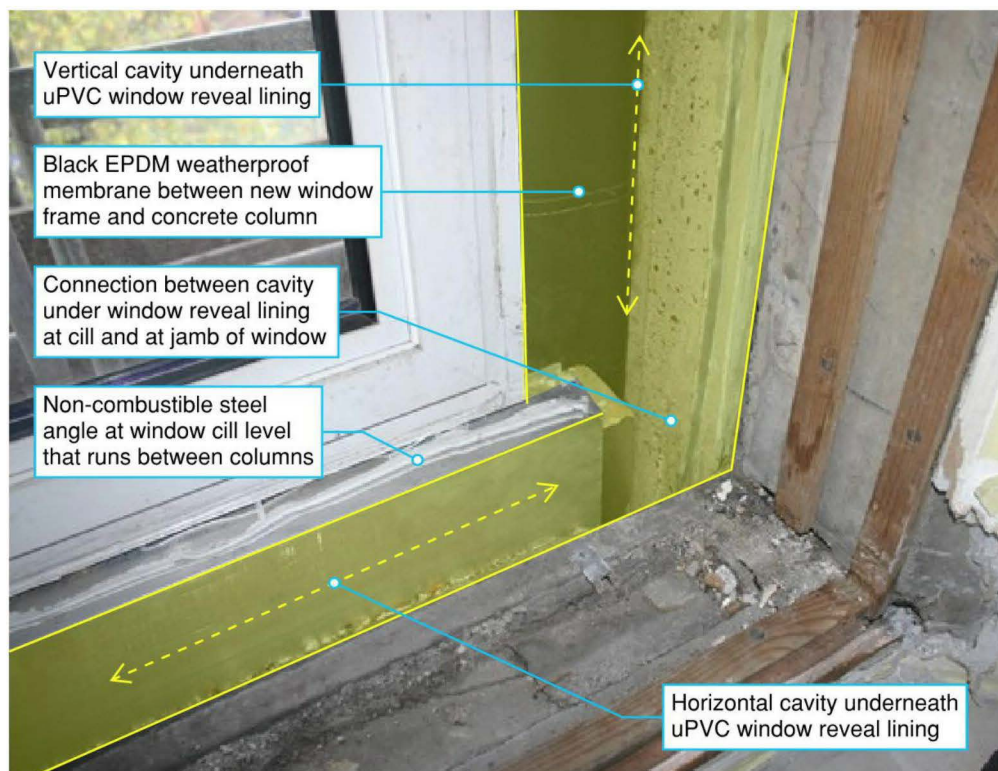
Figure 9.2: window reveals after uPVC linings removed showing cill and jamb next to column (Flat 13, Level 4)

9.2.5 Figure 9.2 shows the cavities behind the uPVC window reveal linings at the jamb and cill of the windows, highlighted in yellow. These cavities were formed by the movement of the new windows out away from the building relative to their original position, and were also partially filled with 25mm combustible insulation, glued to the underside of the uPVC window reveal linings. Note that they are connected where they meet in the bottom corner.

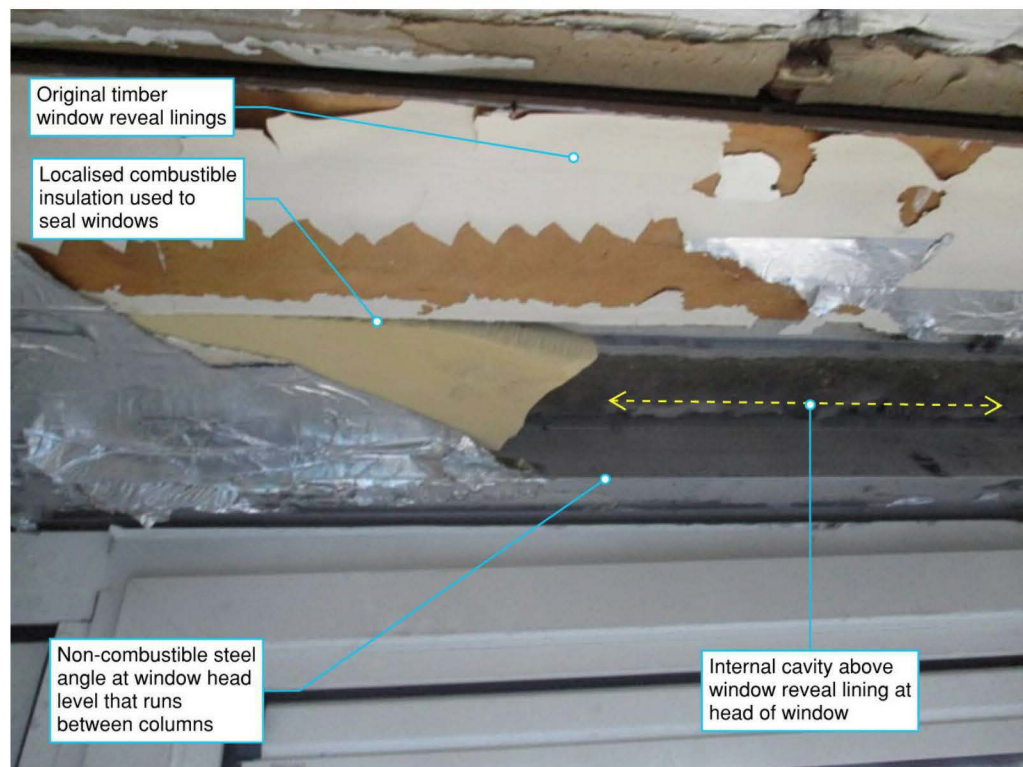
Figure 9.3: materials and cavities under uPVC window reveal lining at head of window

9.2.7 Figure 9.3 shows the cavity at the head of the window behind the uPVC window reveal lining which has been removed. It also shows how localised combustible insulation was placed within this internal cavity.

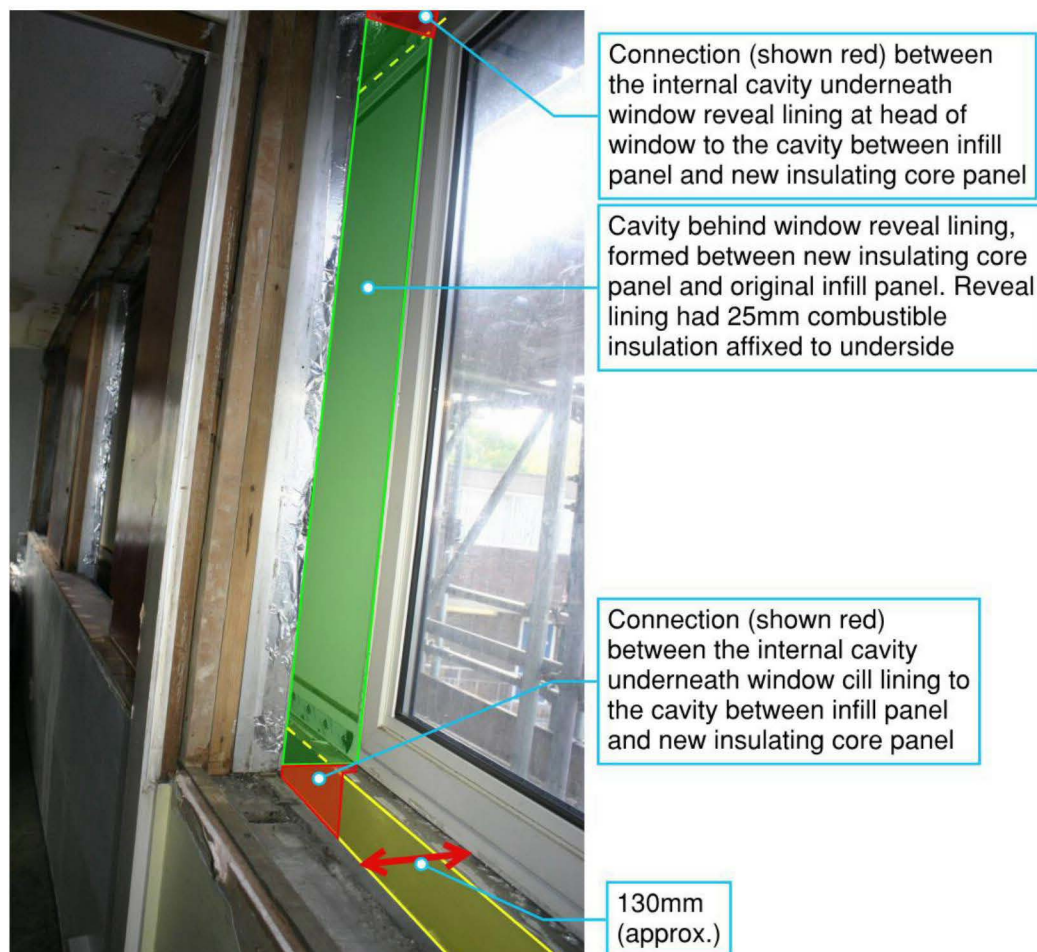
Figure 9.4: cavity and materials under uPVC window reveal lining at infill panel side jamb of window

9.2.9 Figure 9.4 shows that, at the side opposite the column, a large cavity is formed by the space between the original infill panel between the windows and the new insulating core panel which was installed (shaded green, Flat 13). There is a connection with the internal cavities under window reveal linings at both the head and cill of the windows outlined in Figure 9.2 and Figure 9.3, which is shaded in red.

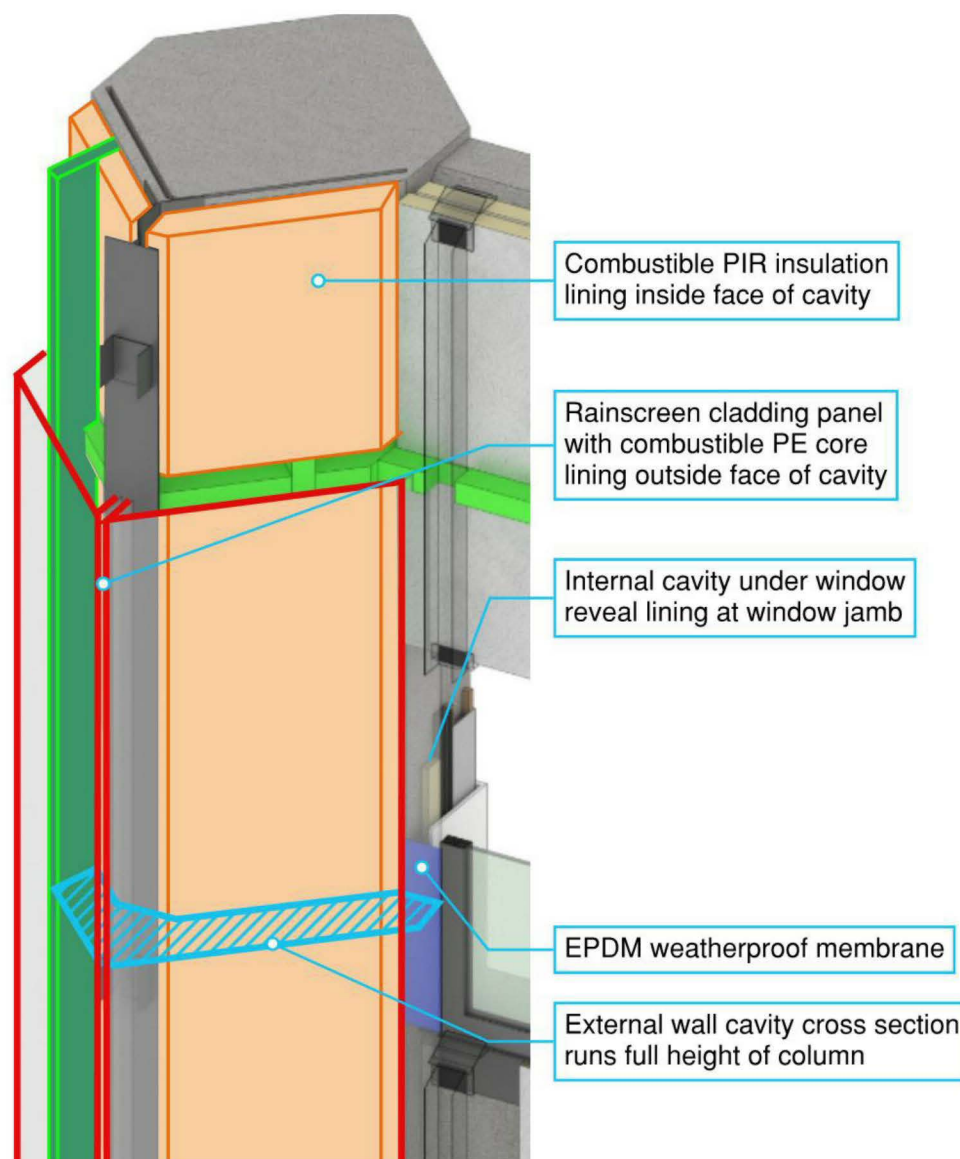
Figure 9.5: 3D render of the external wall construction

- 9.2.11** The relationship of that external wall cavity to the internal cavity at the jamb is also shown. It is clear in Figure 9.5 that the EPDM weatherproof membrane is the only thing separating these two spaces.
- 9.2.12** I have reproduced Figure 8.3 from Section 8 here (Figure 9.6 below) as a reminder of the location of the new window, relative to both the old and new external wall, and this is the reason for the creation of these cavities, in behind the window reveal linings.

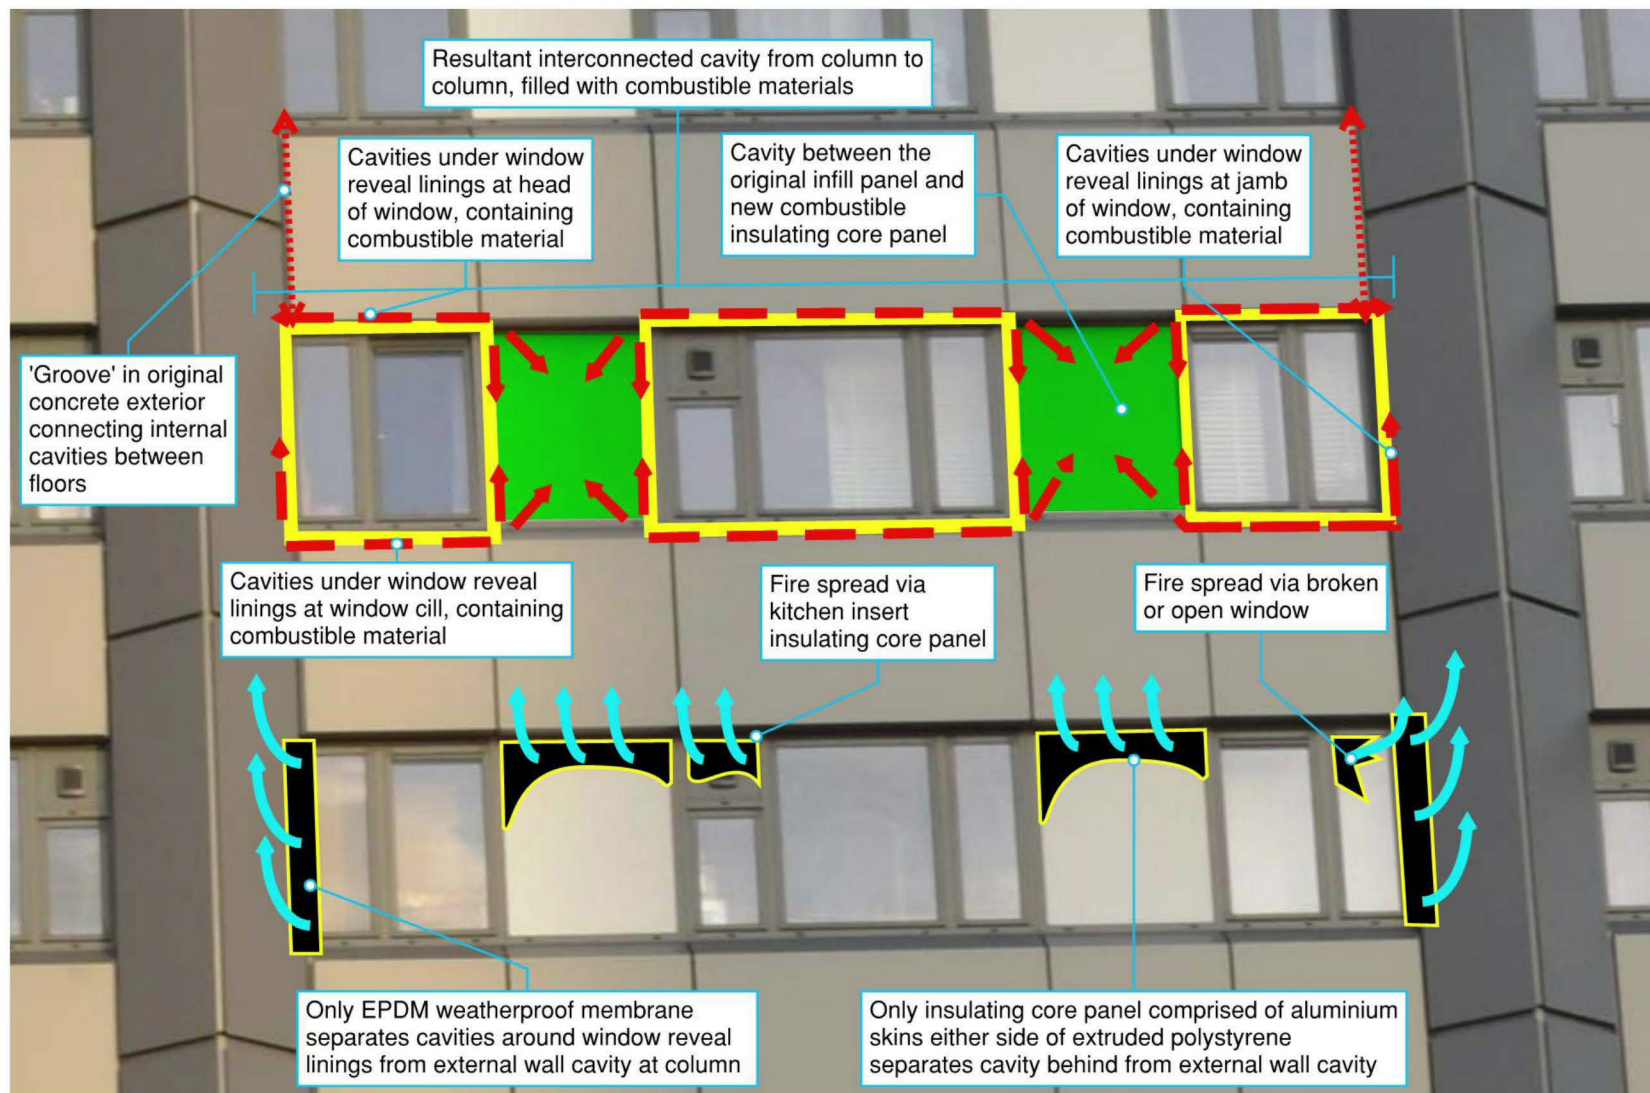
9.2.16 Therefore, this combination of interconnected cavities behind the uPVC window reveal linings formed a network that spanned the full width between each column. This is represented on the exterior of the building in Figure 9.7.

Figure 9.7: Resultant network of cavities superimposed on exterior of building, and routes into external wall cavity (SEA00000350)

- a) yellow lines represent the cavities around the window reveal linings;
- b) green shading represents the cavity formed between the original infill panel and the new insulating core panel.
- c) red dotted arrows therefore demonstrate the connections between the above internal cavities (see 9.2.19 onwards).

9.2.18 The second row of windows with black areas and blue arrows, summarises the routes that a fire within this network of cavities could then take to break into the external wall cavity formed by the rainscreen cladding applied to the building. I will explain all of these routes in section 9.3

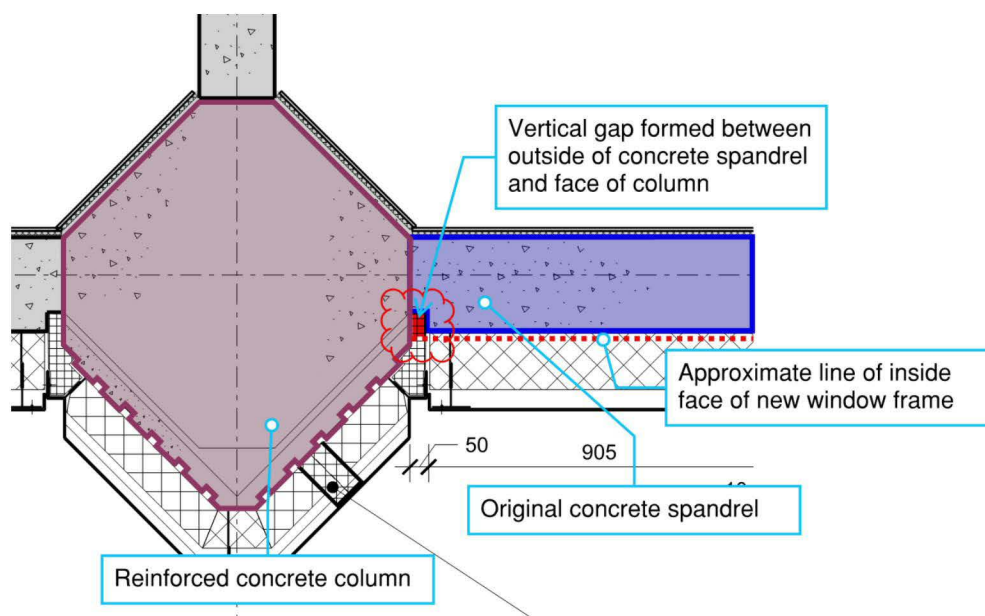
Figure 9.8: Marked up diagram showing gap formed by original concrete exterior of the building marked in red (horizontal section based on SEA00013045)

9.2.21 The Studio E drawing (SEA00013045) identifies that the gap between the column and spandrel should be filled with insulation.

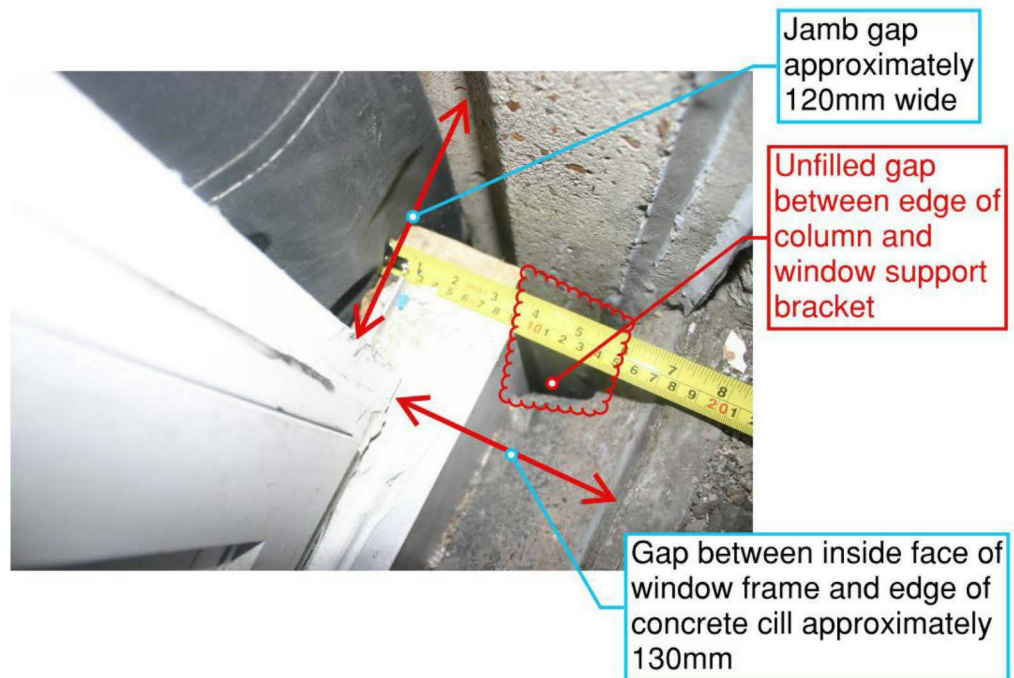
9.2.22 I found evidence of this vertical gap or groove on site as I have presented in Figure 9.9 and Figure 9.10. This groove is formed by the original concrete exterior of the building, which after the refurbishment works, was situated on the interior side of the EDPM weatherproof membrane (see Figure 9.9).

9.2.23 This gap travels the length of each floor between windows and was observed both filled (Figure 9.10) with combustible expanding foam and also unfilled (Figure 9.9).

Figure 9.9: Unfilled gaps in the internal window construction – cill level (Flat 13)

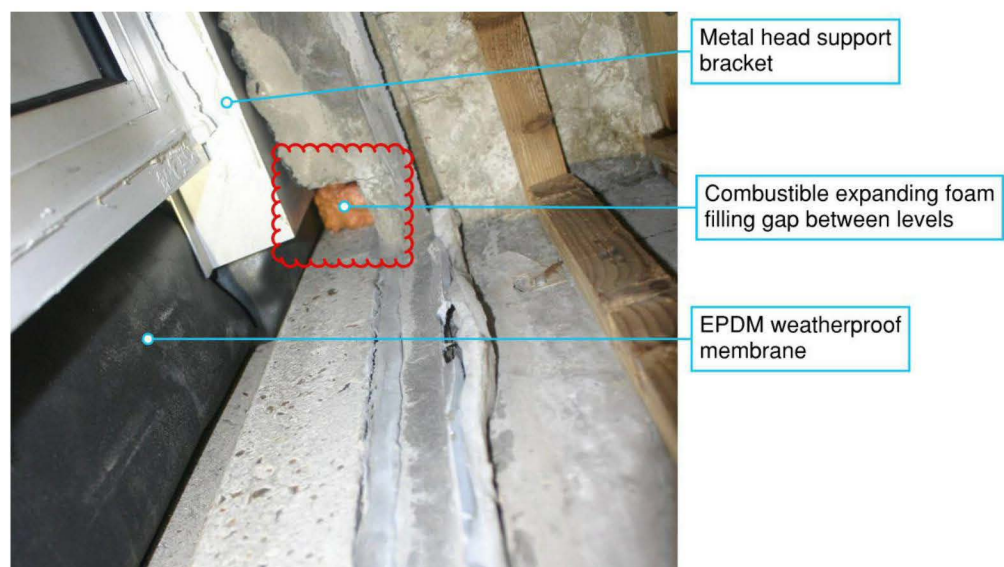
- 9.2.24 Where filled, a combustible expanding polyurethane foam product (HAR00001323) appears to have been used, and from below only.
- 9.2.25 This gap also bypasses the floor slab compartment line (and it is repeated beside each column and on each floor).
- 9.2.26 This gap was not fire rated and represents a potential path of internal fire spread vertically between flats, without breaking the EPDM weatherproof membrane.

Figure 9.10: Gap filled with expanding foam in the internal window construction – Looking up at window head (Flat 13)

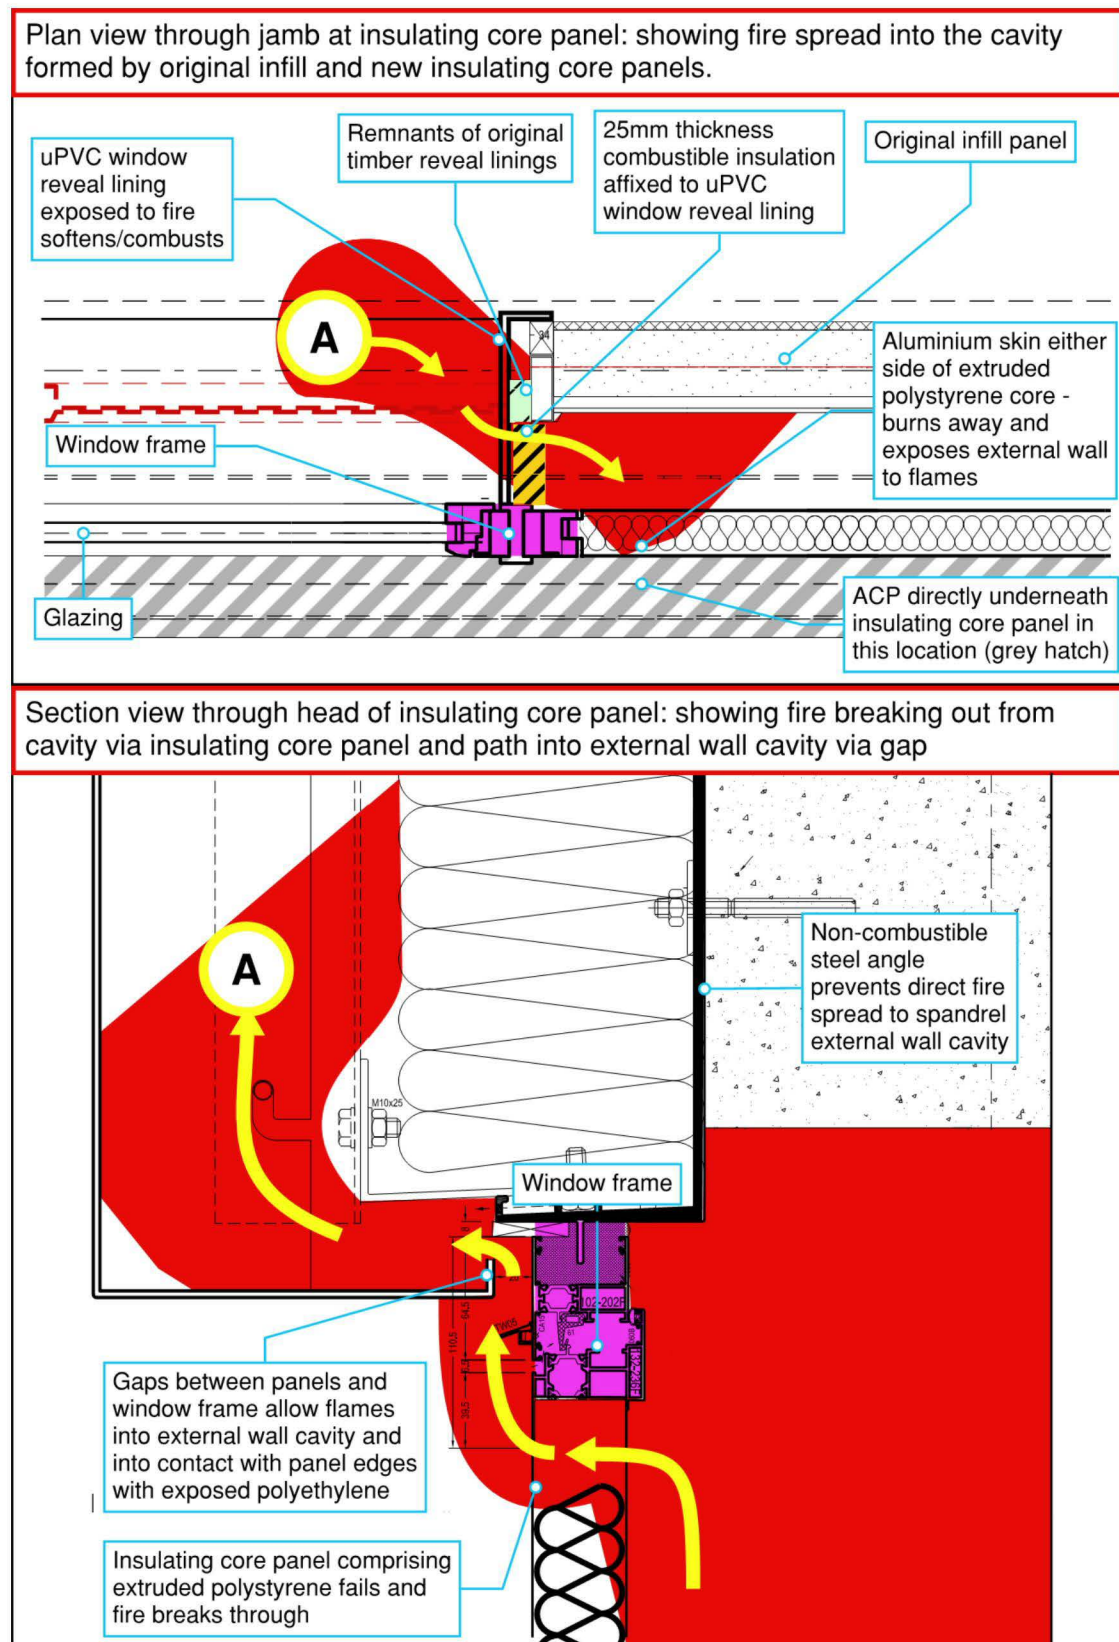
9.3.8 In Figure 9.11 I have illustrated the route of fire spread from a localised fire at or near the insulating core panel side of the window to the spandrel external wall cavity above. In this position radiative heat, hot gases or burning particles from the fire could impinge the vertical materials lining the window jamb. First the uPVC surface lining, then the 25mm combustible insulation affixed to the underside of the uPVC.

Figure 9.11: Diagram of route A (in two parts) originating from a localised fire on or adjacent to cill. (SEA00013045, HAR00008901).

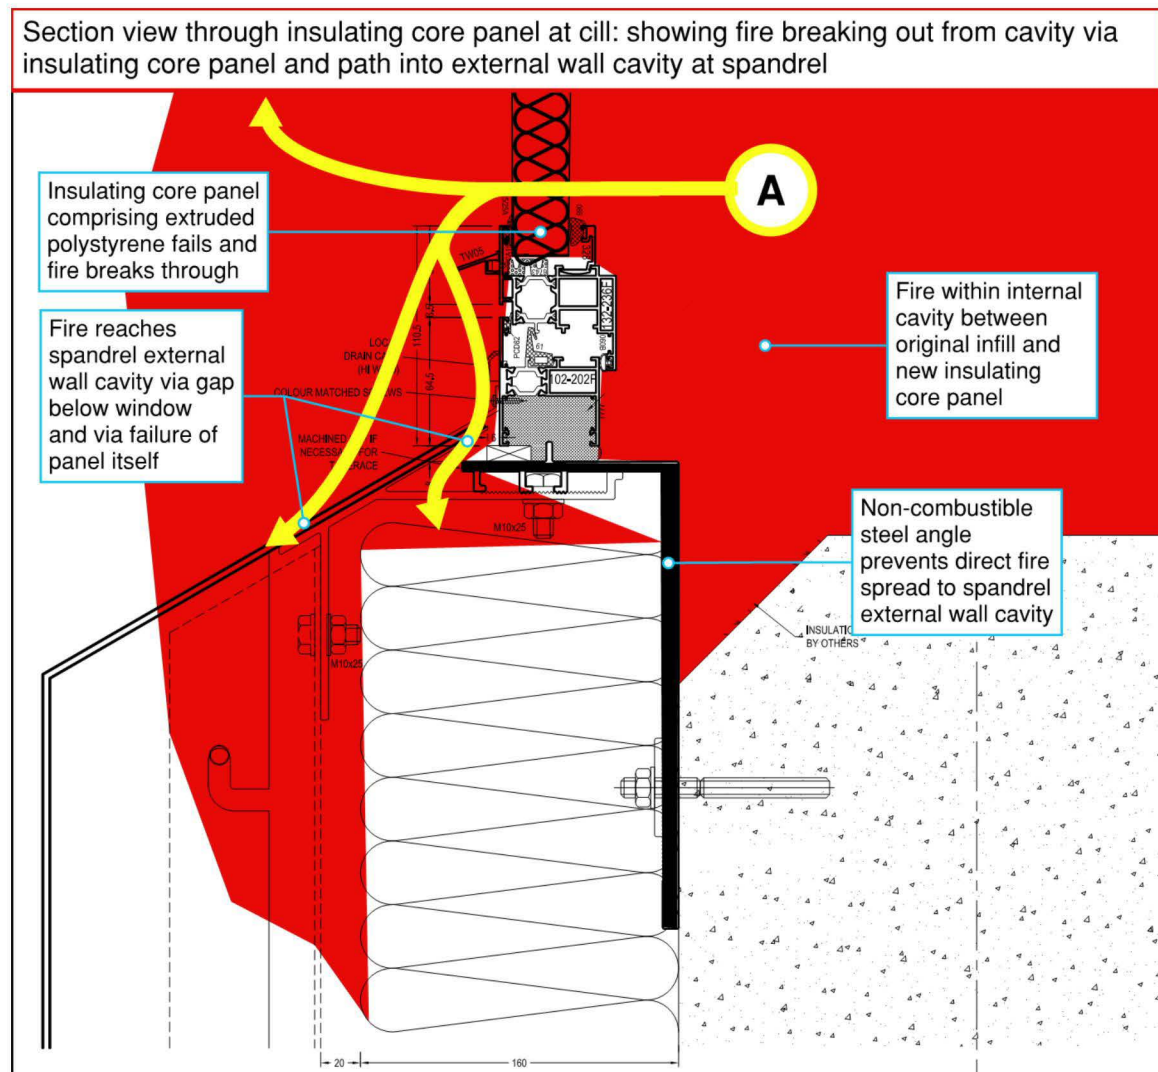
9.3.11 Figure 9.12 shows the ACP cassette where it is folded in towards the insulating core panel, below the window at cill level.

Figure 9.12: Diagram of route A also showing further route into external wall cavity on spandrel panel at cill of window (HAR00008879)

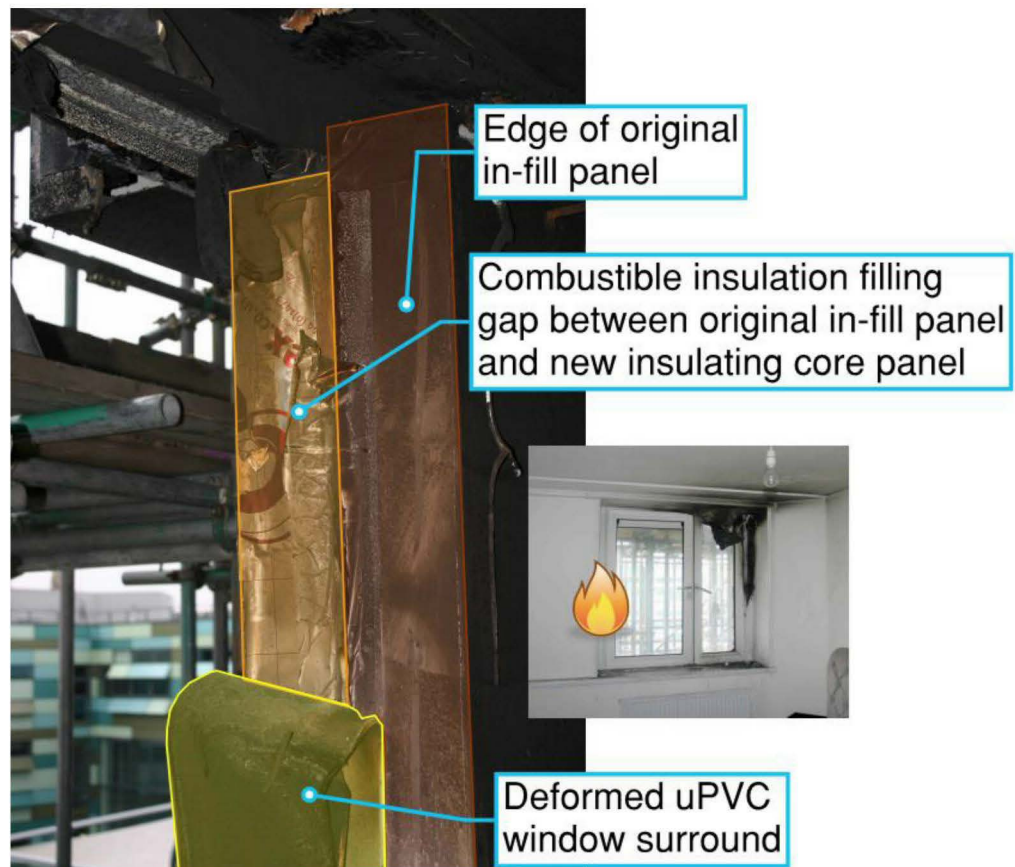
I have also included in Figure 9.13 an example of a heat affected vertical window lining beside the new insulating core panels which I observed onsite. In this photograph the uPVC window lining has softened and deformed to reveal the 25mm combustible insulation behind.

Figure 9.13: Fire on the infill panel side of the window (Flat 16 living room window) with example location inset

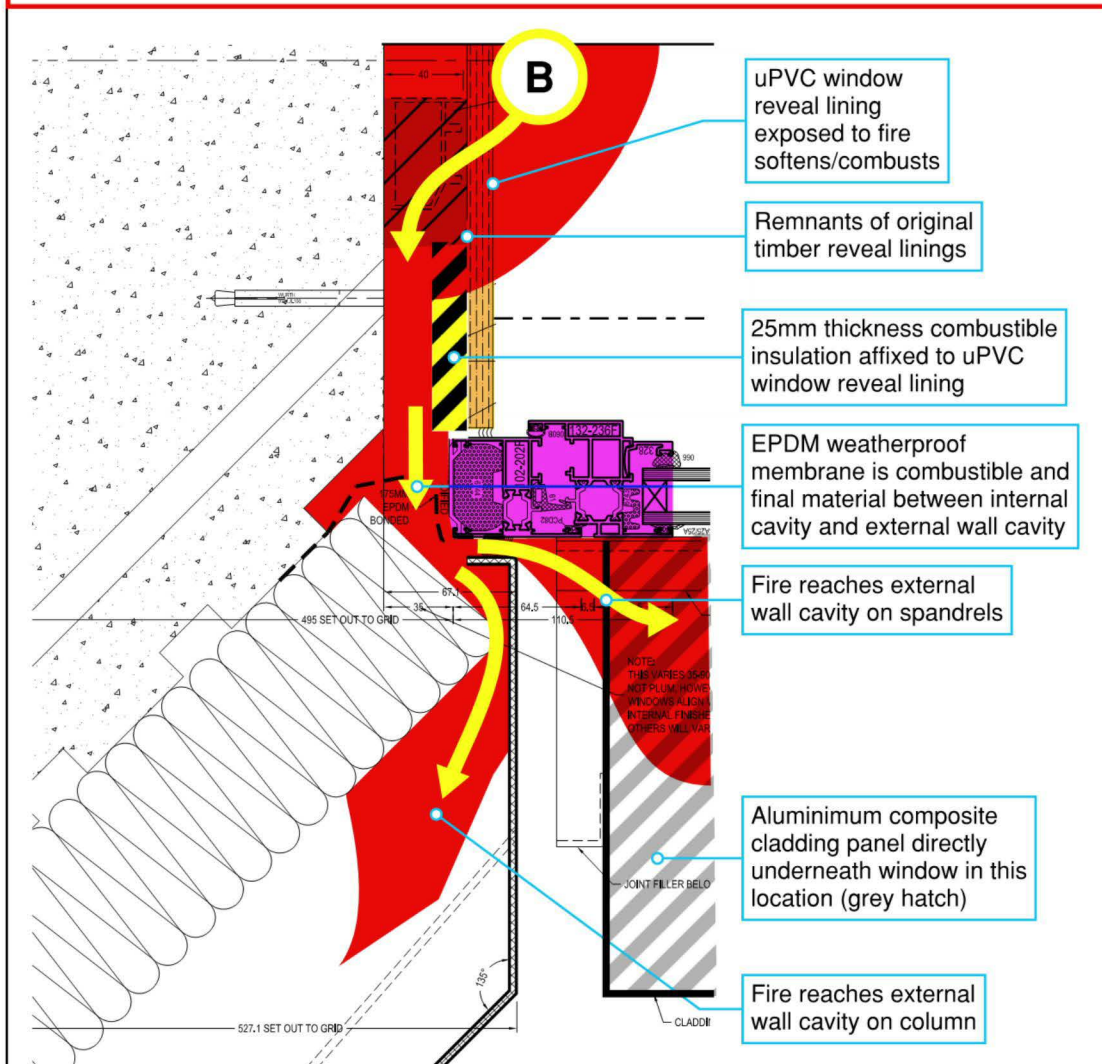
9.3.16 In this position, radiative heat, hot gases or burning particles from the fire could impinge on the vertical materials lining the window jamb. First the uPVC surface lining, then the 25mm combustible insulation affixed to the underside of the uPVC and the retained timber batons from the original window frames.

Plan view through column/ jamb: showing fire spread into uPVC window reveal lining at window jamb, through EPDM directly into external wall cavity

Figure 9.14: Diagram of route B originating from a localised fire adjacent to window jamb (HAR00008902).

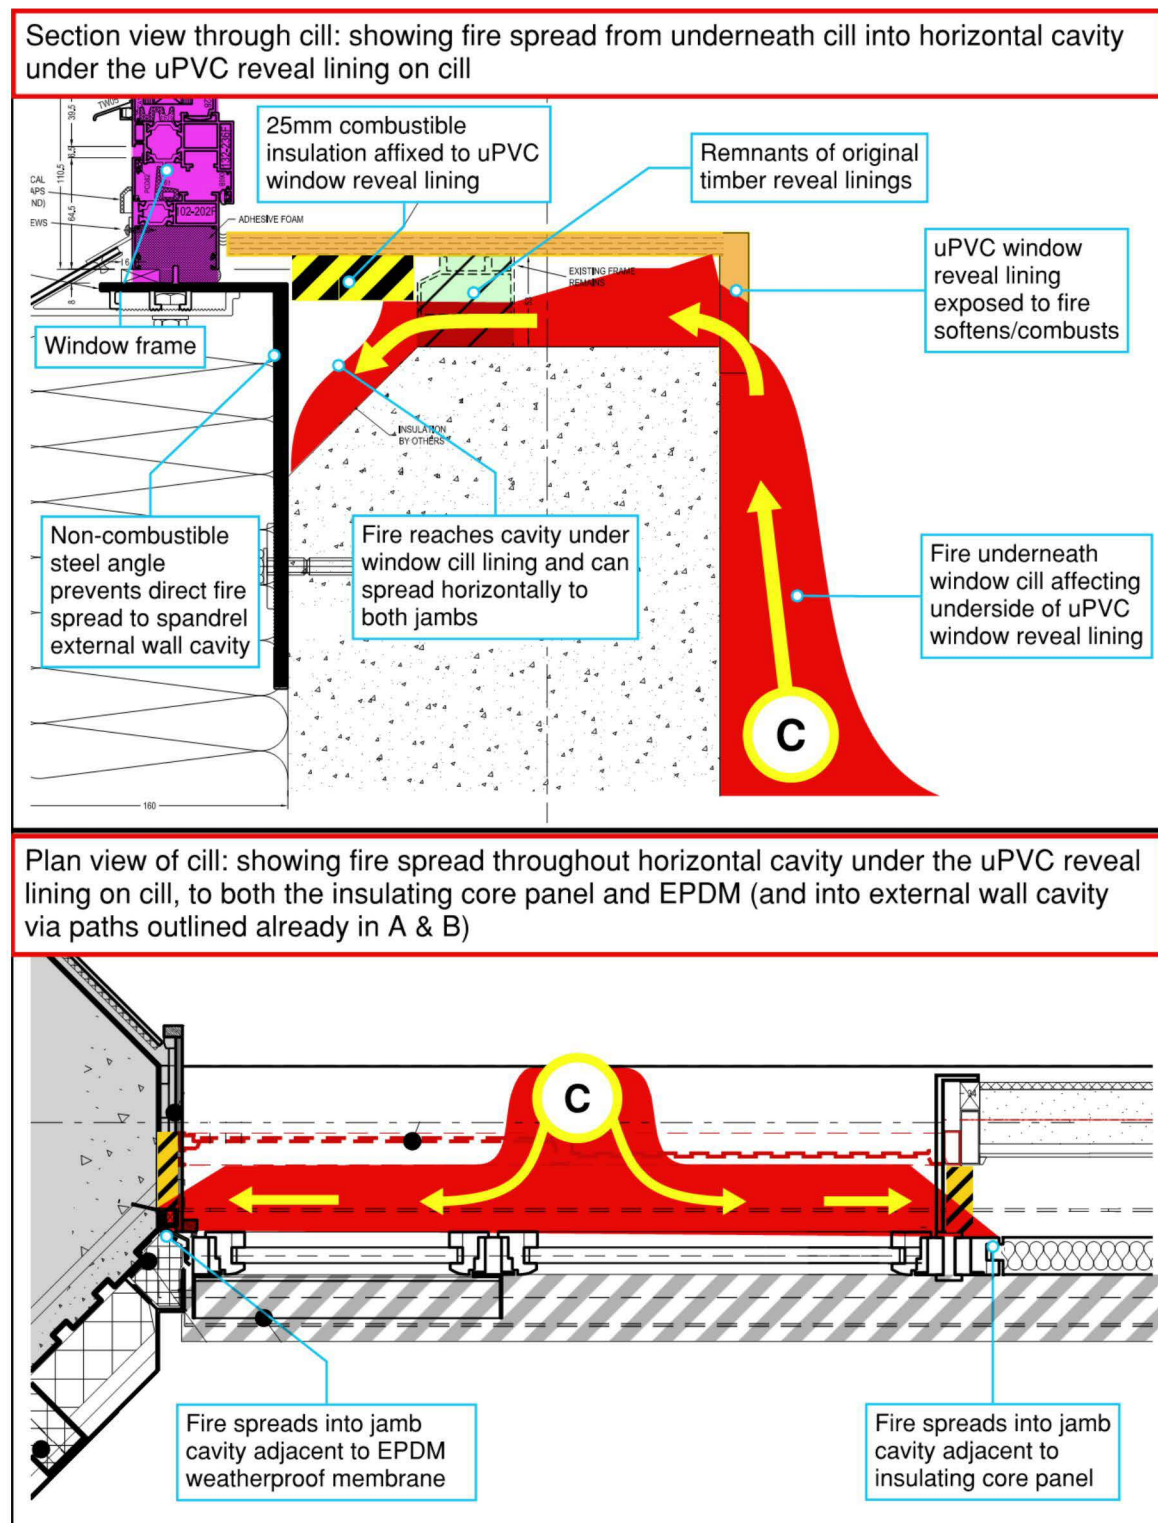
9.3.20 In this position radiative heat, hot gases and/or burning particles from the fire could impinge directly upon the combustible materials of the window cill. First the uPVC surface lining, then the 25mm combustible insulation affixed to the underside of the uPVC surface lining. Any gaps between the uPVC surface lining and horizontal wall would increase in size.

9.3.24 As per route A, once failure of the insulating core panel occurs the fire can spread into the external wall cavity on the spandrel above, and below. This route is illustrated in Figure 9.15.

Figure 9.15: Diagram of route C (in two parts) originating from a localised fire underneath cill and spreading into cill internal cavity, with onward spread to behind both jambs and using the remainder of routes A & B to reach the external wall cavity (HAR00008879, SEA00013045).

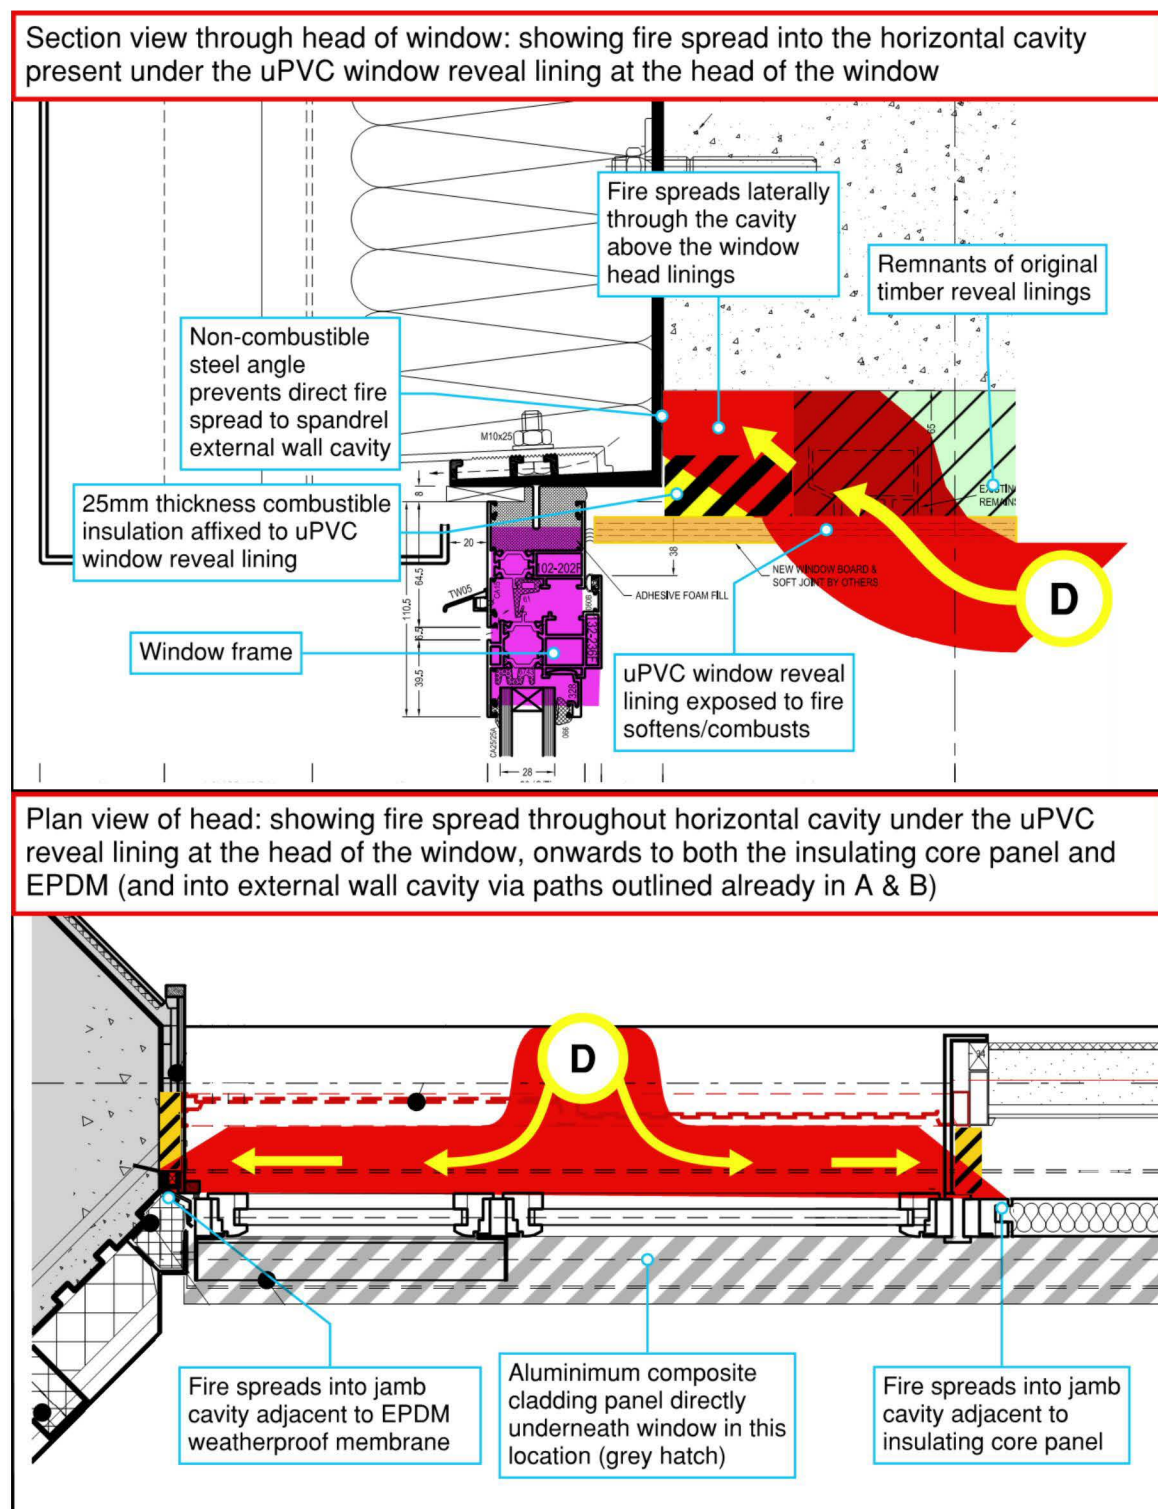
9.3.26 In Figure 9.16 I have illustrated the route of fire spread where a localised fire is at or near the head of the window and travels to the column external wall cavity. In this position radiative heat, hot gases or burning particles from the fire could impinge on the horizontal materials lining the window jamb. First the uPVC surface lining, then the 25mm combustible insulation affixed to the underside of the uPVC.

9.3.28 As for a localised fire at or adjacent to the window cill, once a fire is within the window head cavity, it is separated from the external wall cavity by a non-combustible steel shelf angle. The fire must therefore spread laterally towards either the column or the new insulating core panels. Once the fire is in the head cavity it could spread laterally along the cavity until it reaches the EPDM weatherproof membrane at either the column jamb or the XPS filled insulating core panel located between the windows.

Figure 9.16: Diagram of route D (in two parts) originating from a localised fire on or adjacent to cill, or from a fire remote to window with ceiling plume. Onward spread to behind both jambs and using the remainder of routes A & B to reach the external wall cavity. (HAR00008901, SEA00013045).

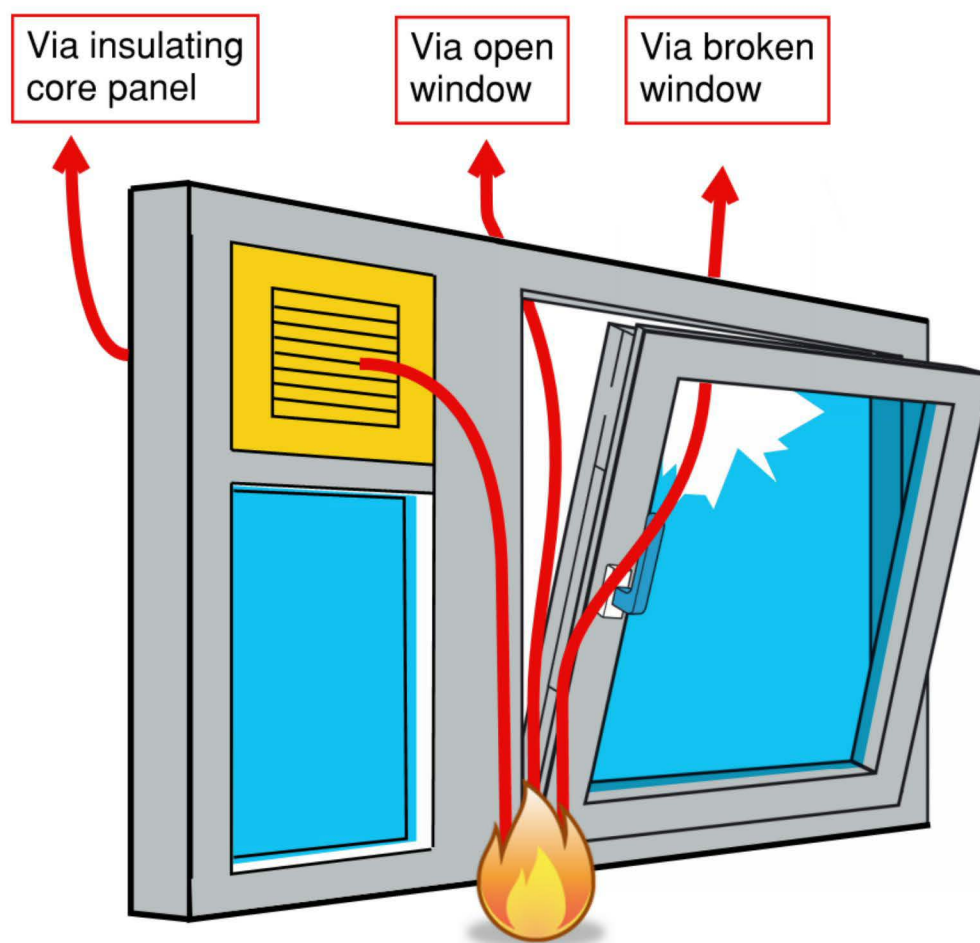
- a) Via the combustible insulating core panel in the window that houses the ventilation fan for the kitchen;
- b) Via an open window;
- c) Via broken glazing in the window.

Figure 9.17: Routes for fire spread directly through a window

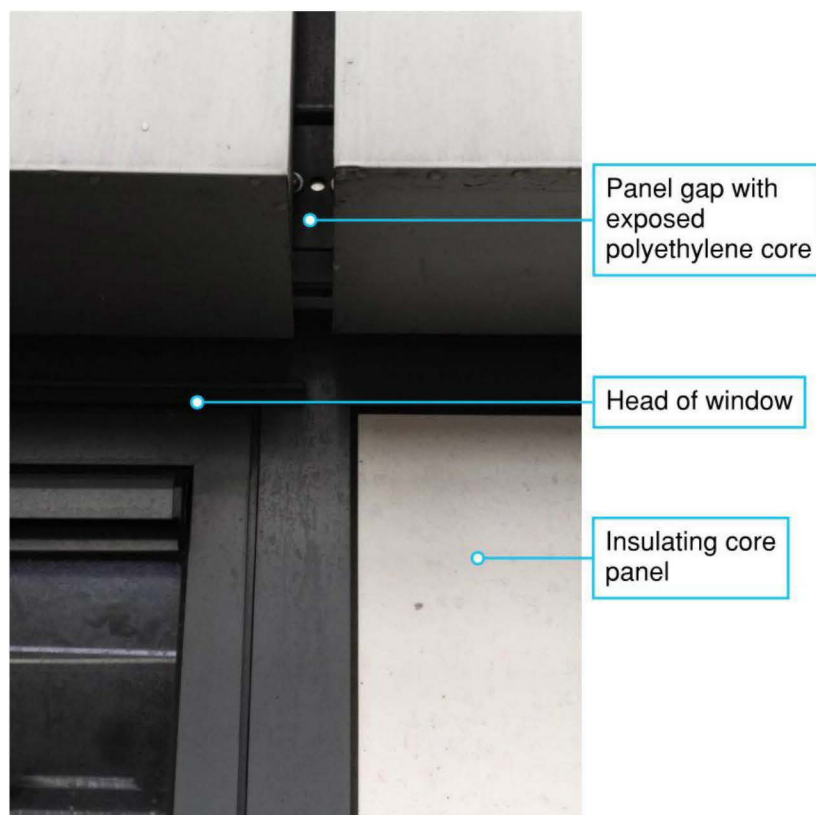
Once flames from the fire are able to penetrate the window by any one of the three scenarios described above, the heat and smoke from the fire could impinge directly on the ACP overcladding on the vertical column and also on the ACP overcladding located above and below the window. Flames can enter both the horizontal and vertical rainscreen cavities through ventilation gaps between the aluminium composite rainscreen panels (Figure 9.22) and also cause ignition of the exposed PE core, shown in Figure 9.19.

Figure 9.19: External wall photograph showing proximity of panel gaps to window and insulating core panel

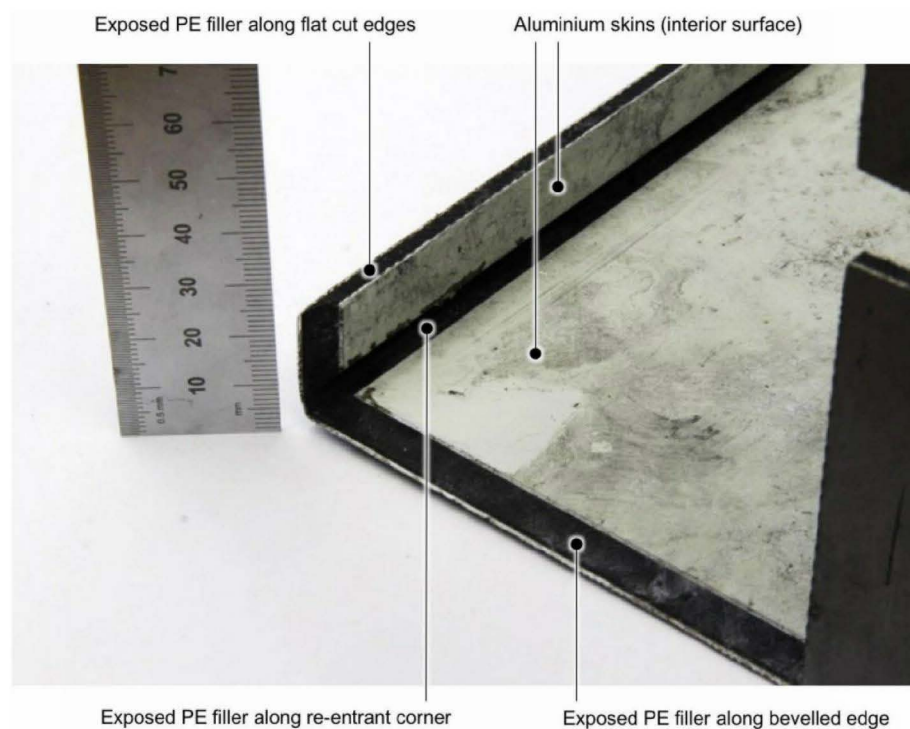
The polyethylene core was exposed along the sides of the panels in this location, as indicated by Figure 9.20. My onsite observations confirm it was exposed and also that it had melted, as shown in Figure 9.21:

Figure 9.20: Prof. Bisby's phase 1 report, figure 20 showing photograph of spandrel cladding panel sample provided by MPS

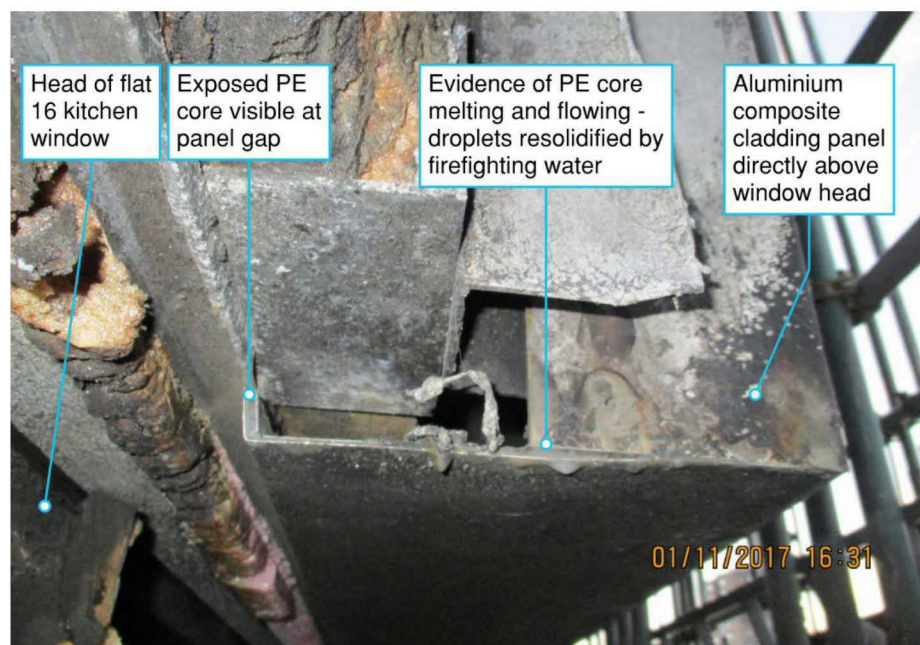
Figure 9.21: Photograph of cladding panel directly above flat 16 kitchen window
