Grenfell Tower – fire safety investigation:
The fire protection measures in place on the night of the fire, and conclusions as to:

Phase 1 Report – Section 9

Routes for fire spread out through the window openings

24th October 2018

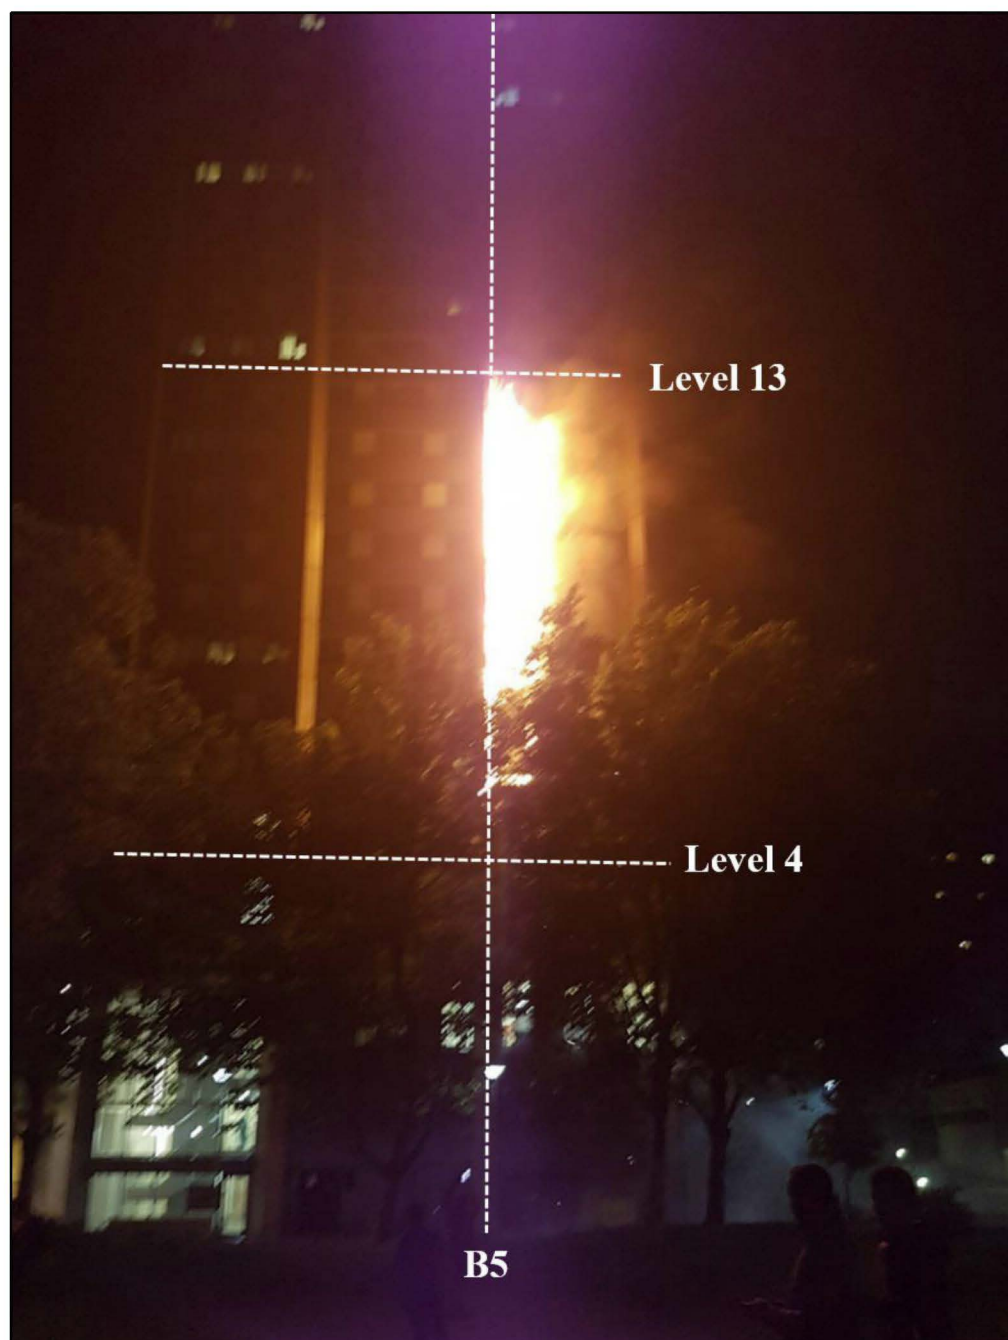
9.4.6 As I have explained in Section 5 of my report, there was rapid flame spread observed up the columns of Grenfell Tower on the 14th June 2017. Figure 9.23 is replicated from Section 5 to visualise this spread.

Figure 9.23: Evidence of flame spread up column at 01:22 (approx)¹

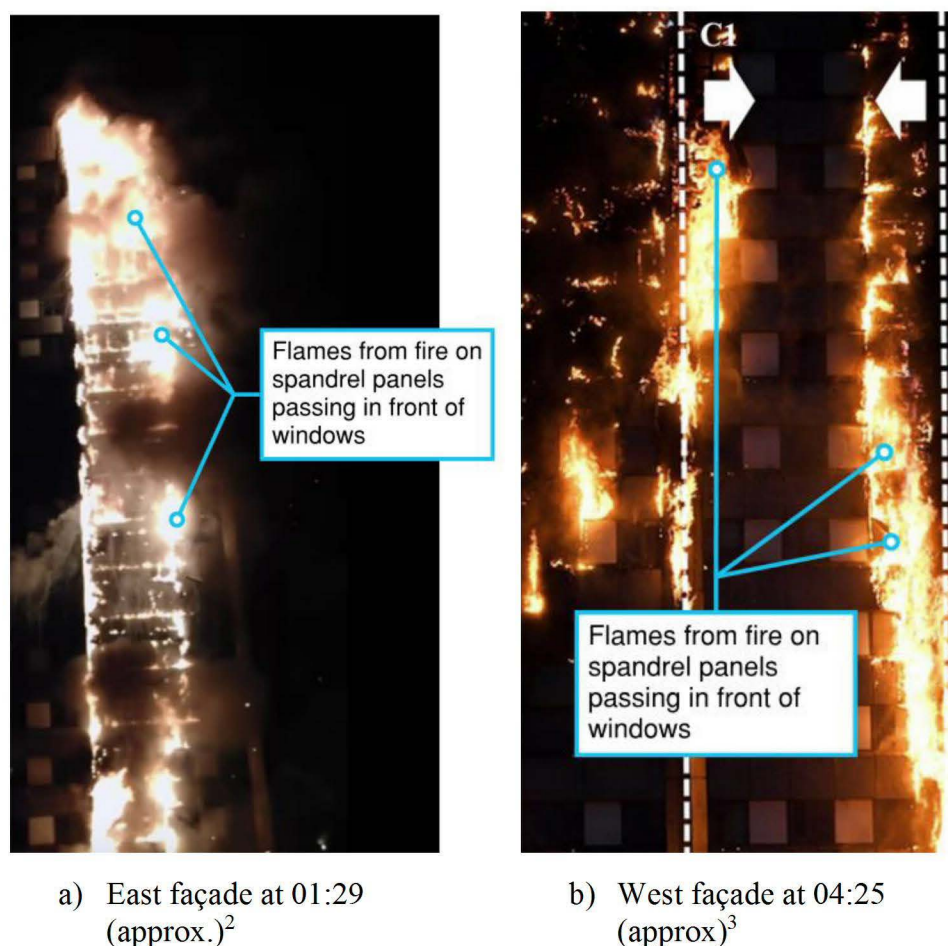
9.4.11 Figure 9.24 presents evidence from the fire on the 14th June 2017 and shows that flames coming from burning spandrel panels were able to engulf some or all of the windows directly above.

Figure 9.24: Evidence of fires from spandrels causing flame fronts in front of windows

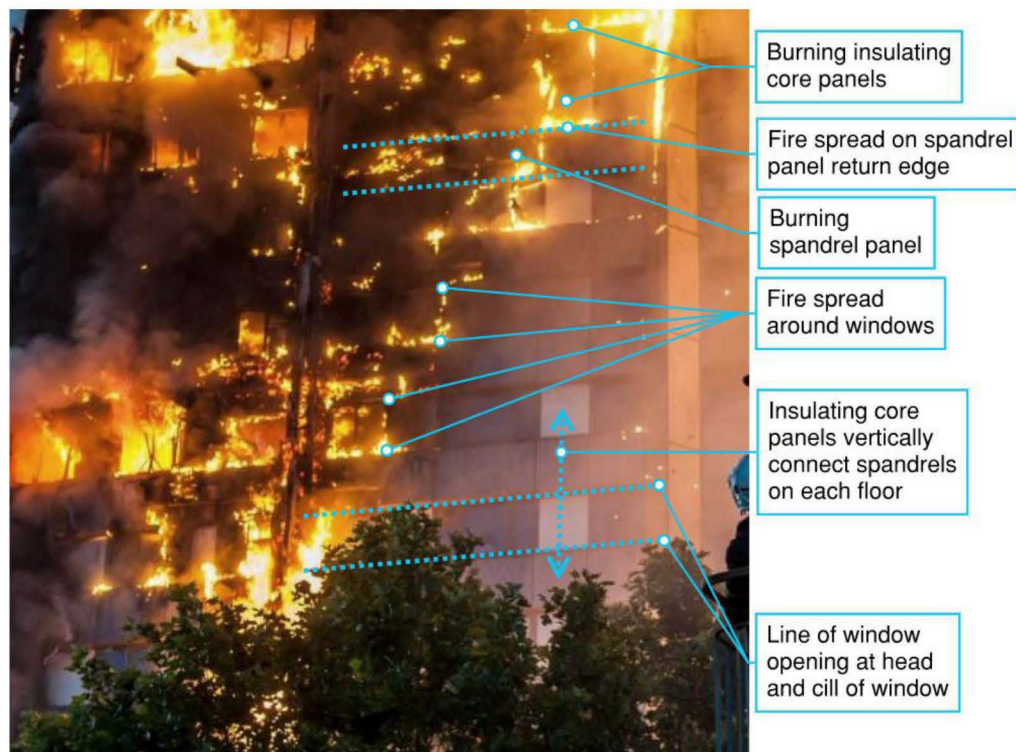
9.4.16 Figure 9.25 below, presents evidence from the fire on the 14th June 2017 of horizontal fire spread along the head and cills of the windows.

Figure 9.25: Example of Pathway C (replicated from Section 10)⁴

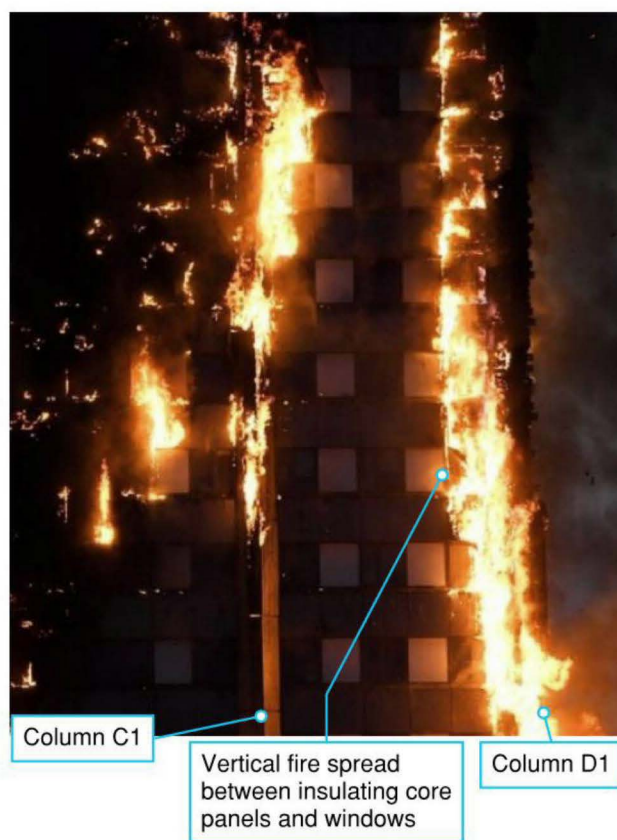
Figure 9.26: Photo evidence of vertical fire spread at the junction between the insulating core panels and windows⁵

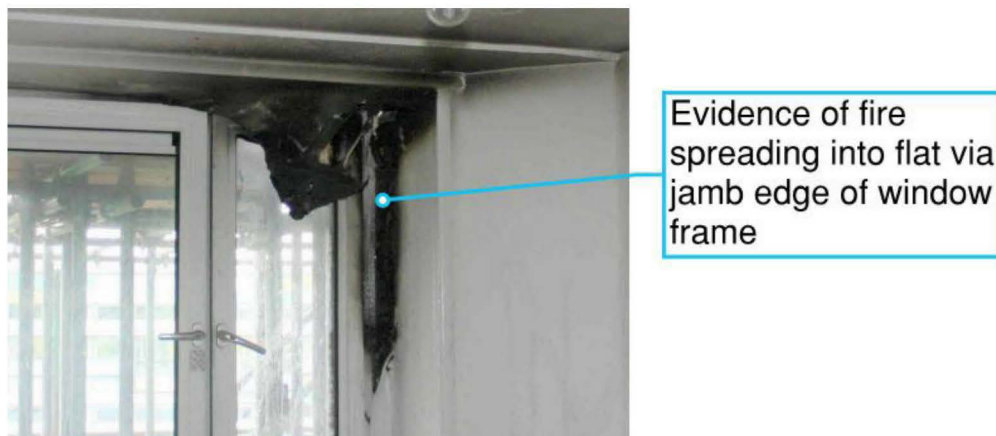
9.4.9 The photograph in Figure 9.29, discussed in Section 9.5.1, illustrates that this was a feasible route for fire spread into the flat.

9.5.2 In my inspection of Flat 15 on Level 4 (Figure 9.28), I observed that there was a window exhibiting evidence of fire spread from outside the building to the inside, shown in Figure 9.29. The evidence of fire spread showed that the entry route for the fire was in the top corner of the window, adjacent to the column, consistent with the mechanism of fire spread presented in Section 9.4. That is a fire being able to penetrate from outside the building, into the cavity behind the new uPVC reveal linings via the EPDM weatherproof membrane (route B).

Figure 9.29: Fire spreading into flat from outside (Flat 15 bedroom)

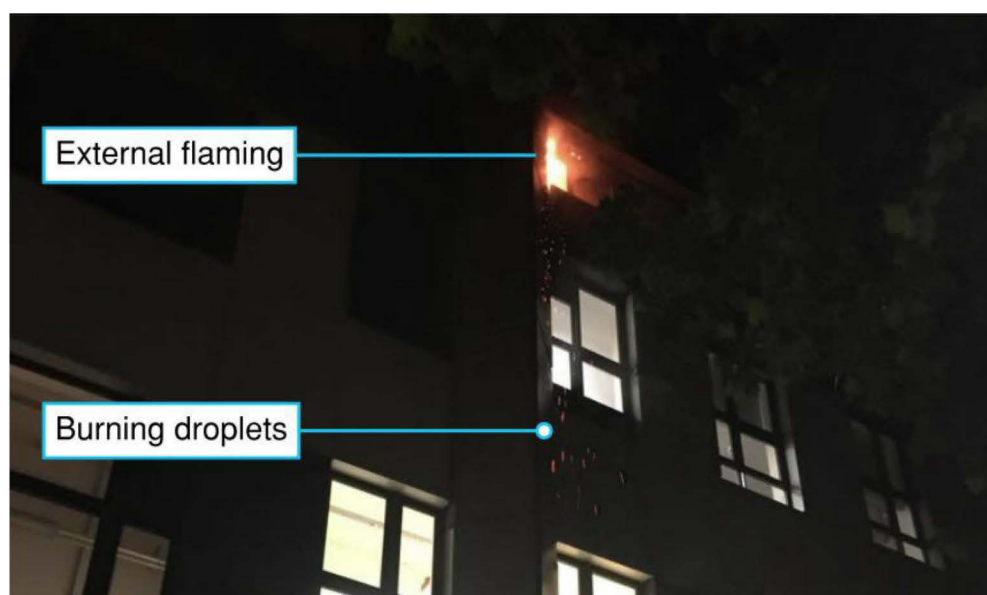
9.5.15 Additionally, Figure 9.35 identifies that burning droplets began falling outside the building at around 01:08.

Figure 9.35: Photograph at 01:08 submitted by witness (IWS00000051)

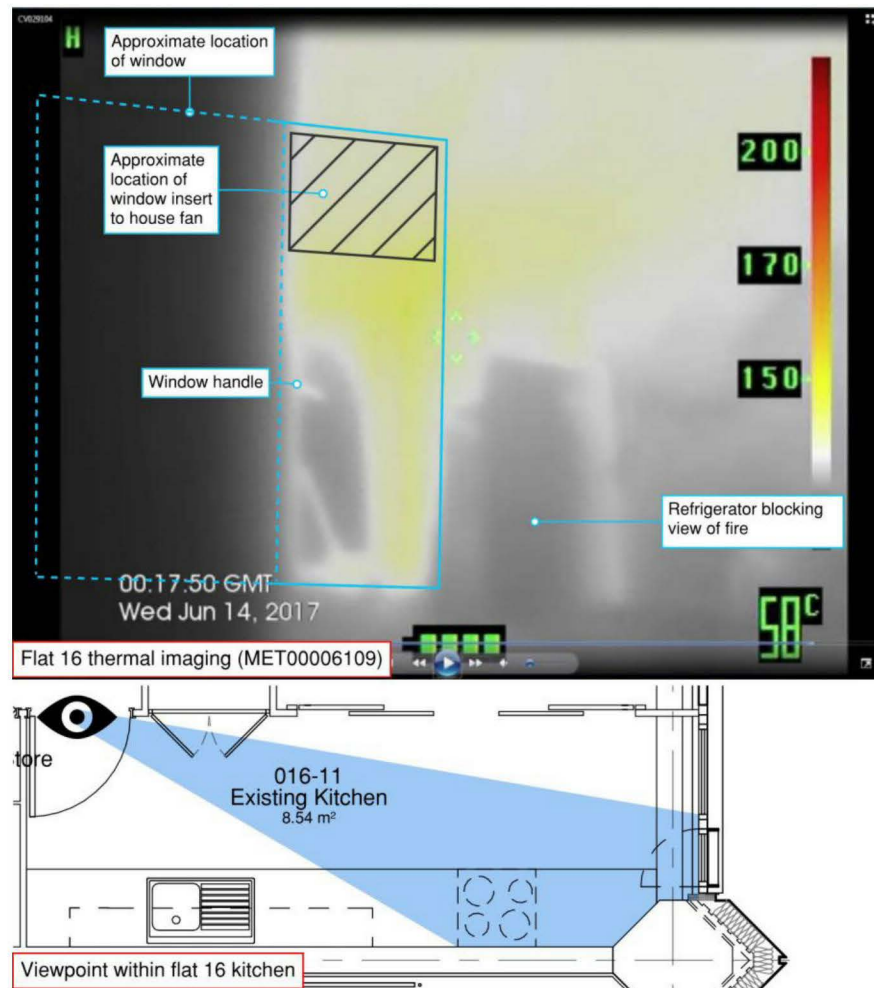
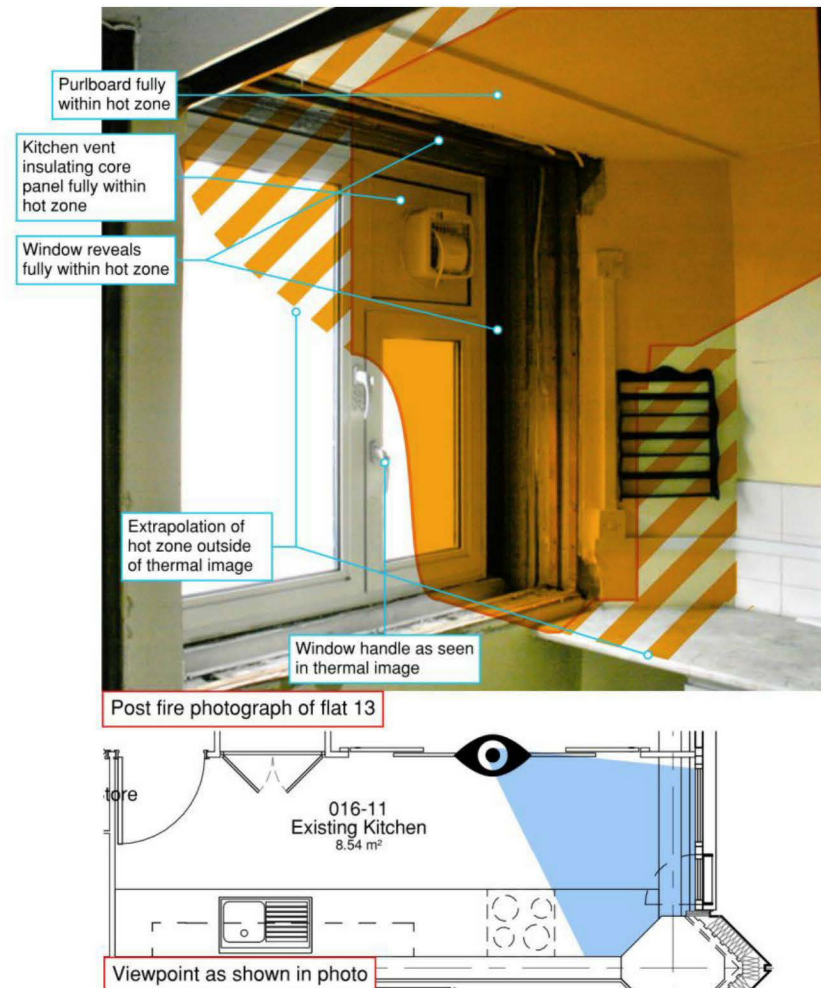
- 9.5.18** Figure 9.38 shows the extent of the area that was subjected to the hot plume observed within the flat 16 thermal imaging camera footage. This therefore also shows the extent of materials that were exposed to the heating from the initial fire, and the possible routes available for fire spread into the external wall cavity.

Figure 9.38: Comparison figure of the area exposed to the hot fire plume observed in thermal imaging from flat 16 (plans: SEA00010474)

- 9.5.19 Therefore, using Figure 9.38, the exposure from the hot zone could lead to the fire reaching the external wall cavity **by either routes B (via jamb/EPDM), or E (directly through the window glazing/kitchen vent panel):**

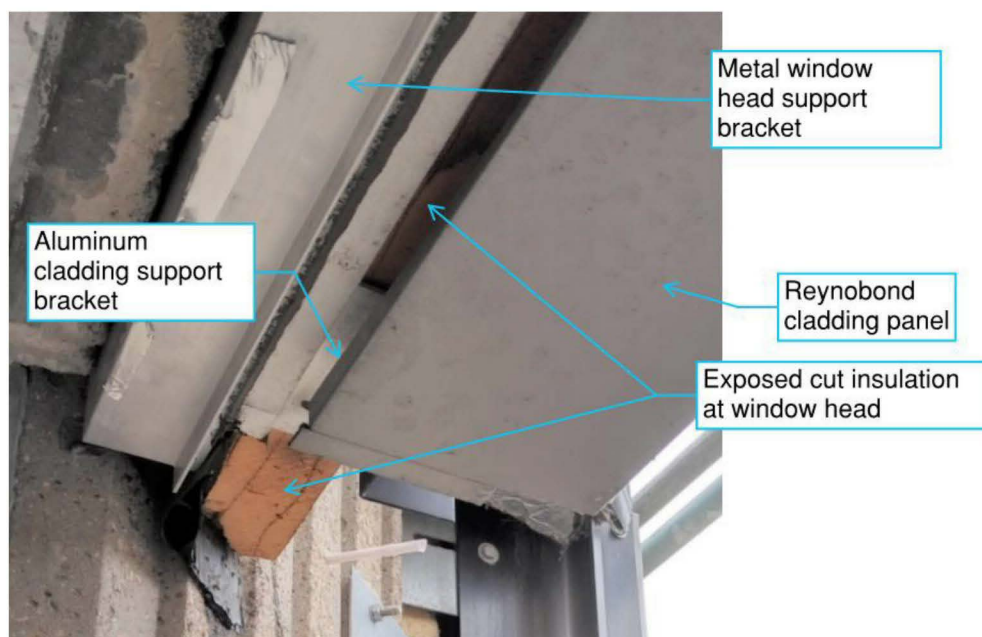
Figure 9.39: Evidence of cut insulation edge above window head

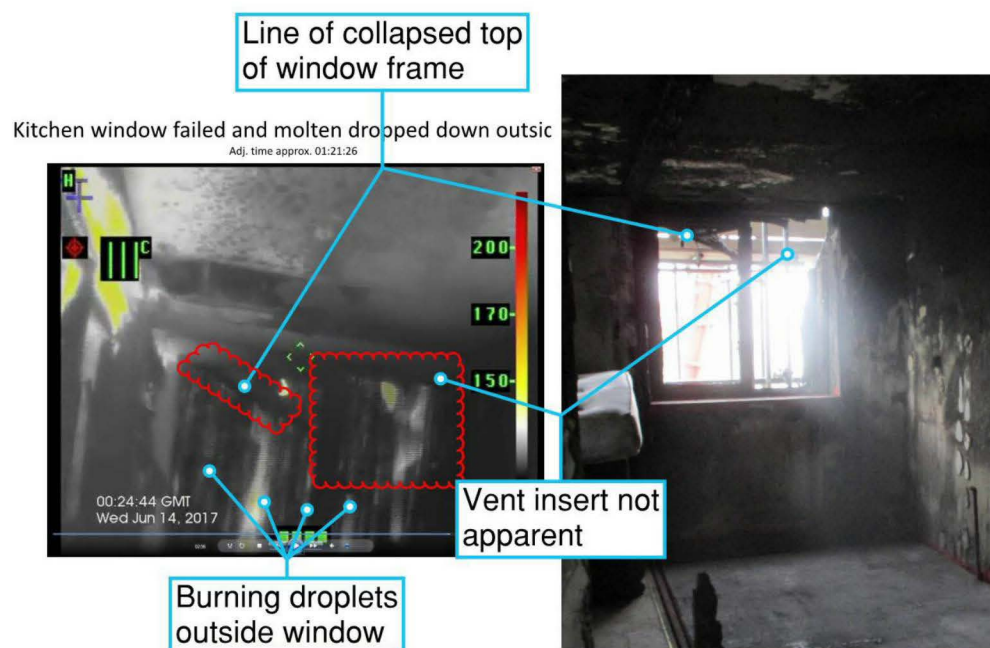
- 9.5.20 Figure 9.40 includes a still taken from LFB thermal imaging camera of the first fire fighter to enter the kitchen of Flat 16 on the 14th June 2017 timestamped 01:21. The right hand side of this image shows a view out of the kitchen window. Burning droplets are apparent, falling outside the window. Furthermore, the kitchen vent insulating core panel does not appear to be visible, indicating that it had already been affected by fire and fallen away (as discussed in route E).

- 9.5.21 The site photograph included in Figure 9.40, taken in Flat 16 on the 8th November 2017, corroborates this evidence by indicating that the worst damage to the kitchen window in Flat 16 was in the top corner where the vent insert was originally positioned. Please refer to Figure 9.38 showing the original window configuration with the vent insert in the top right corner.

Figure 9.40: Evidence of loss of vent insert (MET000006109), compared with post-fire photograph of Flat 16 kitchen window
