**Preliminary Fire Investigation
Status Report to the Grenfell
Tower Public Inquiry**

Delmar “Trey” Morrison III, Ph.D., P.E., CFEI
John Martens, M.B.A., Ph.D., P.E., CFEI
Exponent, Inc.
4580 Weaver Parkway, Suite 100
Warrenville, Illinois, USA 60555

22 January 2018

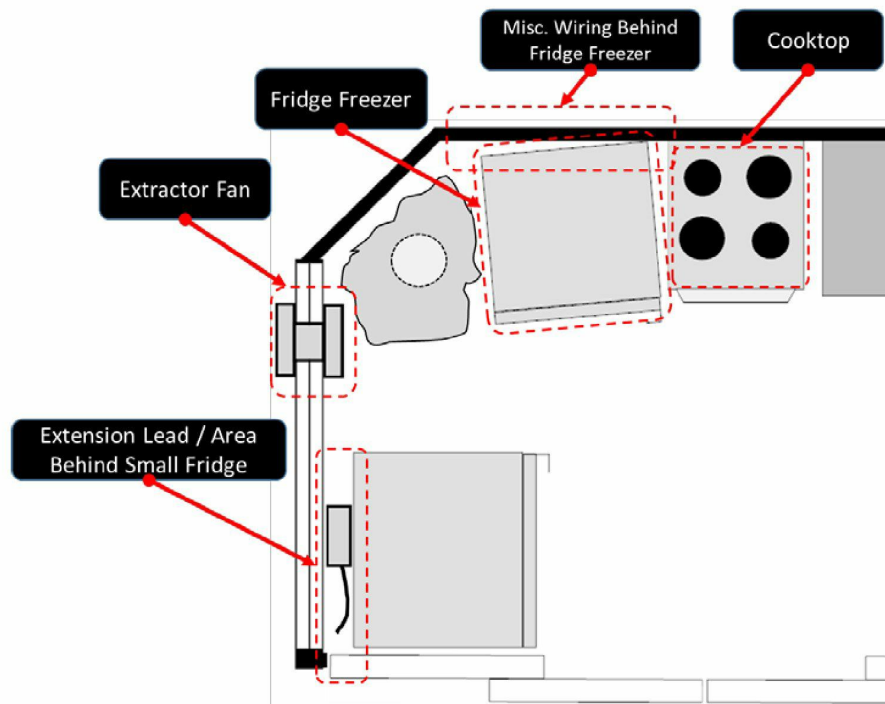
Figure 5. Diagram showing potential points of origin for the fire within the kitchen.

1. Cooktop: Burned debris was visible on the left rear element of the electric cooker's cooktop surface adjacent to the fridge freezer. The content of this burned debris could not be determined from viewing only the photographs and warrants further investigation and analysis. Ceramic backsplash tiles had fallen from the wall behind and above the cooker and were observed on top of the debris on the left rear-heating element on the cooktop. This observation may be consistent with a fire originating on the cooktop and then spreading to the fridge freezer. The précis statement does not mention the cooktop surface, and the activities of the occupant(s) during the time leading up to fire have not been reported to date. This possible fire scenario should be analyzed further. The plastic control knobs for the heating elements were melted away; thus, their position could not be determined from viewing the photographs. A laboratory examination may reveal their position at the time of the fire. Furthermore, to date, no information has been reviewed that explains the source of the debris or whether combustible items were located on or near the cooktop. As a result, it is possible that the cooktop is the point of origin for the fire.

3. FF175BP fridge freezer: Currently no fire patterns or other evidence has been identified that uniquely indicate a point of fire origin at the fridge freezer. Preliminary analysis of the fridge freezer evidence will be presented in a subsequent section of this report, but the damage patterns to the fridge freezer and its immediate surroundings could be the result of either a fire originating within the fridge freezer or from an external fire starting at a point of origin remote from the fridge freezer subsequently attacking the fridge freezer. The severity of damage to the fridge freezer and to the floor directly under the fridge freezer may be attributed to the nature of the materials that burned and the confinement afforded by the steel casing of the fridge freezer. A fire originating elsewhere in the kitchen could create similar fire damage patterns to the fridge freezer and the flooring underneath it. It is possible that the fridge freezer is the point of origin of the fire.

4. Extractor fan: An extractor fan was mounted in a panel in the window adjacent to the fridge freezer. An electrical fault in the fan or its wiring could cause a fire in the kitchen. The fan, wiring for the fan, and controls were not identified in the photographs viewed by Exponent or in the evidence provided for examination. As with any electrical appliance, several potential failure modes can lead to a fire. Given the lack of information, photographs, and physical evidence, these potential failure modes cannot be ruled out by Exponent, and this is a possible point of origin.

5. Extension lead and area behind the small fridge: A power extension lead with multiple sockets was present in the debris between the small fridge and the window. While it was conveyed to us that nothing was plugged into the extension lead, the device itself was believed to be powered by a socket in the living room with its flex cord running through a sliding door into the kitchen. The extension lead's flex cord was burned and severed near the sliding door. The fire scene photographs depicted a local fire pattern on the wall behind the small fridge and above the extension lead and its flex cord, and this pattern appeared to emanate from the severed section of the cord by the sliding door to the north. A failure involving the extension lead or

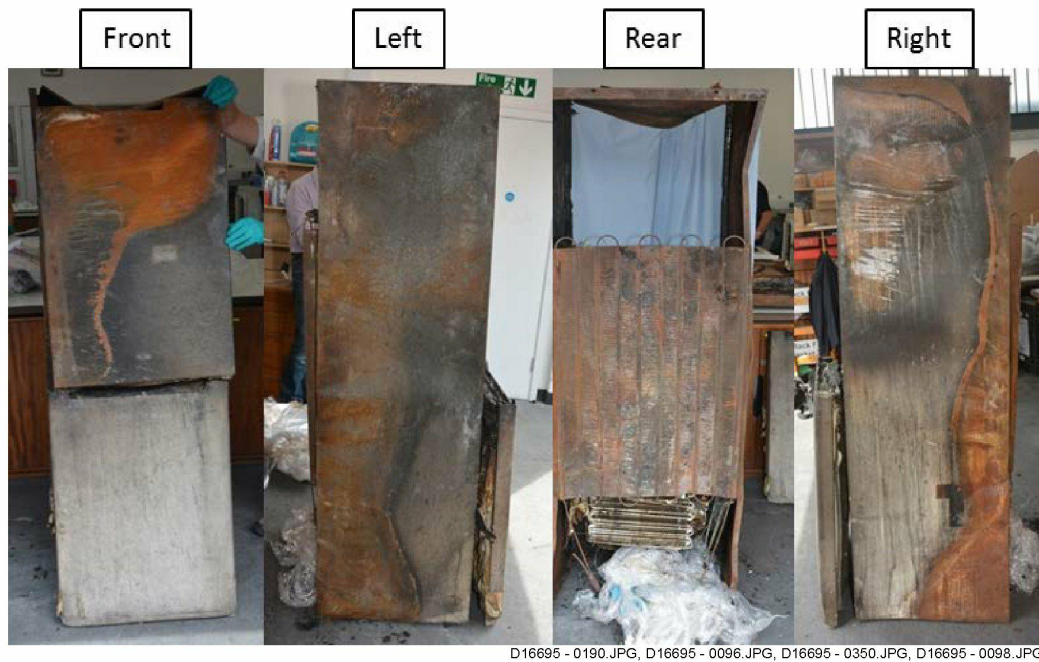
The fridge freezer has the most damage at the top in the refrigerator compartment, which decreased towards the bottom of the appliance and the front of the appliance. This damage is consistent with the anticipated effects of fire exposure with the greatest extent of damage toward the top (i.e., from exposure to the hot gases in the upper level of the room) and rear (i.e., combustible rear wall versus steel side walls affects fire penetration into the interior of the appliance). Images of the four sides of the fridge freezer starting at the front and moving in a clockwise direction around the appliance are provided in Figure 9.

Most of the polyurethane foam insulation, the inner liner, and likely the contents were consumed by the fire in the upper half (fresh food compartment) of the unit. The entire rear wall of insulation and rear panel were consumed. The compressor compartment wall and foam insulation were consumed around the compressor compartment as shown in Figure 10. The fire damage to the bottom of the fridge freezer is consistent with fire involvement of the polypropylene compressor compartment wall, which subsequently melted and created a pool fire under the fridge freezer. This fire damage pattern alone does not indicate that the fire started in the fridge freezer because similar damage will occur if an external fire spreads to the fridge freezer and ignites these materials.

Figure 9. Fridge freezer exterior fire damage patterns.

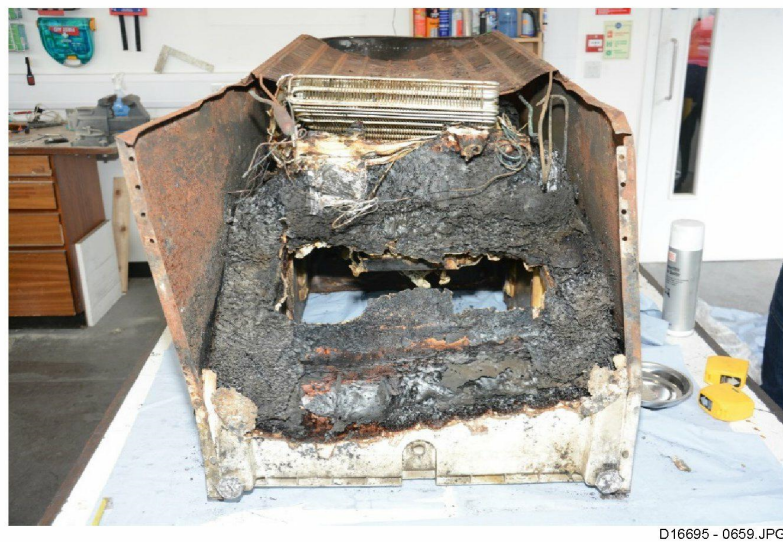
Figure 10. View of the underside of the fridge freezer showing damage to the compressor compartment and the insulation.

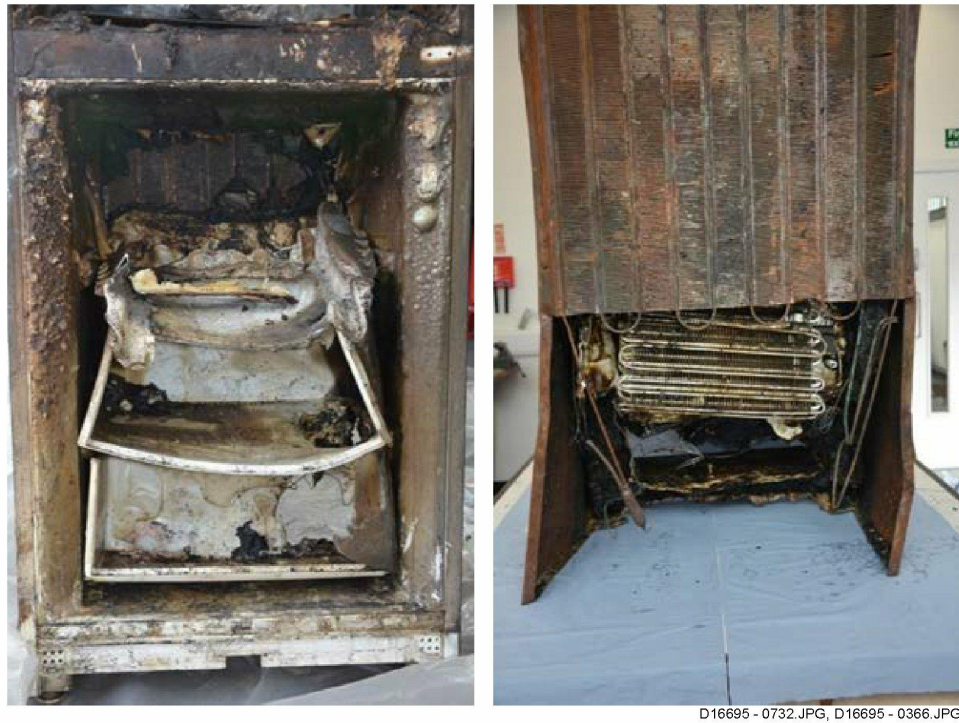
A view of the lower (freezer) compartment from the front indicates that fire breached the rear wall of the freezer compartment with slightly more damage to the right side (Glen cooker side). Views from the front and back of the freezer compartment are provided in Figure 11 to illustrate the extent of damage. This damage is consistent with the effects anticipated by the configuration of the compressor compartment as depicted in Figure 12. The larger open area to the left of the compressor as viewed from the rear will allow preferential burning and more extensive fire development to the left side of the compressor compartment than on the right side of the compressor. The compressor was provided as a separate item of evidence from the fridge freezer, and scene photographs depicted that the compressor mounting plate had come loose from the fridge during the fire and/or during the investigation efforts. The refrigerant tubing was later cut by investigators in order to separate the compressor from the fridge as part of evidence collection.

Figure 11. View of freezer compartment with drawers re-installed (left) and compressor compartment (right, with compressor removed).

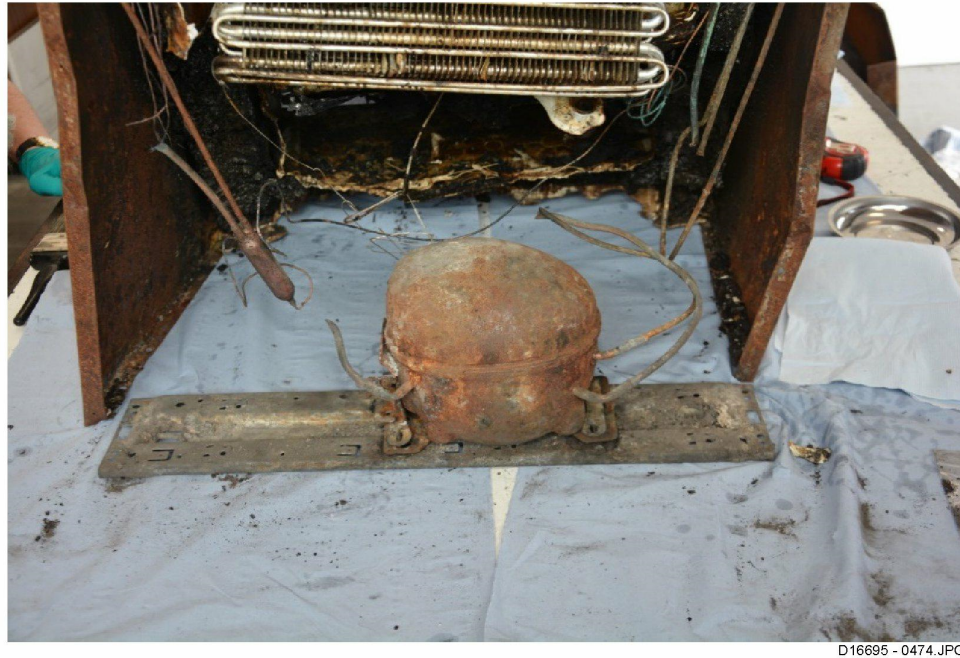
Figure 12. Compressor and mounting plate aligned with the fridge.

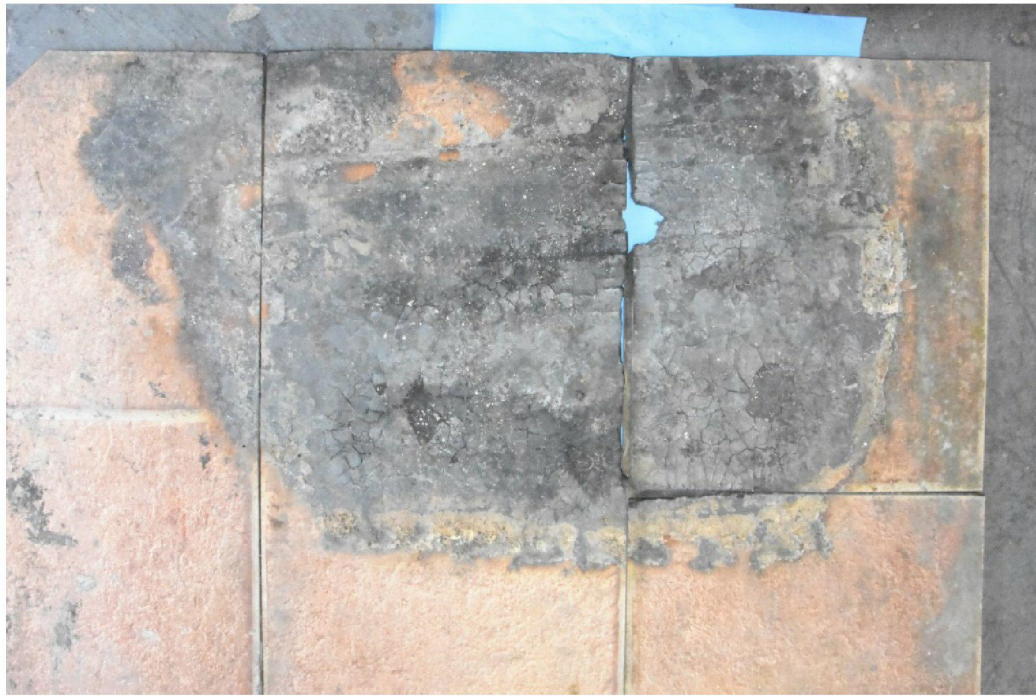
D16793 - 0678.JPG

Fire damage patterns to flooring and surrounding items may be useful in identifying potential points of fire origin and evaluating potential fire causes in some fire incidents. The LFB recovered the flooring located under the fridge freezer, and it was taken into evidence by the MPS. The flooring was constructed of a medium density fiberboard embossed with a faux ceramic tile surface as depicted in Figure 13. The flooring contained an approximately rectangular burn pattern directly under the fridge freezer. The fire damage patterns are consistent with the effects of burning pooled plastic on the floor while confined under the fridge freezer in the compressor compartment. The degree of charring of the flooring is most significant toward the center, open area of the compartment, which is consistent with the effects of re-radiation of heat from the pool fire that occurred in this small compartment and the location of seams between planks in the flooring.

The charred surface of the combustible flooring contains a witness mark (i.e., a protected area) that indicates the location of the compressor mounting plate during the fire. Using this witness mark, the compressor plate is oriented on the flooring in Figure 14 to illustrate the position of the fridge freezer during the fire. A hashed red box outlines the approximate orientation of the fridge freezer. This orientation also matches the fire damage to the underside of the fridge freezer shown in Figure 10. From this orientation, the fridge freezer appears to have been angled away from the wall during the fire. The flooring has a hole along the seam under the compressor. This hole does not align with the capacitor, which is typically installed to the far

right edge of the compressor plate in the image. The hole sits below the compressor electrical terminal enclosure, but there was no damage to the components in the enclosure that would indicate that this is the point of fire origin. The hole is consistent with the anticipated effects of burning at a vertical seam between planks in the flooring, which allows more intense burning than along a flat horizontal surface. This phenomenon is common for fires on combustible plank flooring. Thus, the hole does not indicate a point of origin for the fire.

Figure 13. Fire damage to flooring under fridge freezer. The wall was located to the top of the image.

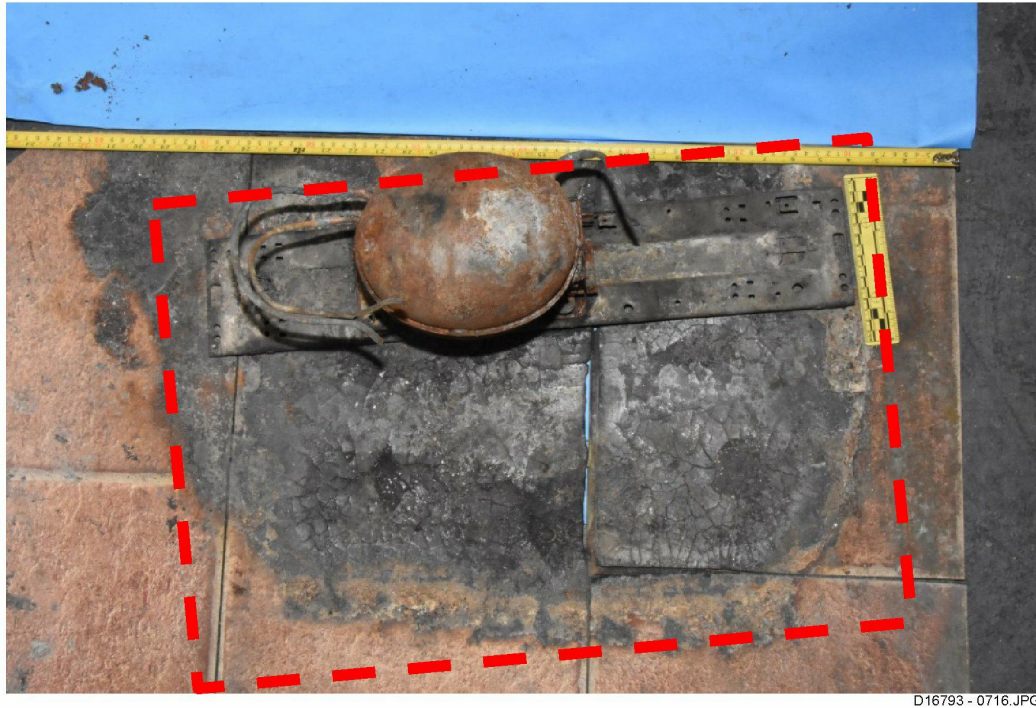
Figure 14. Compressor bracket aligned with fire damage pattern on floor. The hashed line approximates the orientation of the fridge freezer.

The fire pattern to left side of the red box (i.e., east, window side) in Figure 14 is not readily explained by the compressor compartment fire. This fire pattern extends beyond the shell of the fridge freezer, and may have been caused by external burning material or may be due to the angled orientation of the unit, which could allow flames to preferentially escape from this side. Exponent currently has insufficient information to determine the source of this fire damage pattern. A fire originating external to the fridge freezer will create the same or very similar damage patterns to those observed on the flooring under the fridge freezer if the combustible components of the fridge freezer become involved in the fire. The fire damage to the flooring does not uniquely support the fridge freezer as the point of origin or cause of the fire.

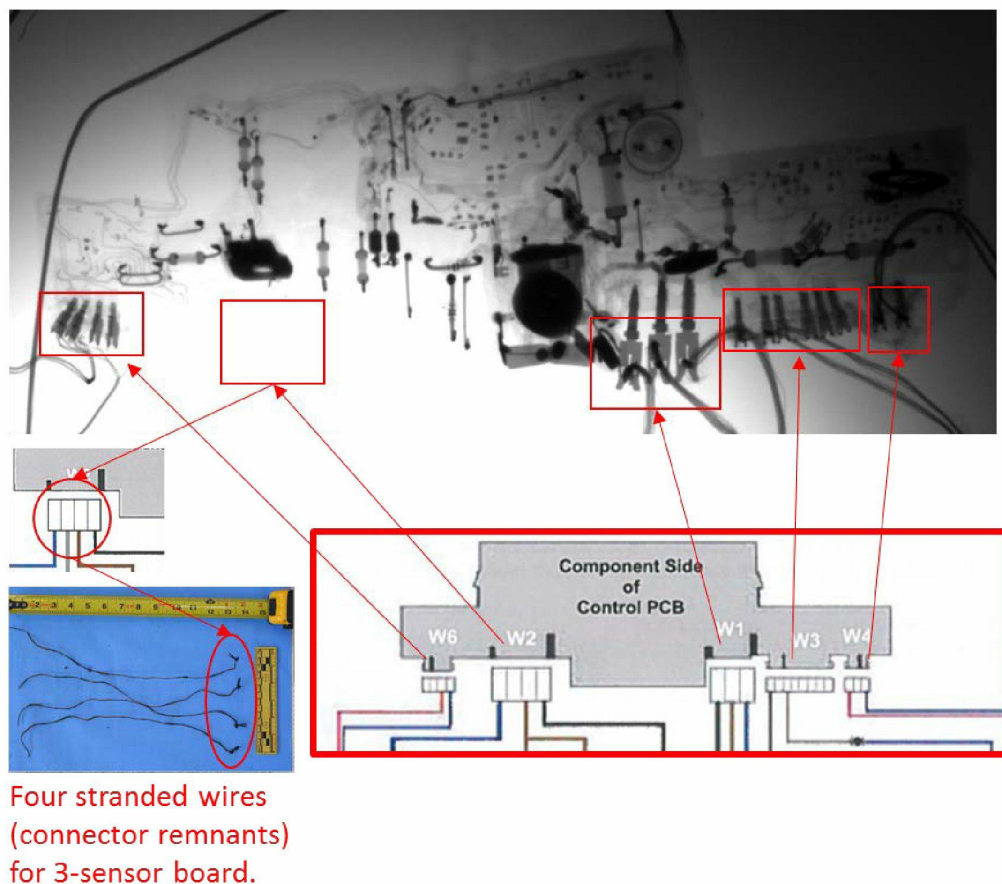
Control Board.PNG

1. Control Board. Exponent examined the contents of evidence bag SLW/5 labeled “Control board taken from within BPS1 – fridge freezer.”²³ Although the control board and wires were damaged by fire, there was no indication of electrical activity consistent with it causing a fire. As shown in Figure 15, all of the connections of wiring to the circuit board are accounted for and have been examined. The control board is therefore not a likely cause for the fire, since this fire cause hypothesis is not supported by the evidence.

Figure 15. Image of control board from evidence that shows all connections have been identified.

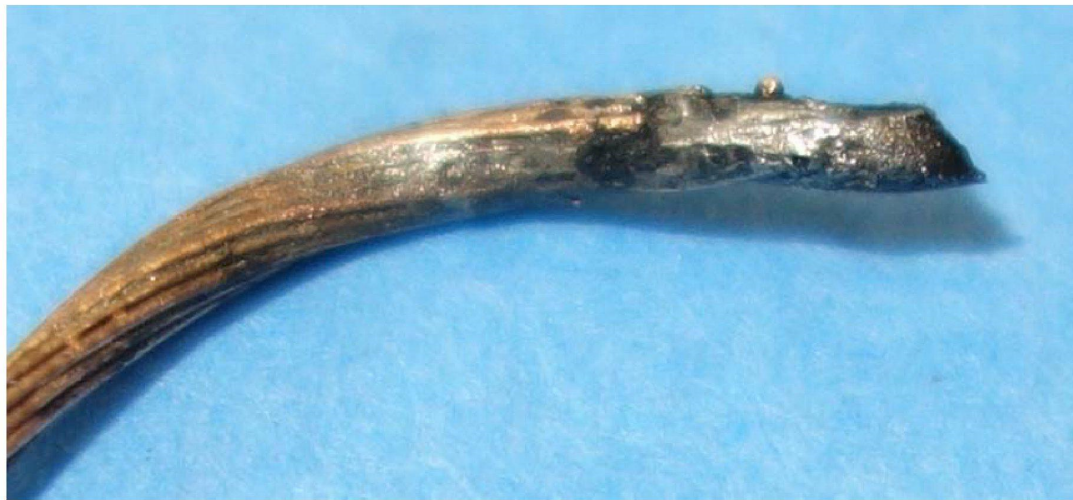
D16792 - 0500.jpg

8. Conductors from Fridge Base. Exponent examined evidence bag BPS3 labeled, “Conductors from fridge base.”³⁰ The bag contained loose sections of wiring, but the source of this wiring (whether from a fridge freezer wiring harness or some other appliance in the area) could not be determined without more information from the fire scene. A melted wire from the bag is depicted in Figure 16. The appearance of the wire indicates material loss, a sharp line of demarcation, and a re-solidified metal bead. These are all indicators of electrical activity, but without further information, they do not differentiate whether the activity was either the cause or the result of fire attack. Thus, hypothetical fire causes involving this wire are possible and cannot be confirmed or eliminated given the available evidence.

Figure 16. Section of wire from evidence bag BPS3 exhibiting evidence of electrical activity.
