Senior Fire Safety Officers Report

Grenfell Tower

Appendix 1 - SFSO Observations Grenfell Tower

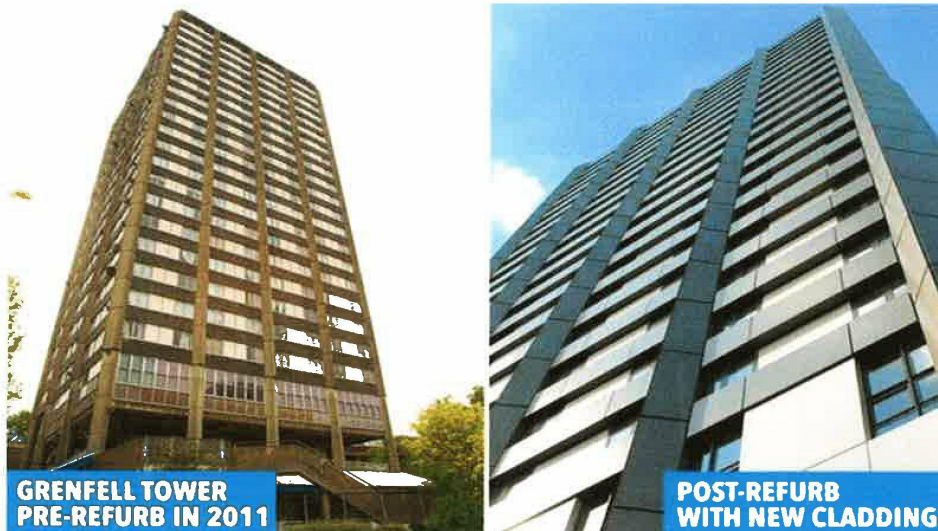
Grenfell tower was built in 1974 and is a 24 storey residential block of 130 flats around a concrete shell and core. The building is managed by Kensington and Chelsea TMO (Tenant Management Organisation) on behalf of the council. The building had a £10million refurbishment, which was completed in 2016. The large scale works included upgrading the external cladding, new windows, new heating system, lobby smoke control system, unused spaces were redeveloped to incorporate a number of new residential dwellings and an upgrade of the existing Crèche and community boxing club. Fire doors to existing flat entrance doors were also upgraded at some point.
